32-33 TORRINGTON SQUARE  
MONITORING

Monitoring Report  
SES-10215-MR05

Date of survey completion: 25<sup>th</sup> June 2018

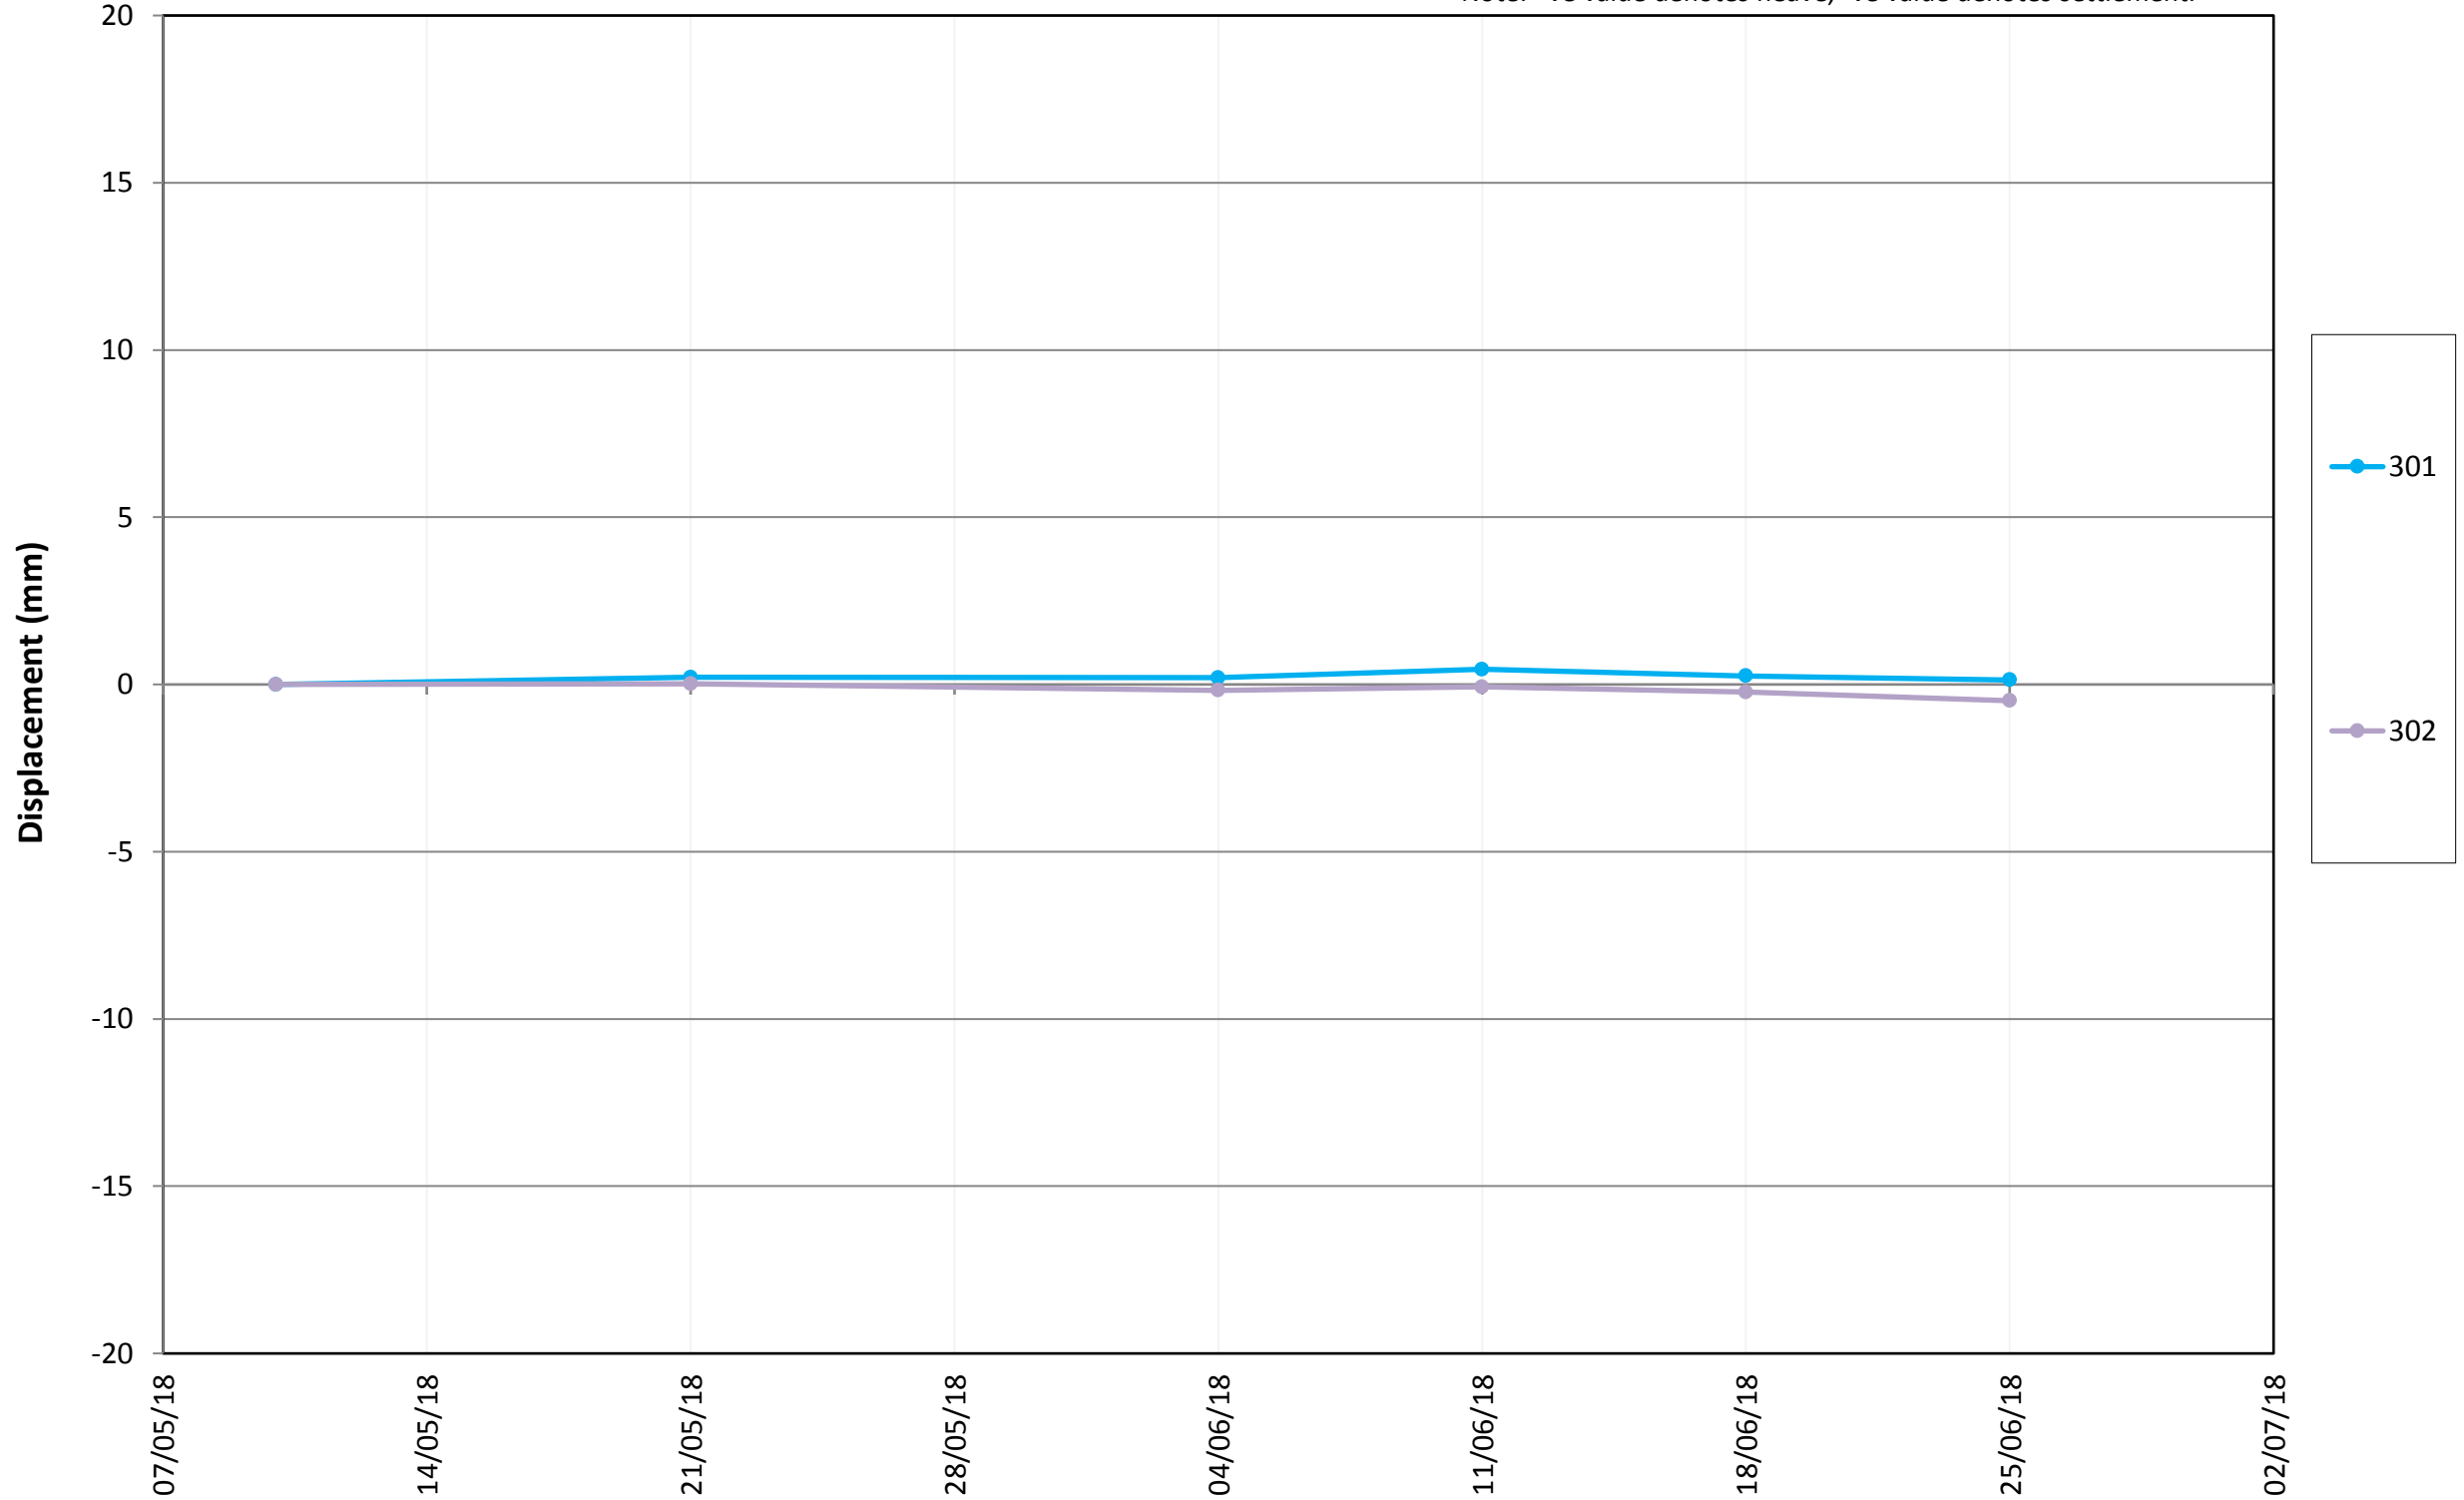
Graph 04 - Precise Level Points on Front Elevation of The Warburg Institute

Precise level points are showing negligible movement.

Note: +ve value denotes heave, -ve value denotes settlement.

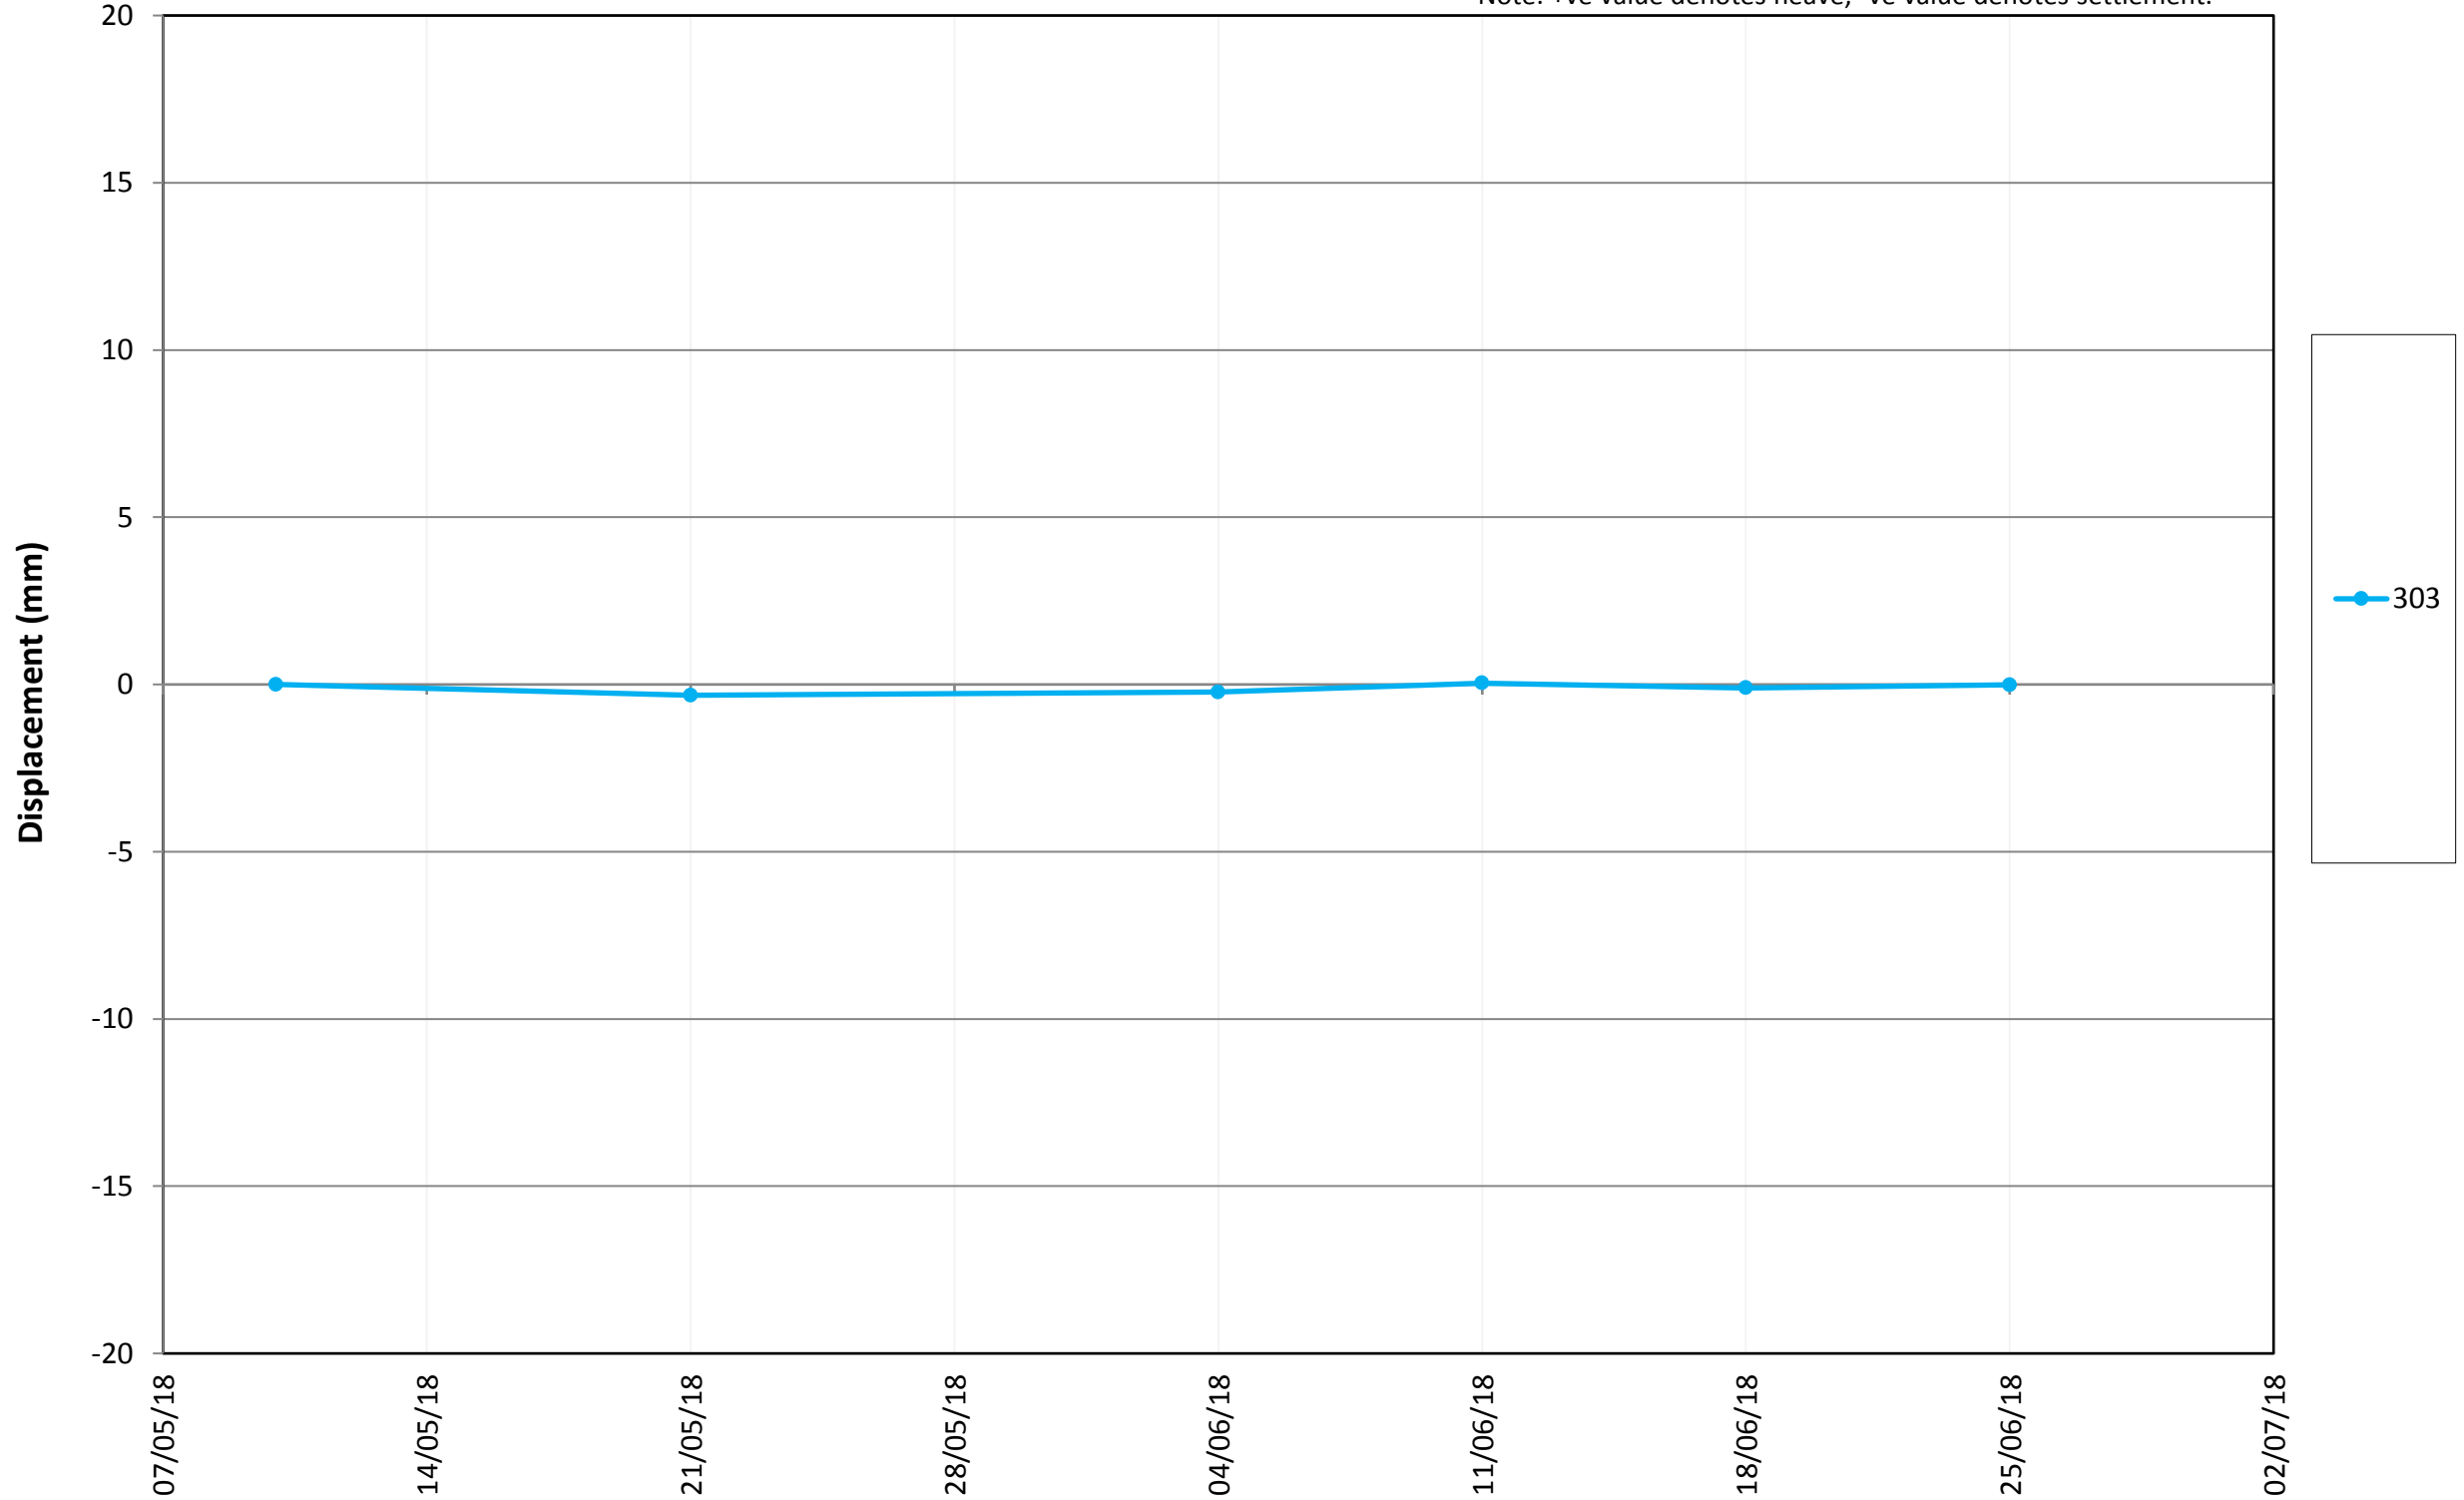
Graph 05 - Precise Level Points on Side Elevation of The Warburg Institute

Precise level points are showing negligible movement.

Note: +ve value denotes heave, -ve value denotes settlement.

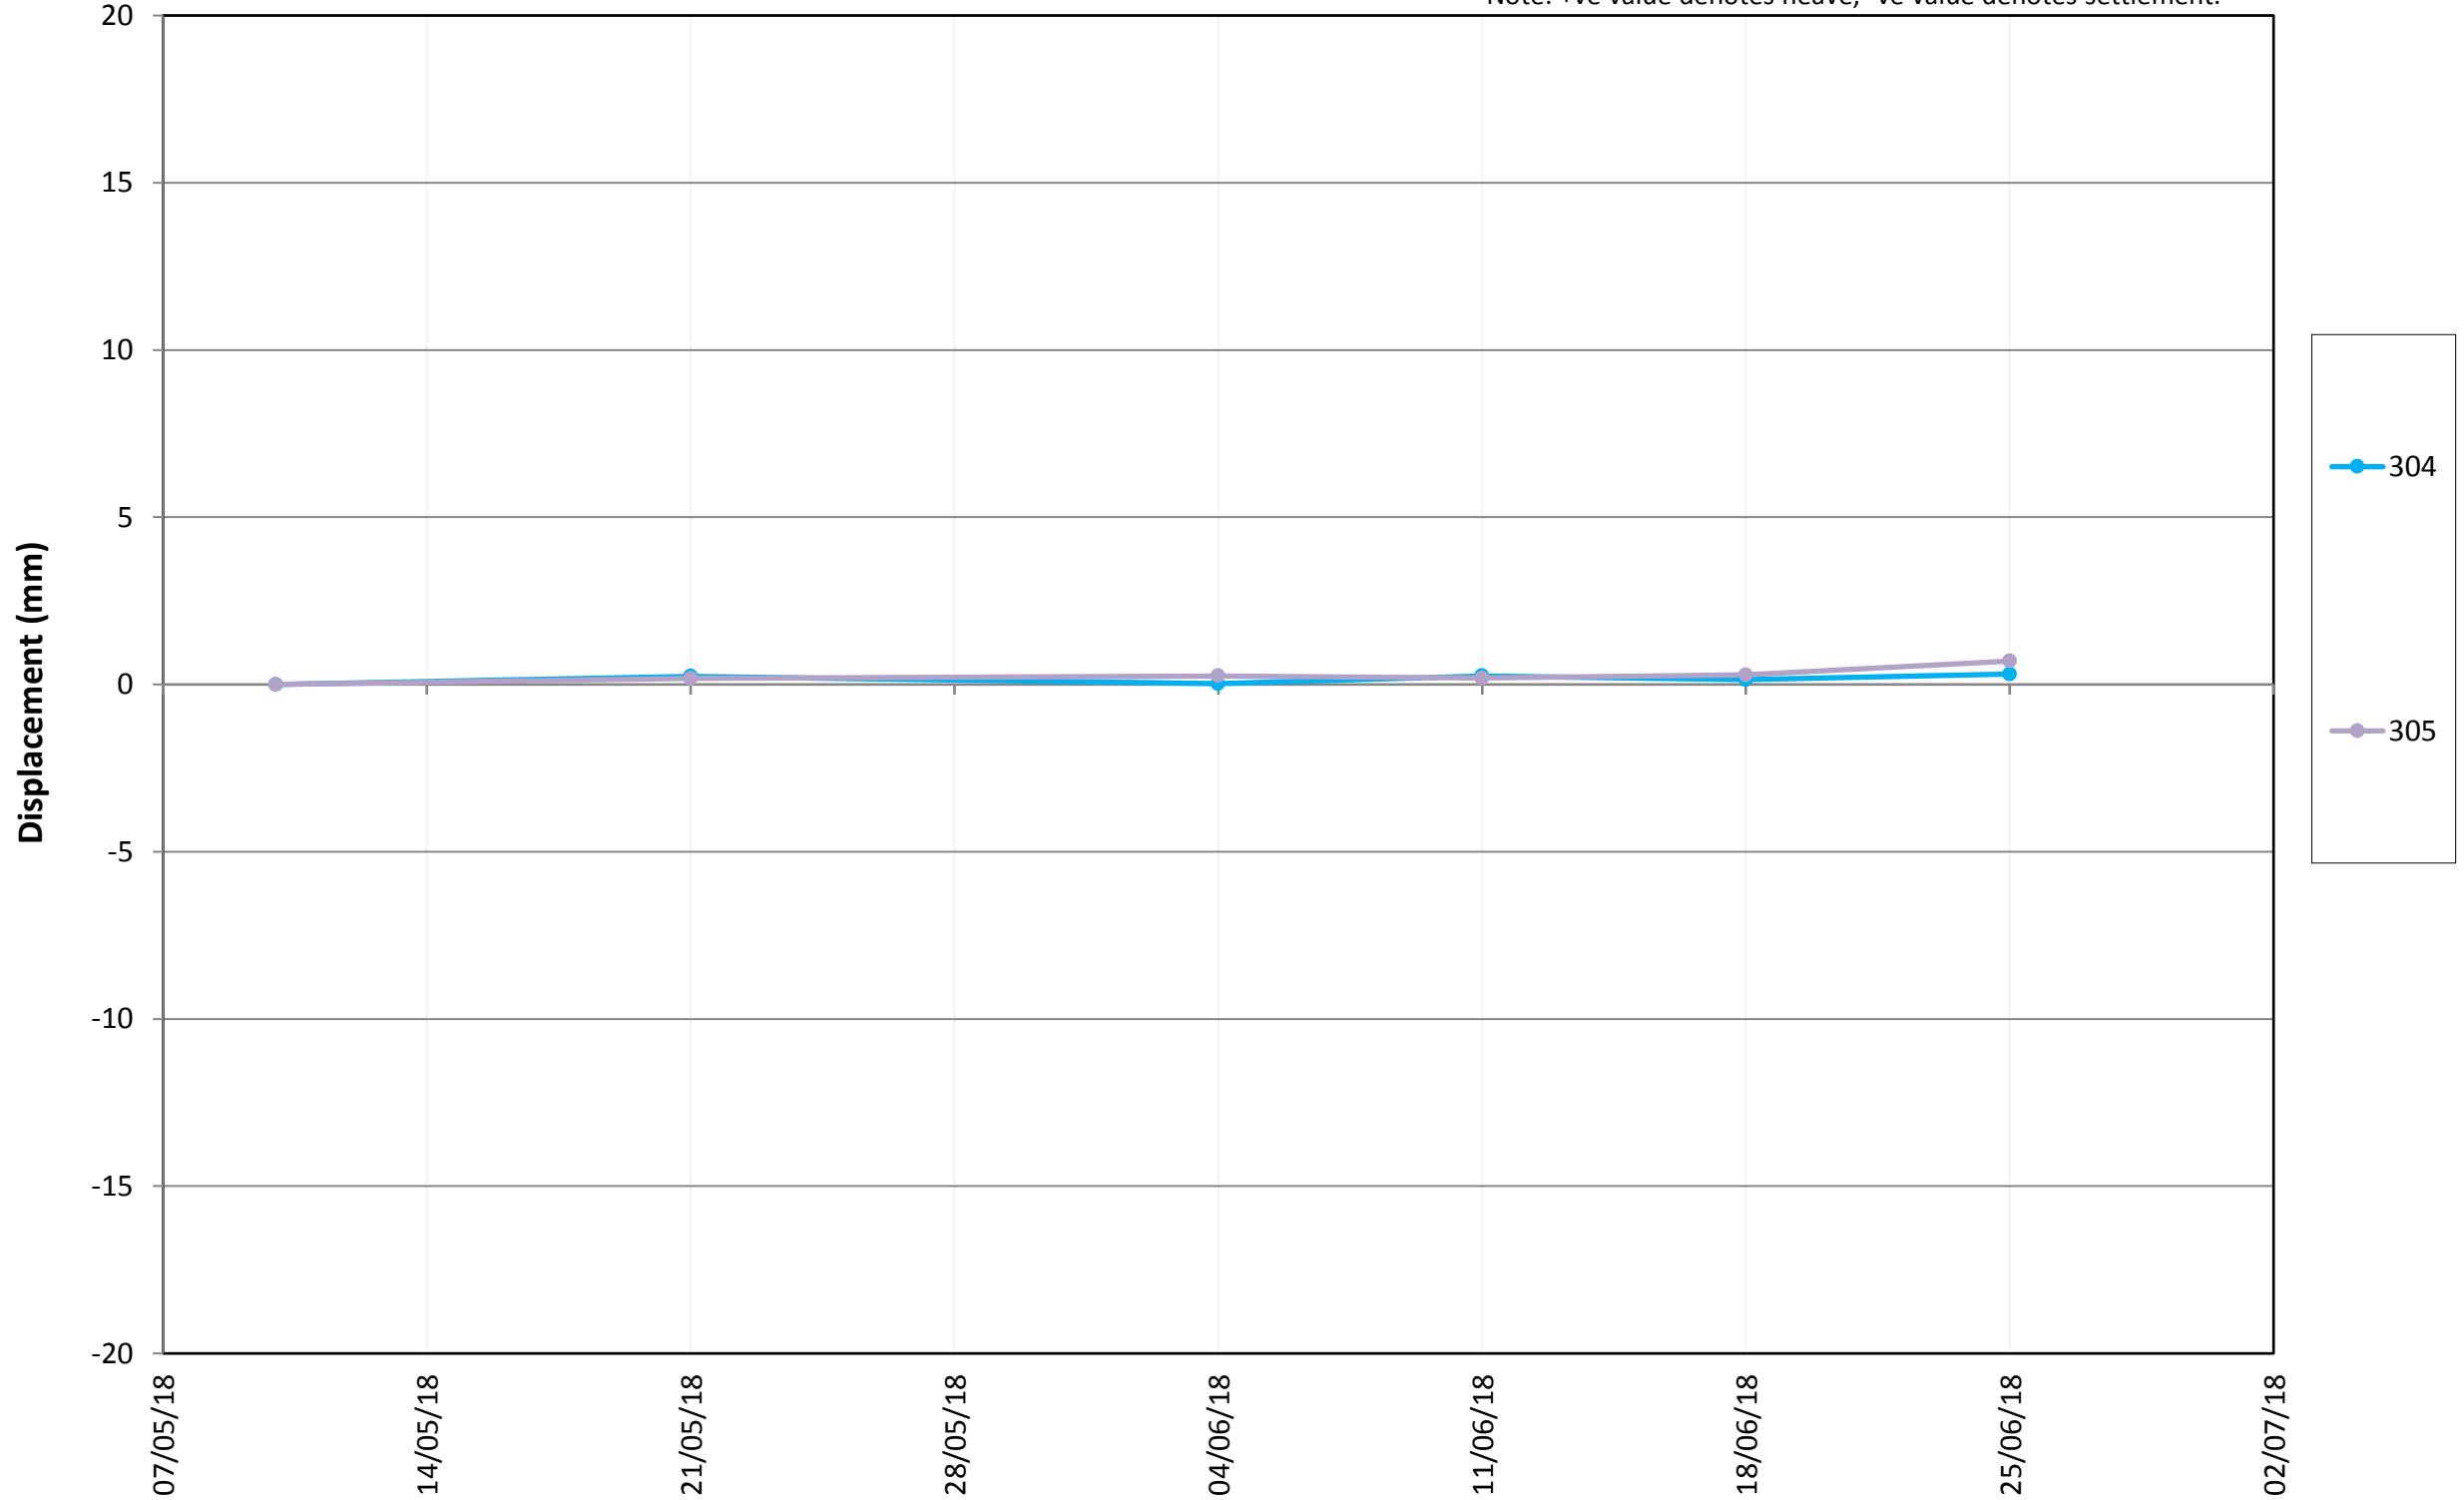
Graph 06 - Precise Level Points on Rear Elevation of The Warburg Institute

Precise level points are showing negligible movement.

Note: +ve value denotes heave, -ve value denotes settlement.

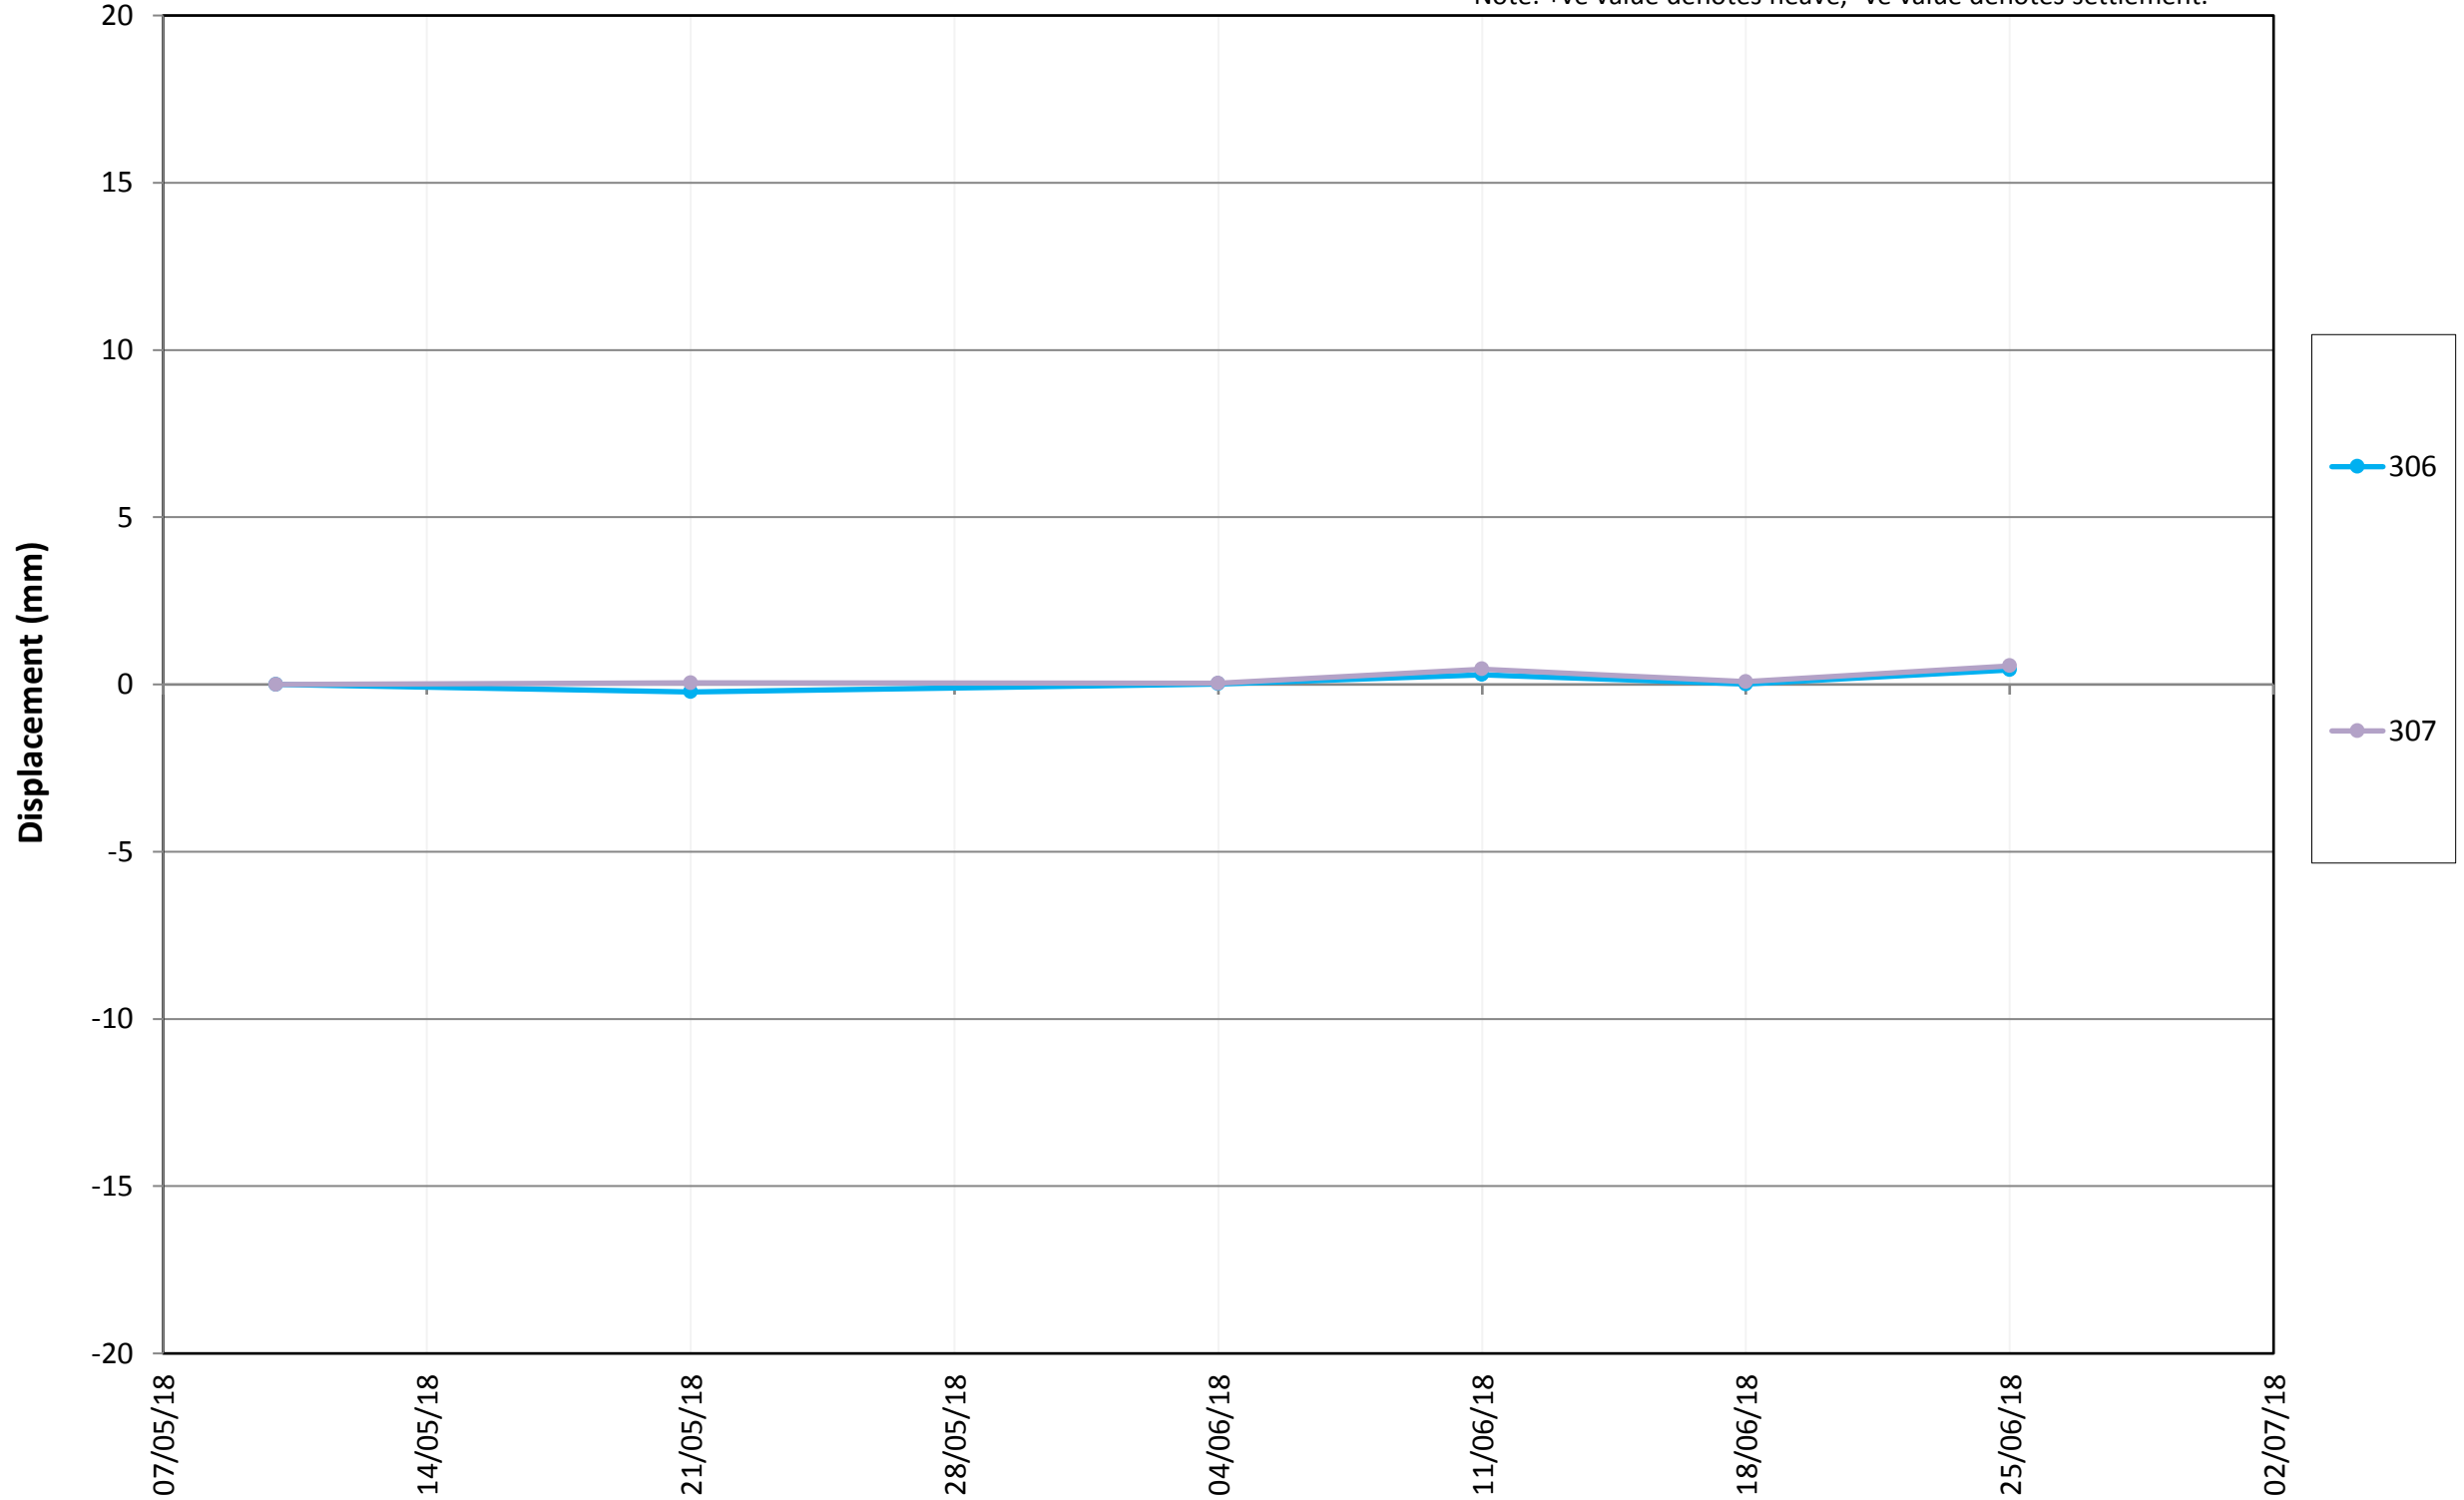
Graph 07 - Precise Level Points on Side Elevation of No. 32 Torrington Square

Precise level points are showing negligible movement.

Note: +ve value denotes heave, -ve value denotes settlement.

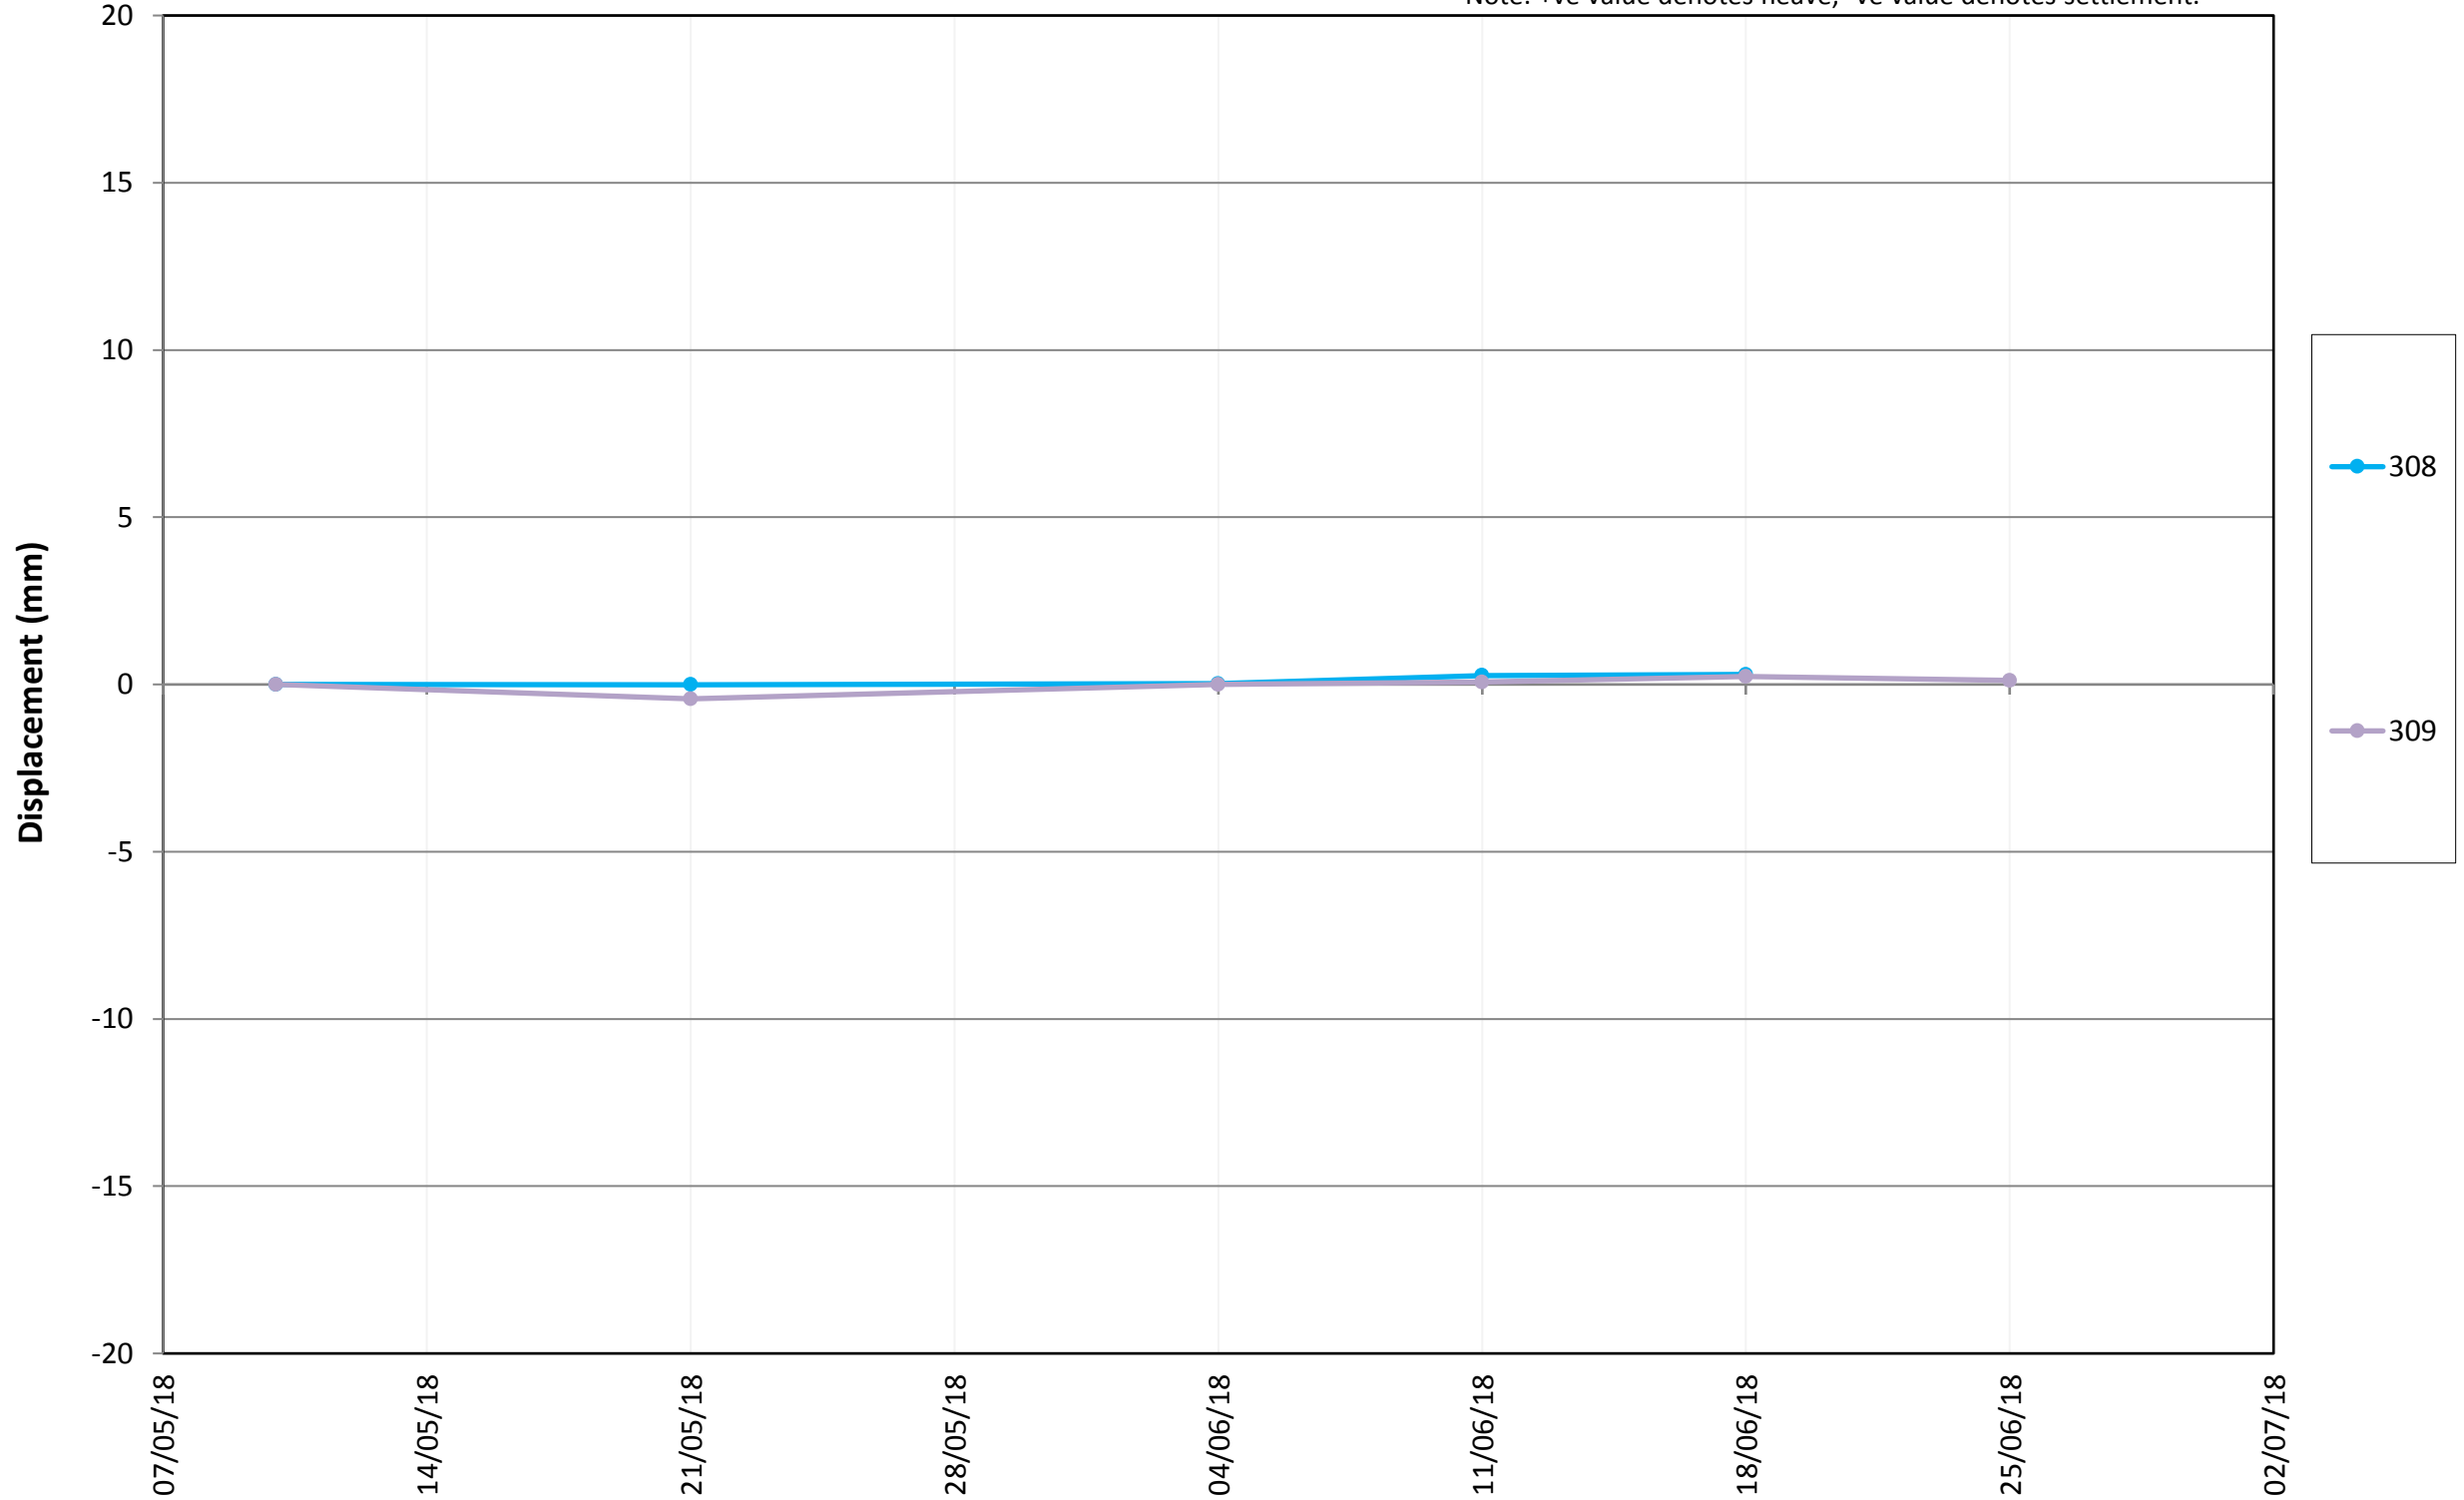
Graph 08 - Precise Level Points on Front Elevation of No. 32 Torrington Square

Precise level points are showing negligible movement.

PLP 308 was not surveyed due to asbestos works.

Note: +ve value denotes heave, -ve value denotes settlement.

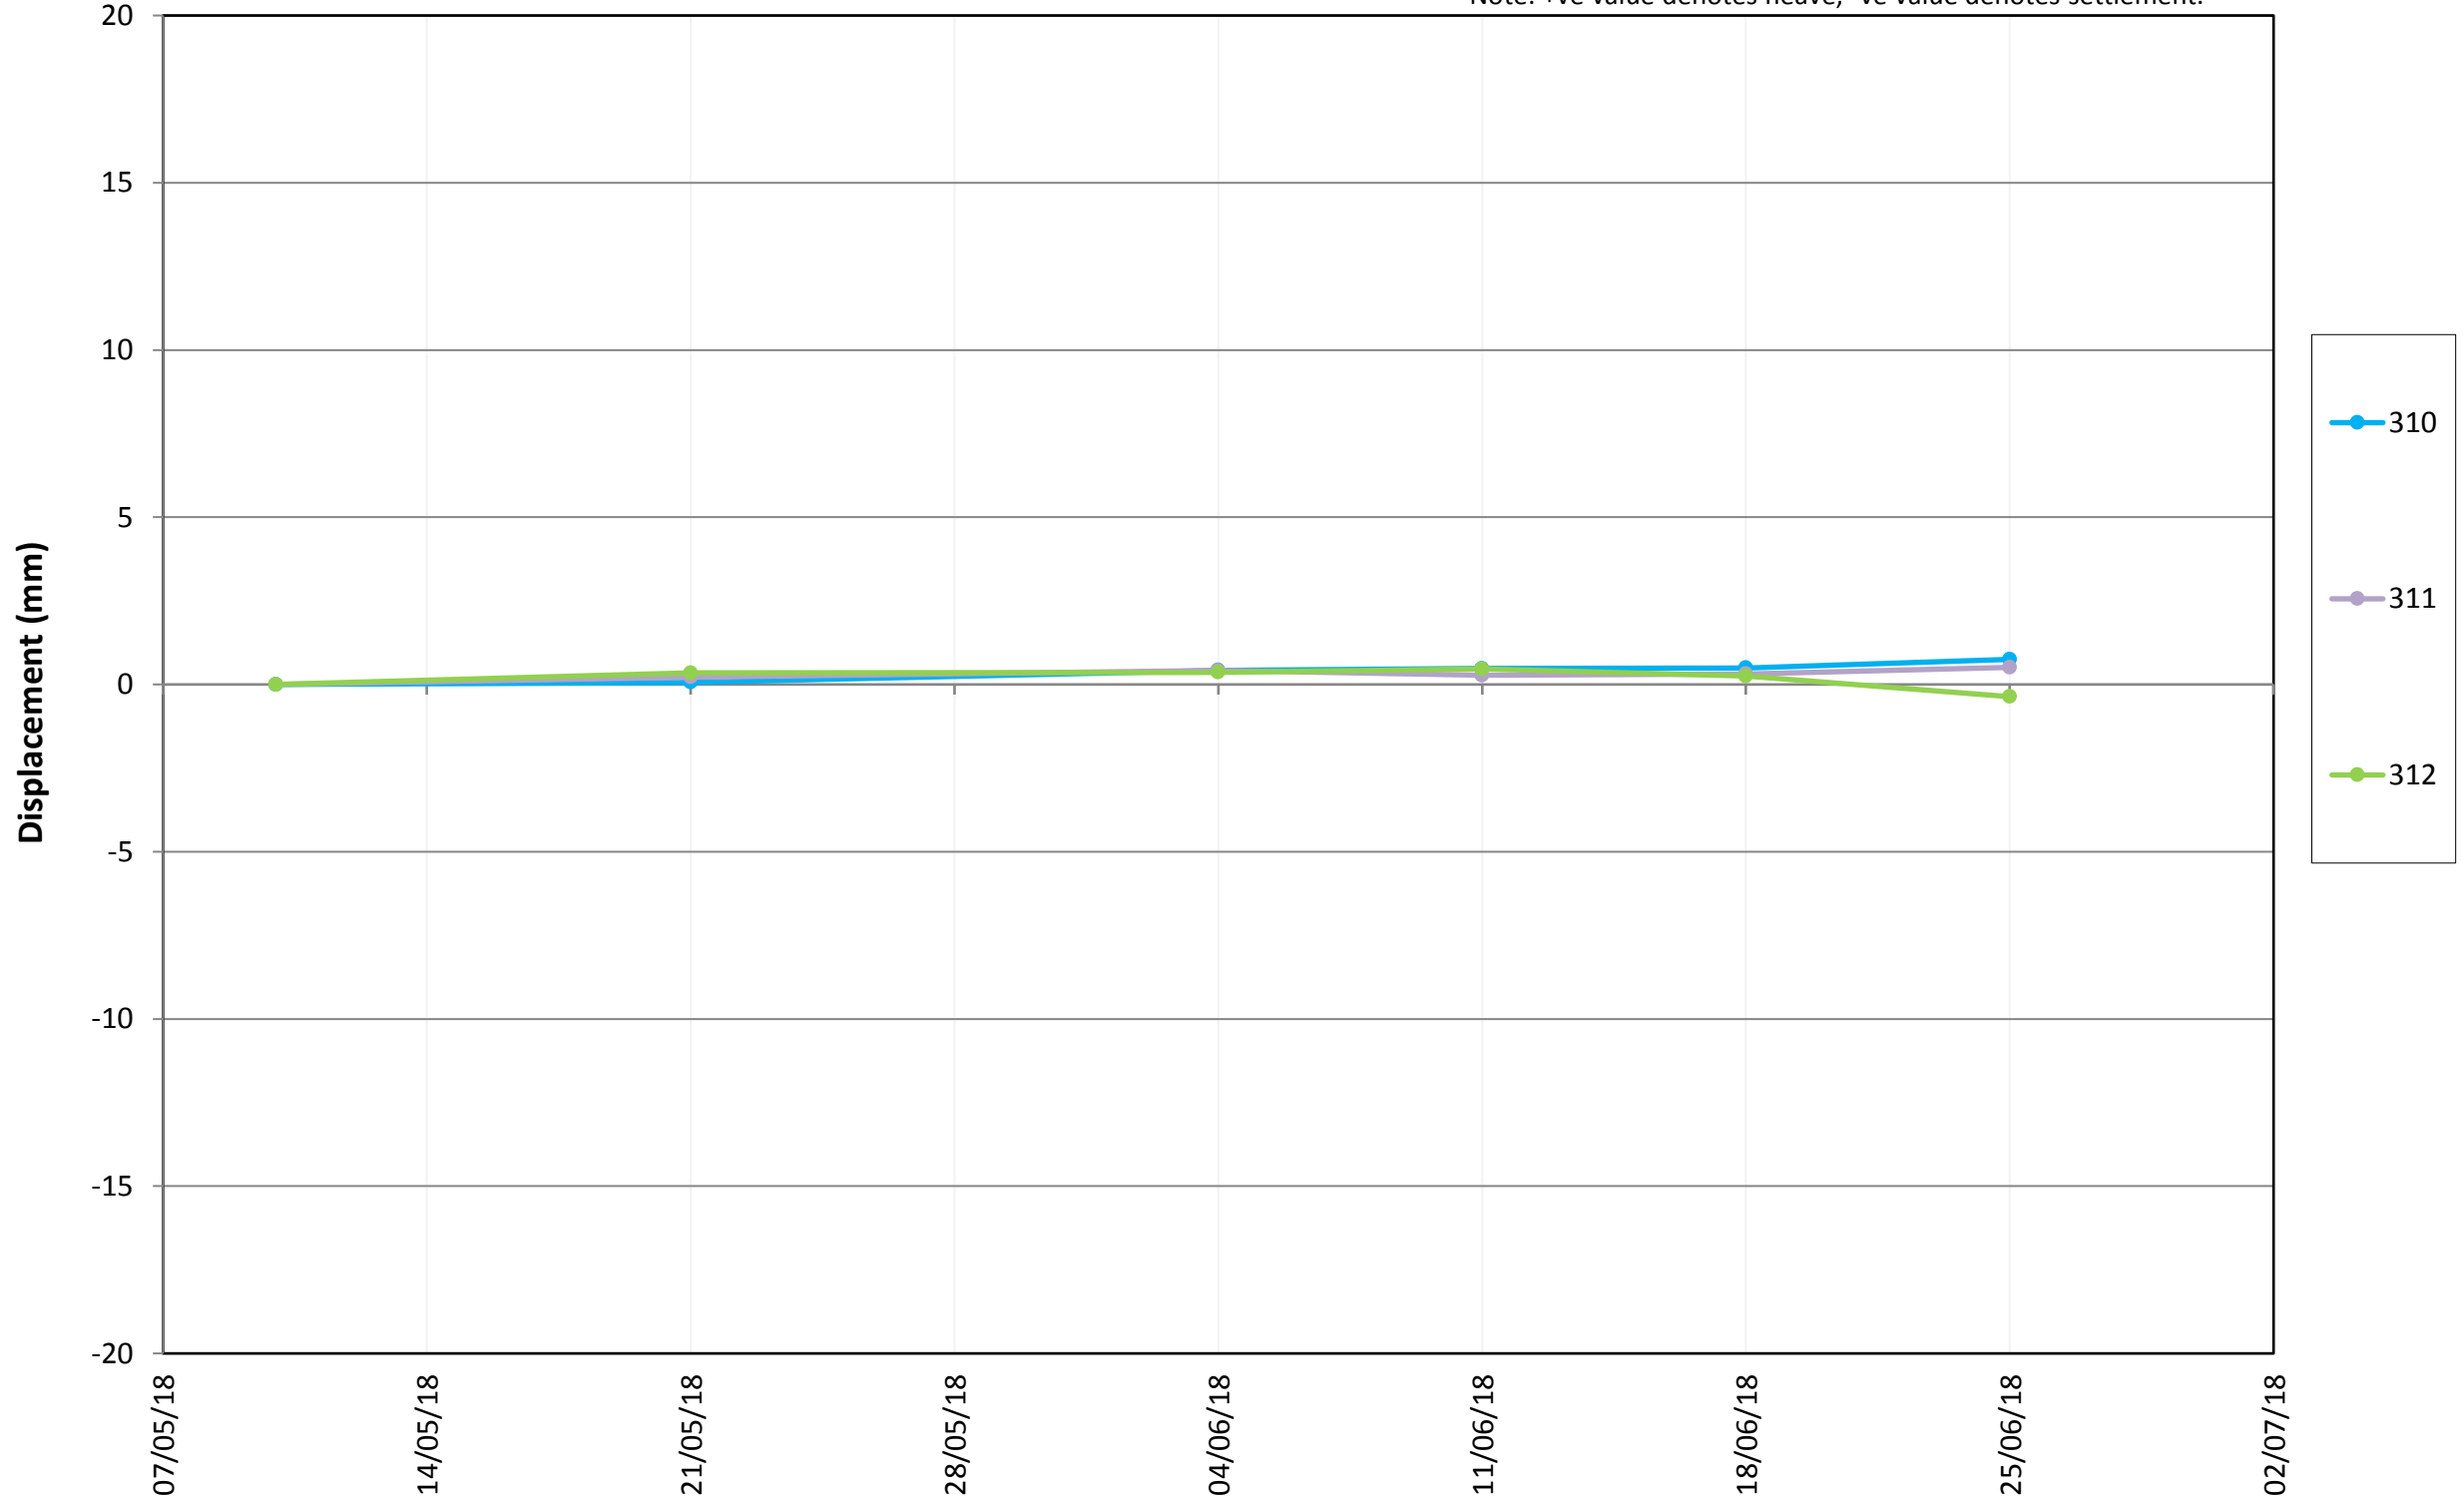
Graph 09 - Precise Level Points on Front Elevation of No. 31 Torrington Square

Precise level points are showing negligible movement.

Note: +ve value denotes heave, -ve value denotes settlement.
