32-33 TORRINGTON SQUARE  
MONITORING

Monitoring Report  
SES-10215-MR05

Date of survey completion: 25<sup>th</sup> June 2018

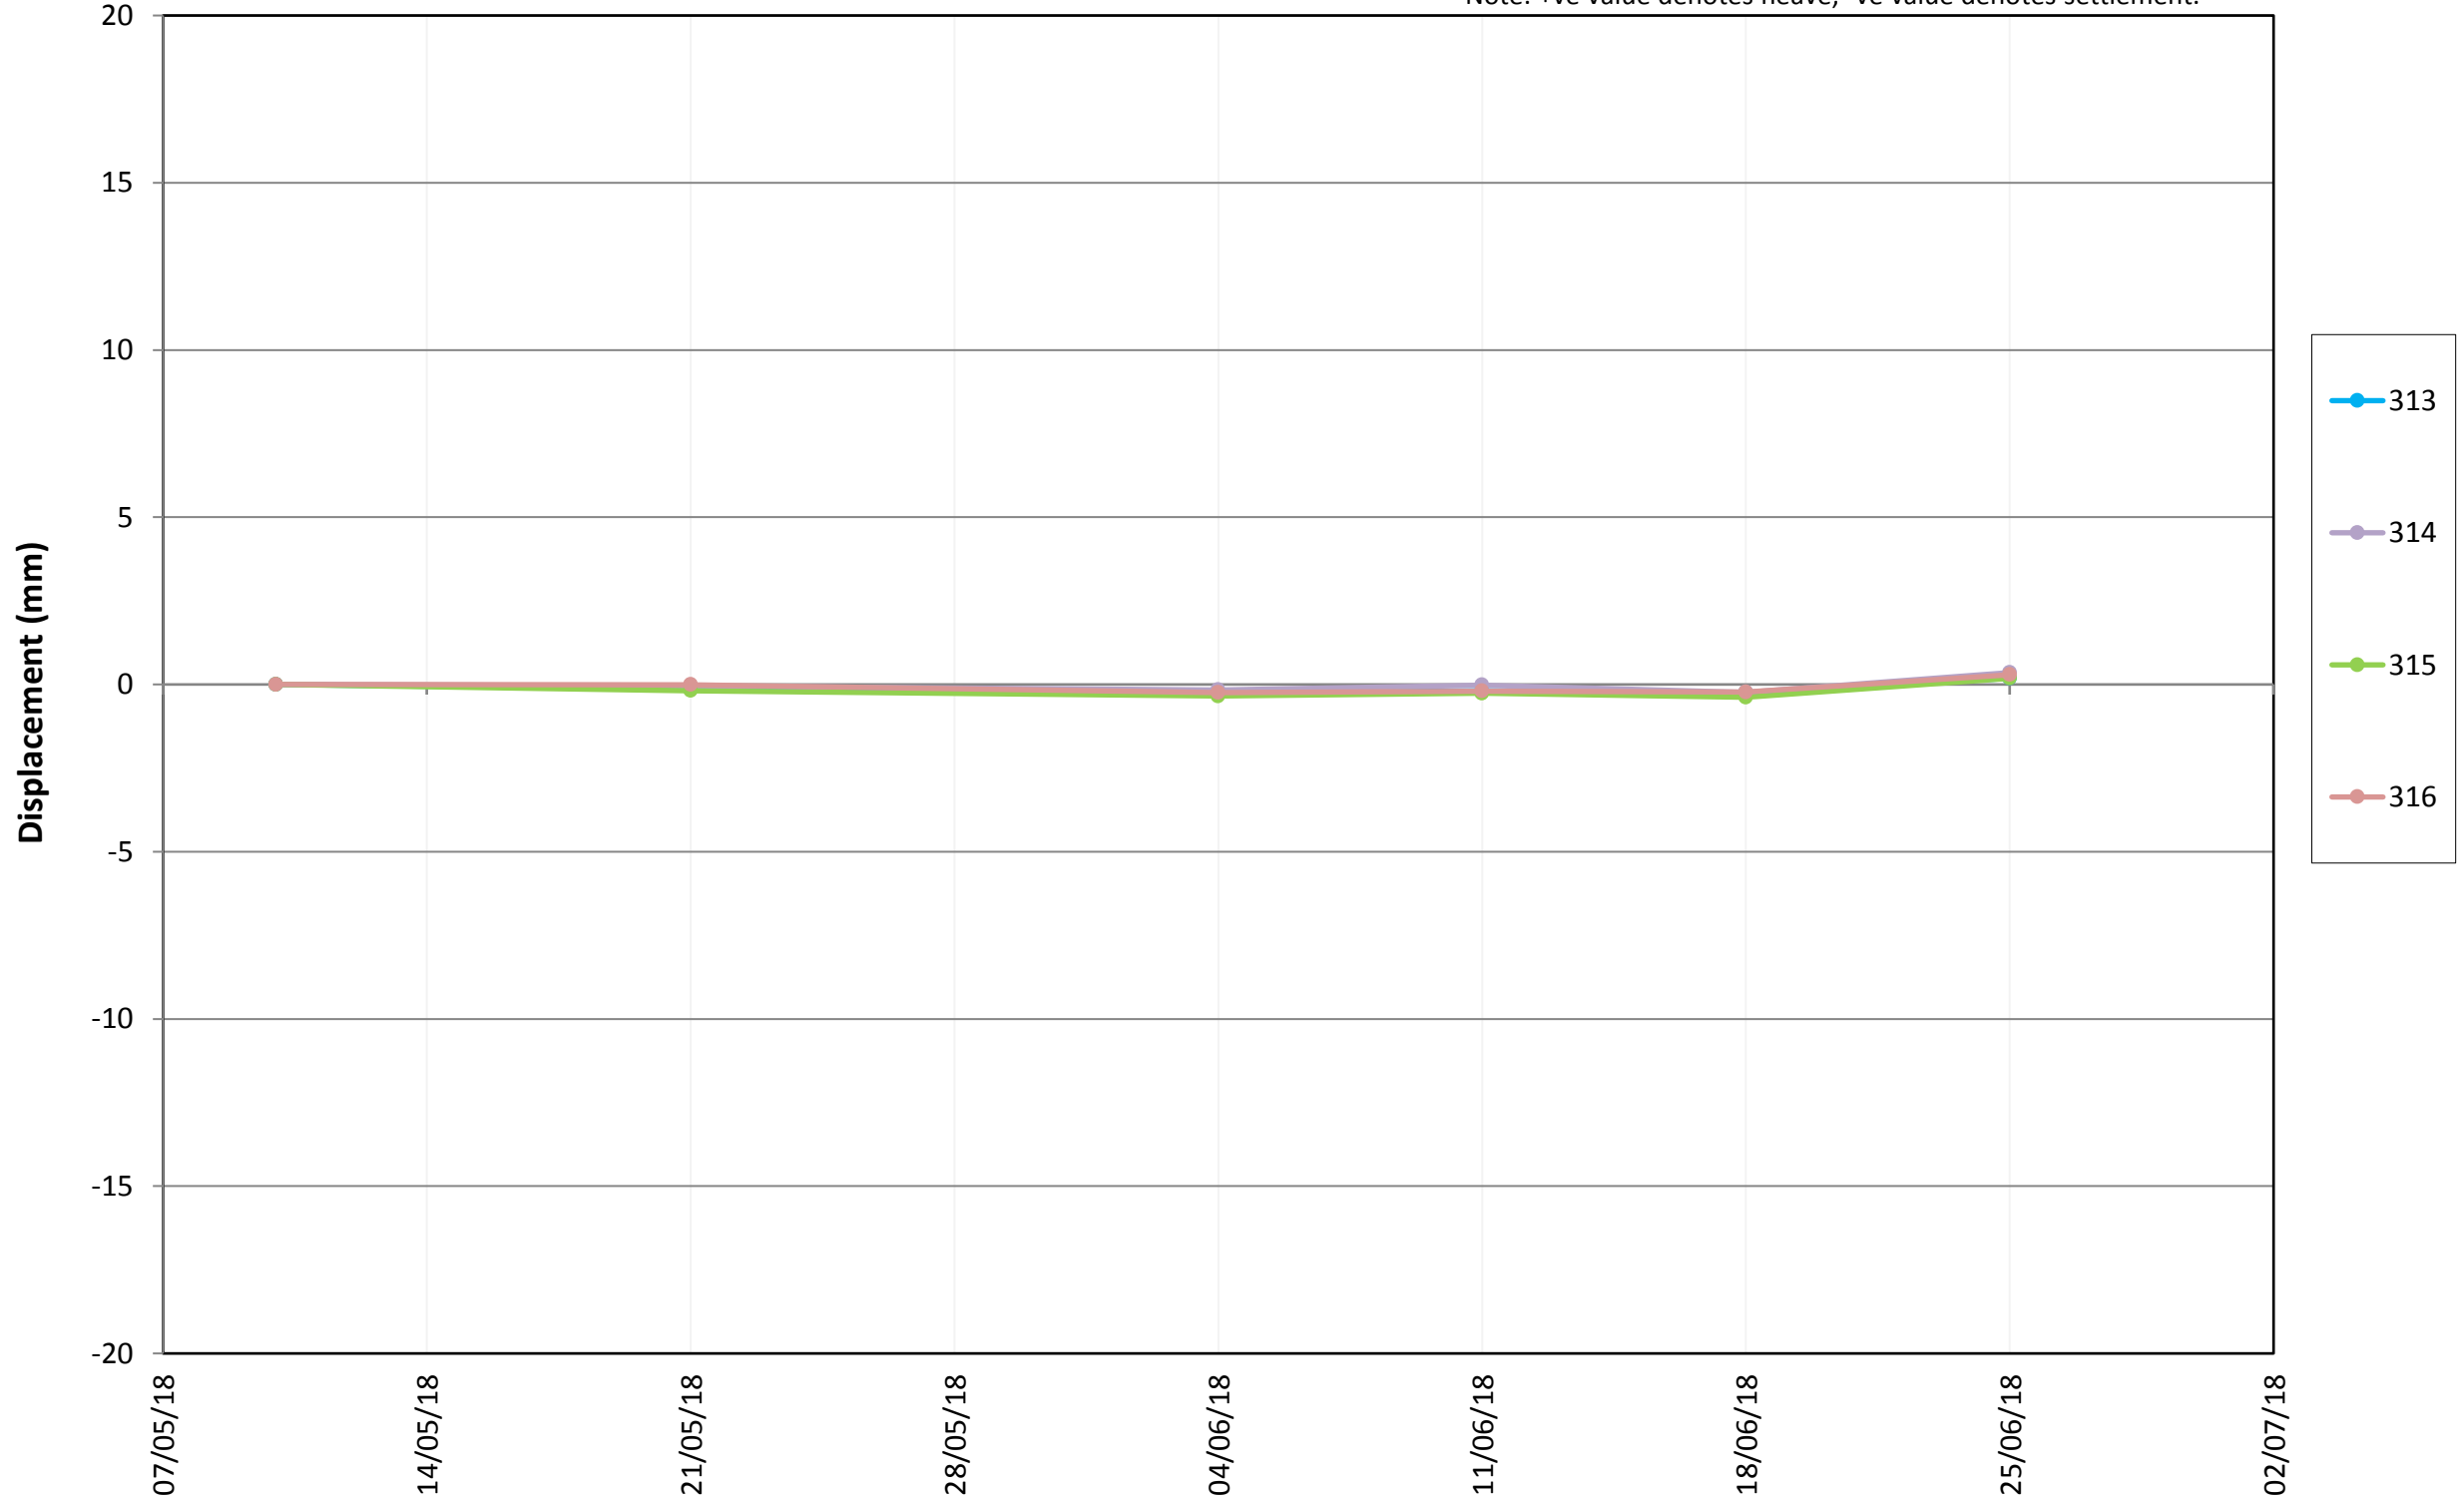
Graph 10 - Precise Level Points on Staircase

Precise level points are showing negligible movement.

Note: +ve value denotes heave, -ve value denotes settlement.
