GROUND INVESTIGATION AND BASEMENT IMPACT ASSESSMENT REPORT

16 ROSECROFT AVENUE, HAMPSTEAD, LONDON, NW3 7QB

Report Reference: GWPR2630/GIR/July 2018		Status: DRAFT	
Issue:	Prepared By:	Verified By:	Surface Flow and Flooding Verified By:
V1.00 JULY 2018

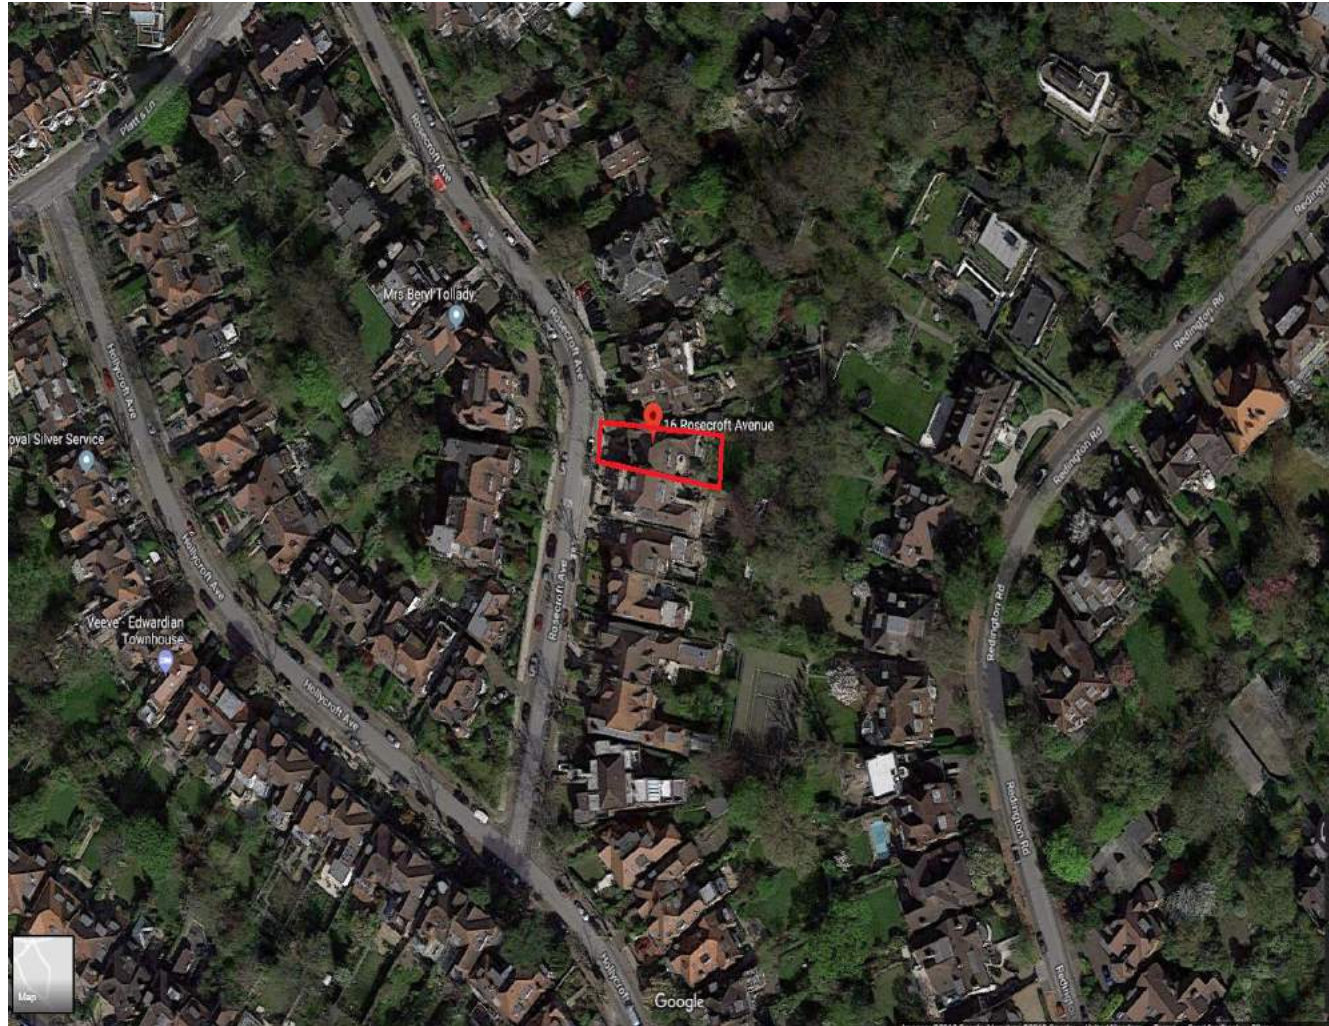
Figure 2

Project:		16 Rosecroft Avenue, London, NW3 7QB	
Client:	Mrs Appleton c/o Vincent&Rymill/5D Architects	Date:	July 2018
Site Development Area		Ref:	GWPR2630

The national grid reference for the centre of the site was approximately TQ 25507 86205 A site location plan is given within Figure 1. A plan showing the site area is given within Figure 2.

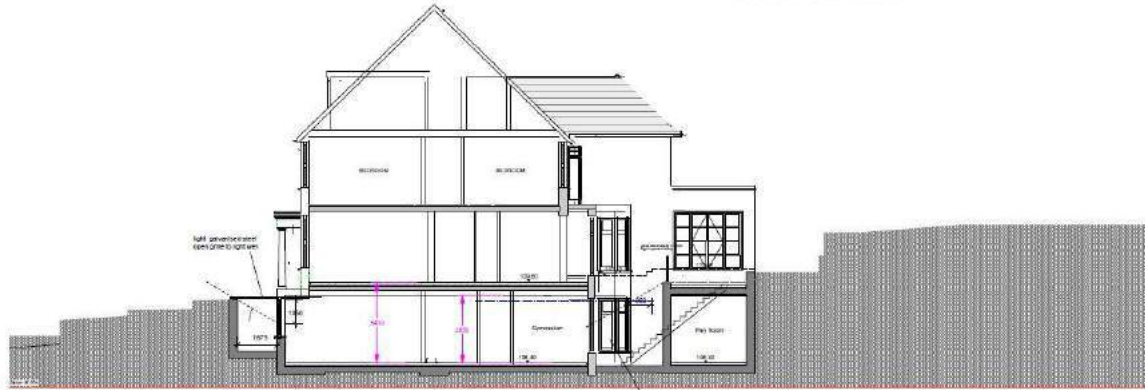
Figure 7

PROPOSED SECTION THROUGH REAR EXTENSION AND LOWER GROUND FLOOR

PROPOSED SECTION THROUGH REAR LIGHT WELL AREA

At the time of reporting, July 2018, the proposed development was understood to comprise the excavation of a basement below the entire footprint of the ground floor (between ~109 – 112m AOD), including construction of lightwells, as well a single storey rear extension. The basement will be excavated ~3.40m below first floor level (formed at 106.40m AOD). The retaining wall foundation of the basement is to be formed at ~2.00m below driveway level (floor level of front garage) (bdl) and ~4.20m below patio level (bpl) at the rear garden. A section view of the proposed development can be viewed within Figure 7, with a proposed plan view provided in Figure 8.
