GROUND APPRAISAL REPORT
for the site at
1 WADHAM GARDENS
LONDON
NW3 3DN
on behalf of
MARCUS COOPER GROUP

Report:	GROUND APPRAISAL REPORT
Site:	1 WADHAM GARDENS LONDON NW3 3DN
Client:	MARCUS COOPER GROUP
Date:	OCTOBER 2015
Reference:	GE10977 – GARv2JT151005
Version:	1.0
Prepared by:	 
	Luke Stock BSc (Hons) Consultant Engineer

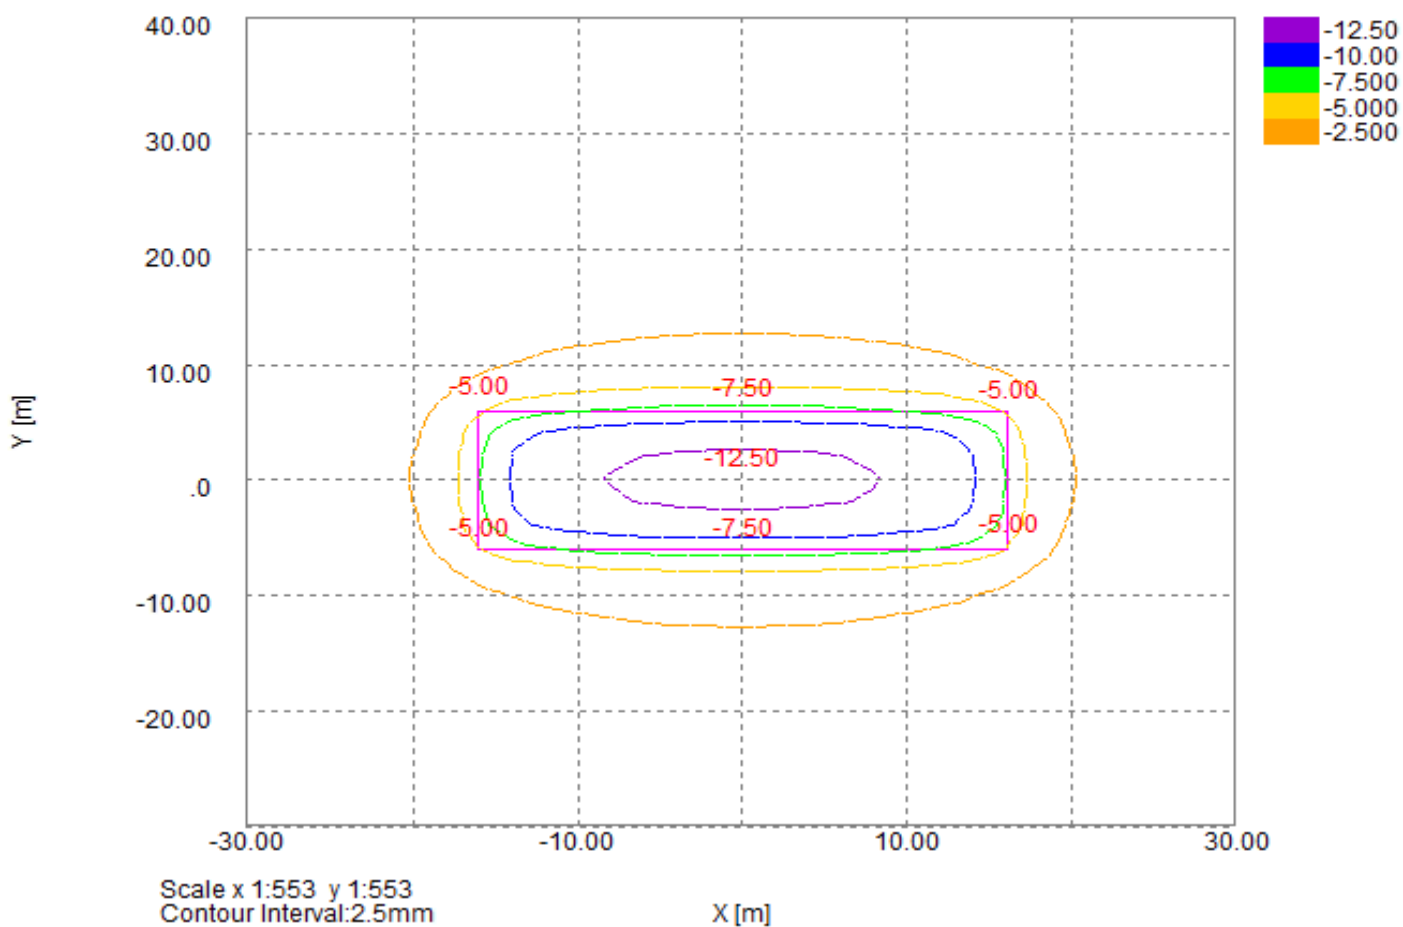
Settlement Contours : Grid 1 at -3.5000m

The loading that results from the new construction will apply in the long term, over the structure's lifetime. Hence there will be both a short term and long term response. Generally, the long term behaviour results in larger movements. The overall movement of the ground following construction is, however, driven by the total changes in loading that have occurred; thus it is a combination of the unloading caused by demolition and excavation of soil and the imposed loading from the new structure.

The ground response to stress changes have therefore been modelled in the short term for the unloading caused by excavation and removal of overburden pressure. The long term response has been modelled for the net stress change caused by the combination of demolition, the excavation and new loading.

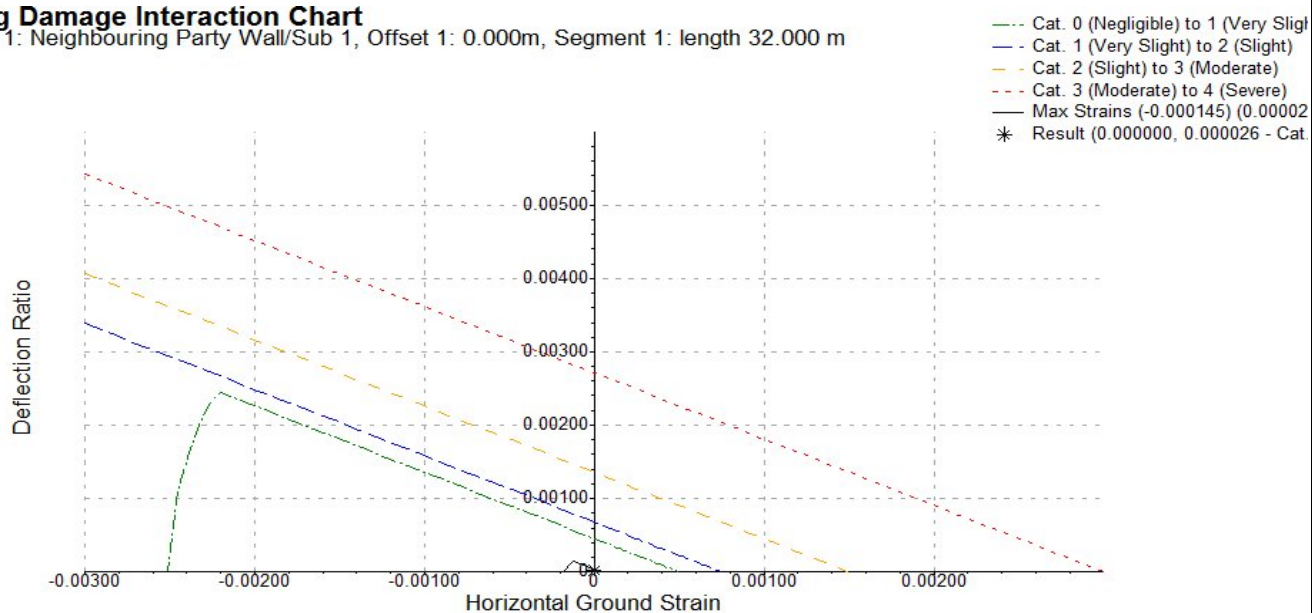
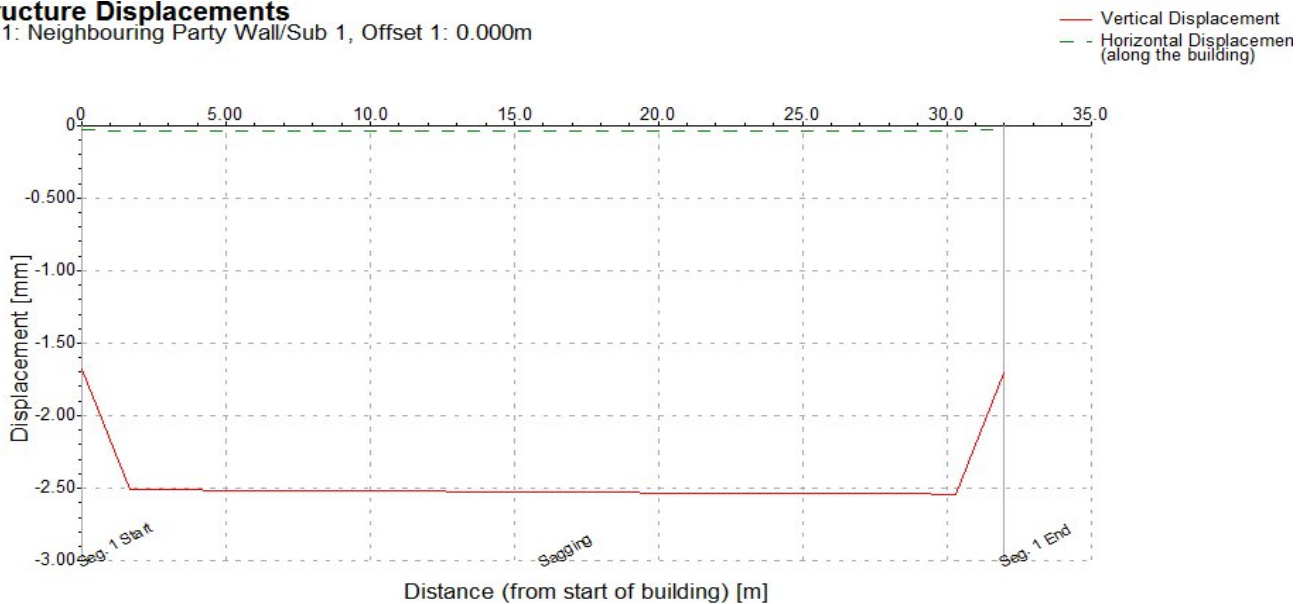
Building Damage Interaction Chart

Structure 1: Neighbouring Party Wall/Sub 1, Offset 1: 0.000m, Segment 1: length 32.000 m

Sub-Structure Displacements

Structure 1: Neighbouring Party Wall/Sub 1, Offset 1: 0.000m

The adjoining structures have been modelled in Xdisp in order to assess the potential category of damage in accordance with the criteria derived by Burland (1997) presented overleaf:

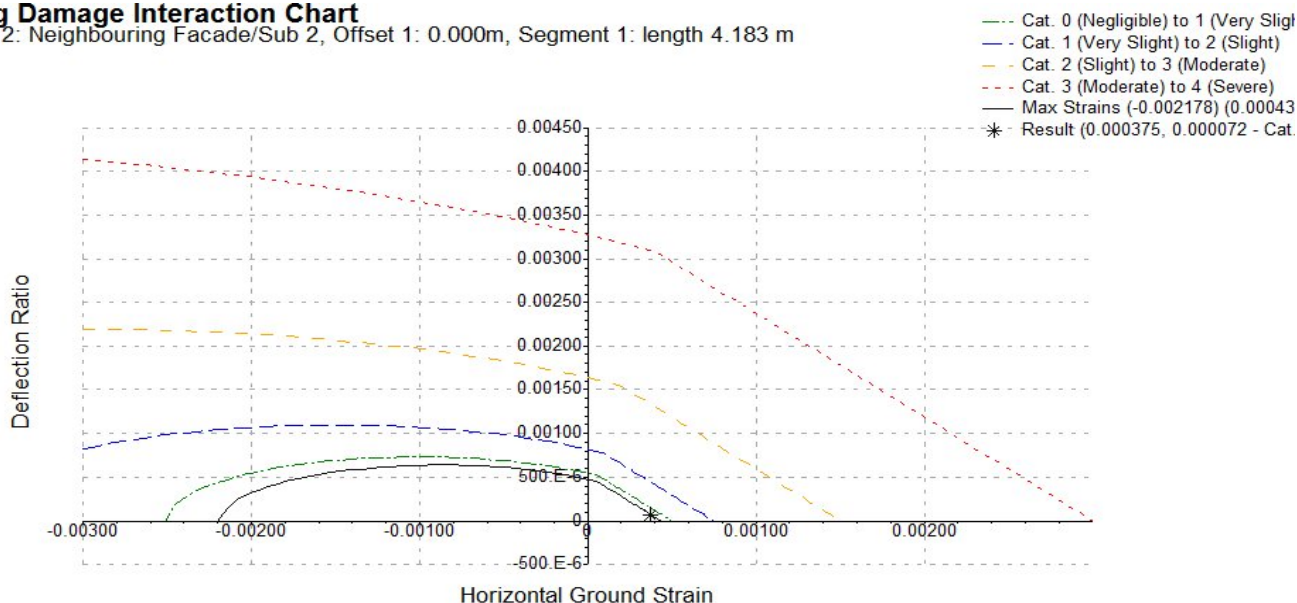
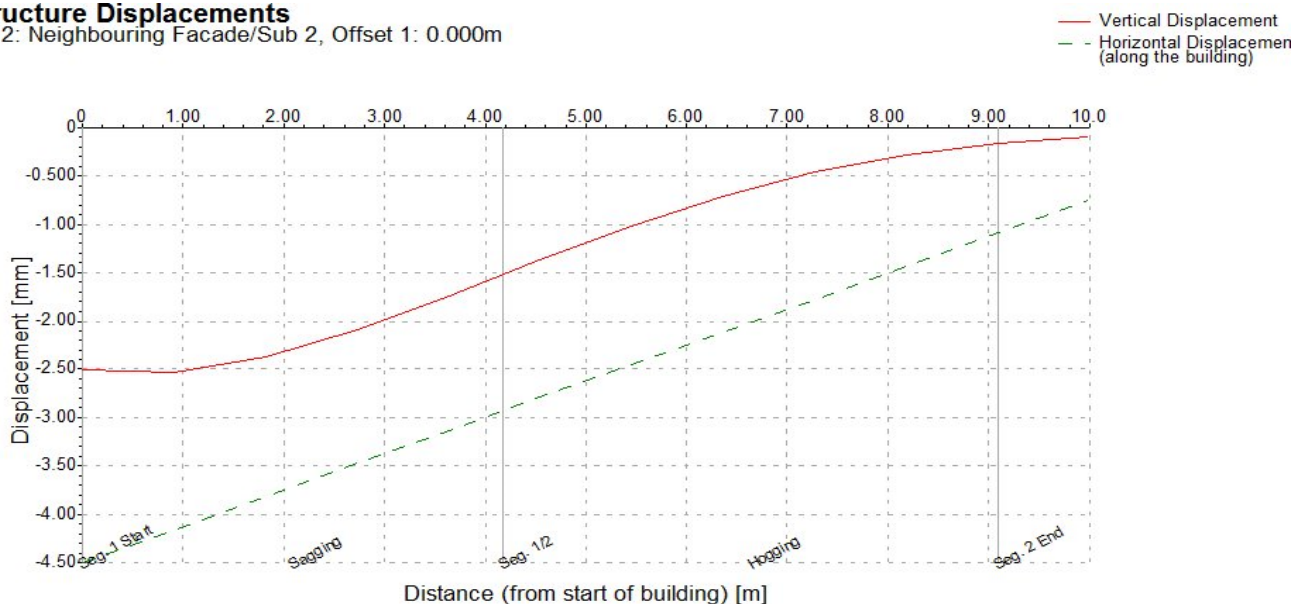
Building Damage Interaction Chart

Structure 2: Neighbouring Facade/Sub 2, Offset 1: 0.000m, Segment 1: length 4.183 m

Sub-Structure Displacements

Structure 2: Neighbouring Facade/Sub 2, Offset 1: 0.000m

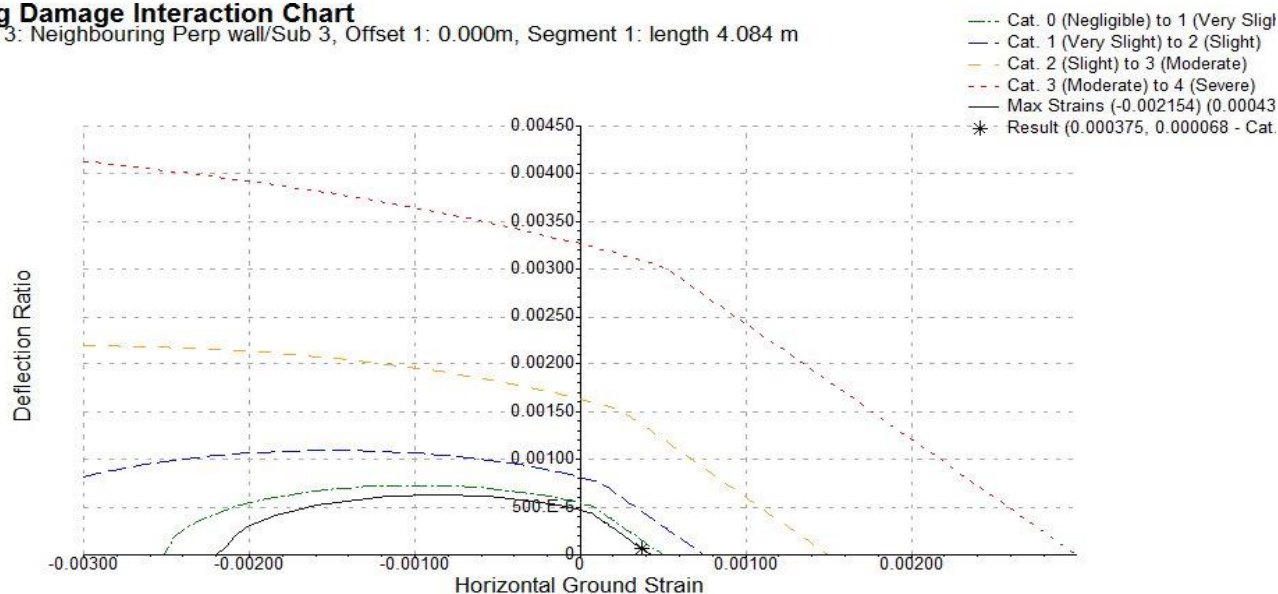
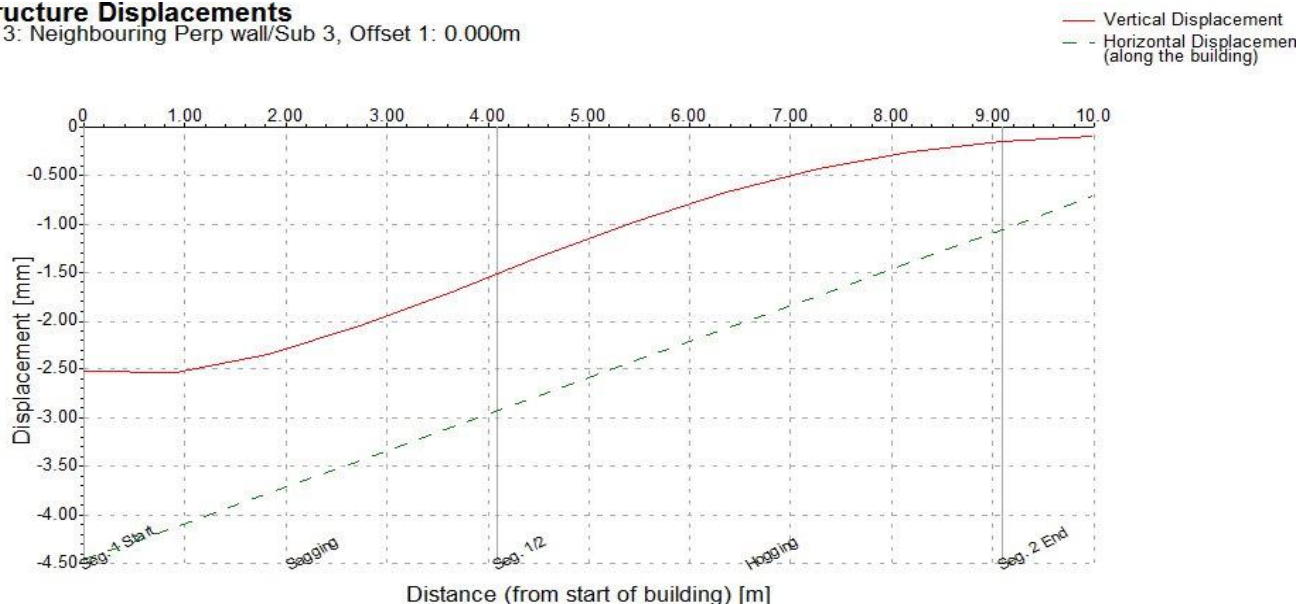
Building Damage Interaction Chart

Structure 3: Neighbouring Perp wall/Sub 3, Offset 1: 0.000m, Segment 1: length 4.084 m

Sub-Structure Displacements

Structure 3: Neighbouring Perp wall/Sub 3, Offset 1: 0.000m
