## Opening up works: photos and explanantions

## No. 28 Fitzroy Square, Camden

On behalf of SKK Design

August 2017

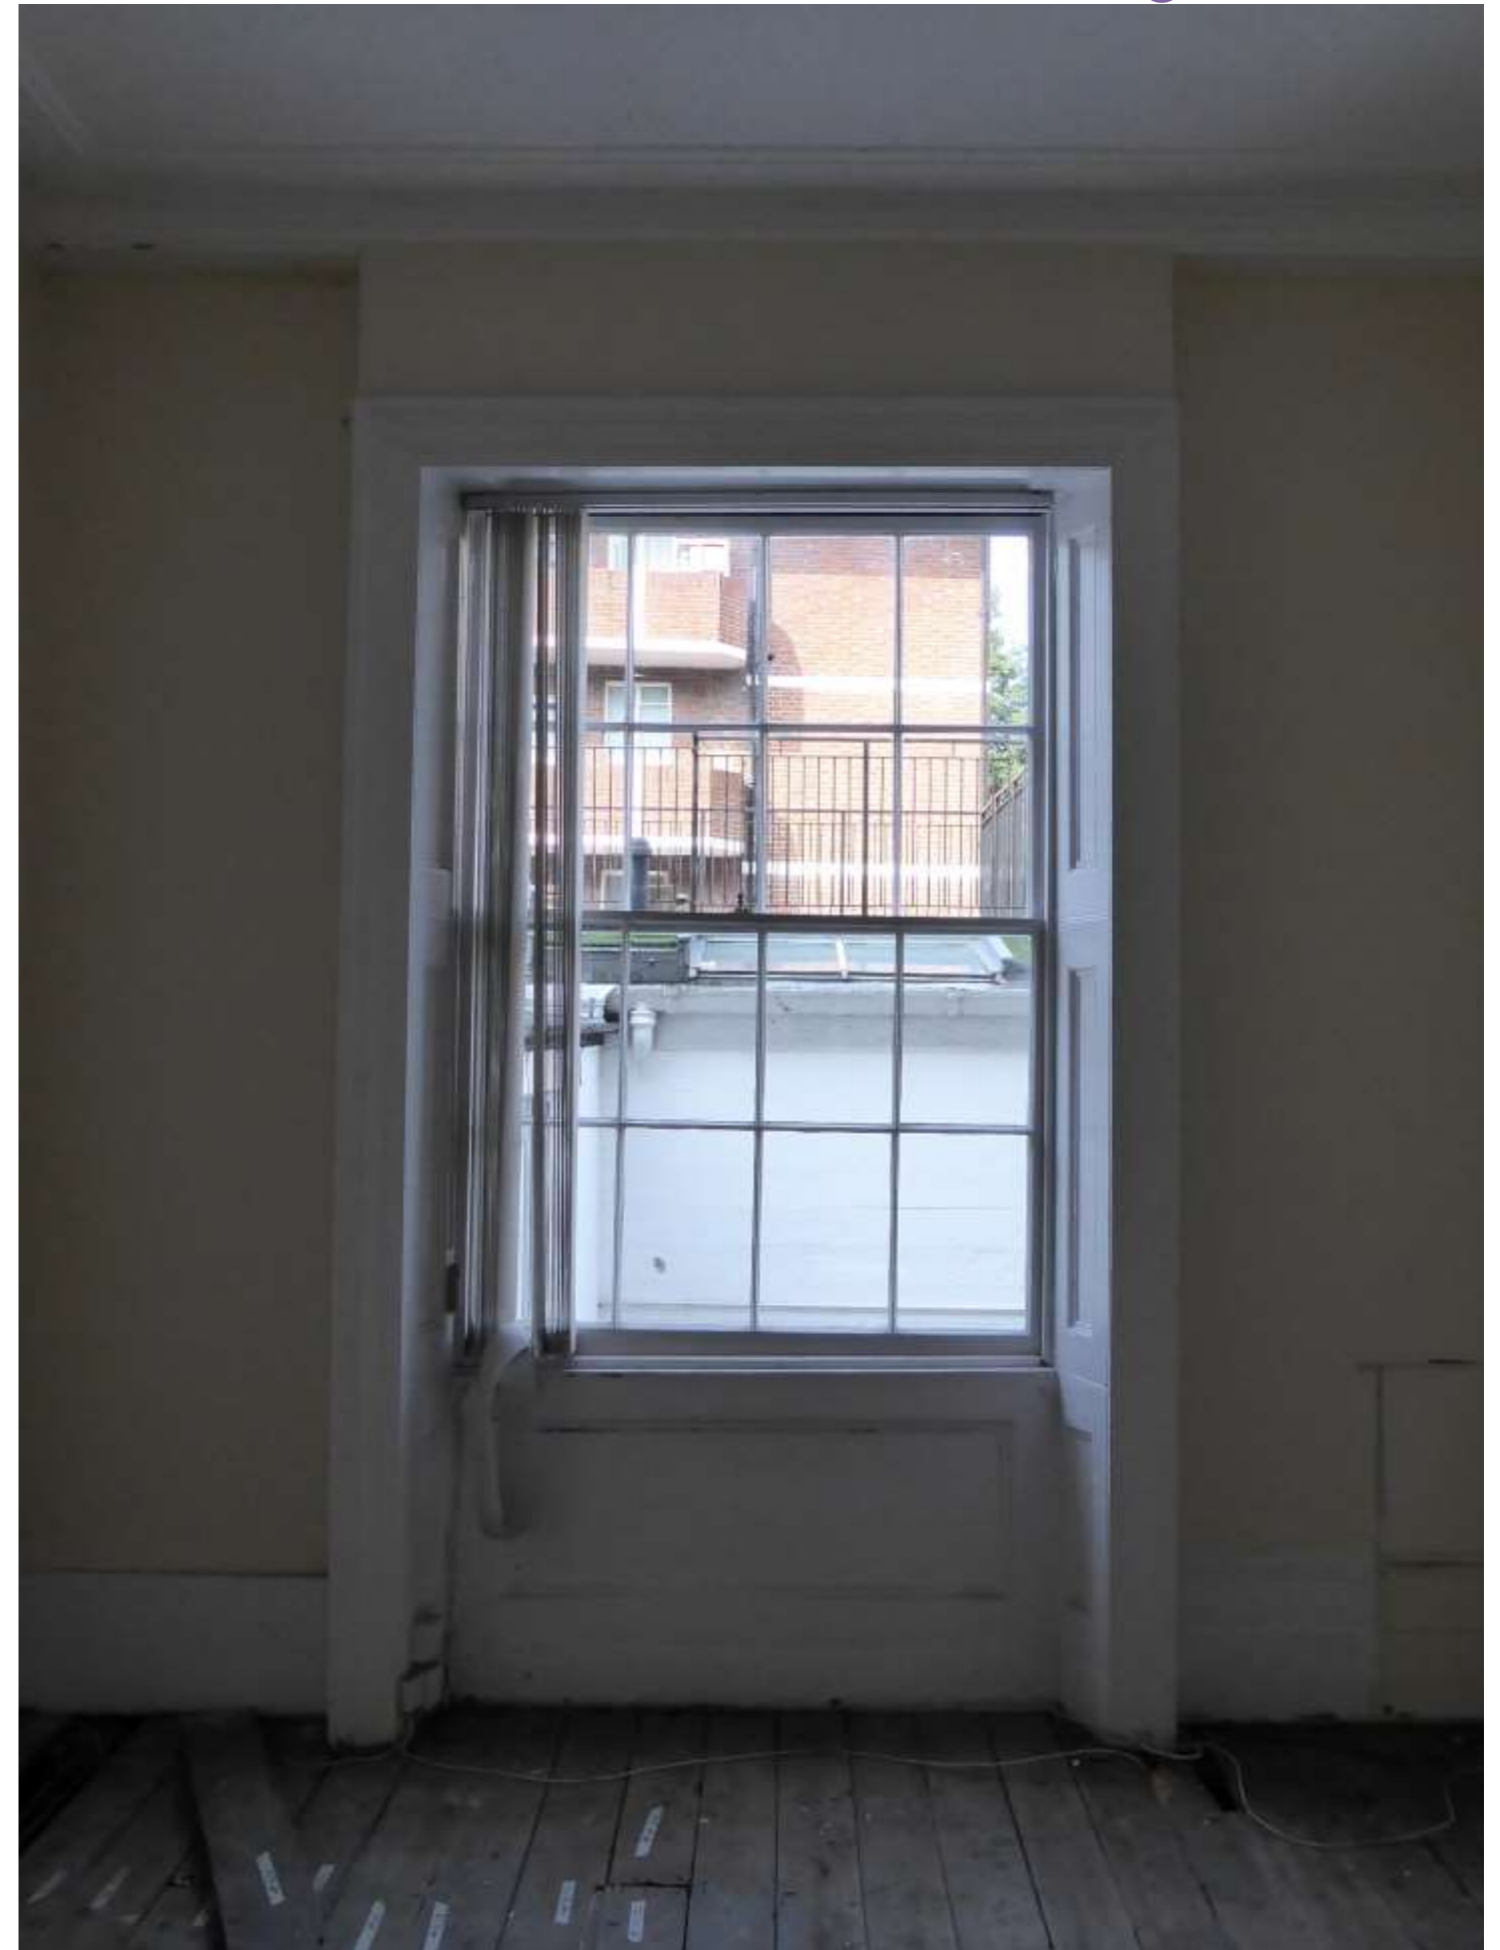
Plate F1: The first floor rear window with shutterbox standing proud of with the walls either side.

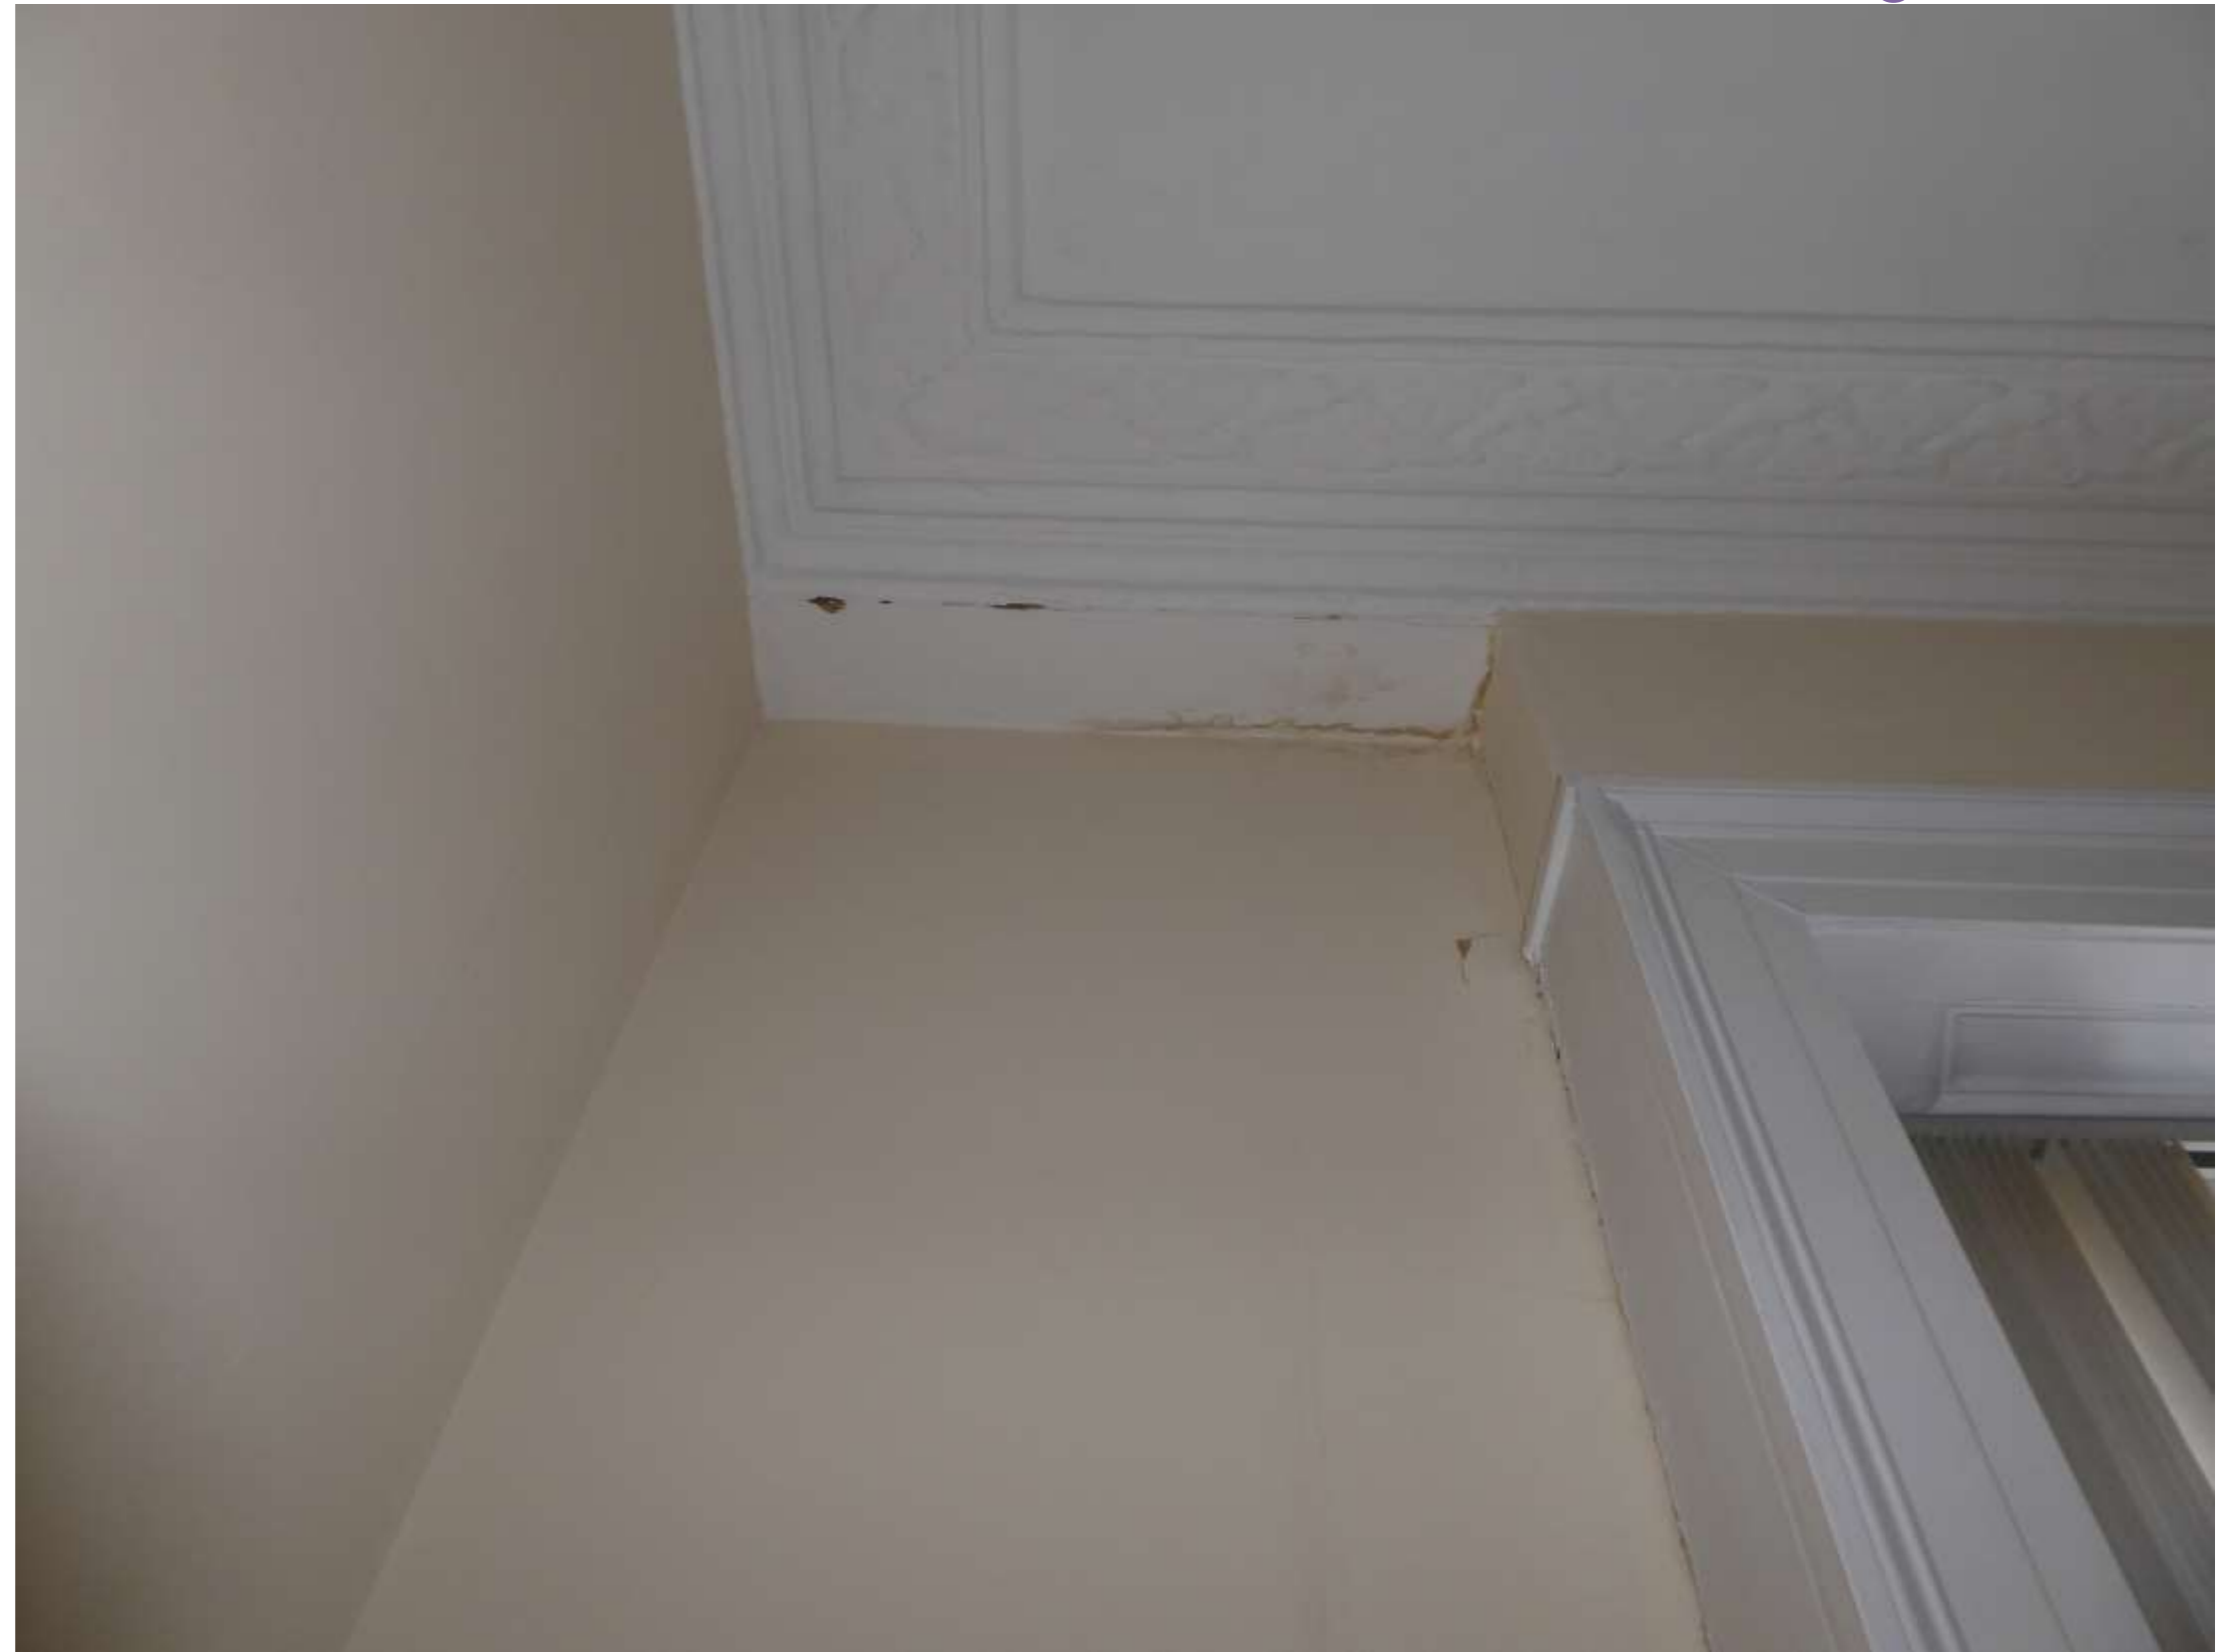
**Plate F2:** The first floor rear window with shutterbox standing proud of with the walls either side. The original cornice is not recessed, indicating that there would have been panels either side of the window as at the ground floor.

**NOTE:** It is now proposed to install panels either side of the shutterboxes and use one of these spaces as a vertical riser.

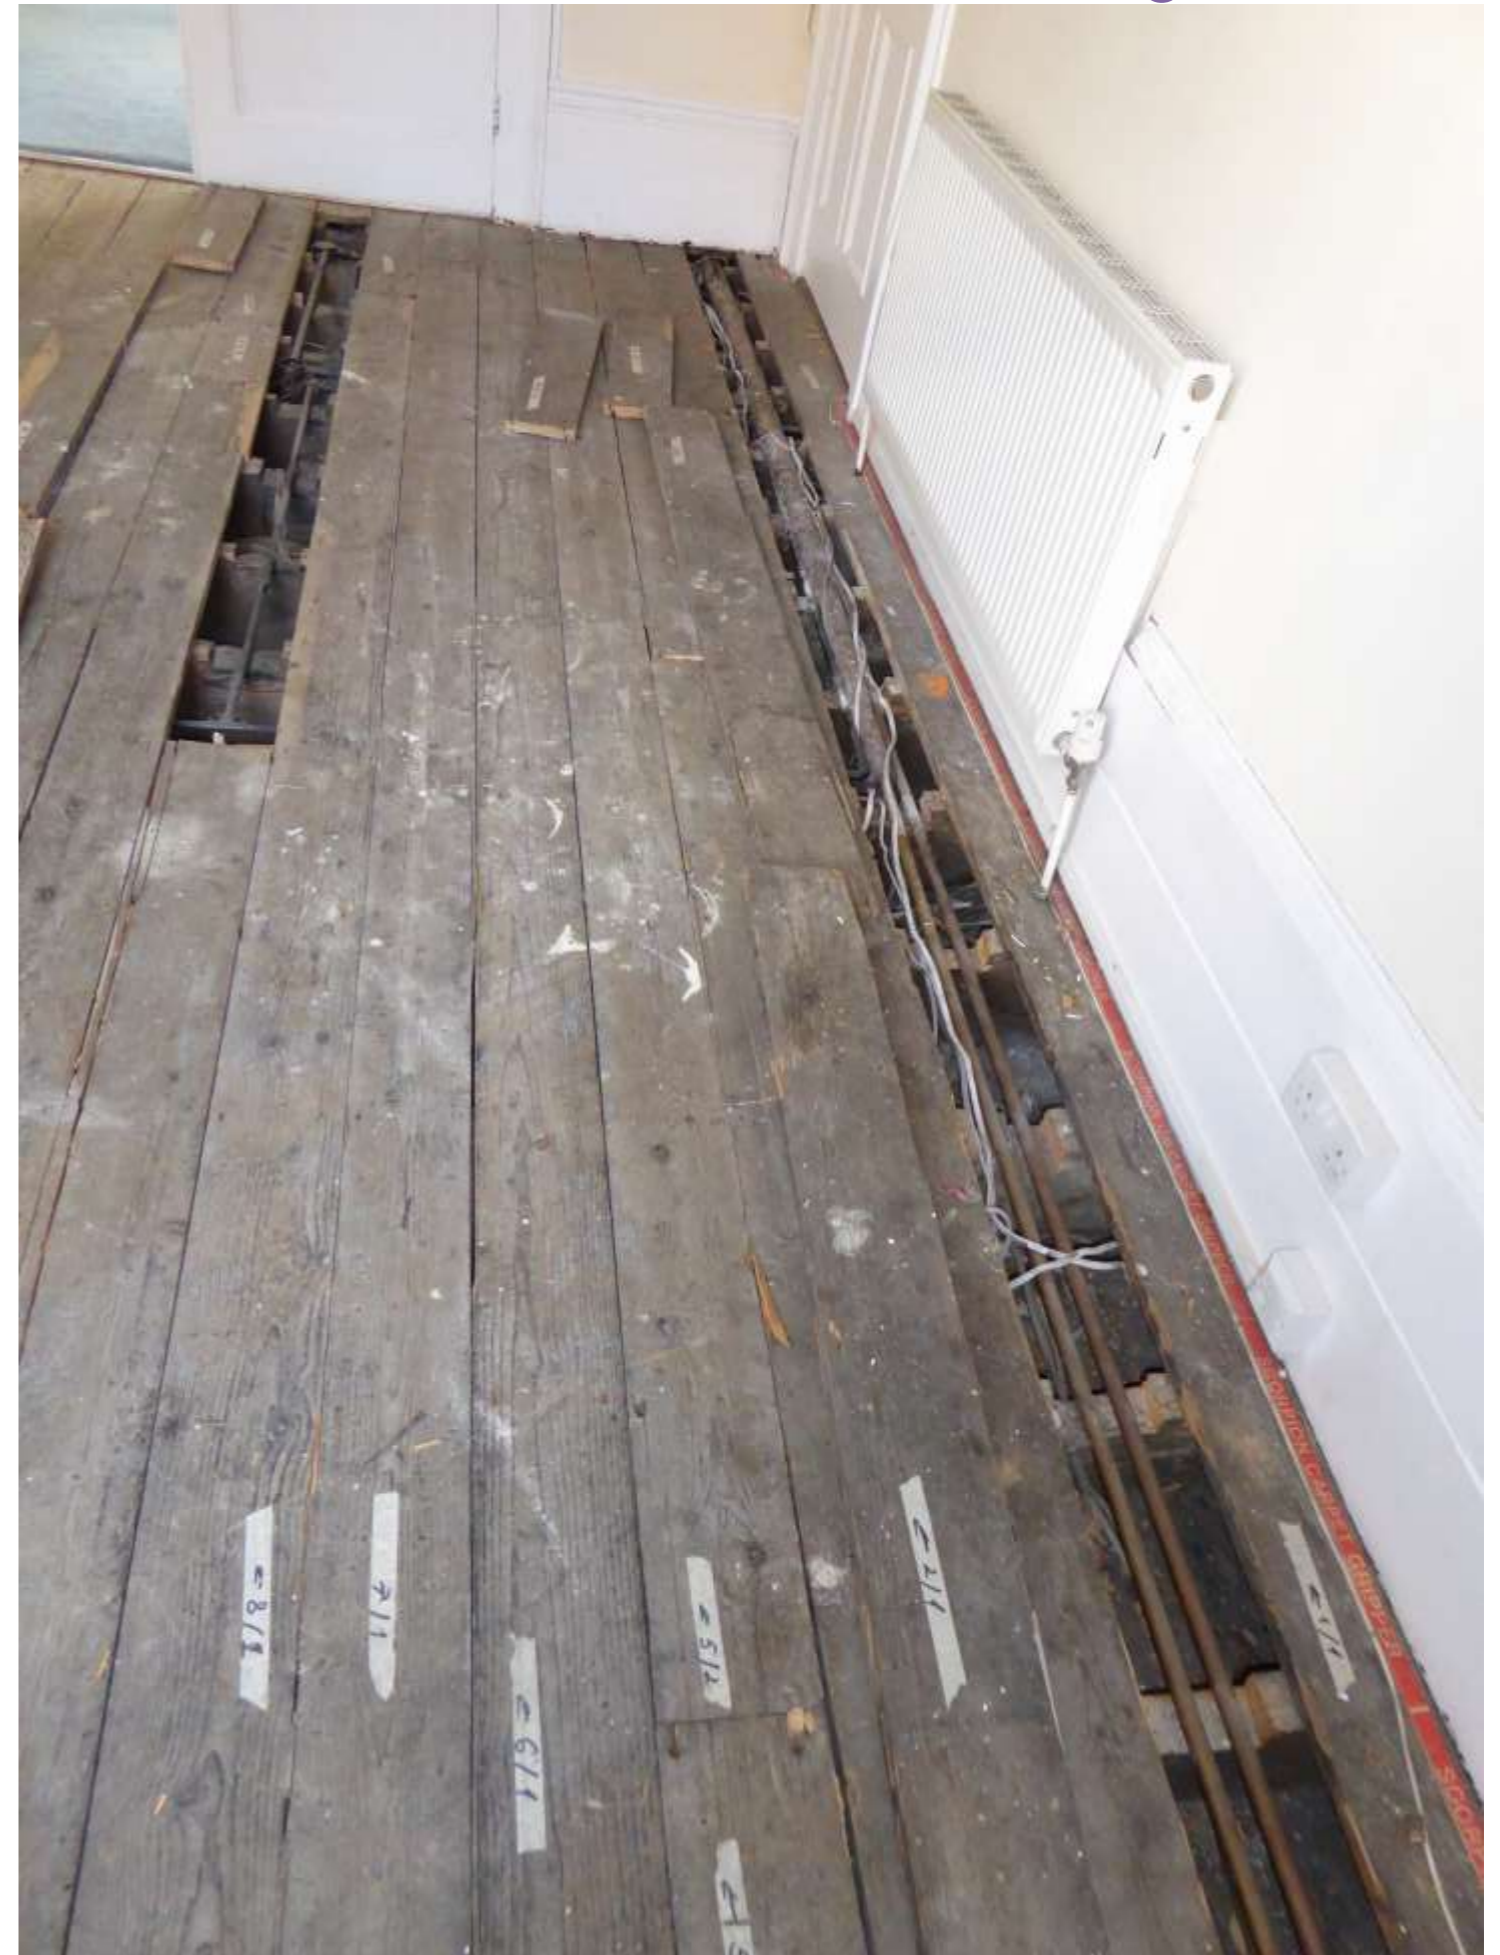
Plate F2: The existing pipe runs in notches, from the rear looking towards the front.

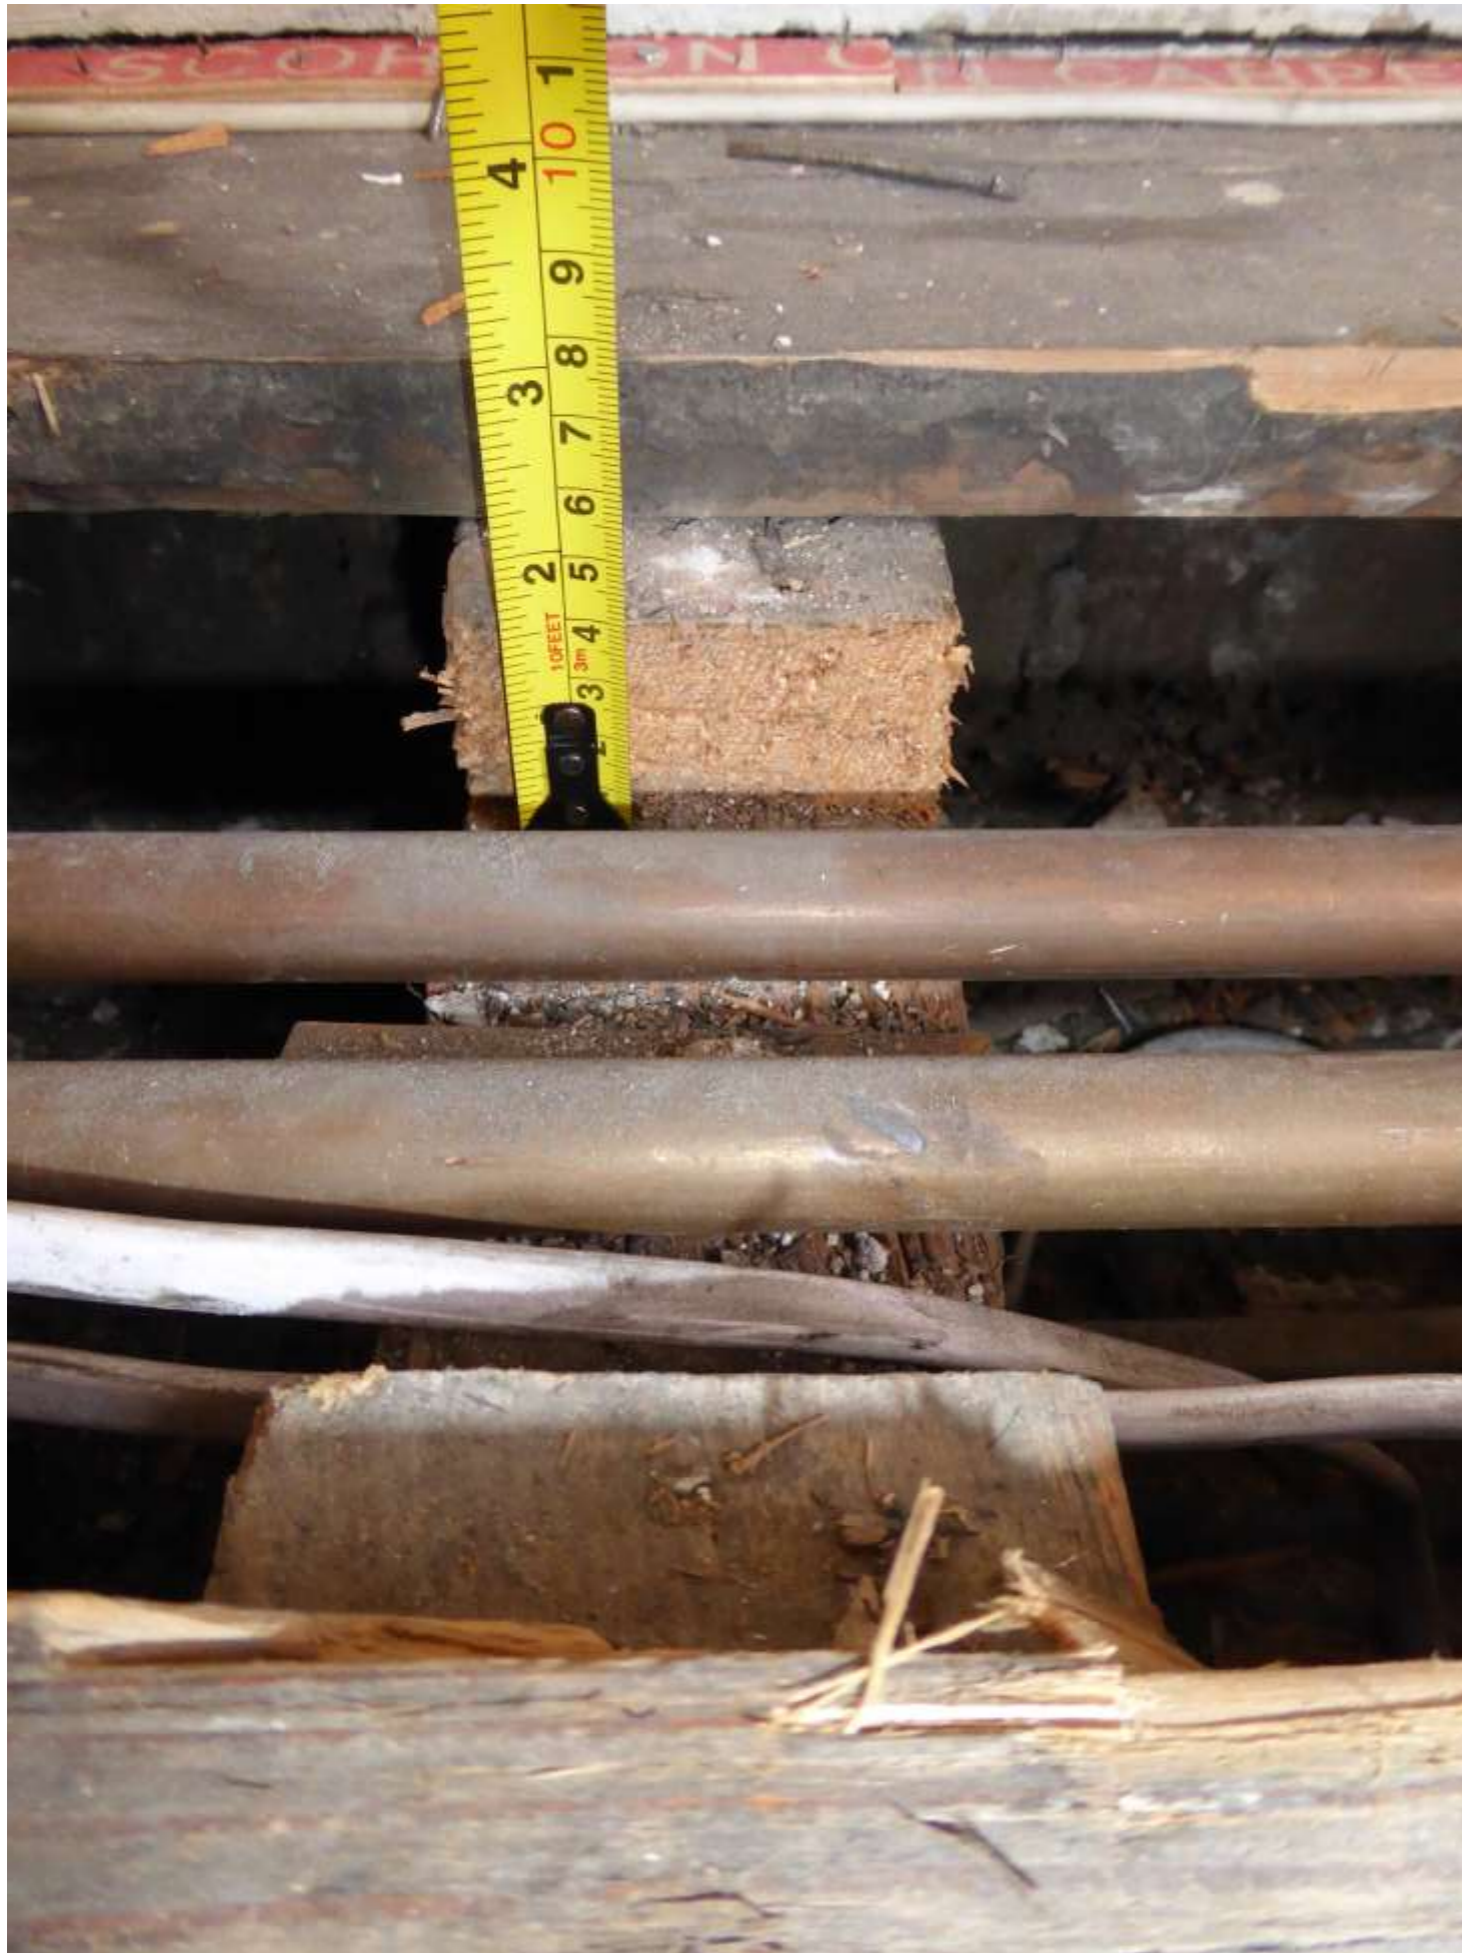
**Plate F3:** Detail showing the depth of the existing pipe run closest to the stairs.

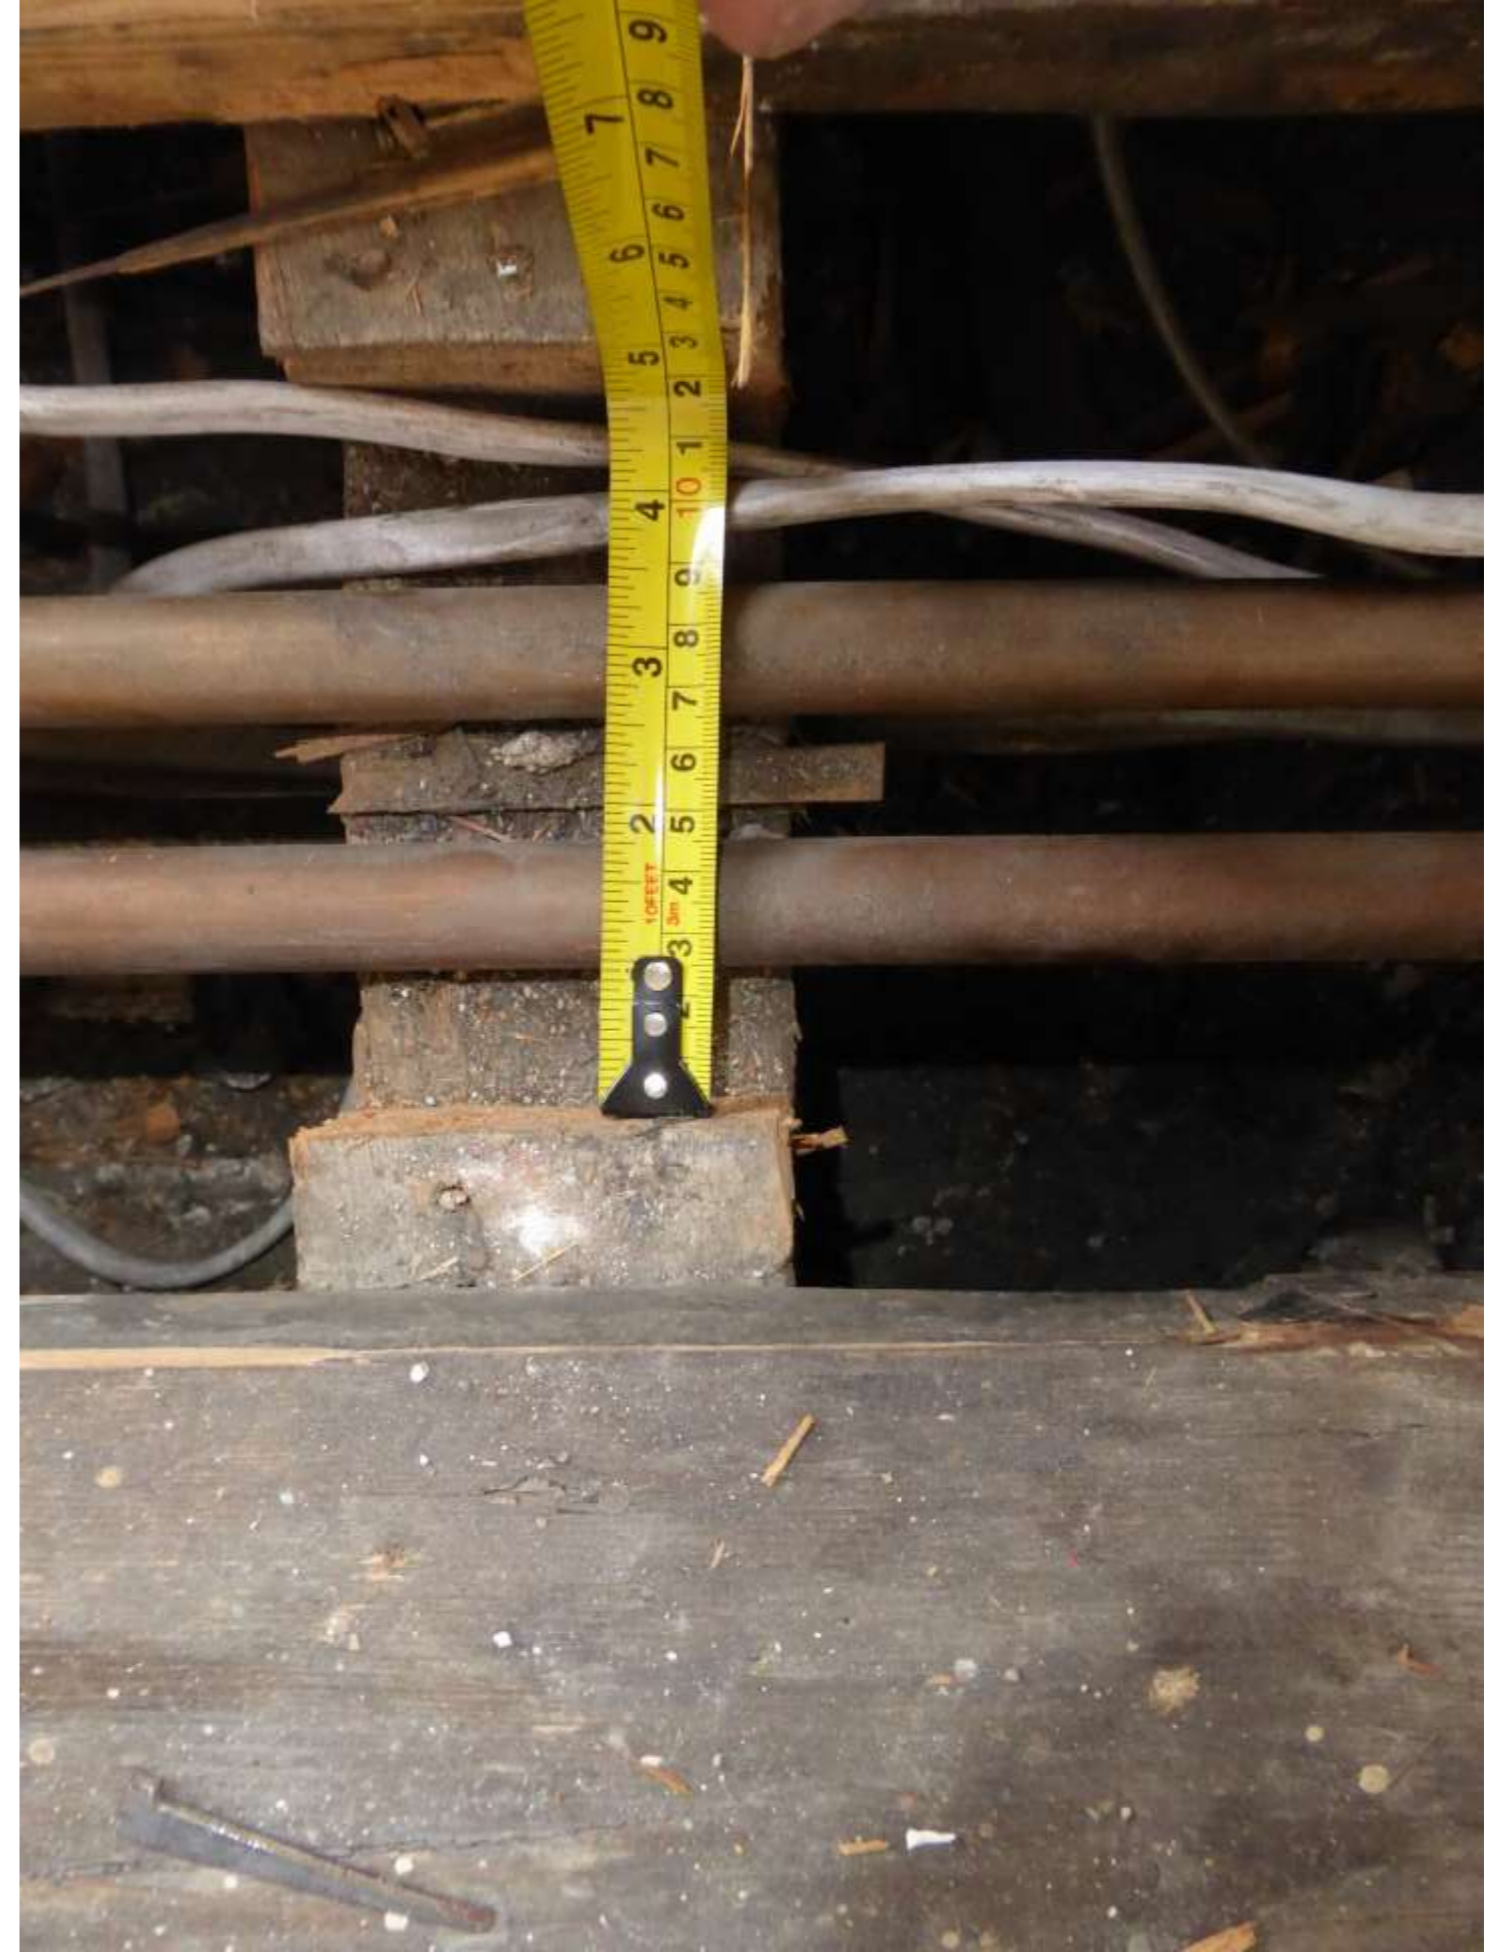
**Plate F3:** Detail showing the width of the existing pipe run closest to the stairs.

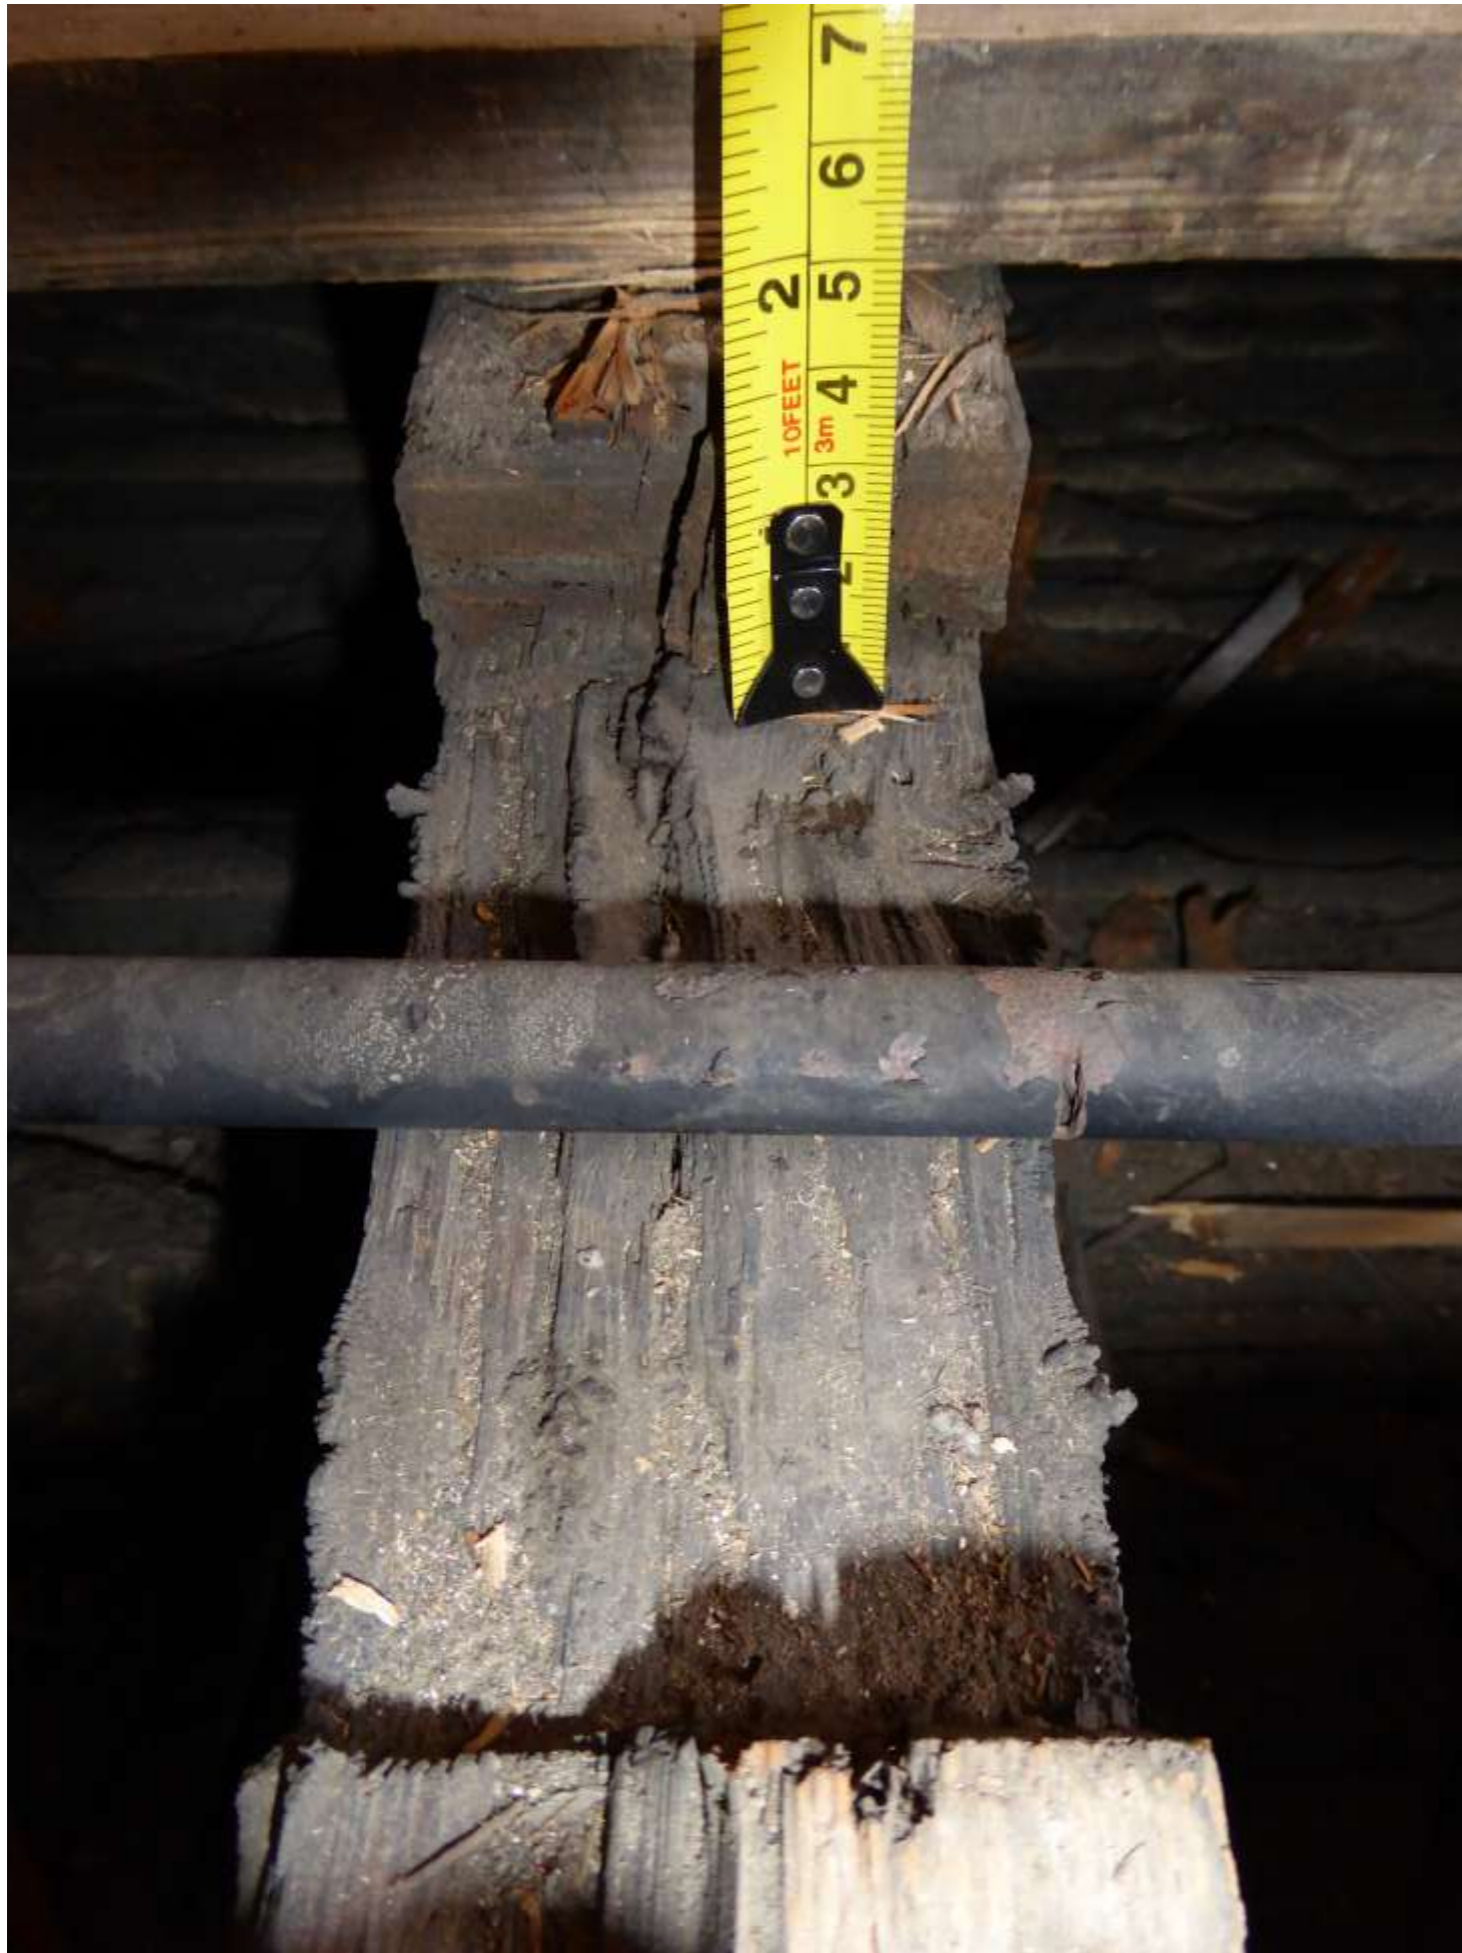
**Plate F4:** Detail showing the depth of the existing pipe run furthest from the stairs.

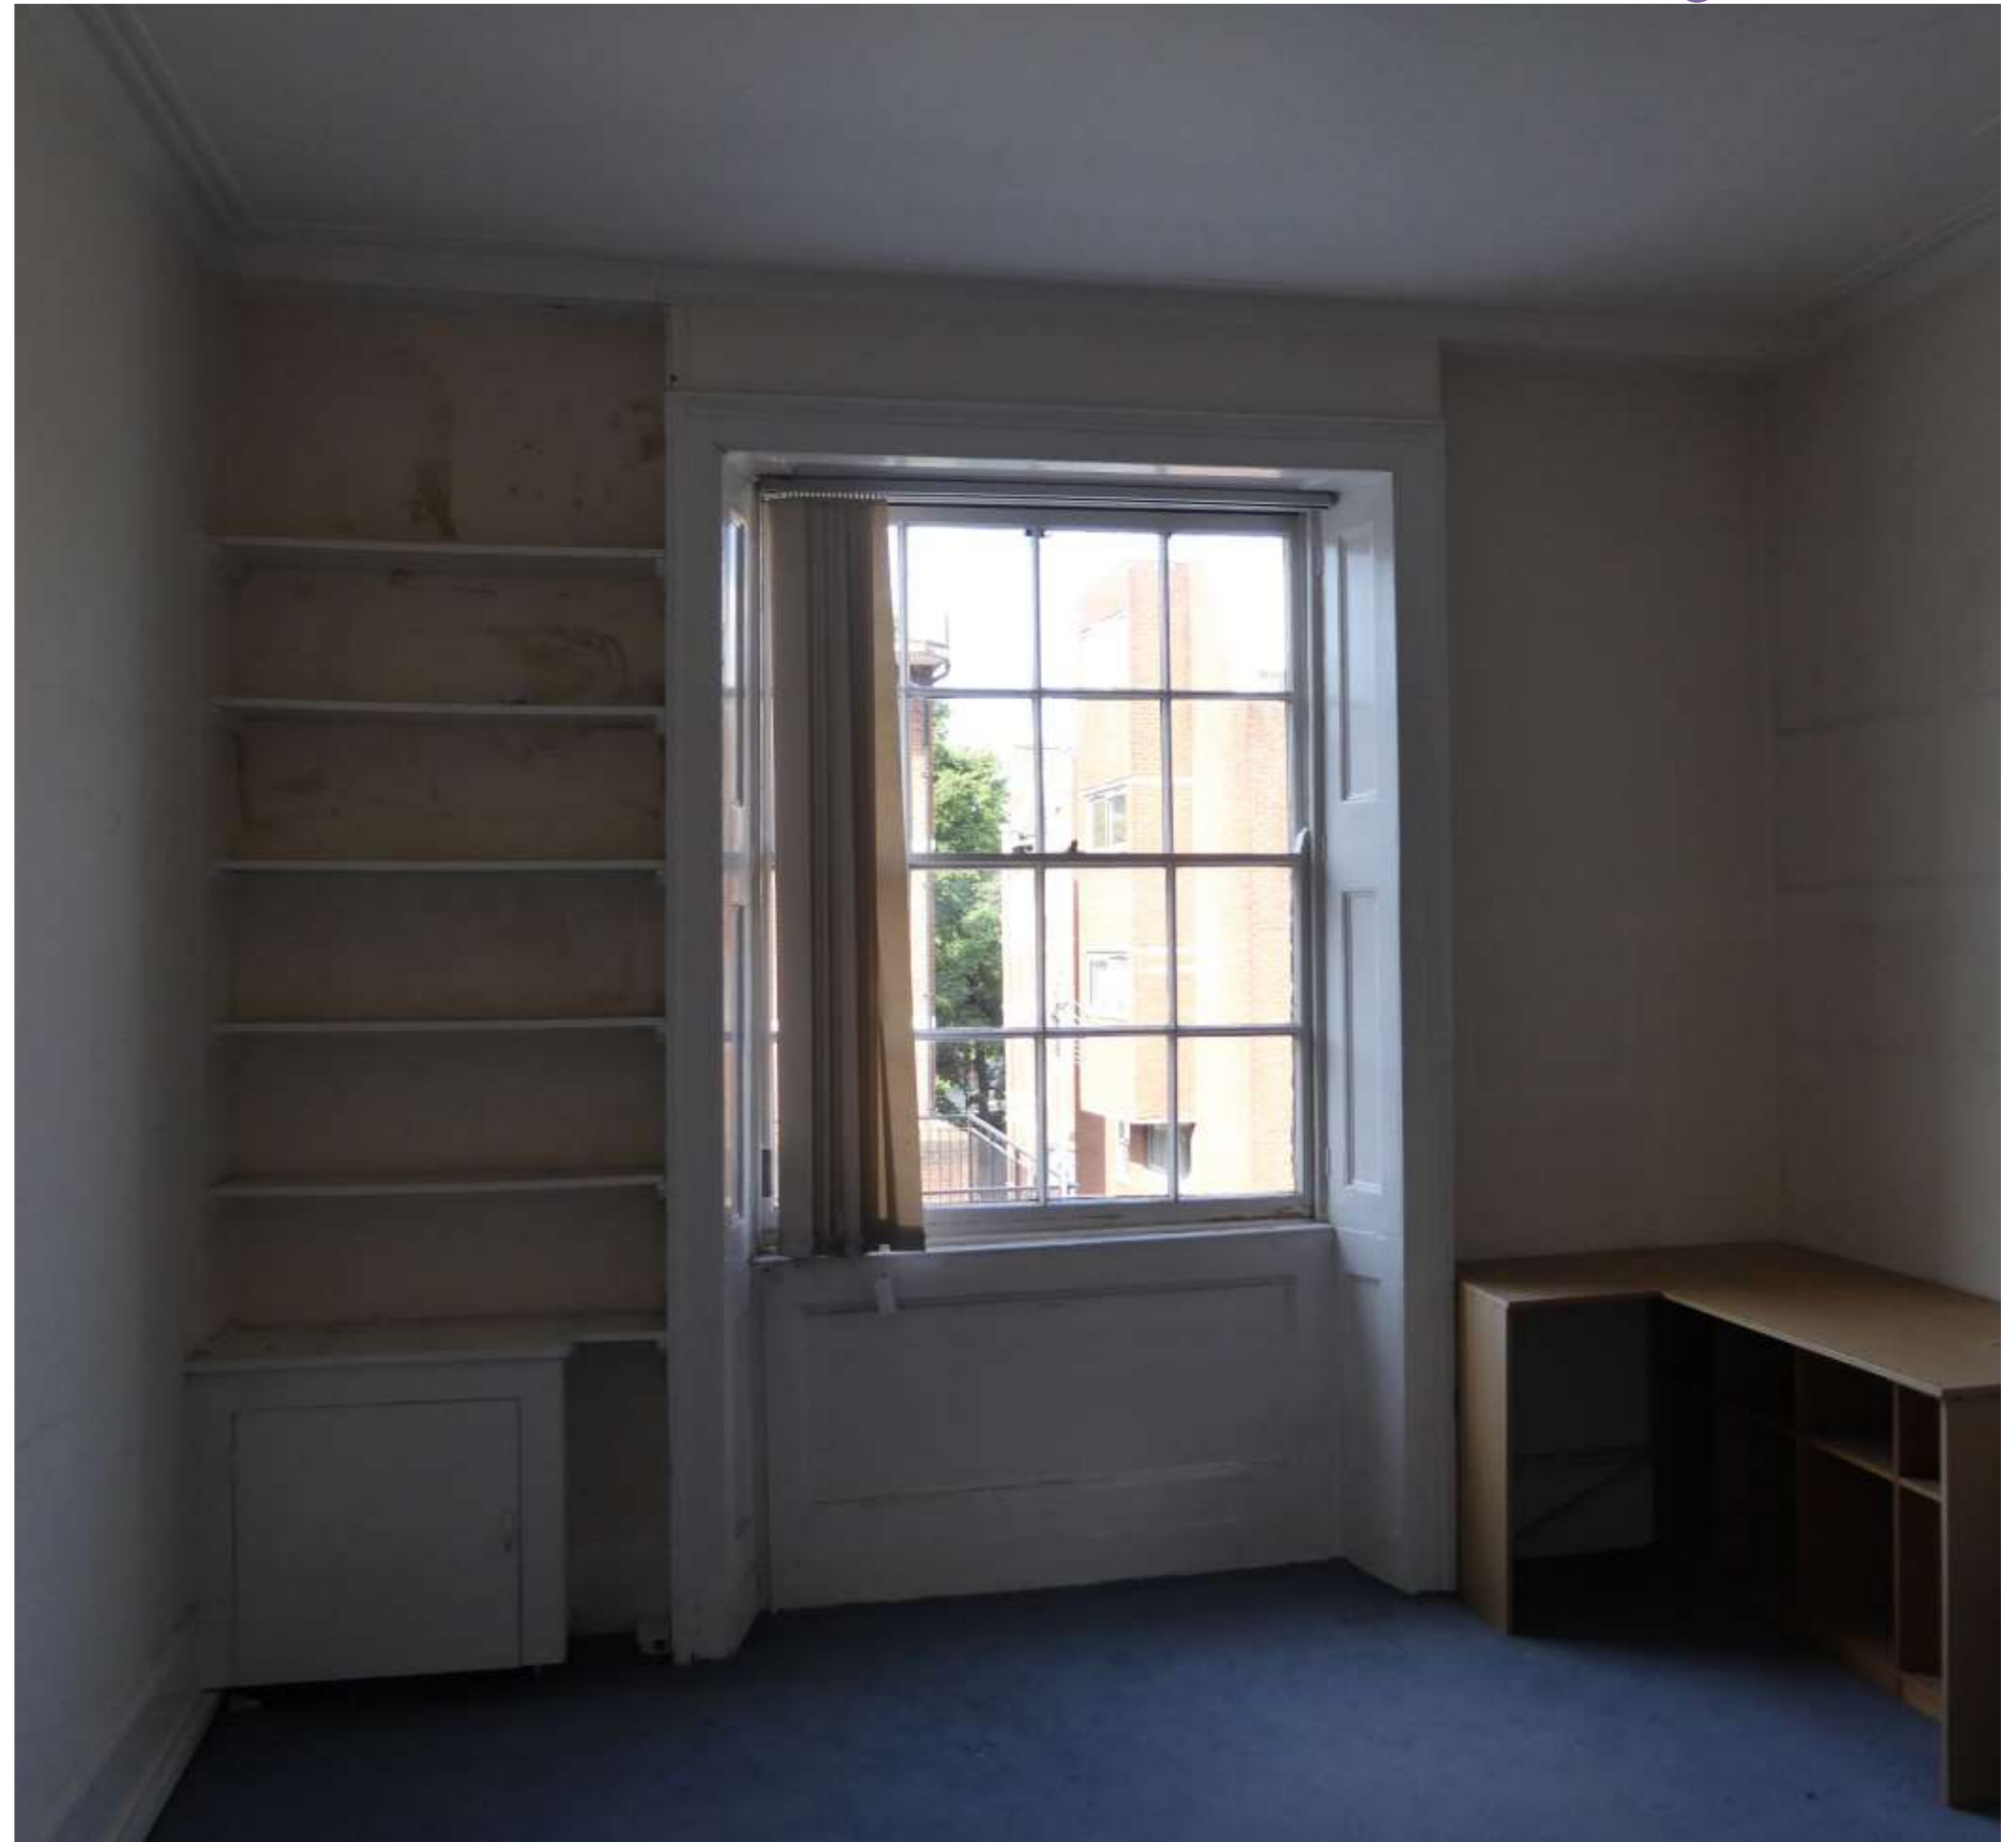
**Plate S1:** The second floor rear window with shutterbox standing proud of with the walls either side.
