## Opening up works: photos and explanantions

## No. 28 Fitzroy Square, Camden

On behalf of SKK Design

August 2017

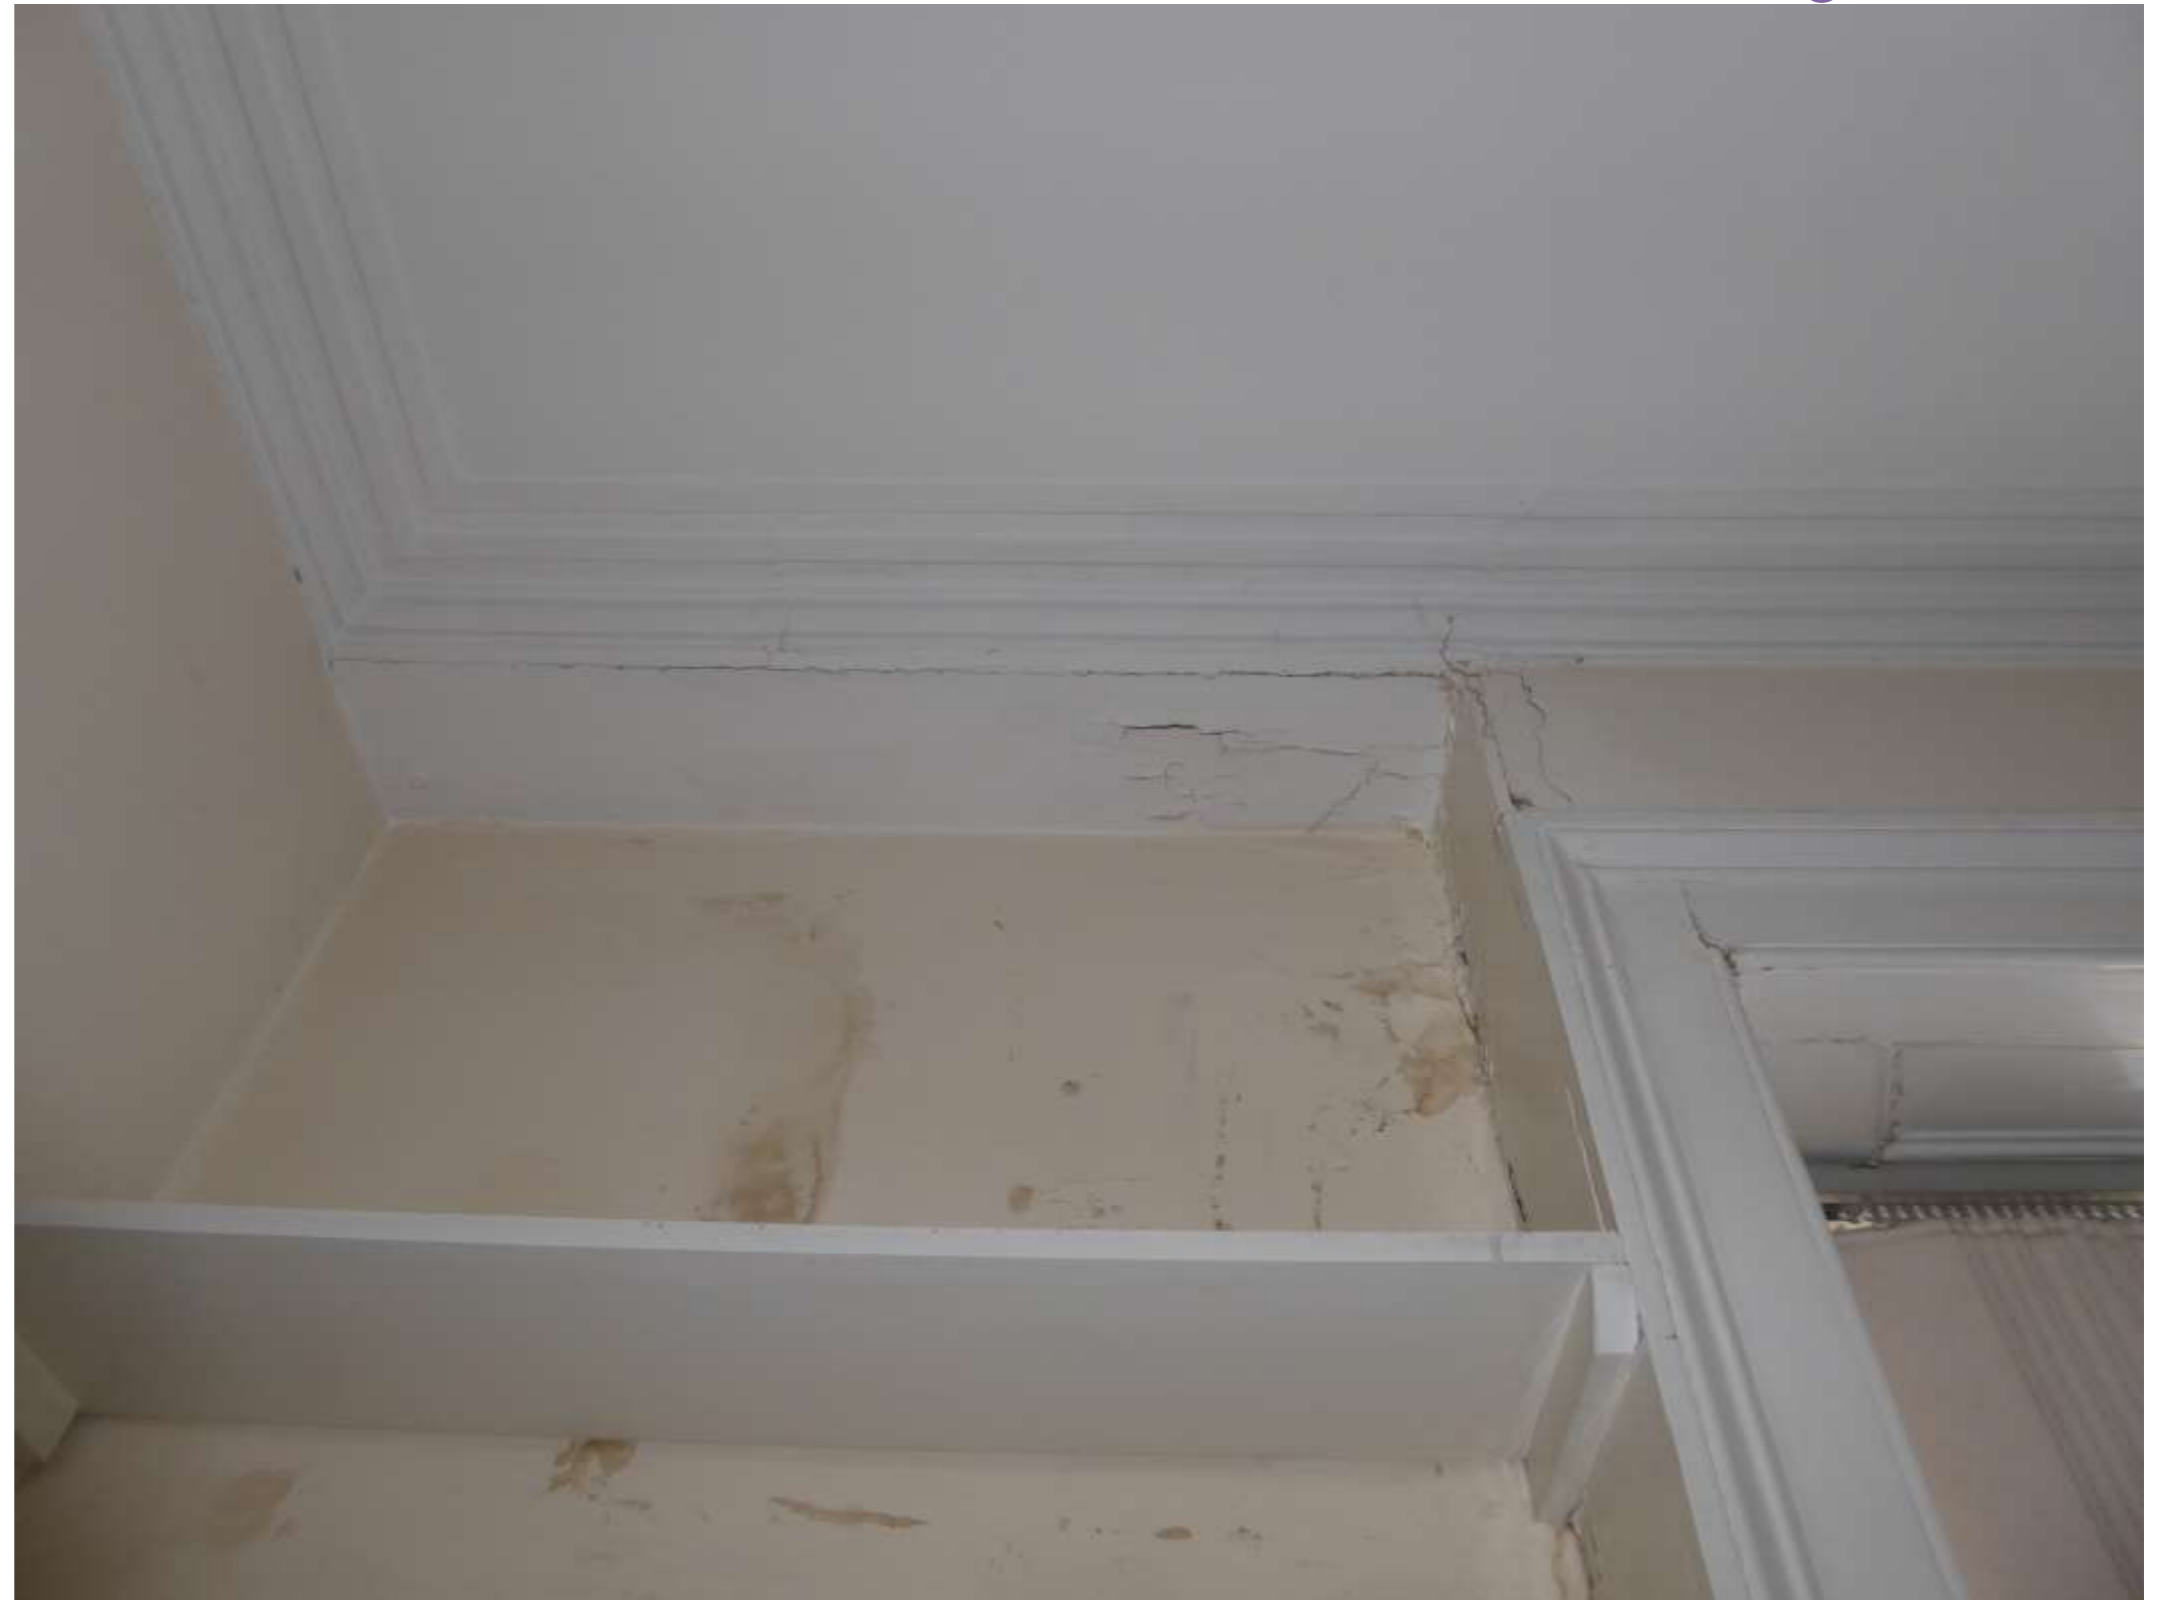
**Plate S2:** The second floor rear window with shutterbox standing proud of with the walls either side. The original cornice is not recessed, indicating that there would have been panels either side of the window as at the ground floor.

**NOTE:** It is now proposed to install panels either side of the shutterboxes and use one of these spaces as a vertical riser.

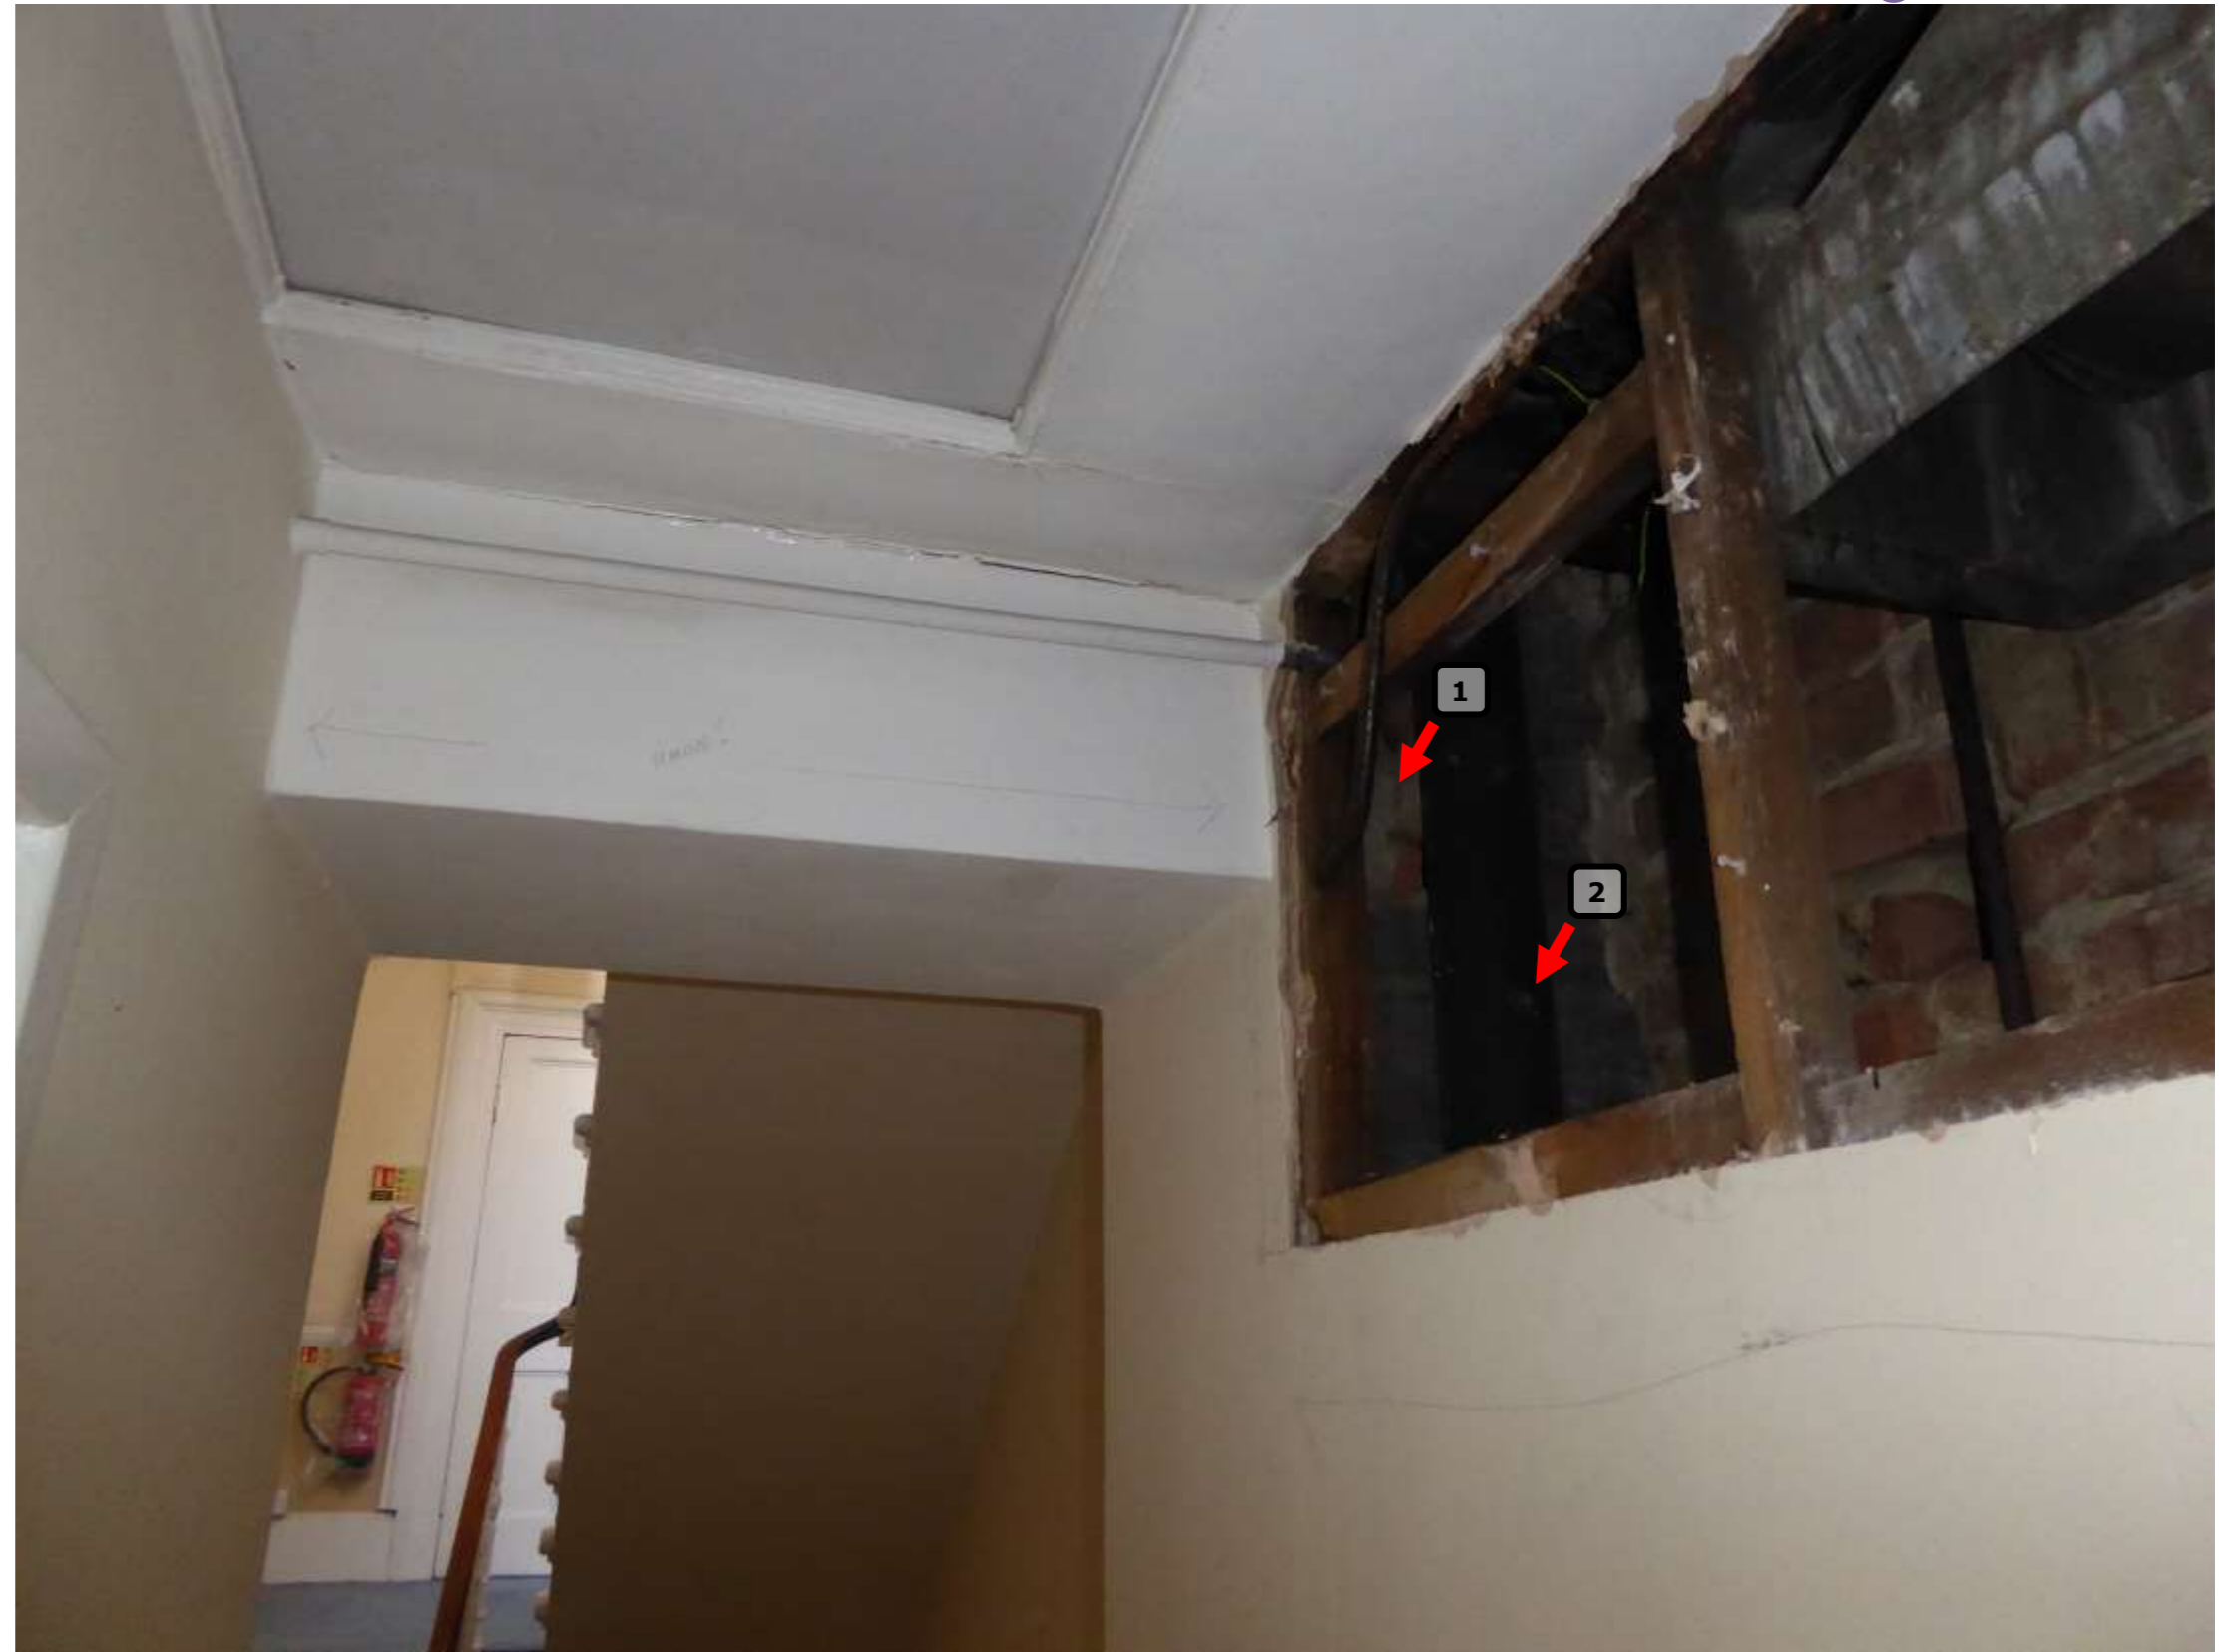
**Plate FL1:** The area that has been opened up. Note the down pipe [2] and the concrete lintol spanning the opening [1]. The down pipe can be seen externally at Plate E2 on page 15.

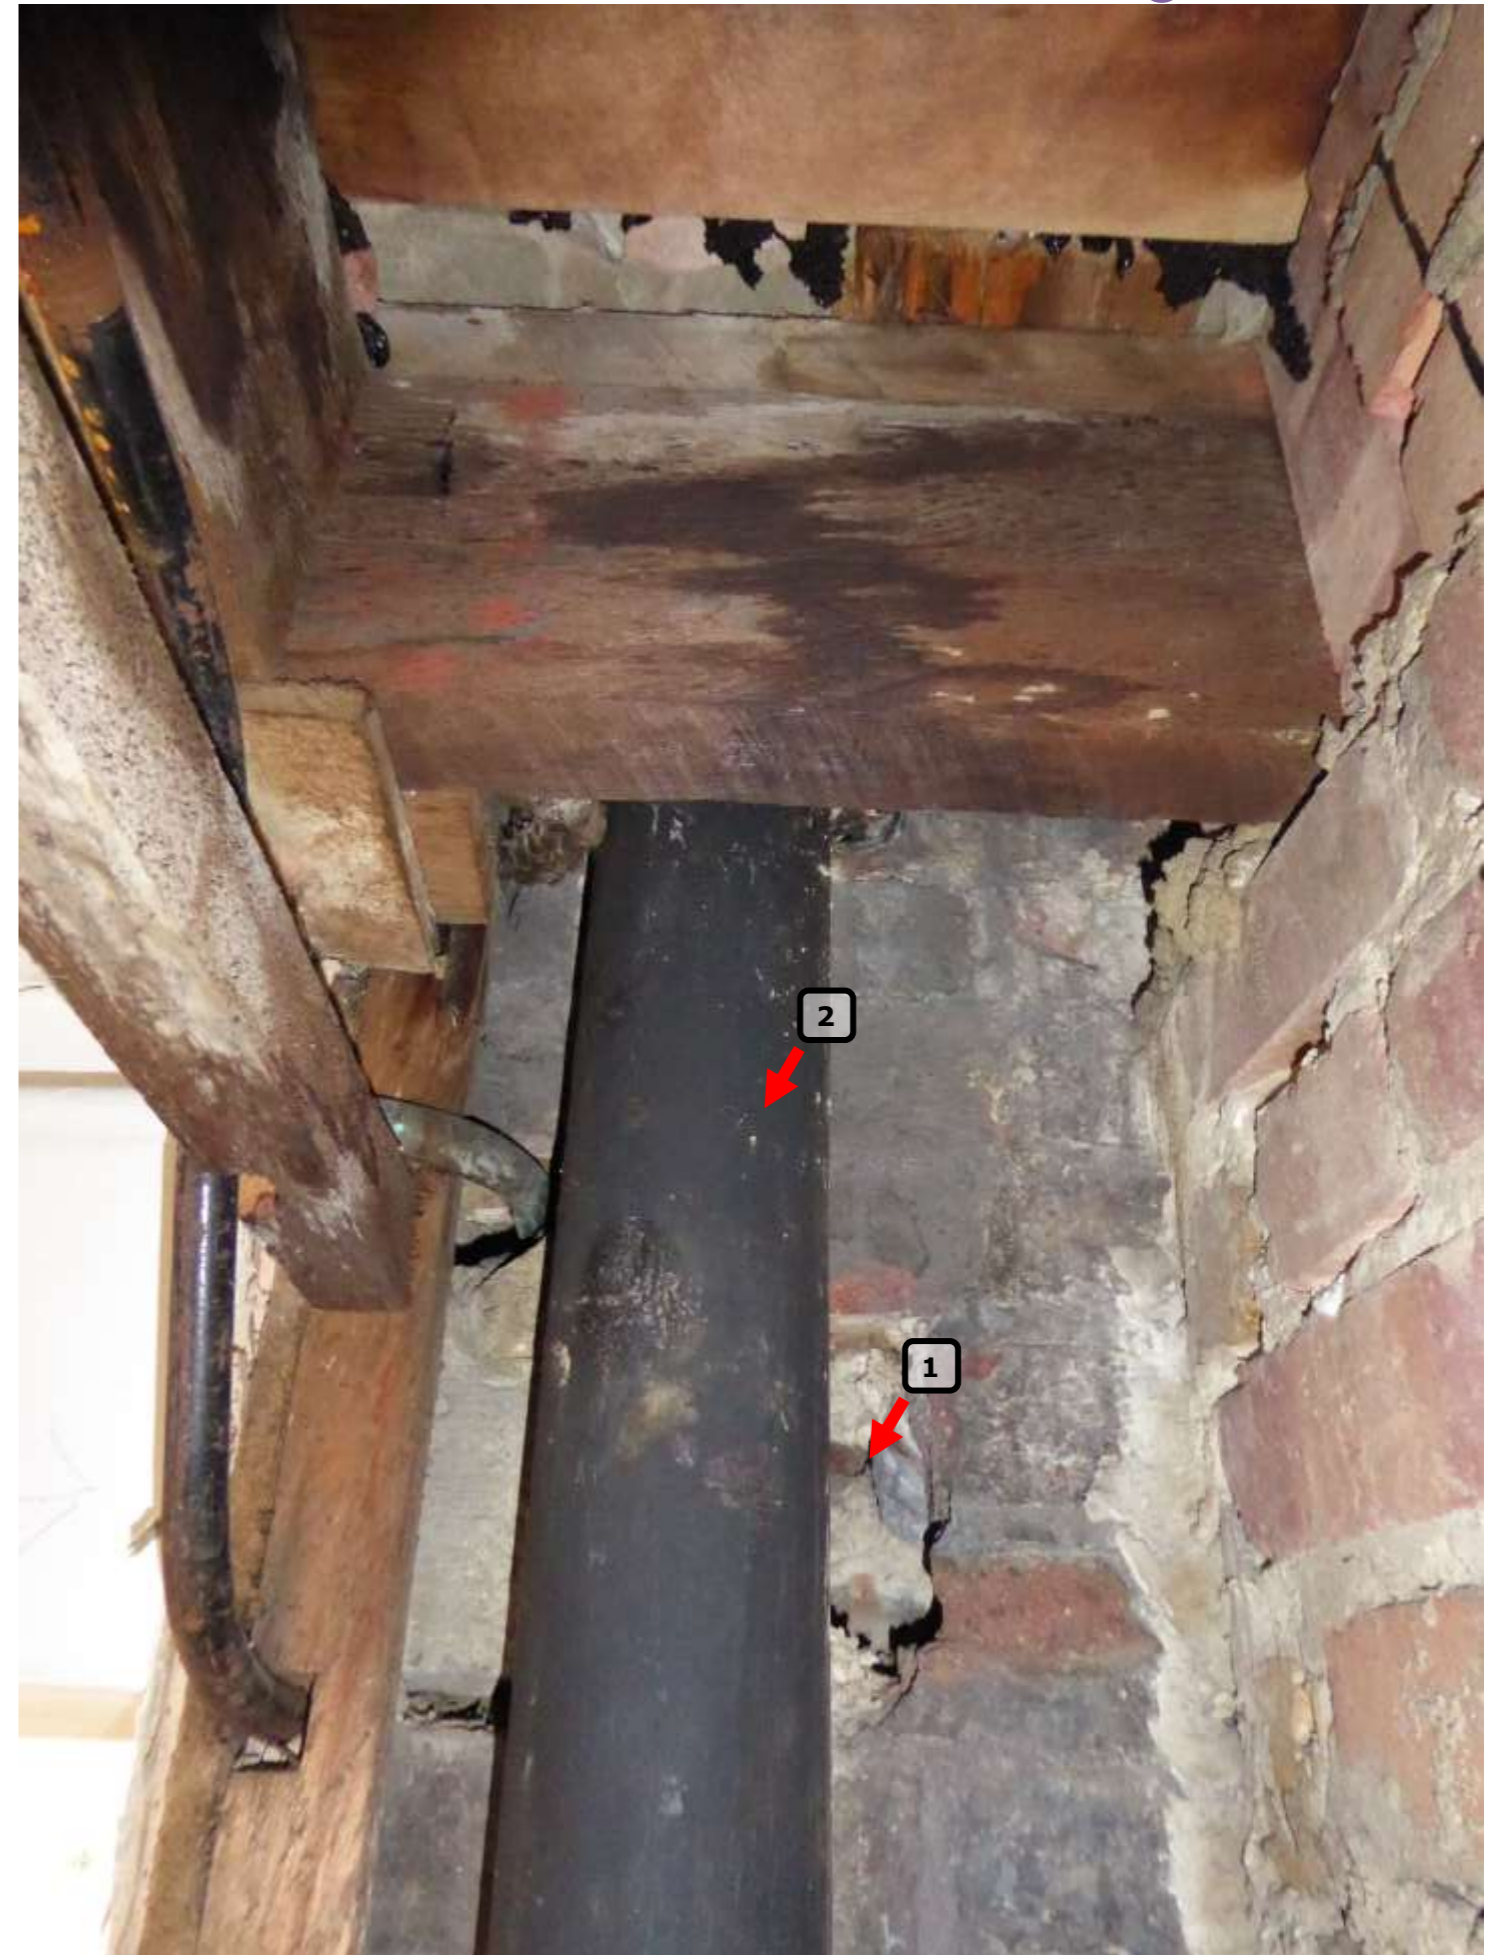
Plate FL2: The area that has been opened up. Note the down pipe [2] and the concrete lintel spanning the opening [1]. The down pipe can be seen externally at Plate E2 on page 15.

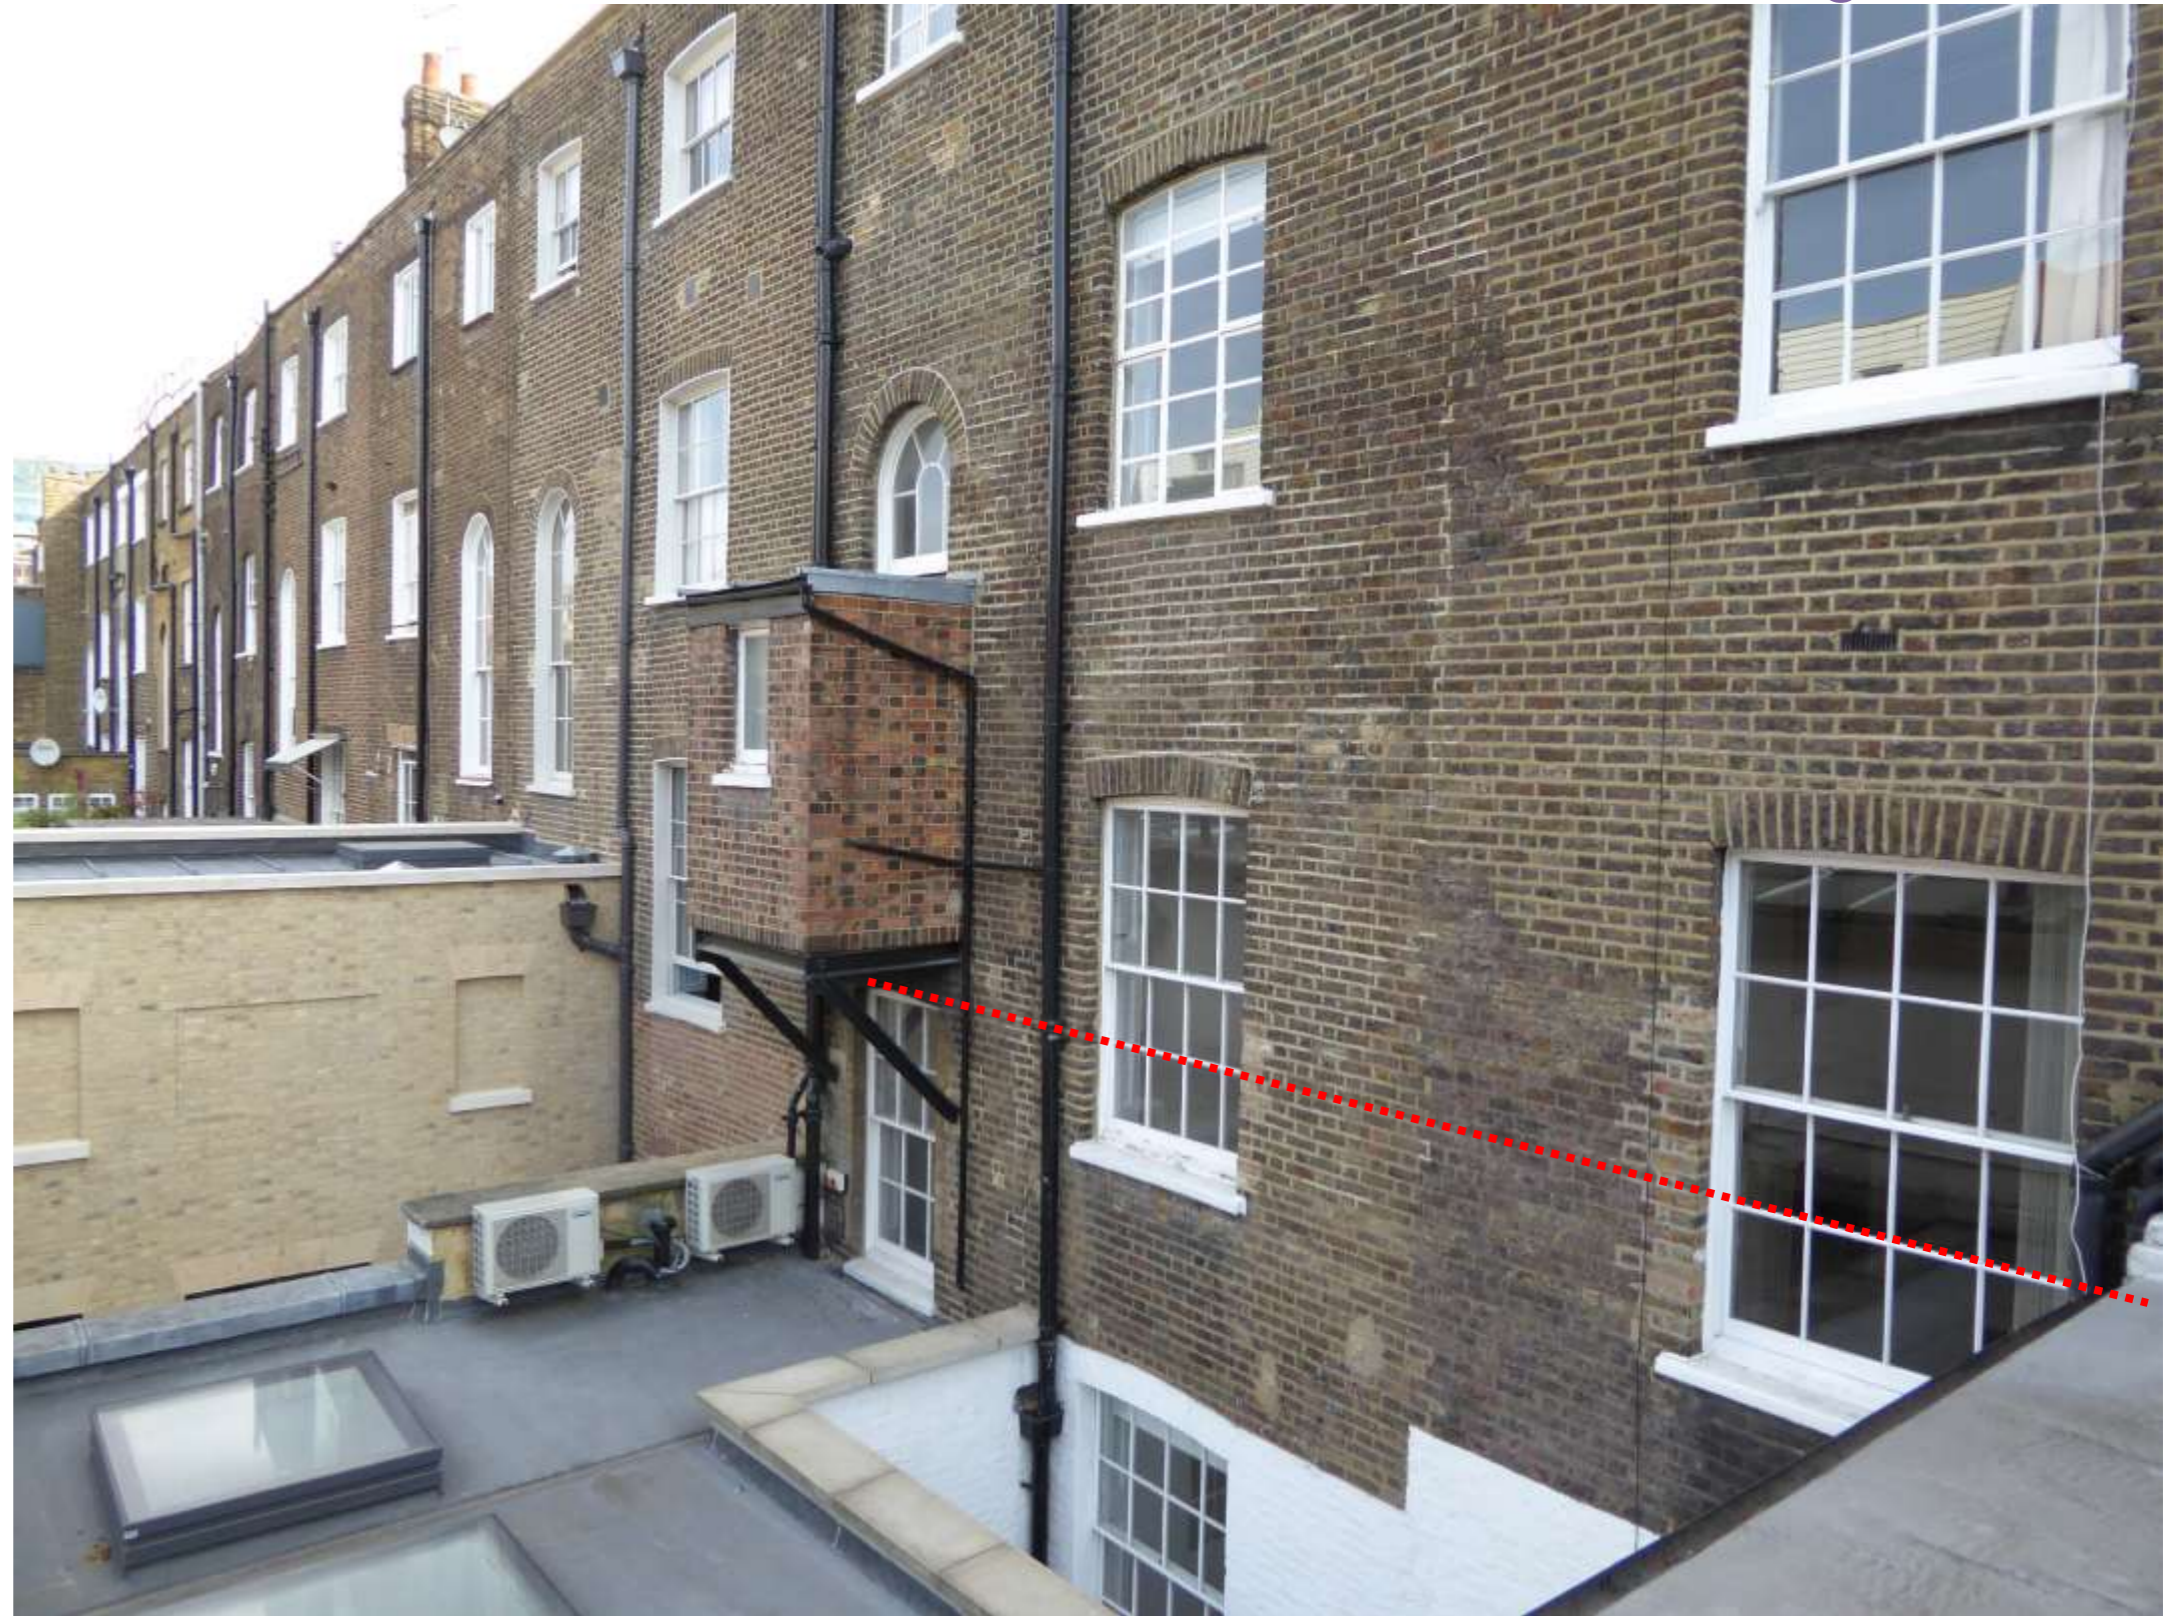
**Plate E1:** The rear elevation, showing an original first landing stairs window, underneath the arched second landing window. The red line shows the approximate height of the window head.

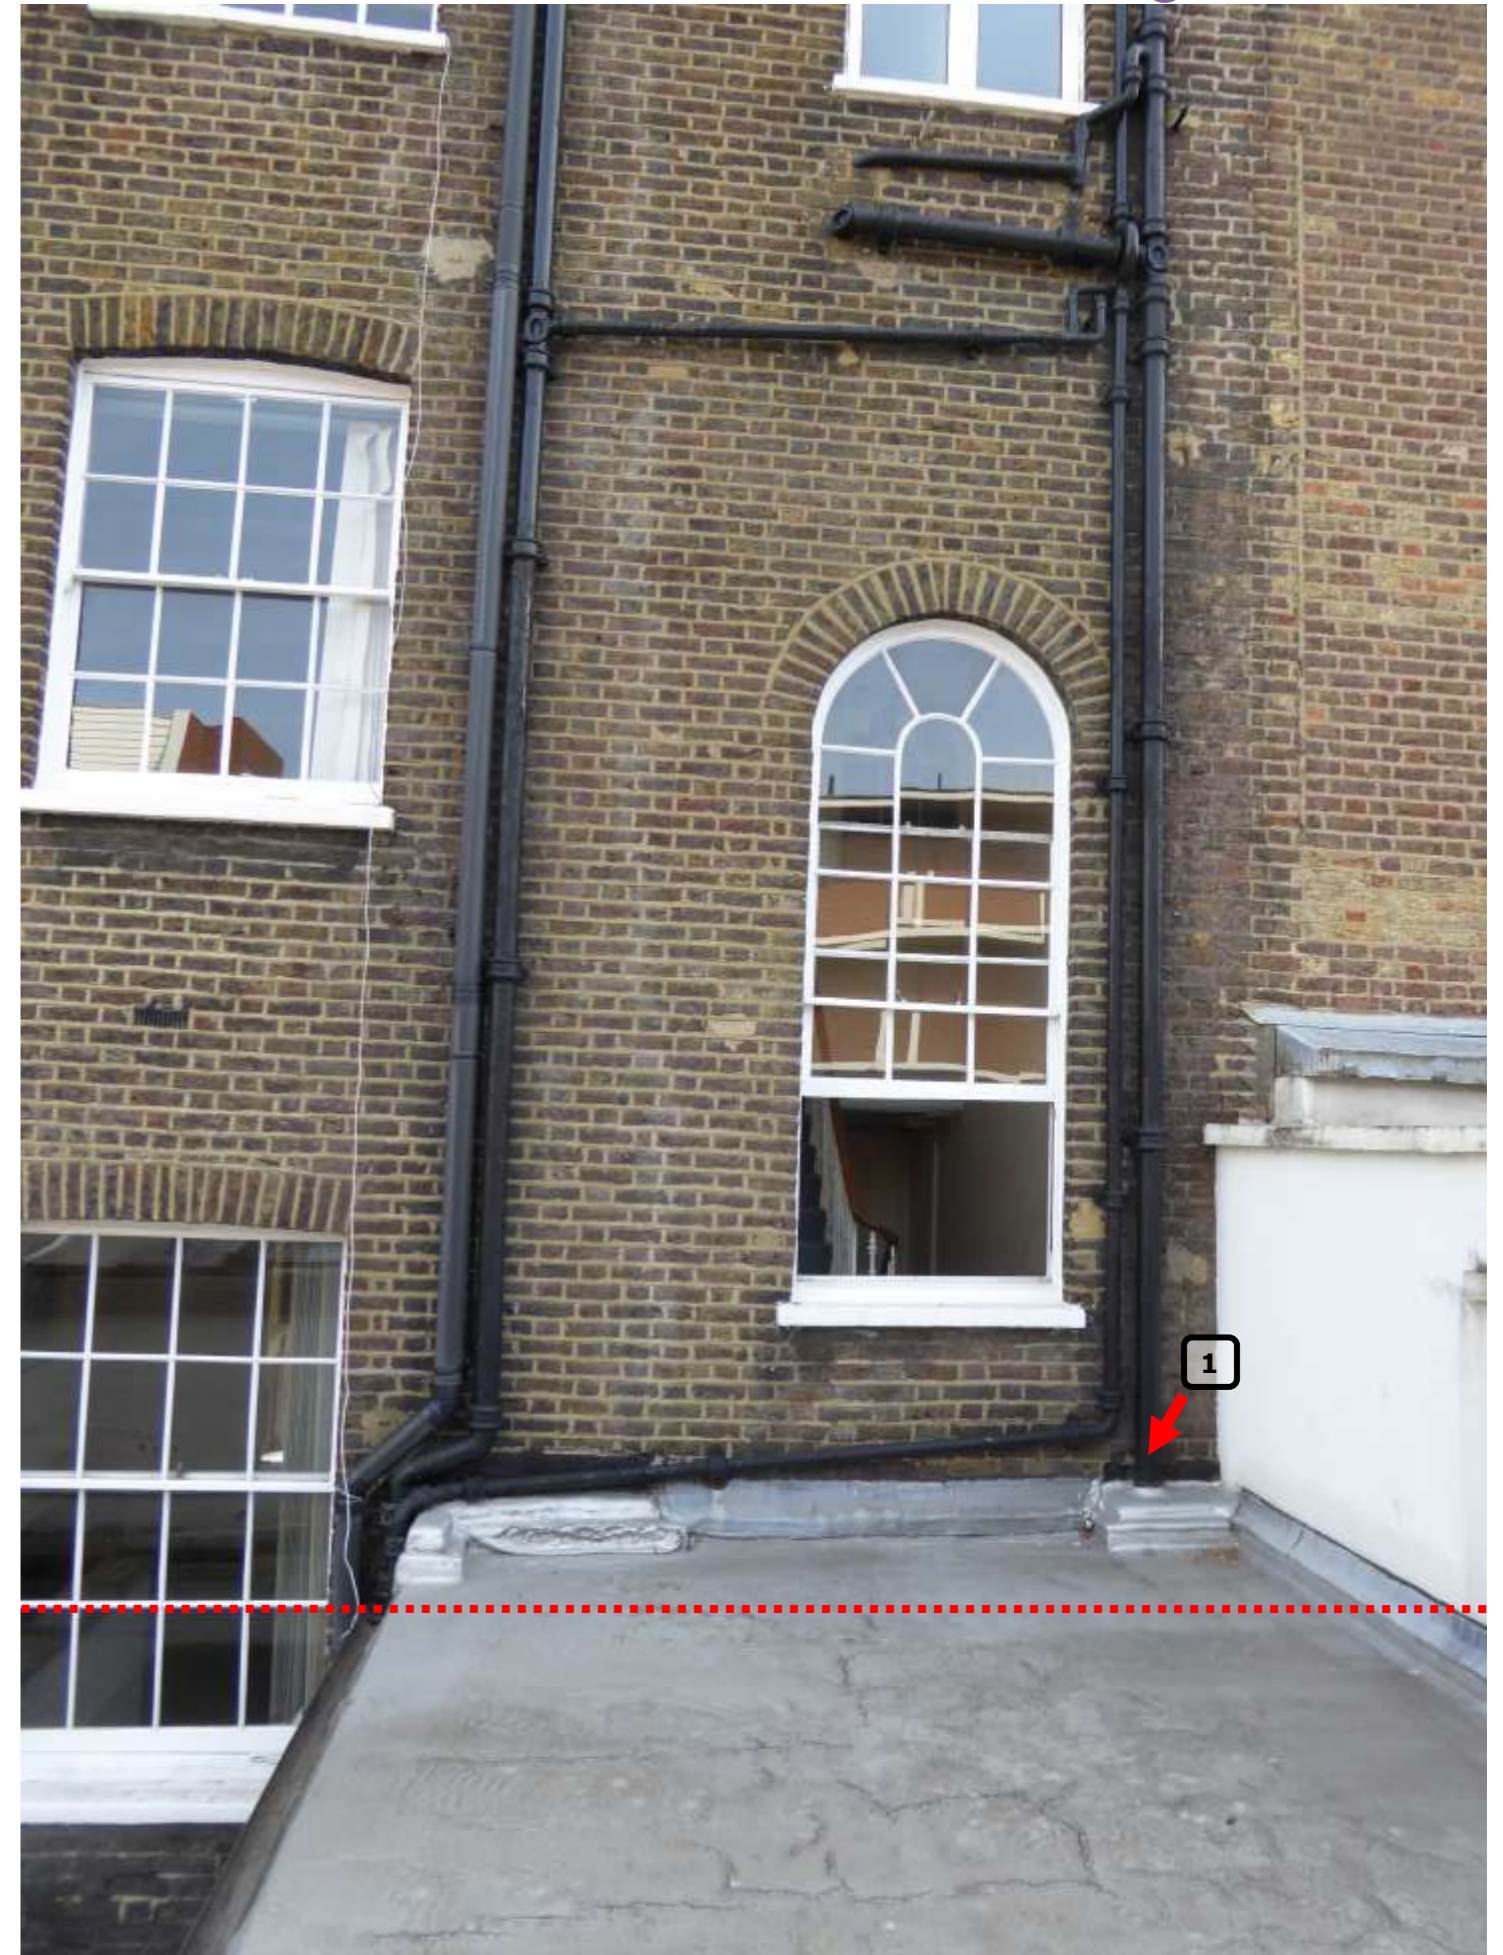
Plate E2: The rear elevation of No. 28 with the red line extrapolated from the previous photo. The down pipe [1] can be seen internally at Plates FL1 and FL2 on pages 12 & 13.
