Design and Access Statement: 22<sup>nd</sup> June 2018

This document is to accompany the Listed Building, Conservation Area and Planning Application for the replacement of an existing single storey rear extension at No 5 Gainsborough Gardens, a Grade II listed semi-detached house located within the Hampstead Conservation Area.

# 5 Gainsborough Gardens - Rear Extension

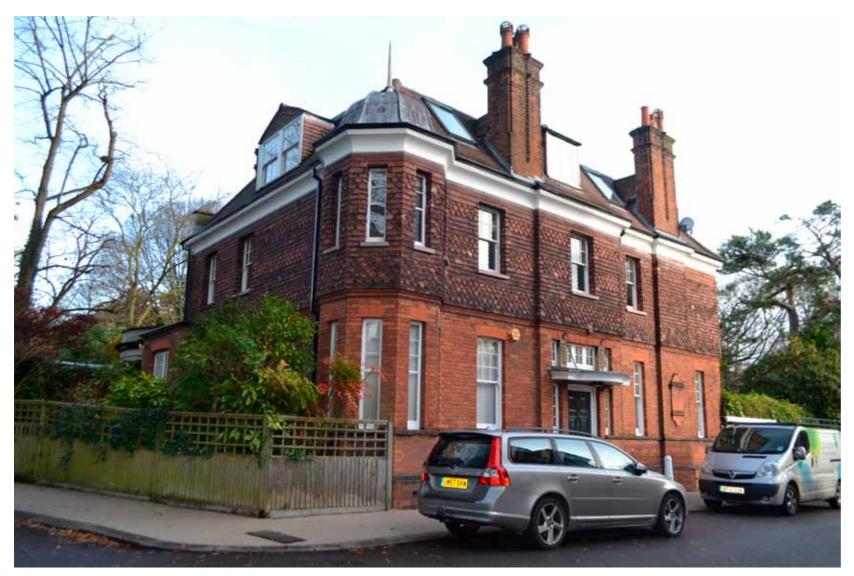
5 Gainsborough Gardens as it exists today

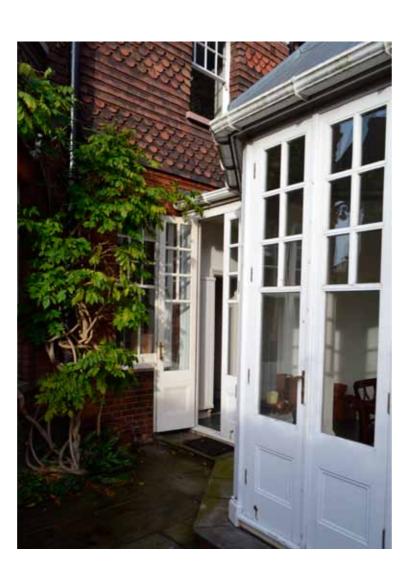
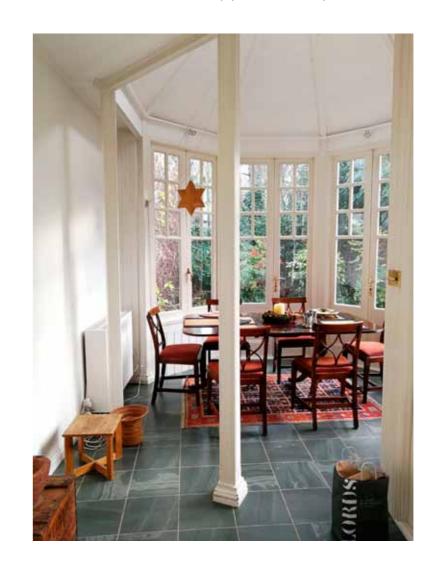
Existing Ground Floor Plan

The existing conservatory is a non original addition to the property and it is in a very poor condition. Its design and construction does not allow for any flexibility of the space and contains a number of internal columns which make the space inflexible and difficult to use. There is currently no level access to the patio area and garden and the extension has very poor thermal performance.

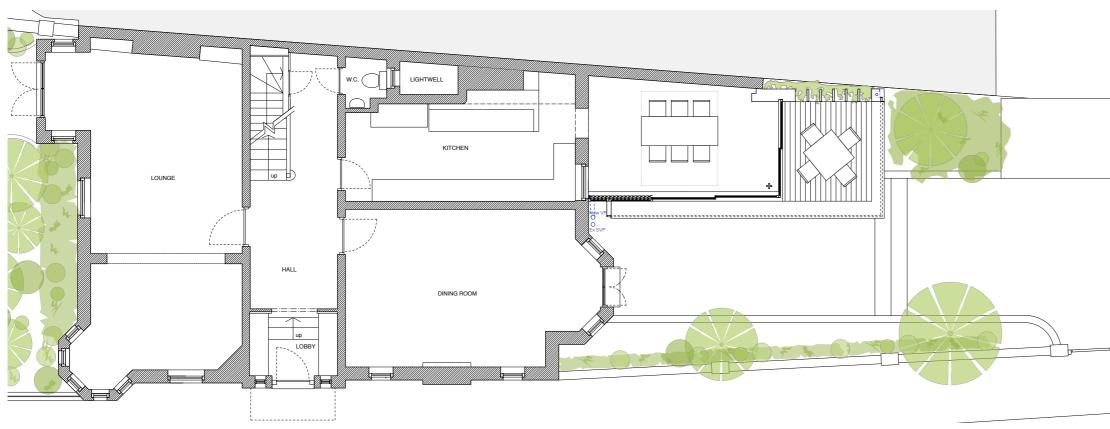
Proposed Ground Floor Plan

The proposed extension projects from the rear, South East wall of the existing house. It is adjacent to the boundary with the neighbouring house, Heath Lodge. Its location, in the corner of the garden, does not cause any loss of amenity to the adjacent properties with regard to sunlight, daylight, outlook, overshadowing, light pollution/spillage, privacy/overlooking and sense of enclosure. It allows retention of the garden and is constructed over the footprint of the existing conservatory and a small part of the existing paved area. In order for the new extension to be subordinate to the original building its height is much lower than the existing conservatory.

A pergola like structure will extend the space further into the garden and provide a privacy screen which will prevent overlooking from neighbouring properties. The design is largely transparent and integrates soft planting into the composition.

Slimline sliding double glazed doors will open up the extension to the terrace and to the rear garden.

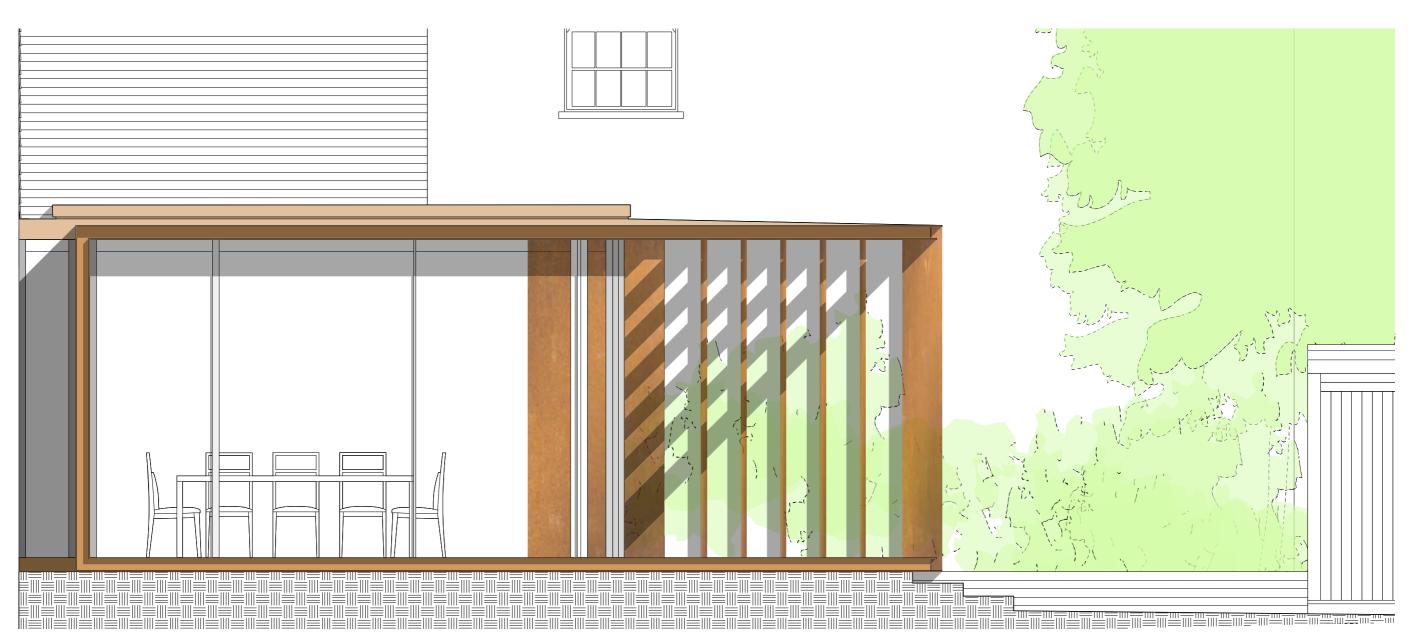
#### **Proposed South Elevation**

The extension has been designed to provide level access to the teraced area.

Introducation of fins to the back wall adds trancaprency qualities and allows for plants to wrap around the structure and blend in with the existing garden landscape.

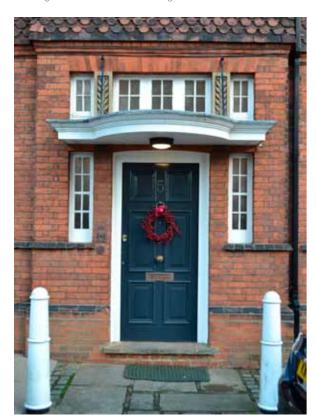
Existing stepped access to the property

Existing access arrangement to the property is via stepped front door leading to the lower level lobby. There are further three steps up internally leading to the main ground floor level. There are no proposals to alter the existing main access arrangement to the property, however it is proposed to provide alternative wheelchair accessible route via existing front garden.

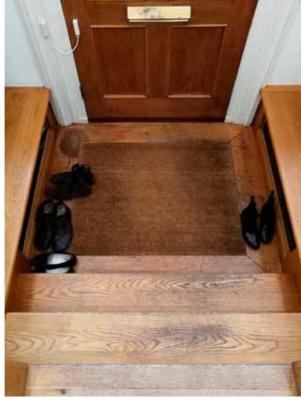
Existing Internal stairs to the front entrance lobby

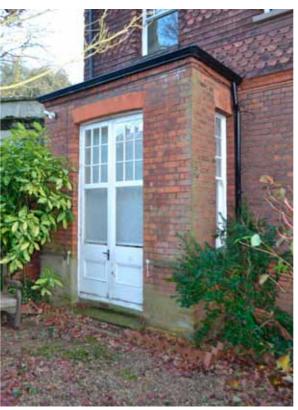
Existing french doors leading to the ground floor

The site naturally slopes from the front garden towards the main entrance door and there are only slight changes in levels between the garden and the ground floor levels. There is existing french door in the side bay leading to the reception room. It is proposed to adjust front garden levels in order to provide landscaped level access to the property.

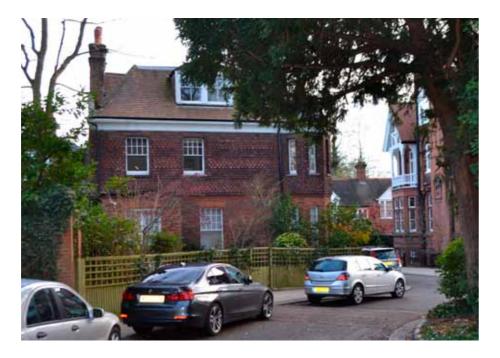
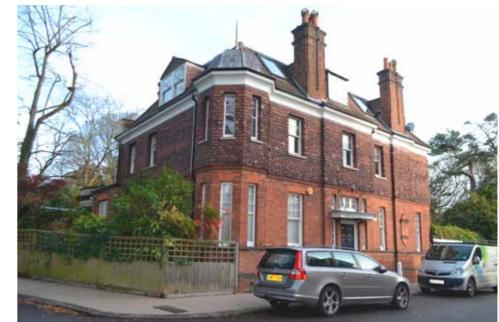
North West Elevation South East Elevation South West Elevation

Whilst a good number of windows are original, a number of them have been provided with new sashes whilst other windows have been replaced.

The front entrance door appears to be a non-original door within an original frame. The side doors to the house appear to be of relatively modern construction.

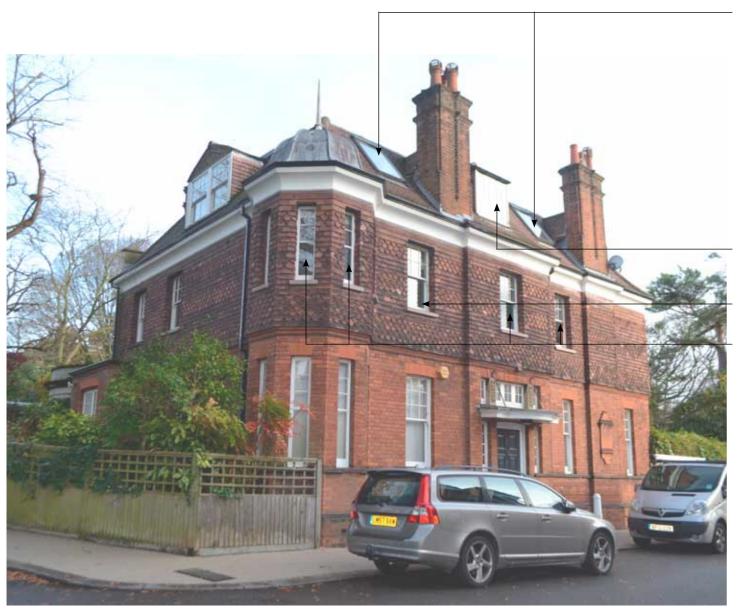
Modern composite aluminium/timber roof lights

Replacement timber double glazed, casement windows to existing dormer

Replacement timber double glazed sash window

Refurbished or replacement sash windows

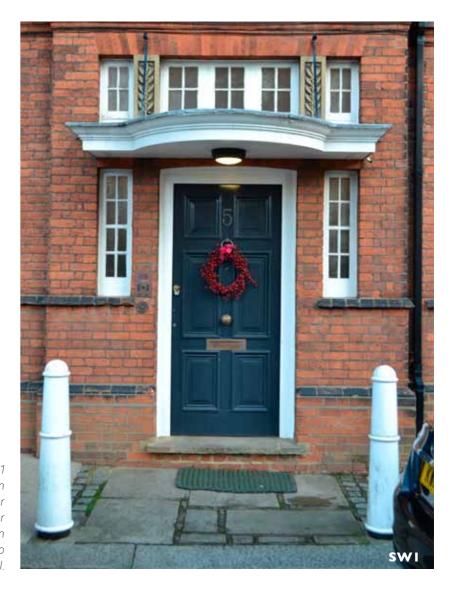
Photo SW1
Existing main entrance on
South -West Elevation. The door
is relatively modern however
the side windows and the fan
windows above canopy appear to
be original.

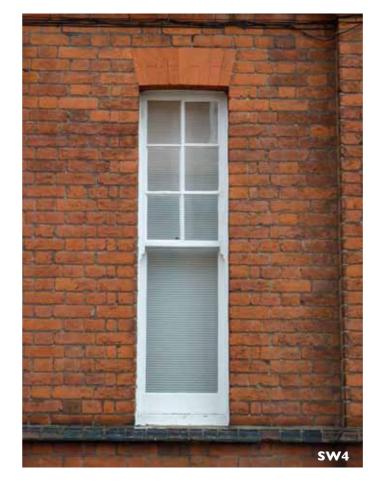
Photos SW4-SW7
Typical windows on ground floor
of South -West Elevation. The
windows seem to be original with
some replacement hinges to the
casement window in the corner
bay.

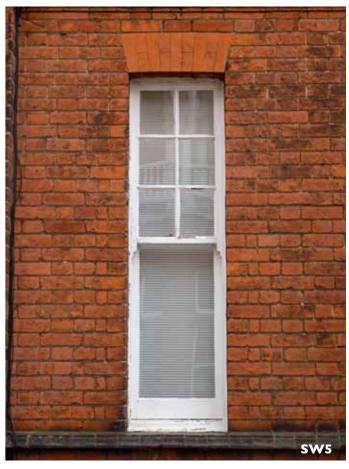
The horn detail shown is typical of the sashes to the ground floor and would appear to be original.

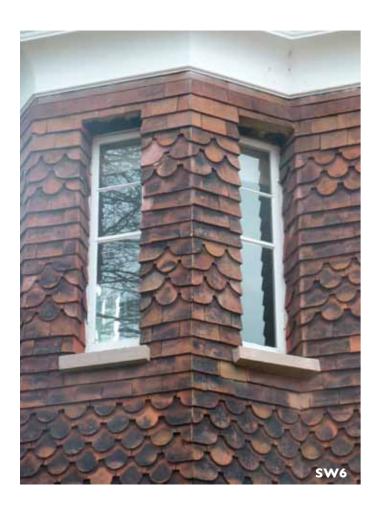
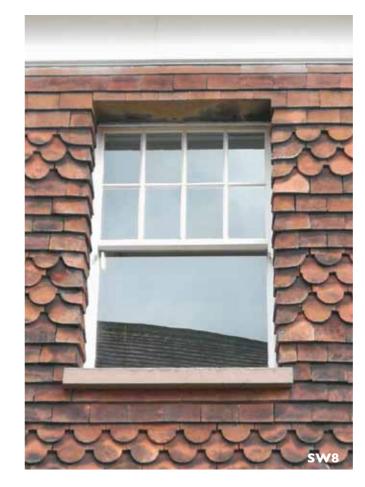
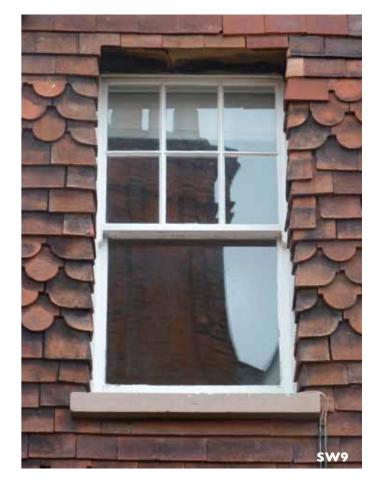
Photos SW6-SW9
Typical windows on first floor
of South-West Elevation. The
windows have been either
replaced or refurbished- SW7 is a
relatively modern double glazed
sash window.

The horn details to the upper floors vary from those at the ground floor. It is likely that either whole windows have been replaced or replacement sashes fitted within the existing sash boxes.

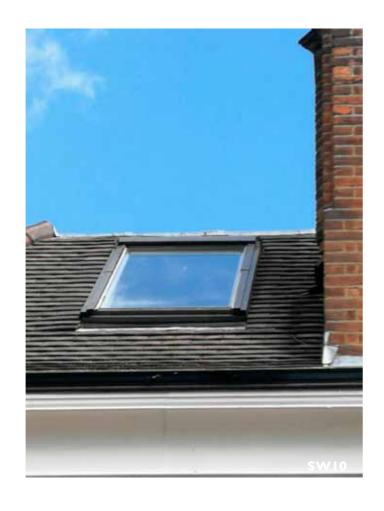
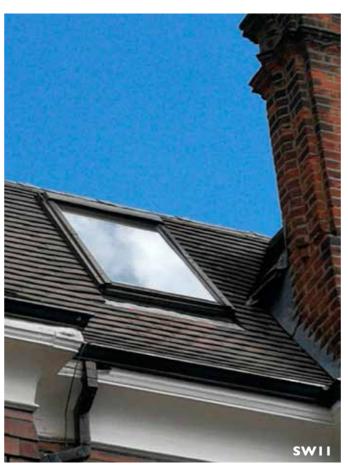
Photos SW10-SW12
Typical windows on second
floor of South -West Elevation.
The roof lights are relatively
new and the dormer window
is replacement double glazed
casement window.

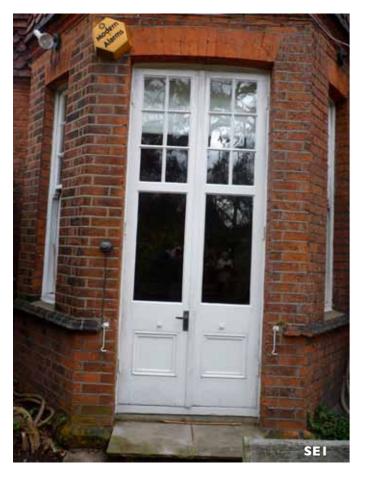
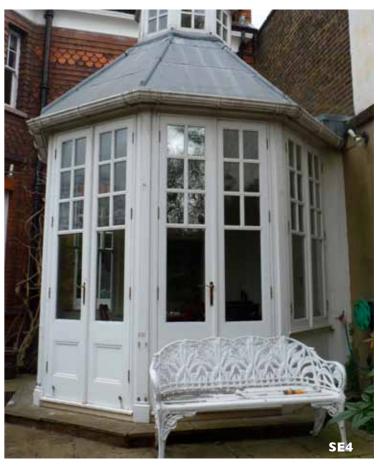
Photos SE1-SE4
Existing garden doors are
modern in construction, however
both windows to its sides seem to
be original. The conservatory is a
modern addition.

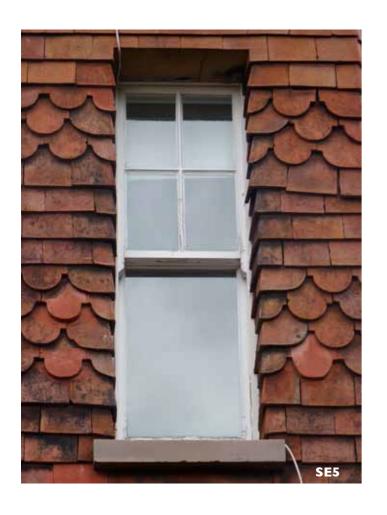
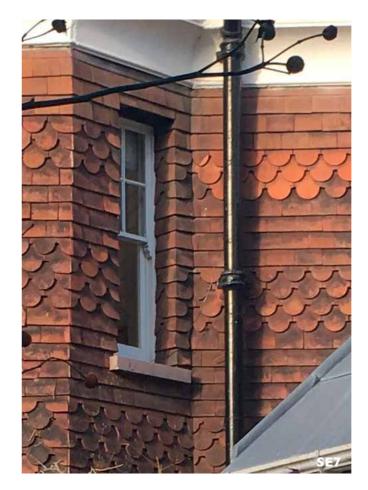
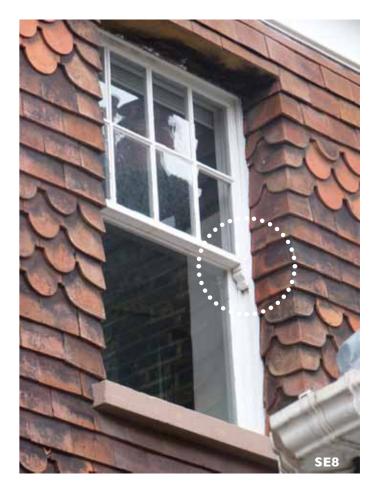
Photos SE5-SE8
Typical windows on first floor of
South-East Elevation. Windows
SE5, SE6 and SE8 are nonoriginal windows with different
horn details to window SE7 which
seems to date from the time of
original building.

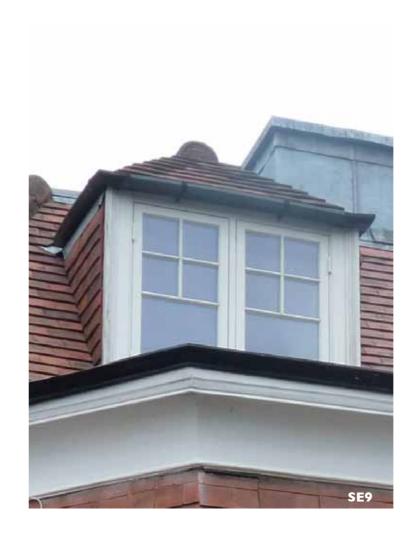
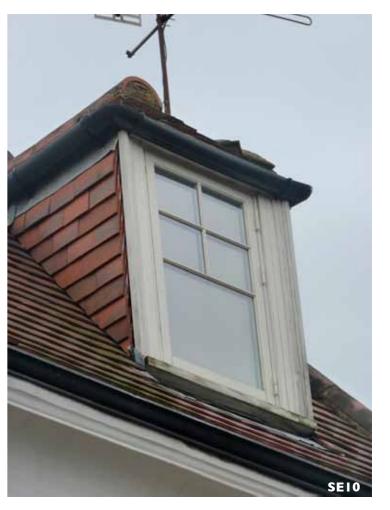
Photos SE9-SE10
Existing second floor dormer
windows on South -East
Elevation. These are modern
timber casement windows.

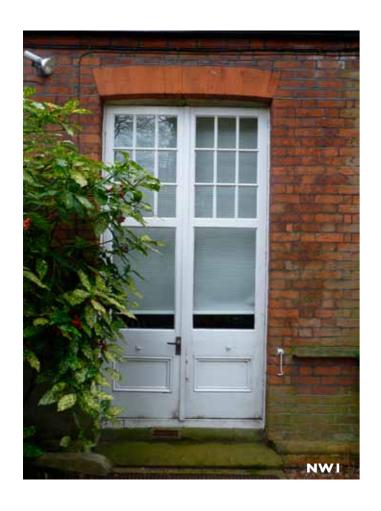
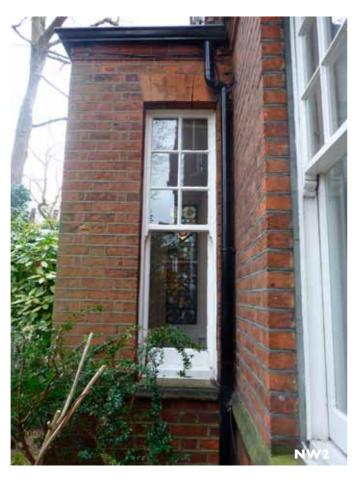
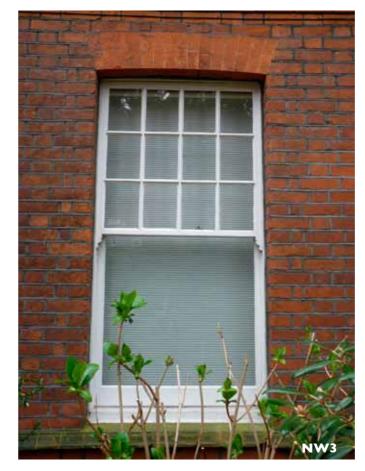
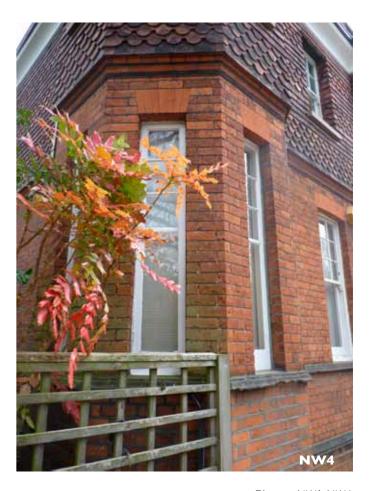
Photos NW1-NW4
Typical ground floor windows and door on North -West Elevation.
The sash windows are original with some drought proofing work done to the window on photo NW3. The door to the ground floor reception room however is relatively modern.

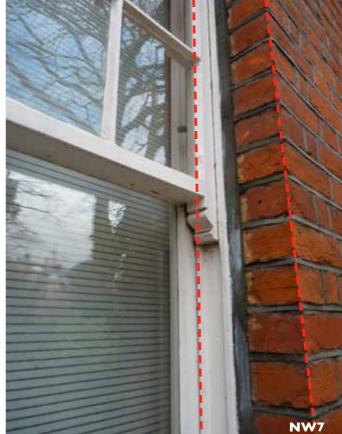
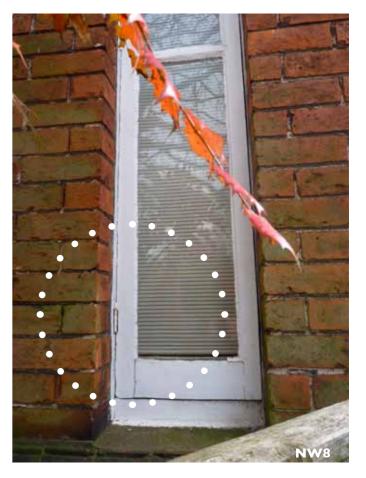
Photo NW8
Circled replacement hinges to some of the casement windows on ground floor of corner bay.

Photos NW5-NW6
Red dashed line denotes the repointing work that was carried out to the ground floor walls.
Some of the windows were drought proofed with caulk which is visible on photo NW7

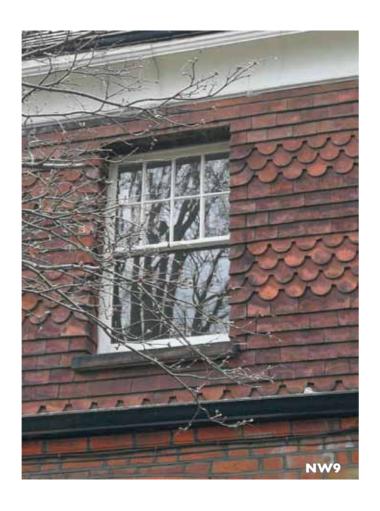
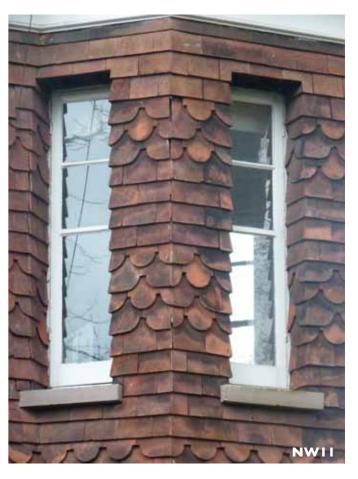
Photos NW9-NW11
Existing first floor windows on
North -West Elevation. The sash
windows seem to be original. The
casement windows in the corner
bay seem to be original as well.

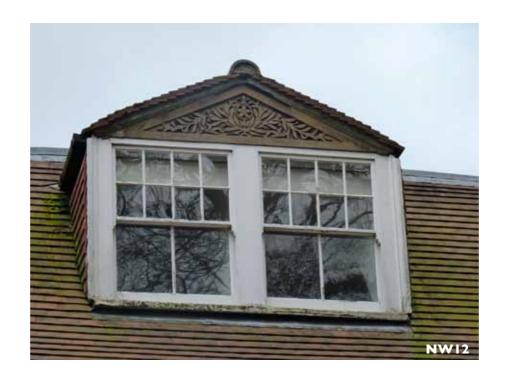
Photo NW12-NW13
Photo NW12 shows gabled twolight dormer with sashes with
decorative gable. Photo NW13
shows the ogival leaded roof with
tall finial to corner bay.

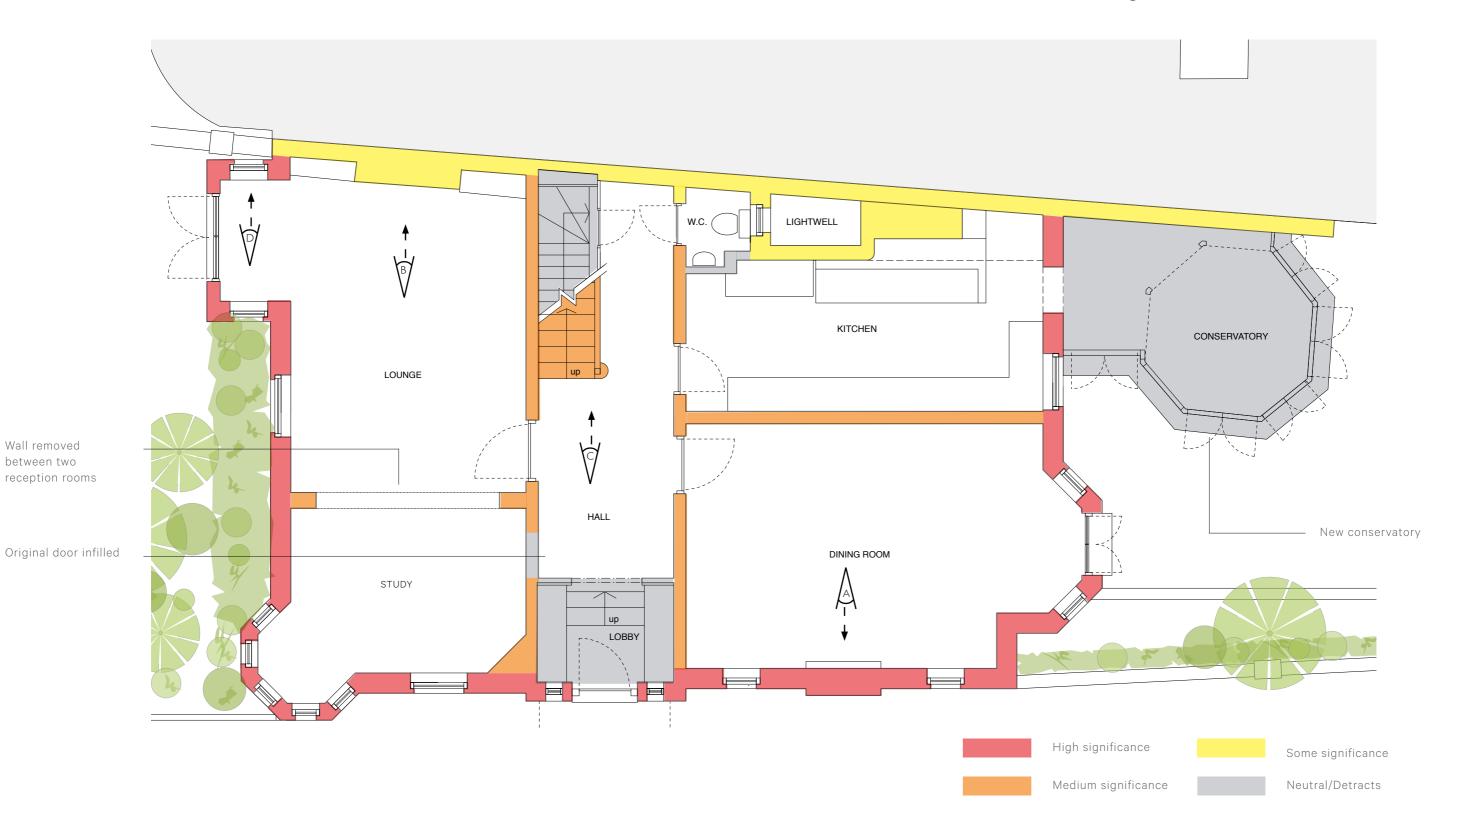
## Internals : Existing Ground floor

Wall removed between two

# Photos A-B These photos show ornamental fireplaces to dining and drawing rooms, typical window surrounds and stained glass sash window to side bay. It should be noted that the fireplaces were installed by the current owners before the building being listed and are not original to the building

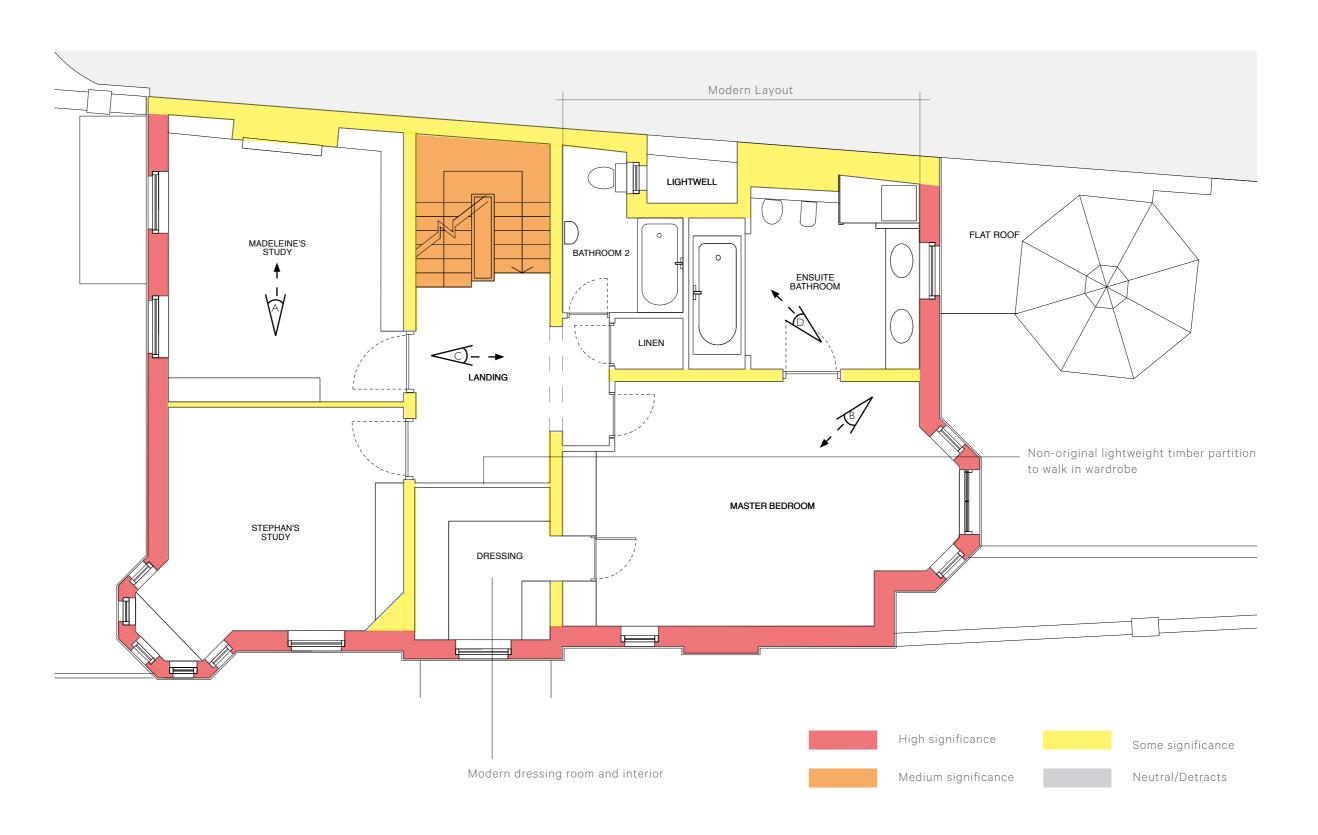
#### Internals: Existing First Floor

Photos A-D
These photos show typical door architrave detail, art nouveau fireplace, modern joinery within the bedrooms and en-suit bathroom.

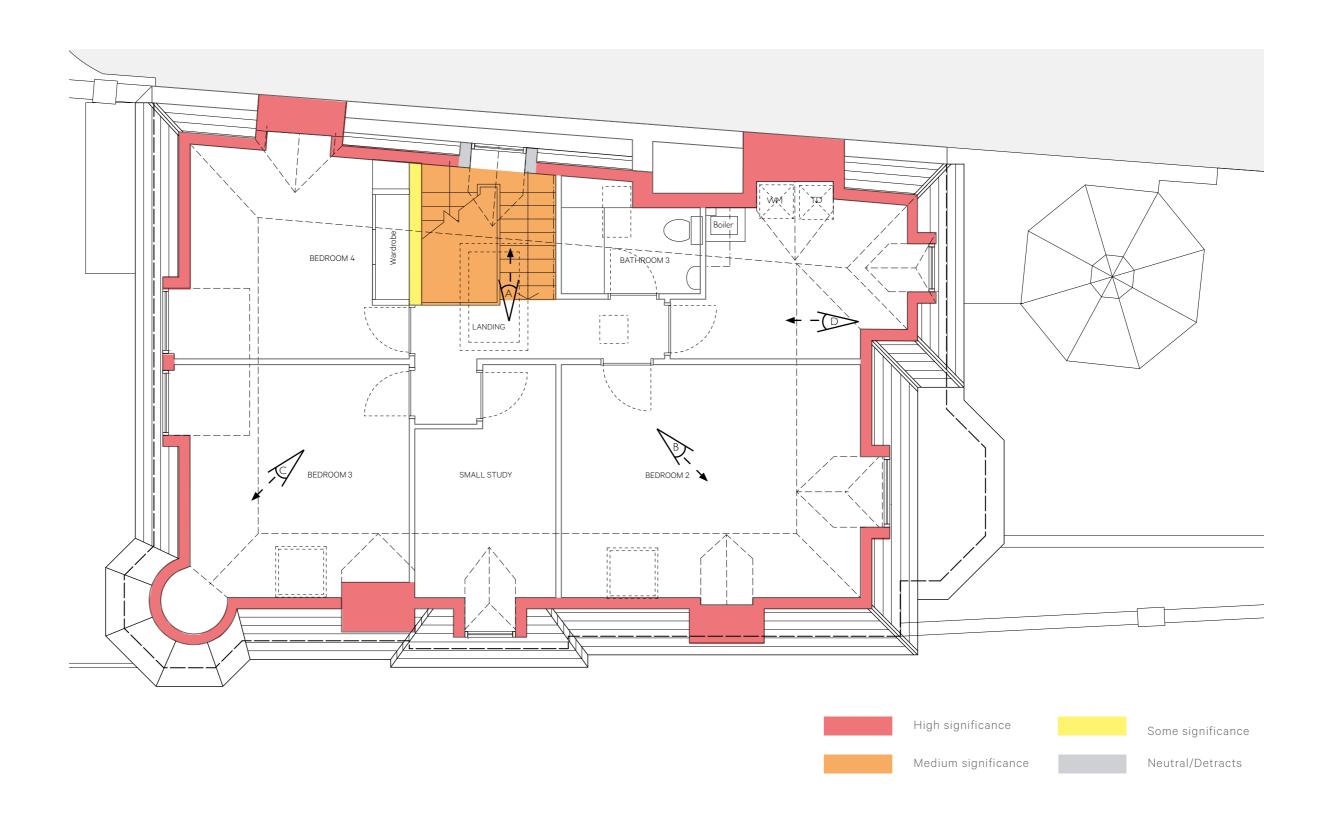
Internals: Existing Second Floor

Photos A-D
These photos show typical door architrave detail, simple skirting boards to all rooms and various modern dormer windows.

There is a new dormer to the North-East elevation with fixed glazing and heavy glazing bars. There are number of new rooflighs.
