1EWo2 Enabling Works – Area South

Heritage Agreement Method Statement

Dismantling and Storage of the Obelisk to Baron Southampton in St James's Gardens

Document number: 1EW02-CSJ-HS-MST-S003-000153

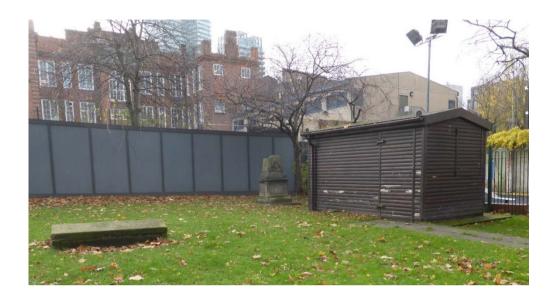
Figure 1 View of the Obelisk to Baron Southampton in St James's Gardens

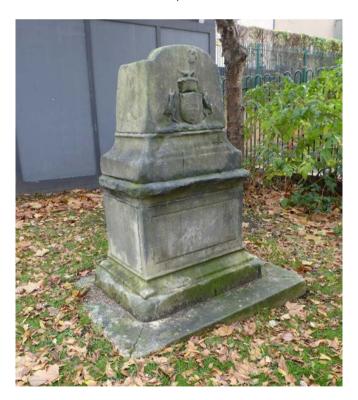
Figure 2 North elevation of the Obelisk to Baron Southampton

- Although the commemorative inscription is illegible in normal ambient daylight, use of RTI enhanced legibility to the extent that short fragments could be read and were consistent with the text of the epitaph to the Earl of Rosse, which had been recorded in a publication of 1869-72. Heritage consultants to the HS2 project employed an imaging methodology known as RTI (Reflectance Transformation Imaging) or Polynomial Texture Mapping in attempts to decipher the severely eroded inscription on the north face of the monument. Combined use of photogrammetry and RTI in July 2017 digitally captured the inscribed face. Although the upper lines were too eroded to allow transcription, the lower lines (including the fourth from the bottom, beginning 'of the Disaffected among...' and the fifth from the bottom, starting 'To his many valuable Qualities...') match F.T. Cansick's transcription of the epitaph for Laurence Harman, Earl of Rosse, Baron and Viscount Oxmantown dated c.1869, which is reproduced below in Figure 7. (see Figures 2 and 7)

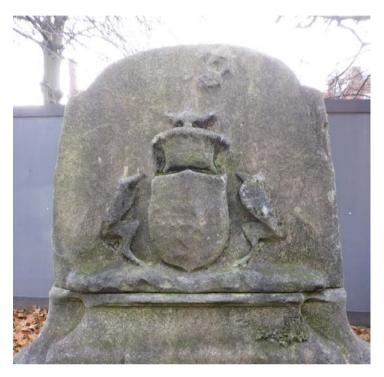
Figure 3 Detail view of the armorial relief

2.3.1 The obelisk's architectural and artistic significance has been diminished by surface decay and loss. Little remains of the sculptural carvings of the heraldic animals, coronet and coat of arms, which originally adorned the monument. The upper section, the obelisk which capped the monument, has been lost, and the inscriptions on the plinth are no longer legible. Still, the remains of the armorial relief and the traces of inscription detected using specialist imaging provide an element of information about who the memorial commemorated. The use of imported stone, in this case white marble, which is not available in the UK, is more typical of

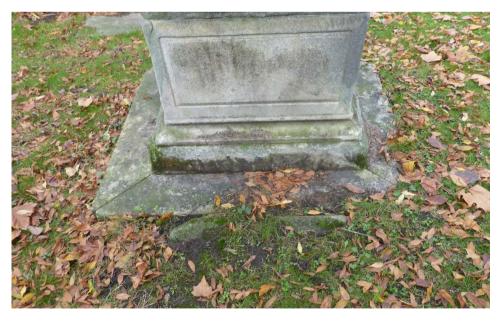
Figure 4 $\,$ Partially buried section of stone on the south side of the obelisk

- The upper section of the obelisk has been lost. A section of stone partially buried in the ground on the south side of the monument may form part of the upper obelisk originally fixed above the round-headed stone. The listing description, written in 1999, notes that the upper part of the obelisk's tapering shaft was broken at the time of designation.

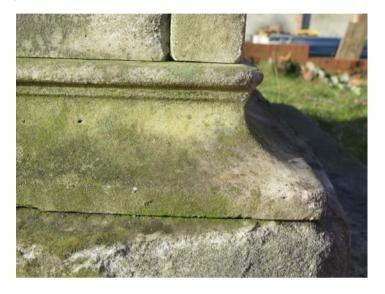
Figure 5 Detail illustrating very fine joints between marble blocks

- The stone courses of the monument are very finely jointed, in the order of 1-3mm in width, so that in places the bed joints are virtually indistinguishable. With a few exceptions the dressed marble blocks have lost their original, sharp arrisses. The mouldings have eroded very extensively so that the decorative profile has been lost or at least obscured in most areas. Micro-organic growth, ranging in colour from green to greys, has colonised almost all surfaces and some larger species are visible at the joints.

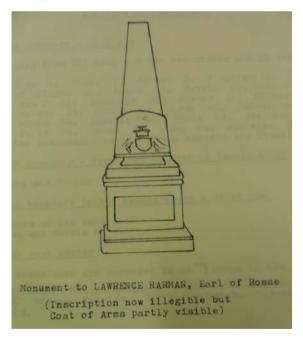
Figure 6 Depiction of the Obelisk in 1986 ²

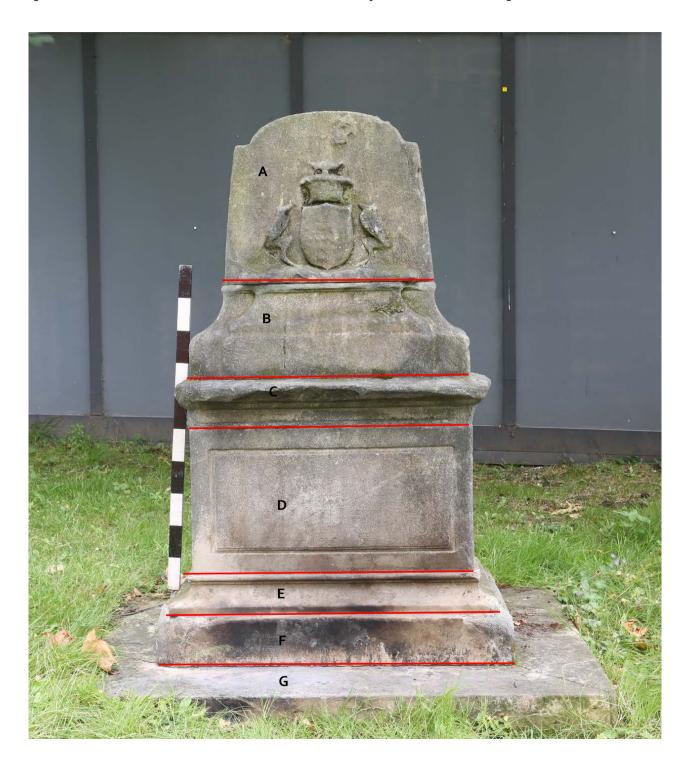
Figure 8 North Elevation of monument annotated to show bed joints and course labelling

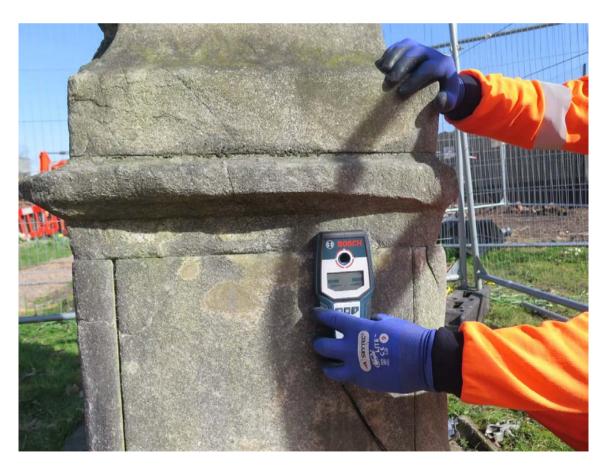
Figure 9 West face of monument illustrating surface fractures and thin facing slab of course D

Photograph below illustrates opening up of perpend (vertical joints); see left of frame below, which appears to be due to corrosion of imbedded ferrous fixings. The photograph also shows metal detection in progress. This indicated imbedded metal fixings are present along bed joints and along most perpend (vertical joints). The red colour around circle on metre indicates a positive reading, confirming metal at this location and along this bed joint (between blocks B and C)

Fine, often hair-line, fractures are visible on all four elevations of the monument. These fine fractures may, in some cases, be the result of weathering, which has exploited naturally occurring micro-fissures in the stone. Fractures may also be caused by corrosion of imbedded ferrous cramps. This is a common defect in monuments, especially at the corner of blocks and at perpendicular (vertical joints). Fractured corners and mouldings are particularly vulnerable to spalling and detachment during lifting and handling. As far as safely possible, lifting equipment (slings) will be positioned to avoid contact with fractured areas and heavily deteriorated, friable surfaces. However, surface deterioration is extensive and it may not be possible to avoid all vulnerable areas. The stone condition and lift plan will be re-assessed at all stages of lifting and handling to minimise the risk of damage and surface loss.

- In general, the obelisk appears to be a reasonably stable structure. However, there is minor evidence of movement, which is probably due to the corrosion of imbedded (concealed) ferrous cramps within the monument and resulting expansion which forces blocks apart. This is a typical problem with monuments of this type and date, which can cause severe distortion and displacement, often in the form of wide open bed joints. In the case of the Baron Southampton obelisk, the perpend (vertical) joints on the shorter (west and east) ends of the monument are now slightly open and this is almost certainly due to corrosion of imbedded iron cramps. Ferrous (iron) metal cramps were detected along the open perpend joints and along bed joints using a surface metal detector with a detection limit of approximately 100mm depth. (see Figure 9)

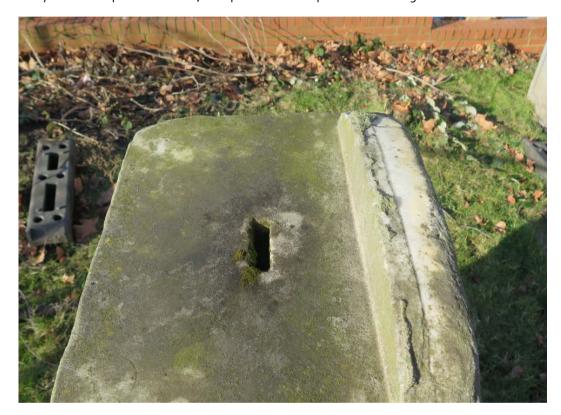
Figure 10 Bird's eye view of top of monument, with probable Lewis pin hole and fixing hole for fallen obelisk

A further optional lifting method may be used, subject to re-assessment by the sub-Contractor in consultation with the project's Built Heritage specialist during the dismantling process. Lifting by re-using the original Lewis pin holes may be employed, provided the holes remain in sound condition suitable for re-use in the top surface of blocks. (see for example Figure 10, which is probably a Lewis pin hole) This option would be considered, depending on the progress of cutting through to release the block and give access for lifting slings, and also depending on the condition of Lewis pin holes as found and assessed by a suitably qualified stone mason experienced in traditional masonry methods. A combination of lifting using slings (polyester) and traditional masonry lifting with Lewis pins may be used, subject to assessment of the various factors set out above and the risks to the monument and health and safety of those carrying out the lifting operation.
