TREE PROJECTS

Re: 13 St Augustine's Road, London NW1 9RL – Camden Council & Front Boundary Wall Issues

SKETCH DESIGN 1: NEW BOUNDARY WALL
TO BE READ IN CONJUNCTION WITH
TREE PROJECTS NOTES OF 25 APRIL 2018

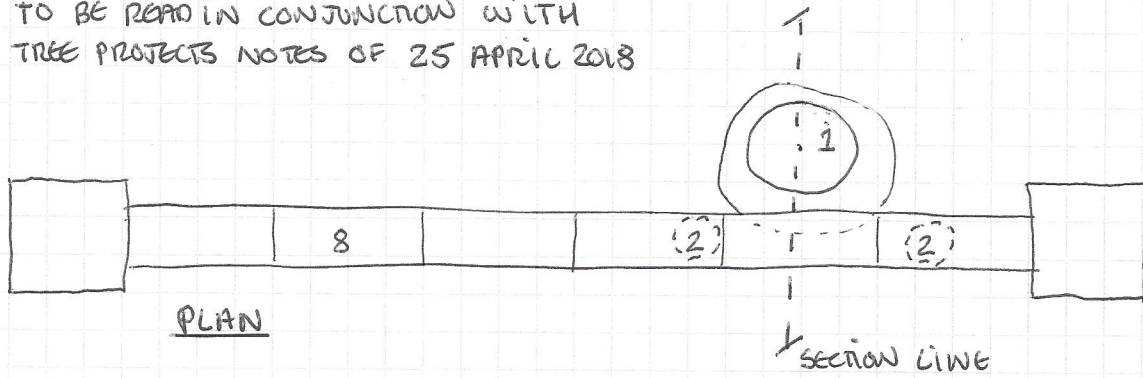
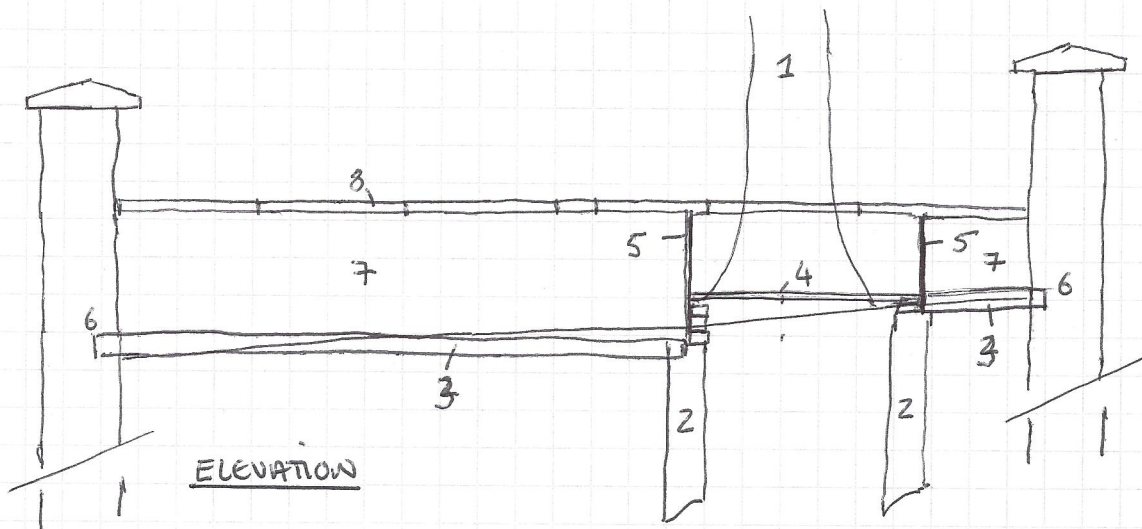
- 1 TREE
- 2 MINI-PILE POSITIONED TO AVOID ROOTS >25mm
- 3 CATNIC LINTEL
- 4 PCC LINTEL 100 x 65mm
- 5 EXPANSION GAP / FILLER BOARD
- 6 REBATE INTO EXISTING PILE
- 7 NEW MASONRY
- 8 COPING STONE

4.3 Attached to these notes, Tree Projects have prepared design sketches which outline the principles to be followed. It has to be accepted that without intricate and detailed 3D modeling, site work should prevail to ensure the separation required is achieved. In design terms a new foundation structure is proposed associated with three brick panels formed such that future damage, should it occur, is localised. In brief the principles advised are summarised:

- 4.3.1 A new, localised hand dug foundation, constructed so as to form a mini-pile, should be installed each side of the tree as close to it as is reasonably practical. Existing footings are to be removed with hand power tools (SDS drill) and a 250-300mm diameter reinforced concrete mini-pile formed with a post hole digger to a minimum of 1200mm depth or to 300mm beneath visible roots whichever is greater. Any roots greater than 25mm in diameter are to be retained and the position of the hole(s) altered. The mini-piles are to support lintels and masonry above and help provide resistance from uplift arising from tree root action.

- 4.3.2 Remove all remaining brickwork and footings and backfill with soil to within 50mm of pavement level.
- 4.3.3 Install two Catnic lintels between mini-piles to be cut into piers. Construct two sections of 9" walls with copings to height to match front walls of adjacent properties. Install expansion gap filler-board up exposed inner face of two new walls where facing tree to top level of brickwork. Lay bricks on top of remaining half of each pile to height such that one 100 x 60mm pre-stressed concrete lintel can be placed to span on the outer face of the wall and bridge the bulge of tree to give 150mm clearance.

- 4.3.4 Raise height of supporting brickwork for a second inner lintel (pre-stressed concrete 100 x 60mm) such that lintel can be laid to provide 150mm clearance from the tree. Lay bricks to required height, maintaining expansion gap filler. Lay coping on top of panel of bricks in front of tree with a mortar joint to outer sections. Render wall where necessary subject to type of brick utilised.

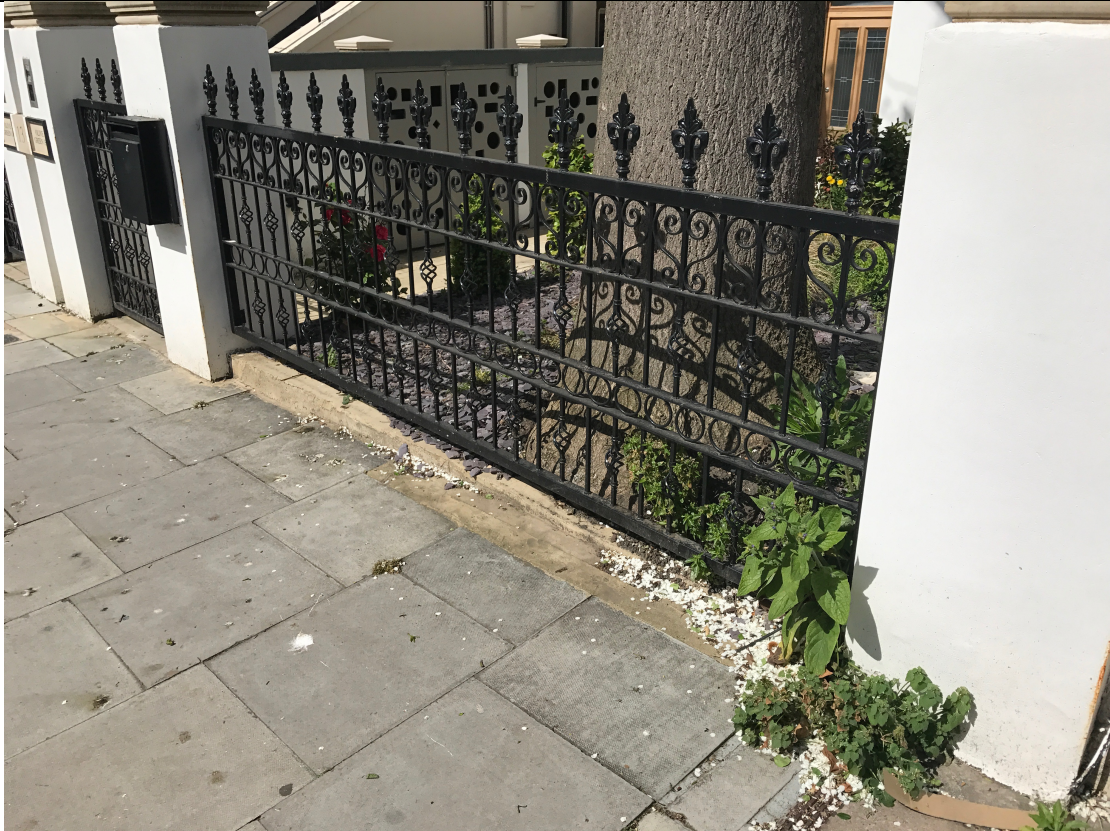
photo 1

- 4.1 In all probability there was once a 9inch /225mm (double width brick) wall topped with coping stones, defining the boundary of the property, similar to what can be seen elsewhere within St. Augustines Road. There is little doubt that the incremental growth of the roots and lower trunk of the Ash overtime, have given rise to damage to this wall, culminating in its removal and replacement with the picket fence as seen in 2013. At the time of recent inspection, the remnants of the wall appear visible at ground level over which the bulge of the tree extends such that there is approximately 100mm remaining before the base of the tree will have fully bridged the entire width of the original wall (towards the back of the pavement). Re-building the wall to match the original is completely impossible whilst the tree remains. An allowance for future growth should be made in any repair. See Photos 1 and 2, attached.

- 4.2 Given the statement above, the best that can be achieved whilst using conventional masonry is to bridge the bulge at the lower part of the tree, to create separation, which will leave a gap. To do anything less would render new construction pointless as further growth, which is inevitable while the tree remains, would very rapidly be damaged and deformed. This has to be accepted by the LPA. There is no gain to be had in cutting away wood at the base of the tree as this would induce rapid reaction growth, and is contrary to best arboricultural practice. There are alternatives to bridging
