BS 5837 Arboricultural Report

Impact Assessment & Method Statement

**80 – 90 South Hill Park
London
NW3 2SN**

Arboricultural Report to BS 5837: 2012 for: Peter Morris

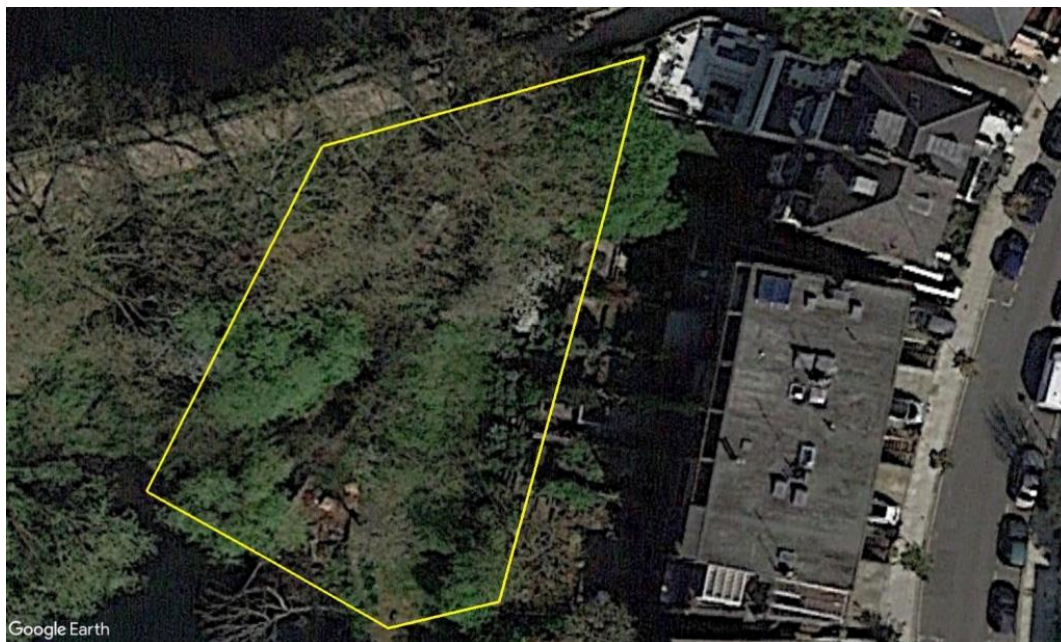
Figure 1 Extent of the survey (image may not be current).

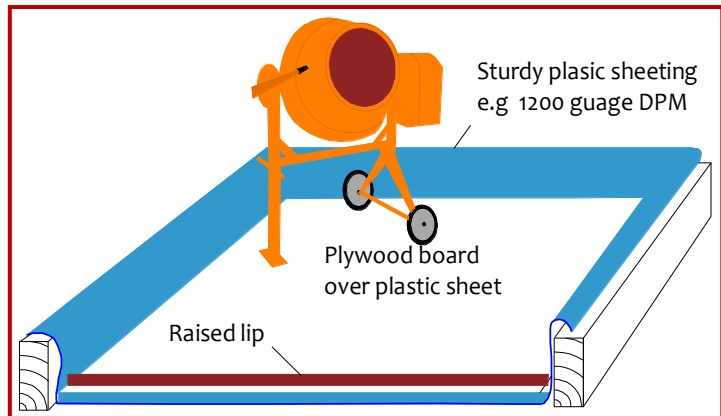
5.8.3. Otherwise, provision shall be made to ensure that the mixing area is contained so that no water run-off enters the Root Protection Area of any trees (see diagram for example). Mixers and barrows shall be cleaned within this area.

5.8.2. Any mixing of cement based materials shall take place outside the *Construction Exclusion Zones* and *Restricted Activity Zones*. Where cement is to be mixed at considerable distances from trees and water run-off cannot enter Root Protection Areas, then no further special measures are required.

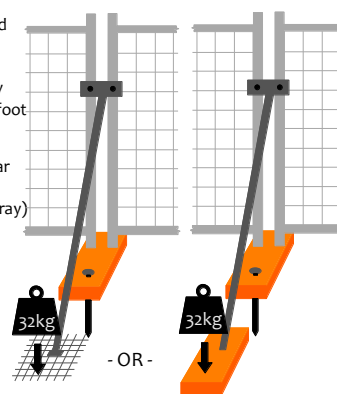
Each panel attached to a back stay which is founded in an additional foot or mesh tray as illustrated

Minimum 32kg ballast to retain rear foot or tray (including the weight of the foot/tray)

Front feet to be secured with ground pins or additional ballast

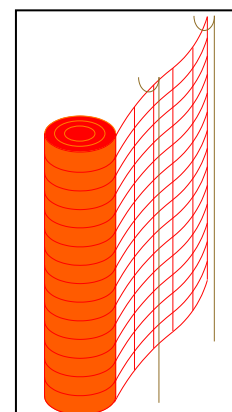
- 7.3.2. In this system, high visibility plastic safety fencing, 1m high, minimum grade 140g/m² is supported on steel fencing pins located at 2.5m intervals.

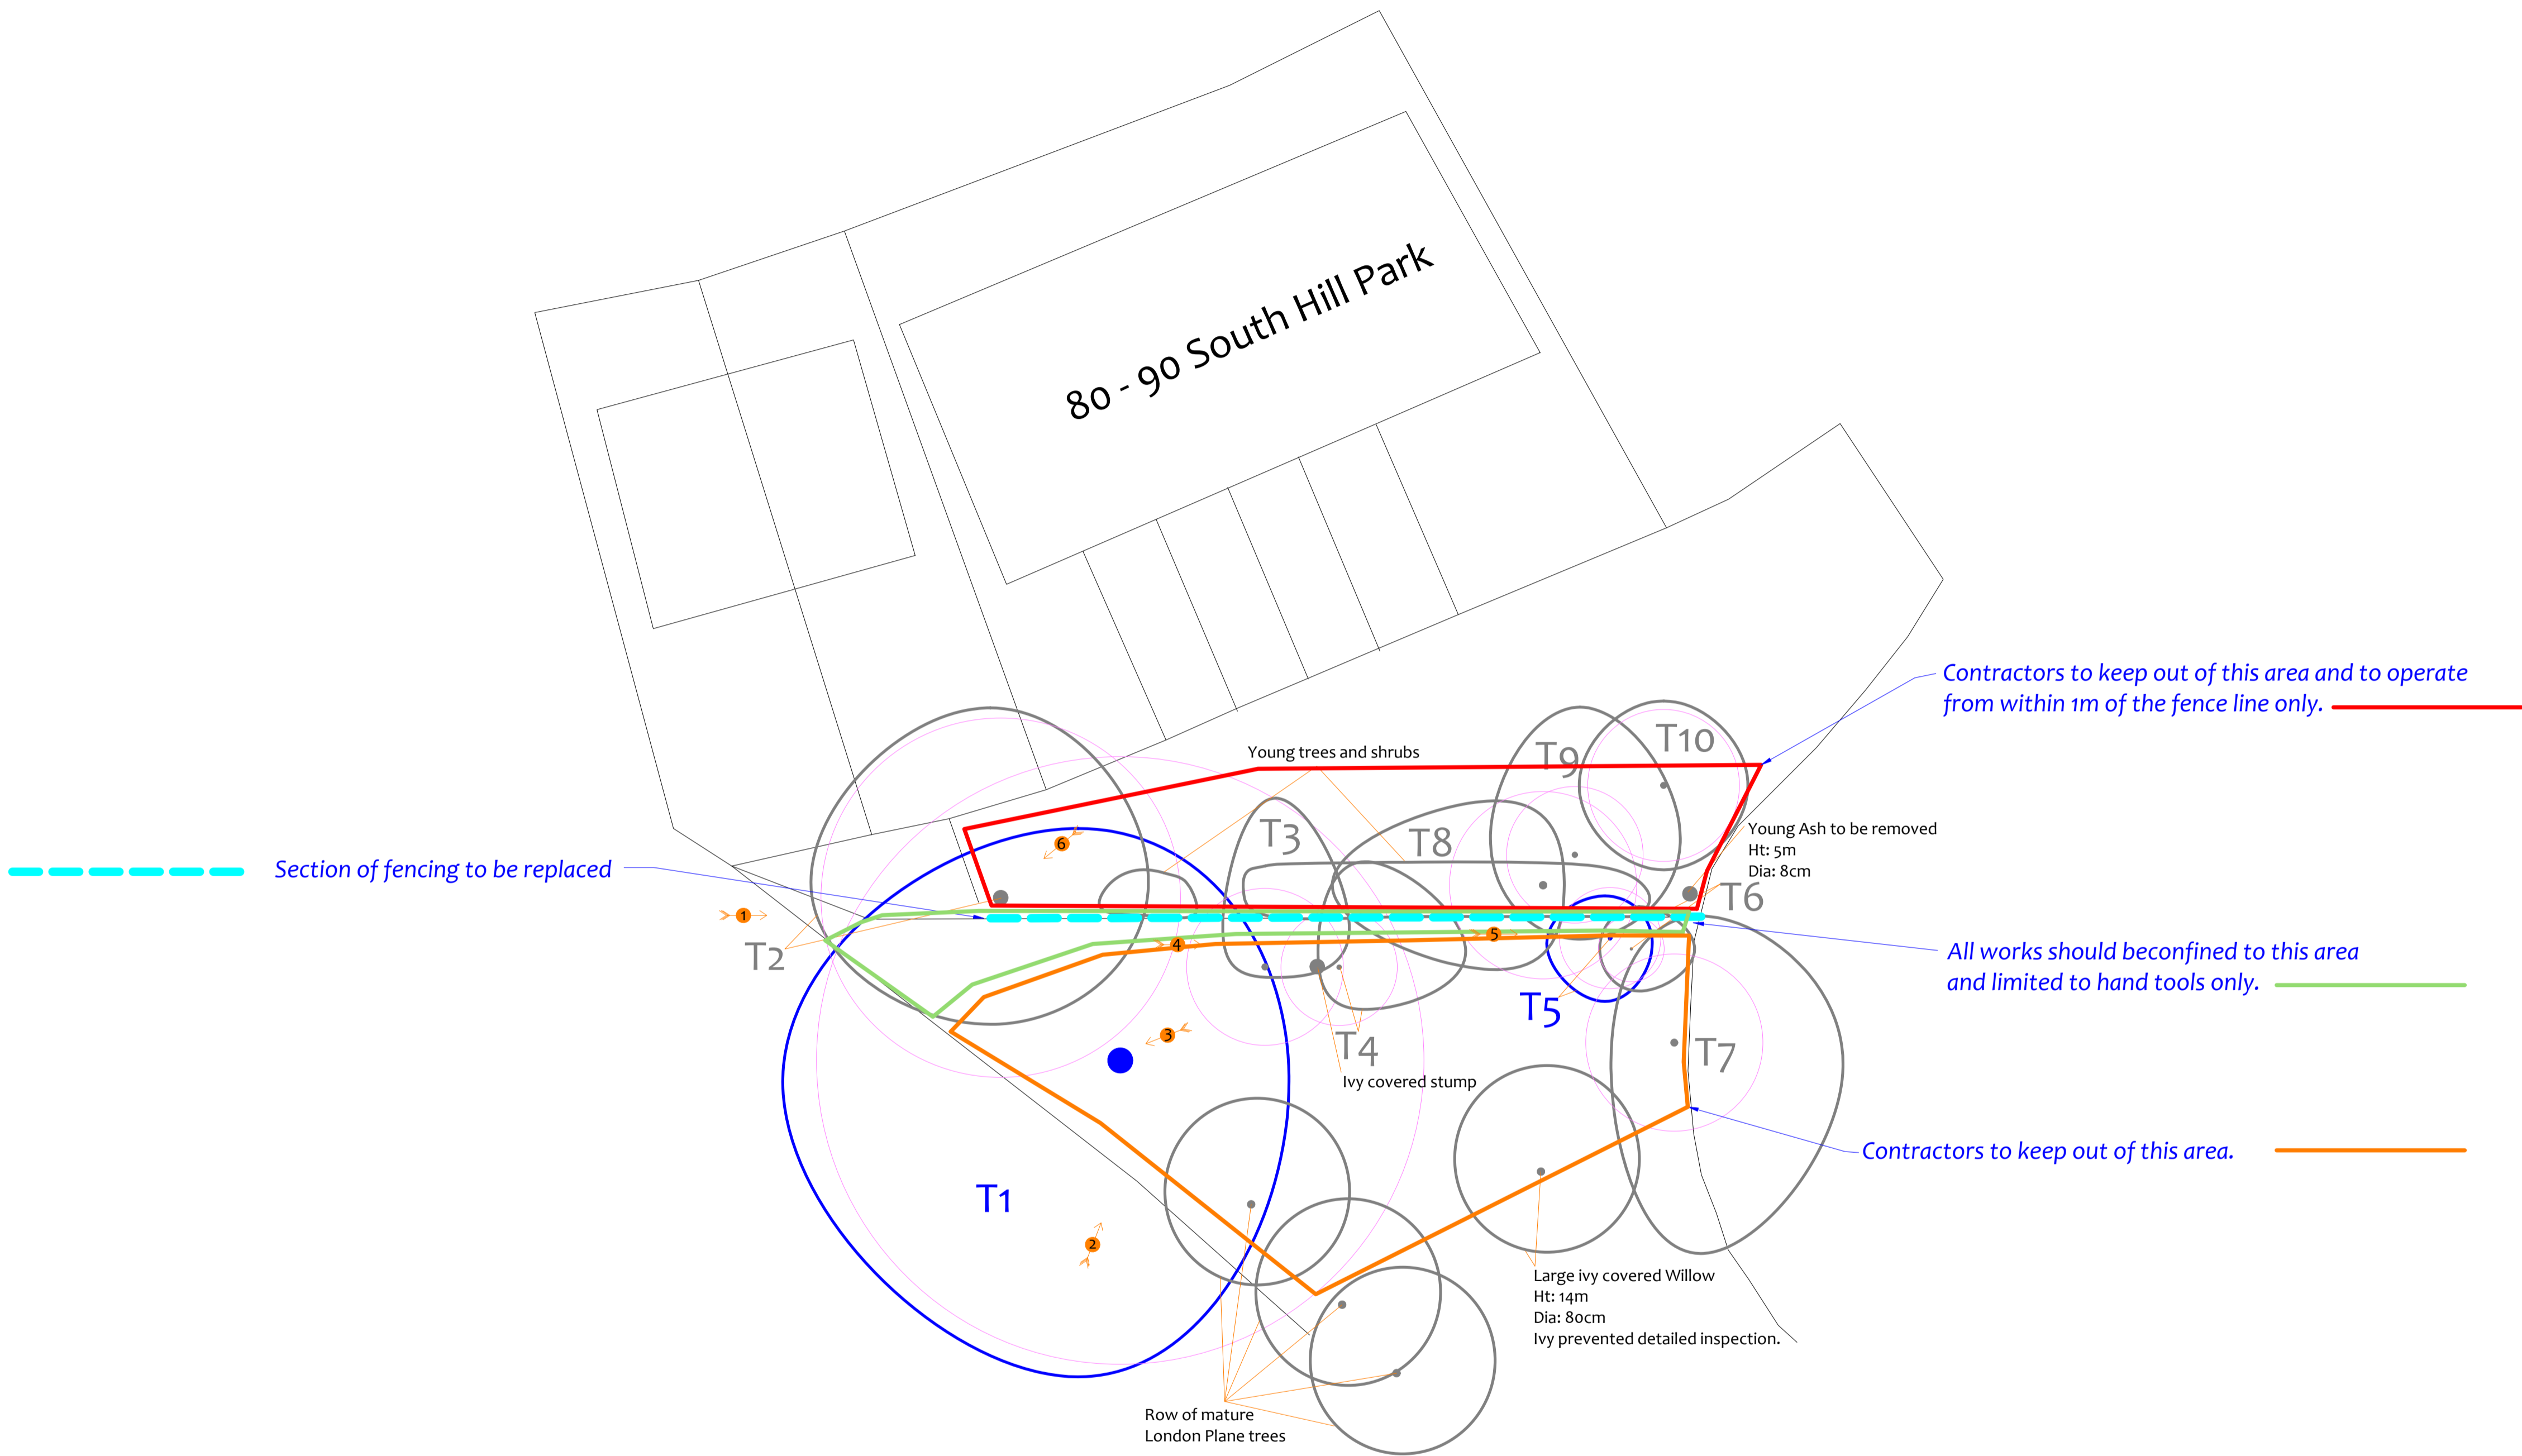
Drawing No: CCL 09958 / IAP Rev: 1
Title: Impact Assessment Plan
(Existing Layout with Proposals Overlaid)
Site: 80 - 90 South Hill Park
NW3 2SN
Scale: 0 5 10m
1:200 Paper Size: A1

- 4.1.1. It is proposed to replace the existing timber fence with a metal railing where indicated on the Impact Assessment Plan. In order to do this the existing fence posts will need to be carefully removed where tree roots are likely to be present and the new post holes will need to be excavated by hand. Provision should be made to ensure that new post holes may be re-located if large tree roots are found to be present.
- 4.1.2. The fence should be installed by contractors working from the footpath side of the fence in order to avoid damaging the shrubs and young trees growing within the private gardens.
- 4.1.3. Ground protection measures should be installed close to the top of the footpath to avoid compacting the soils in which the roots of T1 grow. If only pedestrian activity is proposed in this area, these measures may be as simple as a few timber boards.

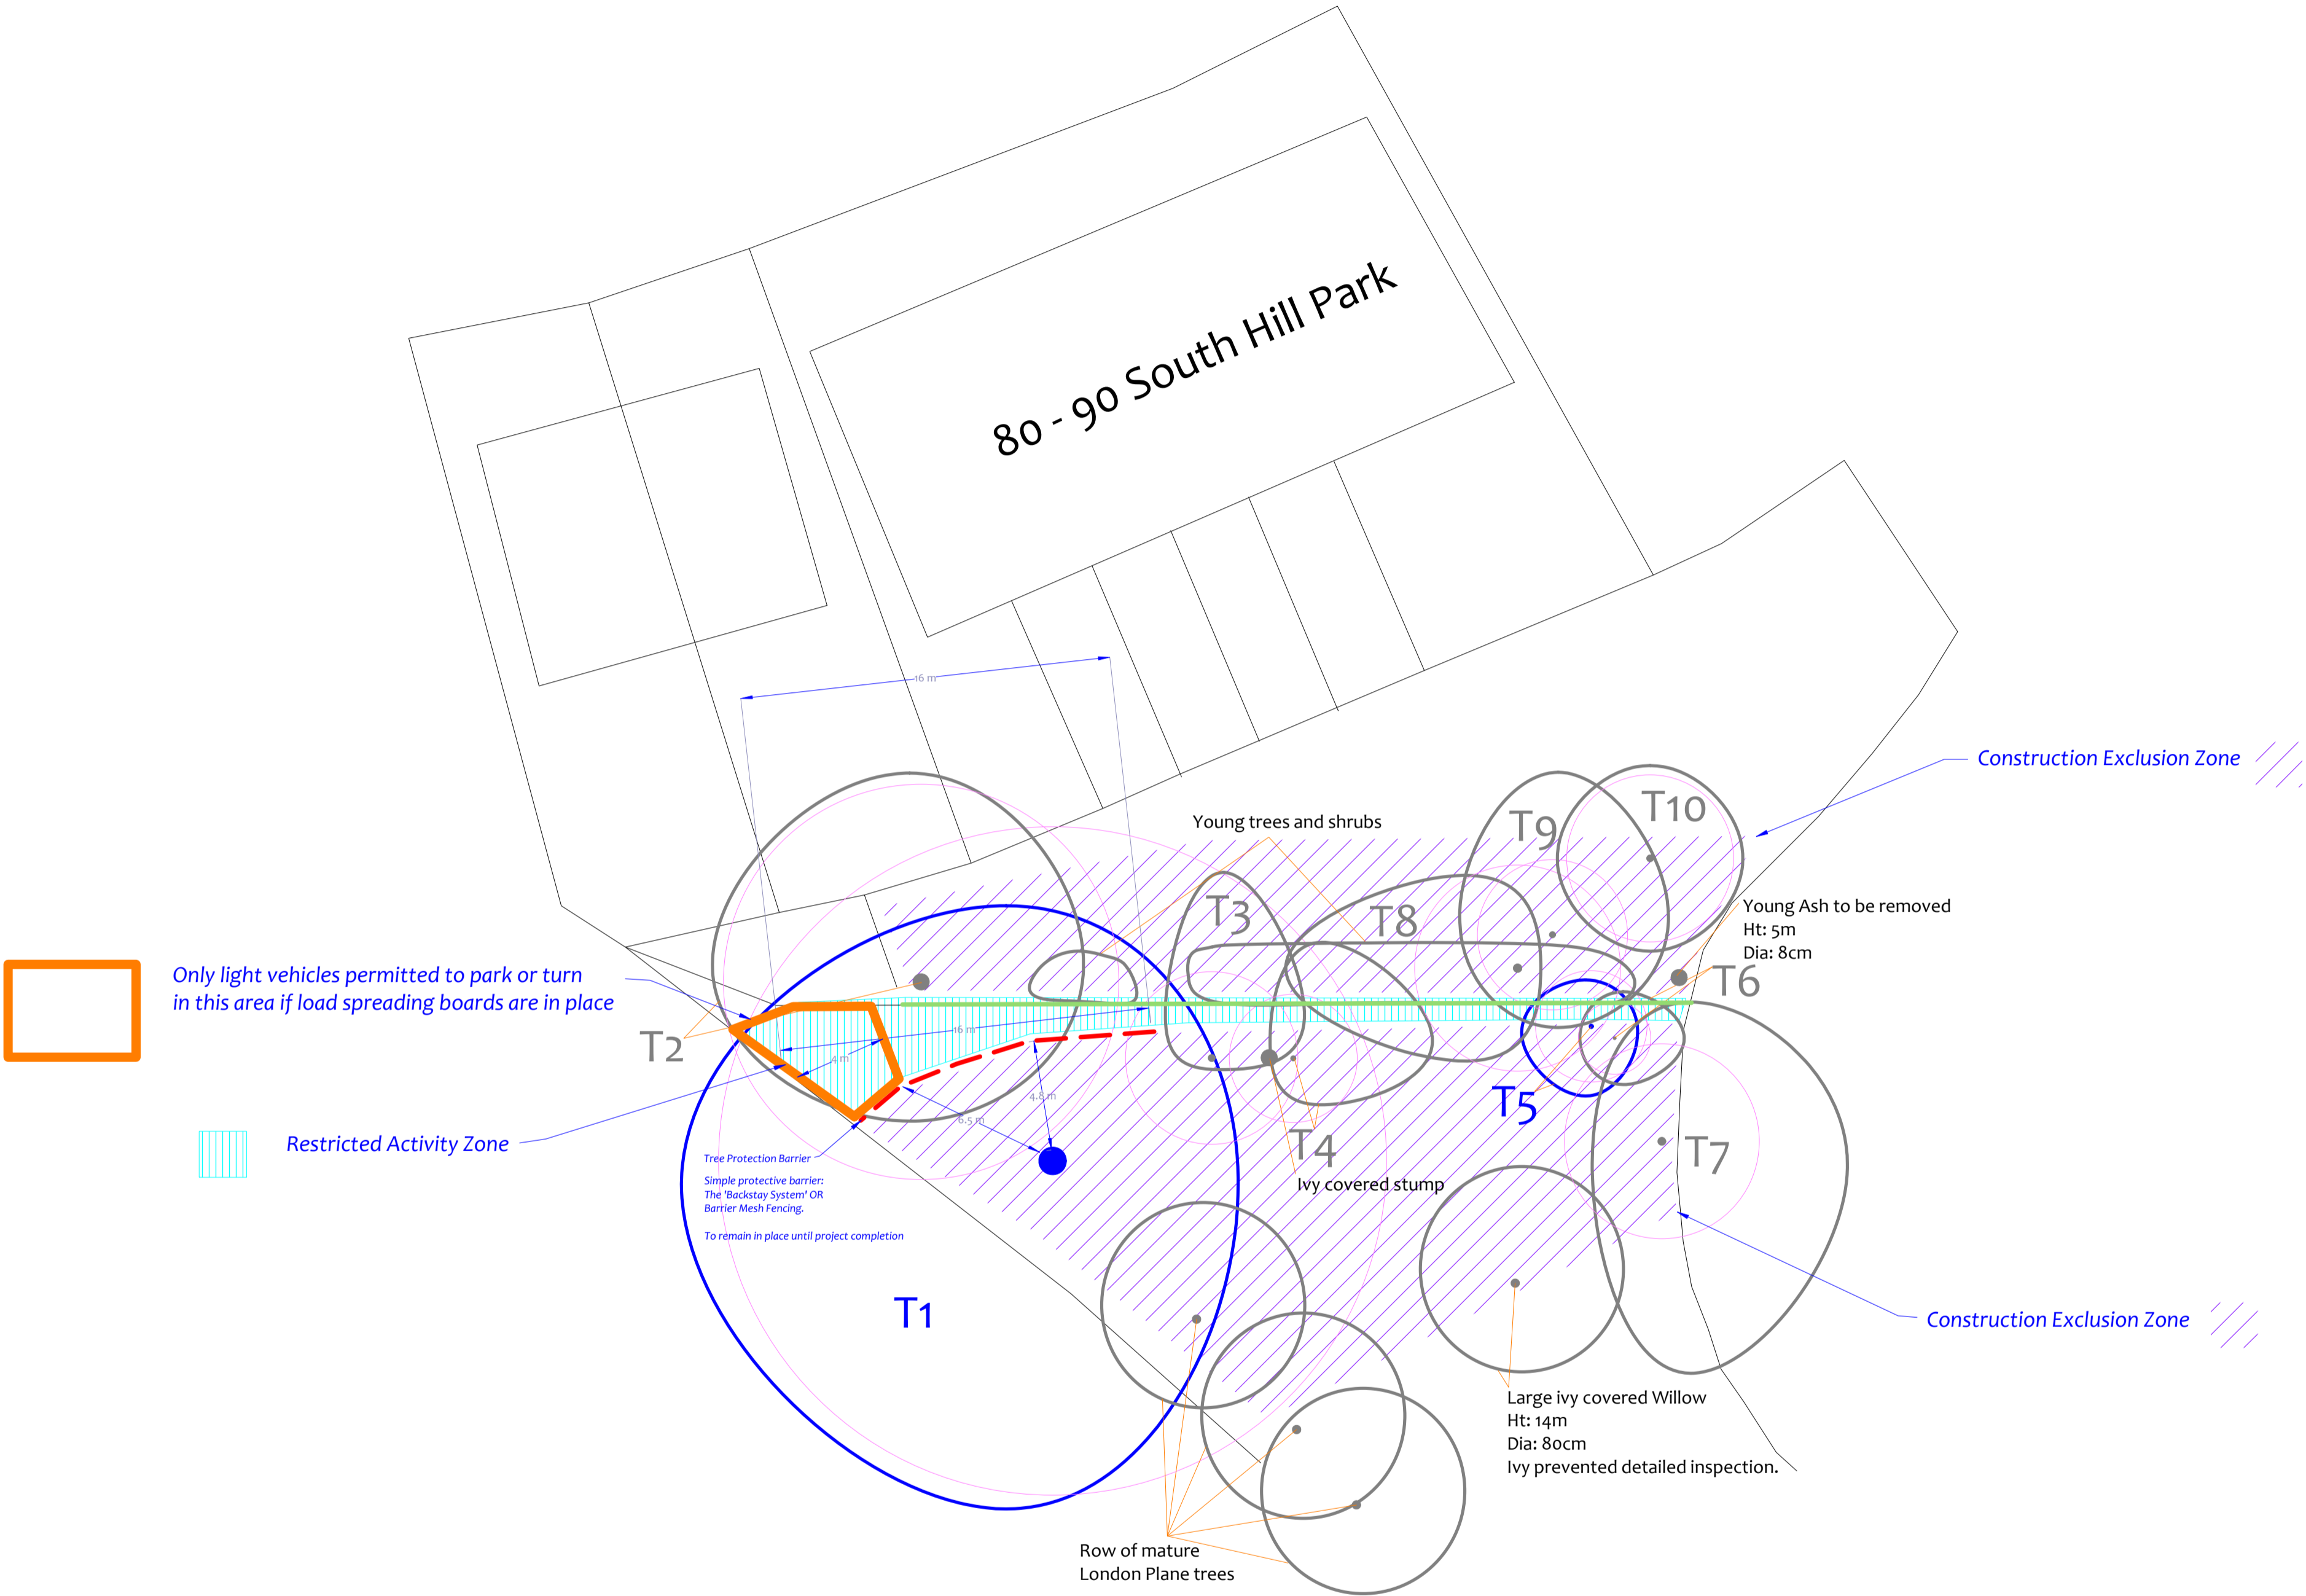
| Drawing No: | CCL 09958 / TPP Rev: 1 |

- If any roots in excess of 40mm are unearthed, they shall be left intact and the post hole relocated.
- This may require some fence panels to be shortened. Alternatively, a variety of panel sizes should be available to the contractor working on site so that shorter panels may be occasionally be selected if required.

- No further excavation or ground disturbance shall occur.
- No cement washings to enter the soil.

See Section 5 for
more restrictions that
apply throughout the site

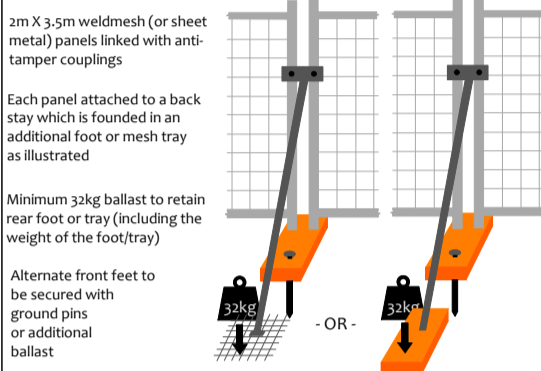
The 'Back Stay System'

- Simple protective barrier: The 'Backstay System' OR Barrier Mesh Fencing.
- To remain in place except when approved works are being undertaken in the Restricted Zone
