ARBORICULTURAL METHOD STATEMENT

Title
Tree Protection Plan

Project
Gondar Gardens, London NW6 1QG

Date May 2017	Drawn by HR	Checked by -
Drawing No 170205-P-12-02	Rev b	Scale 1:250@A1

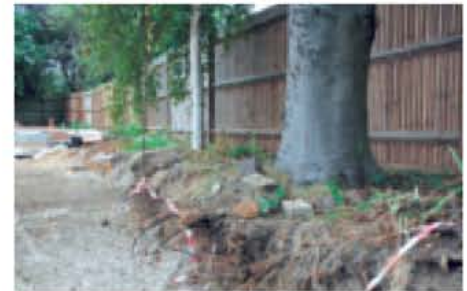
Potential loss of existing tree due to poor construction techniques.

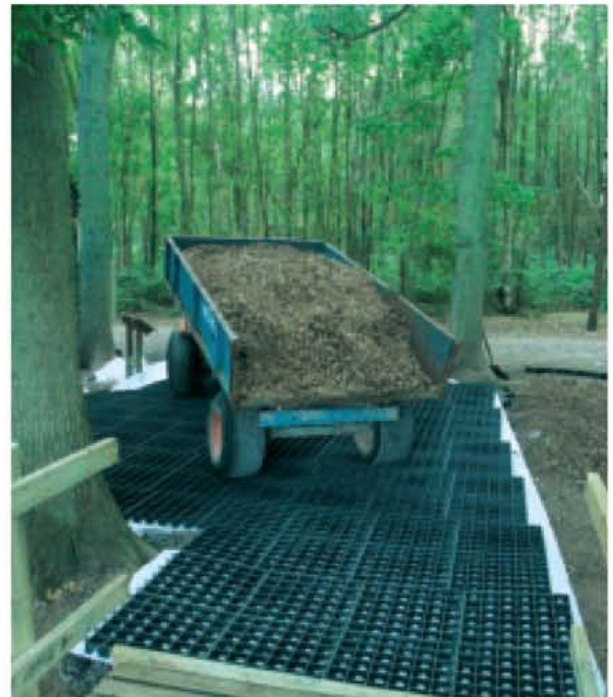
Glynebourne Wood.

Pedestrian path to recreational woodland built using a CellWeb™ foundation which was covered with DuoBlock and then filled with woodchip to create a porous surface.
