HERITAGE STATEMENT

64 Delancy Street
Camden NW1 7RY
July 2018

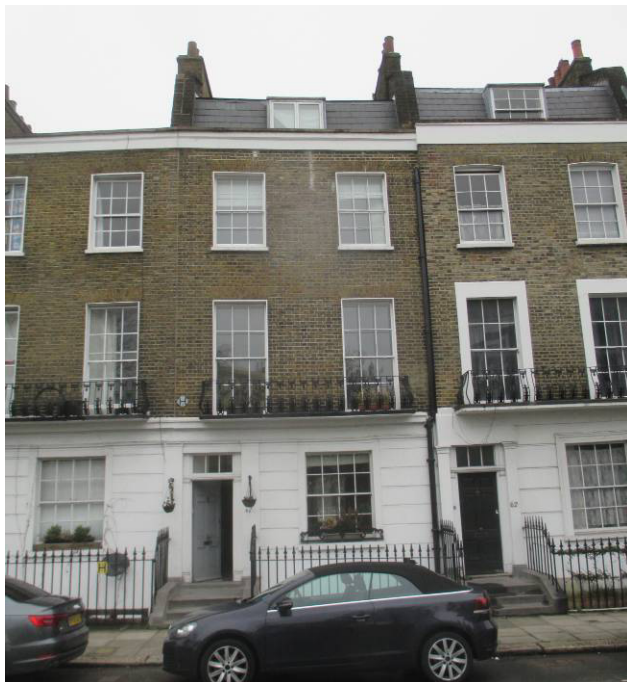
Front view

The current building has been recently refurbished, with a new roof, basement flat, and general refurbishment to all rooms.

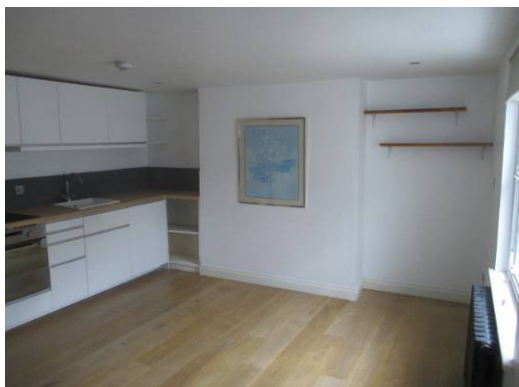
Basement kitchen

The basement has no retained features. The recent refurbishment included new kitchen and bathroom, with door to rear area. The steps from the rear area have been covered over with decking.

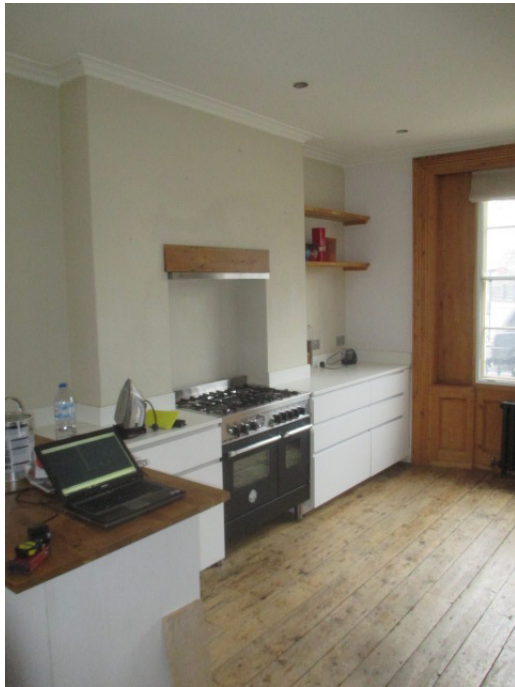
Kitchen/dining

The first floor has been stripped of the fireplaces with new radiators. Original ceiling roses and cornices have been removed with new cornices. Modern downlights have been installed. A new kitchen and joinery has been installed. The windows have modern secondary glazing. Windows and doors have been stripped of paint.

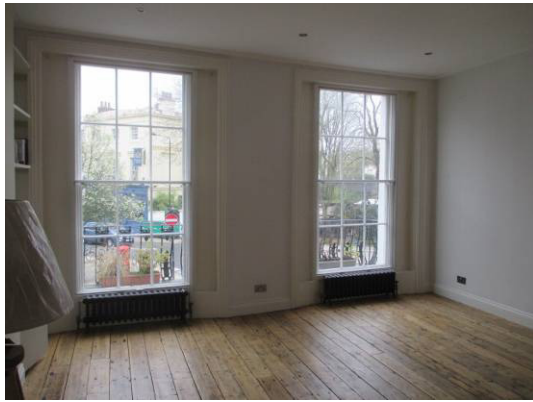
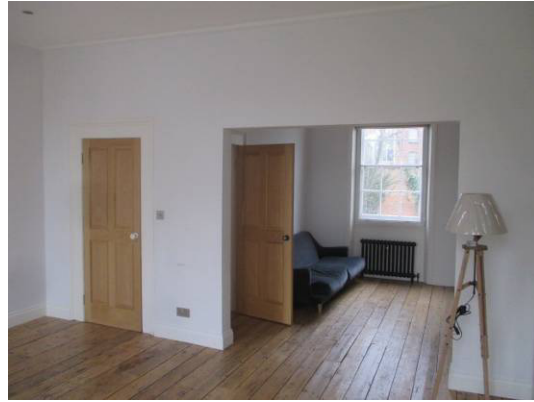
First floor

The first floor has been stripped of the fireplaces with new radiators. Original ceiling roses and cornices have been removed with new cornices. Modern downlights have been installed. The front and rear rooms have been opened up. The windows have modern secondary glazing.
