project name and address
LIGHTWELL STAIR RENOVATION
17 Regents Park Terrace, NW1 7ED

drawing title
**STREET LEVEL
LIGHTWELL AND VAULT AREA
PLAN AS EXISTING**

drawing number	rev
RPT(L)11	-

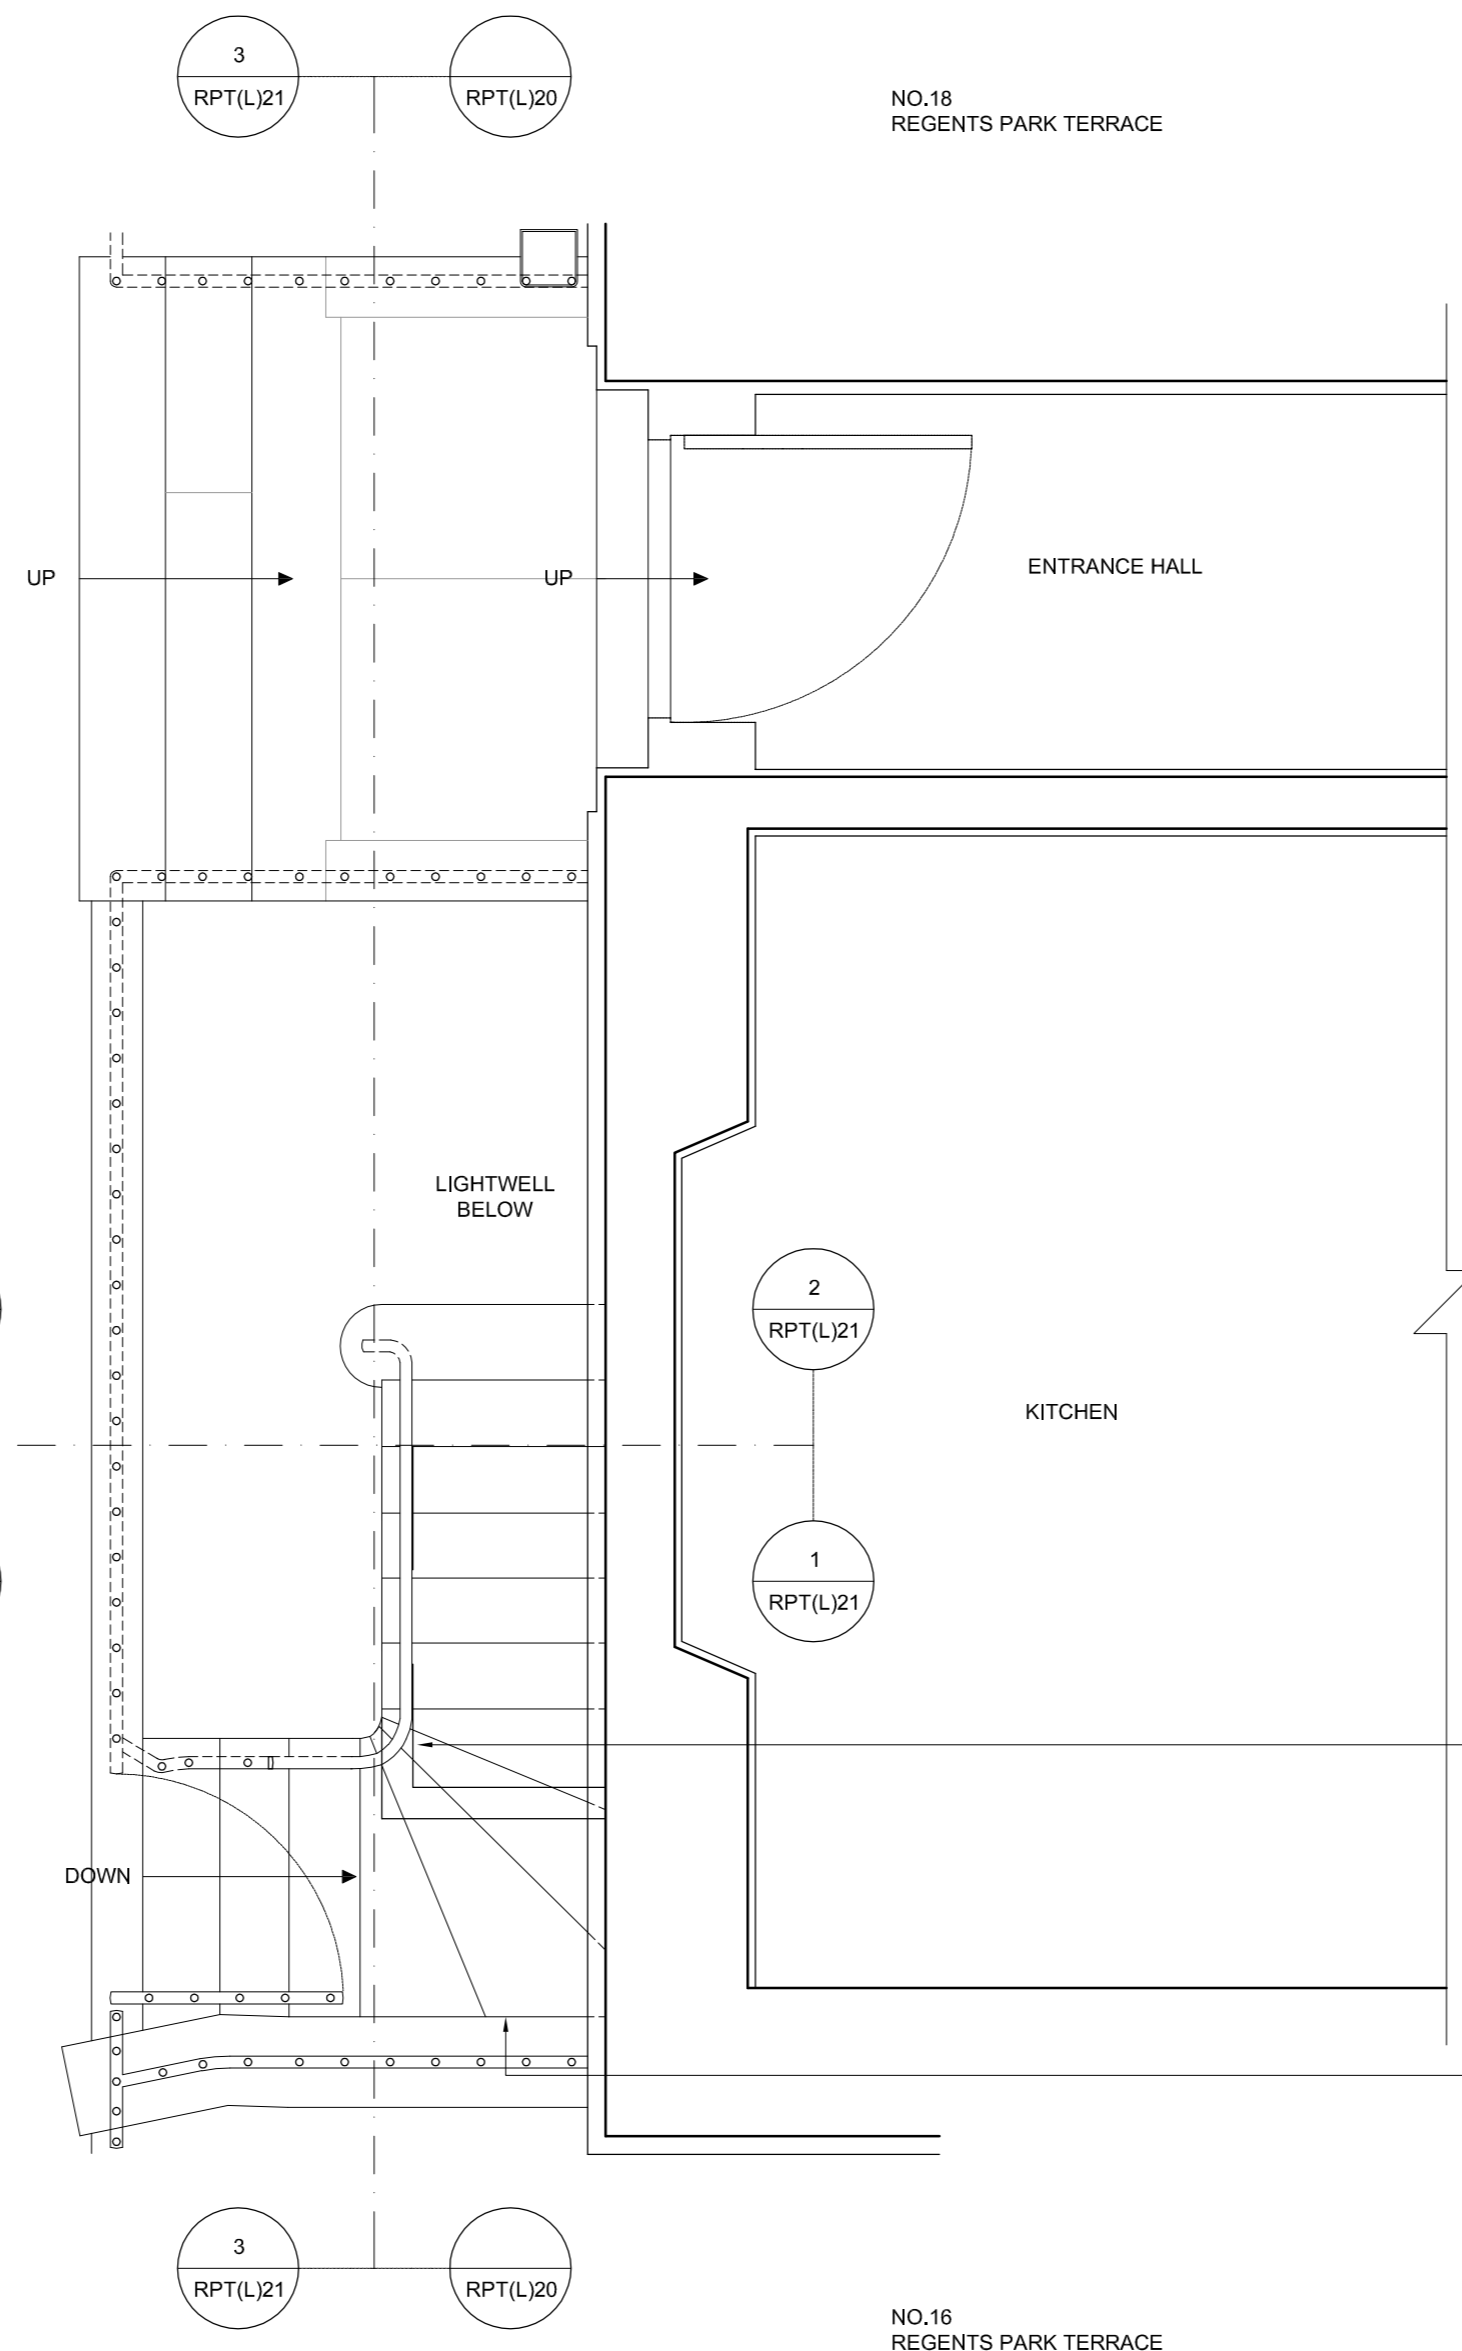
1
RPT(L)11
STREET LEVEL PLAN OF LIGHTWELL AND VAULT AREA - AS EXISTING

DOTTED LINE OF EXISTING SINGLE BRICK WALL BELOW, SUPPORTING LOWER PART OF STAIR. THE WALL RETURNS AROUND THE BIN STORE TO FORM AN ENCLOSED SPACE UNDER THE STAIR WHICH IS SEVERELY DAMP

EXISTING BRICK PARTY WALL SUFFERS FROM DAMP DUE TO MOISTURE INGRESS AT CRACKED COPING STONE

- PLEASE NOTE ALL VERY FEW OF THE ORIGINAL YORK STONE TREADS AND RISERS REMAIN. MOST HAVE BEEN REPLACED BY CONCRETE TREADS AND RISERS AT SOME TIME IN THE PAST. THOSE THAT DO REMAIN HAVE SEVERELY DETERIORATED, THE STONE IS DELAMINATING AND HAS LOST BETWEEN 1/3 AND 1/2 OF ITS ORIGINAL THICKNESS. ALSO IN THESE ORIGINAL STONE TREADS, WHERE THE BALUSTRADE IS LEADED IN, CORNERS HAVE BEEN REPLACED BY CONCRETE.
