British Museum – No. 41 Russell Square Planning Submission Statement Prepared for the British Museum July 2018

Planning Submission Statement

EXISTING STRUCTURE
BASEMENT PLAN

PROPOSED STRUCTURE
BASEMENT PLAN

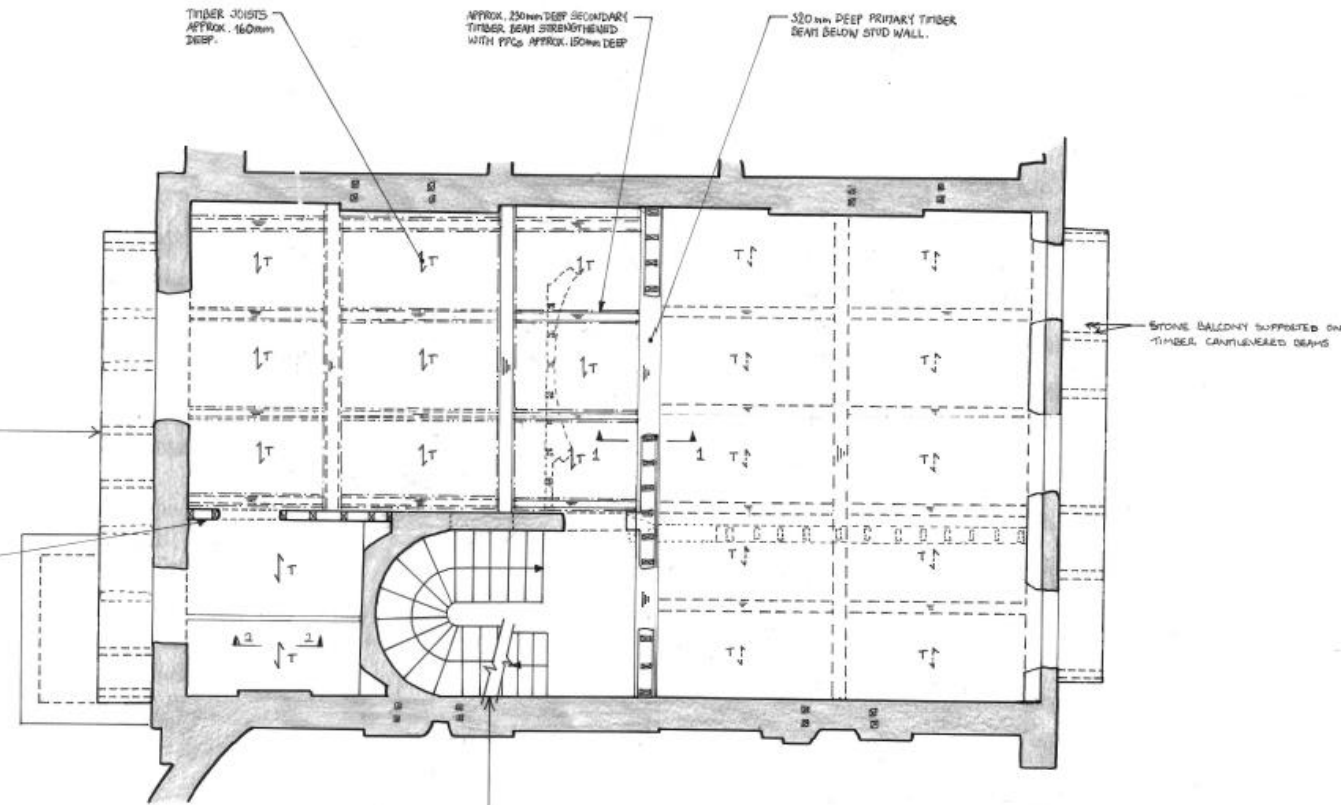
Figure 3: No. 41 first floor showing strengthening

The opening up work showed that the floors of the house have generally been strengthened in the past with steel angles fixed to the sides of the timber beams, as shown on the existing structure drawings in Appendix 1.

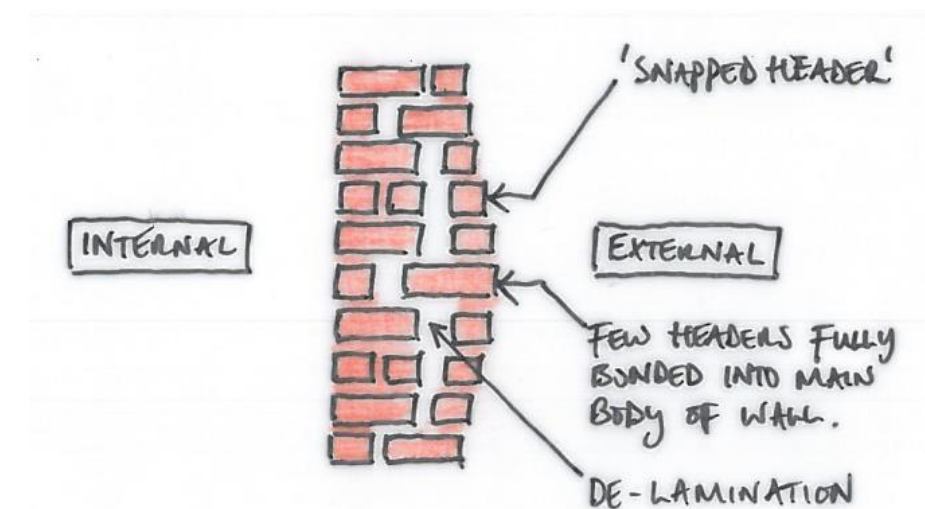
Figure 5: Sketch showing issues with de-lamination

Our appraisal of the external walls has found some issues with de-lamination of the outer skin of facing brickwork. The survey shows significant bulging at the upper levels, as shown on figure 5, which may indicate that the facing brick is separating from the backing brick. These issues need to be addressed in order to reinstate the robustness of these walls.

The proposed repairs to the façade involve pinning the facing brick back to the main body of the wall where practical and where there is limited de-lamination. Where there is significant de-lamination pinning would not be effective, and local areas of re-building may be needed. Existing bricks are to be carefully removed and reused for this.

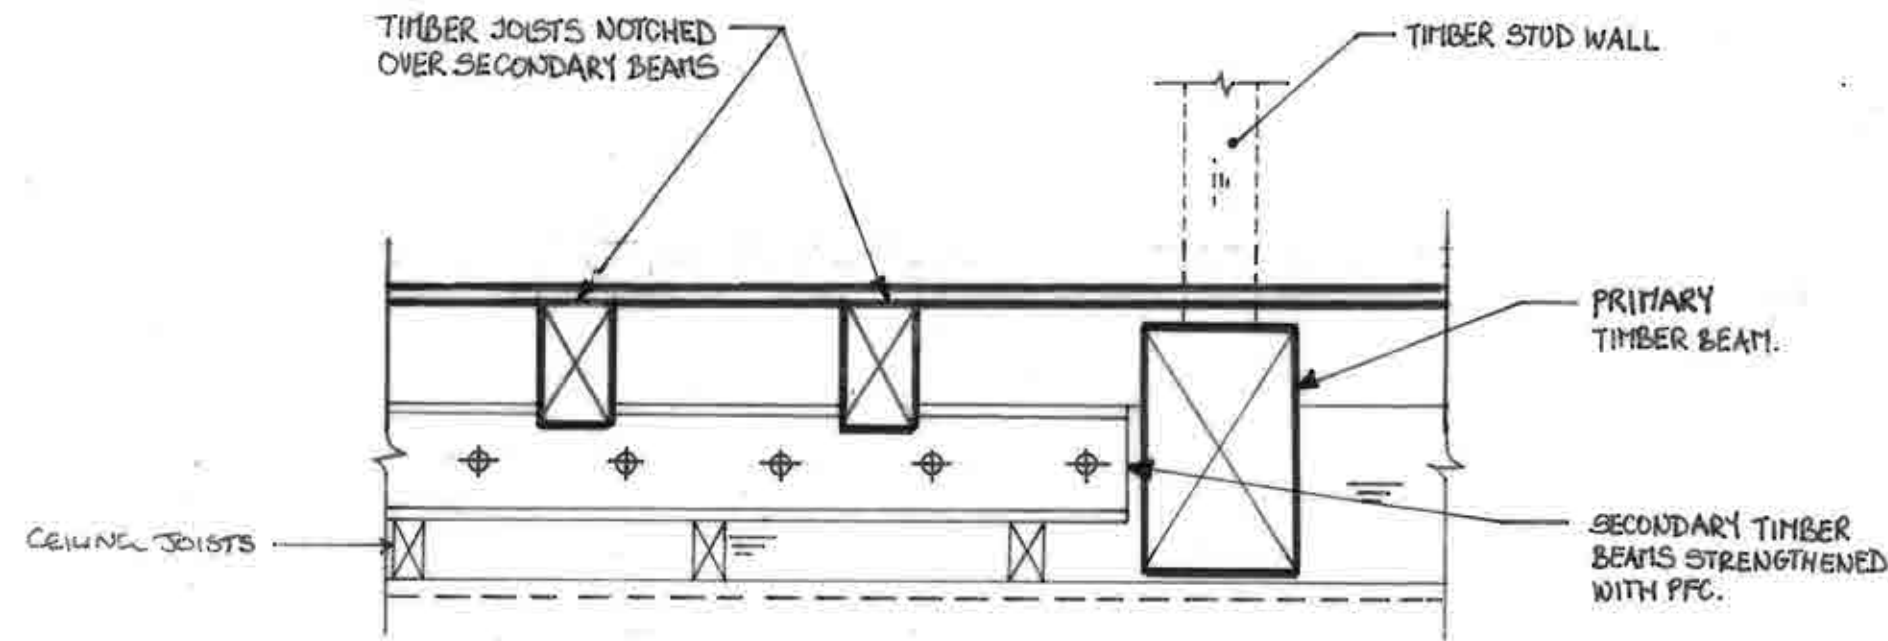
DETAIL 1-1
(1:10)

TIMBER JOISTS APPROX. 160mm DEEP.

APPROX. 230mm DEEP SECONDARY TIMBER BEAM STRENGTHENED WITH PFCs APPROX. 150mm DEEP

320mm DEEP PRIMARY TIMBER BEAM BELOW STUD WALL.

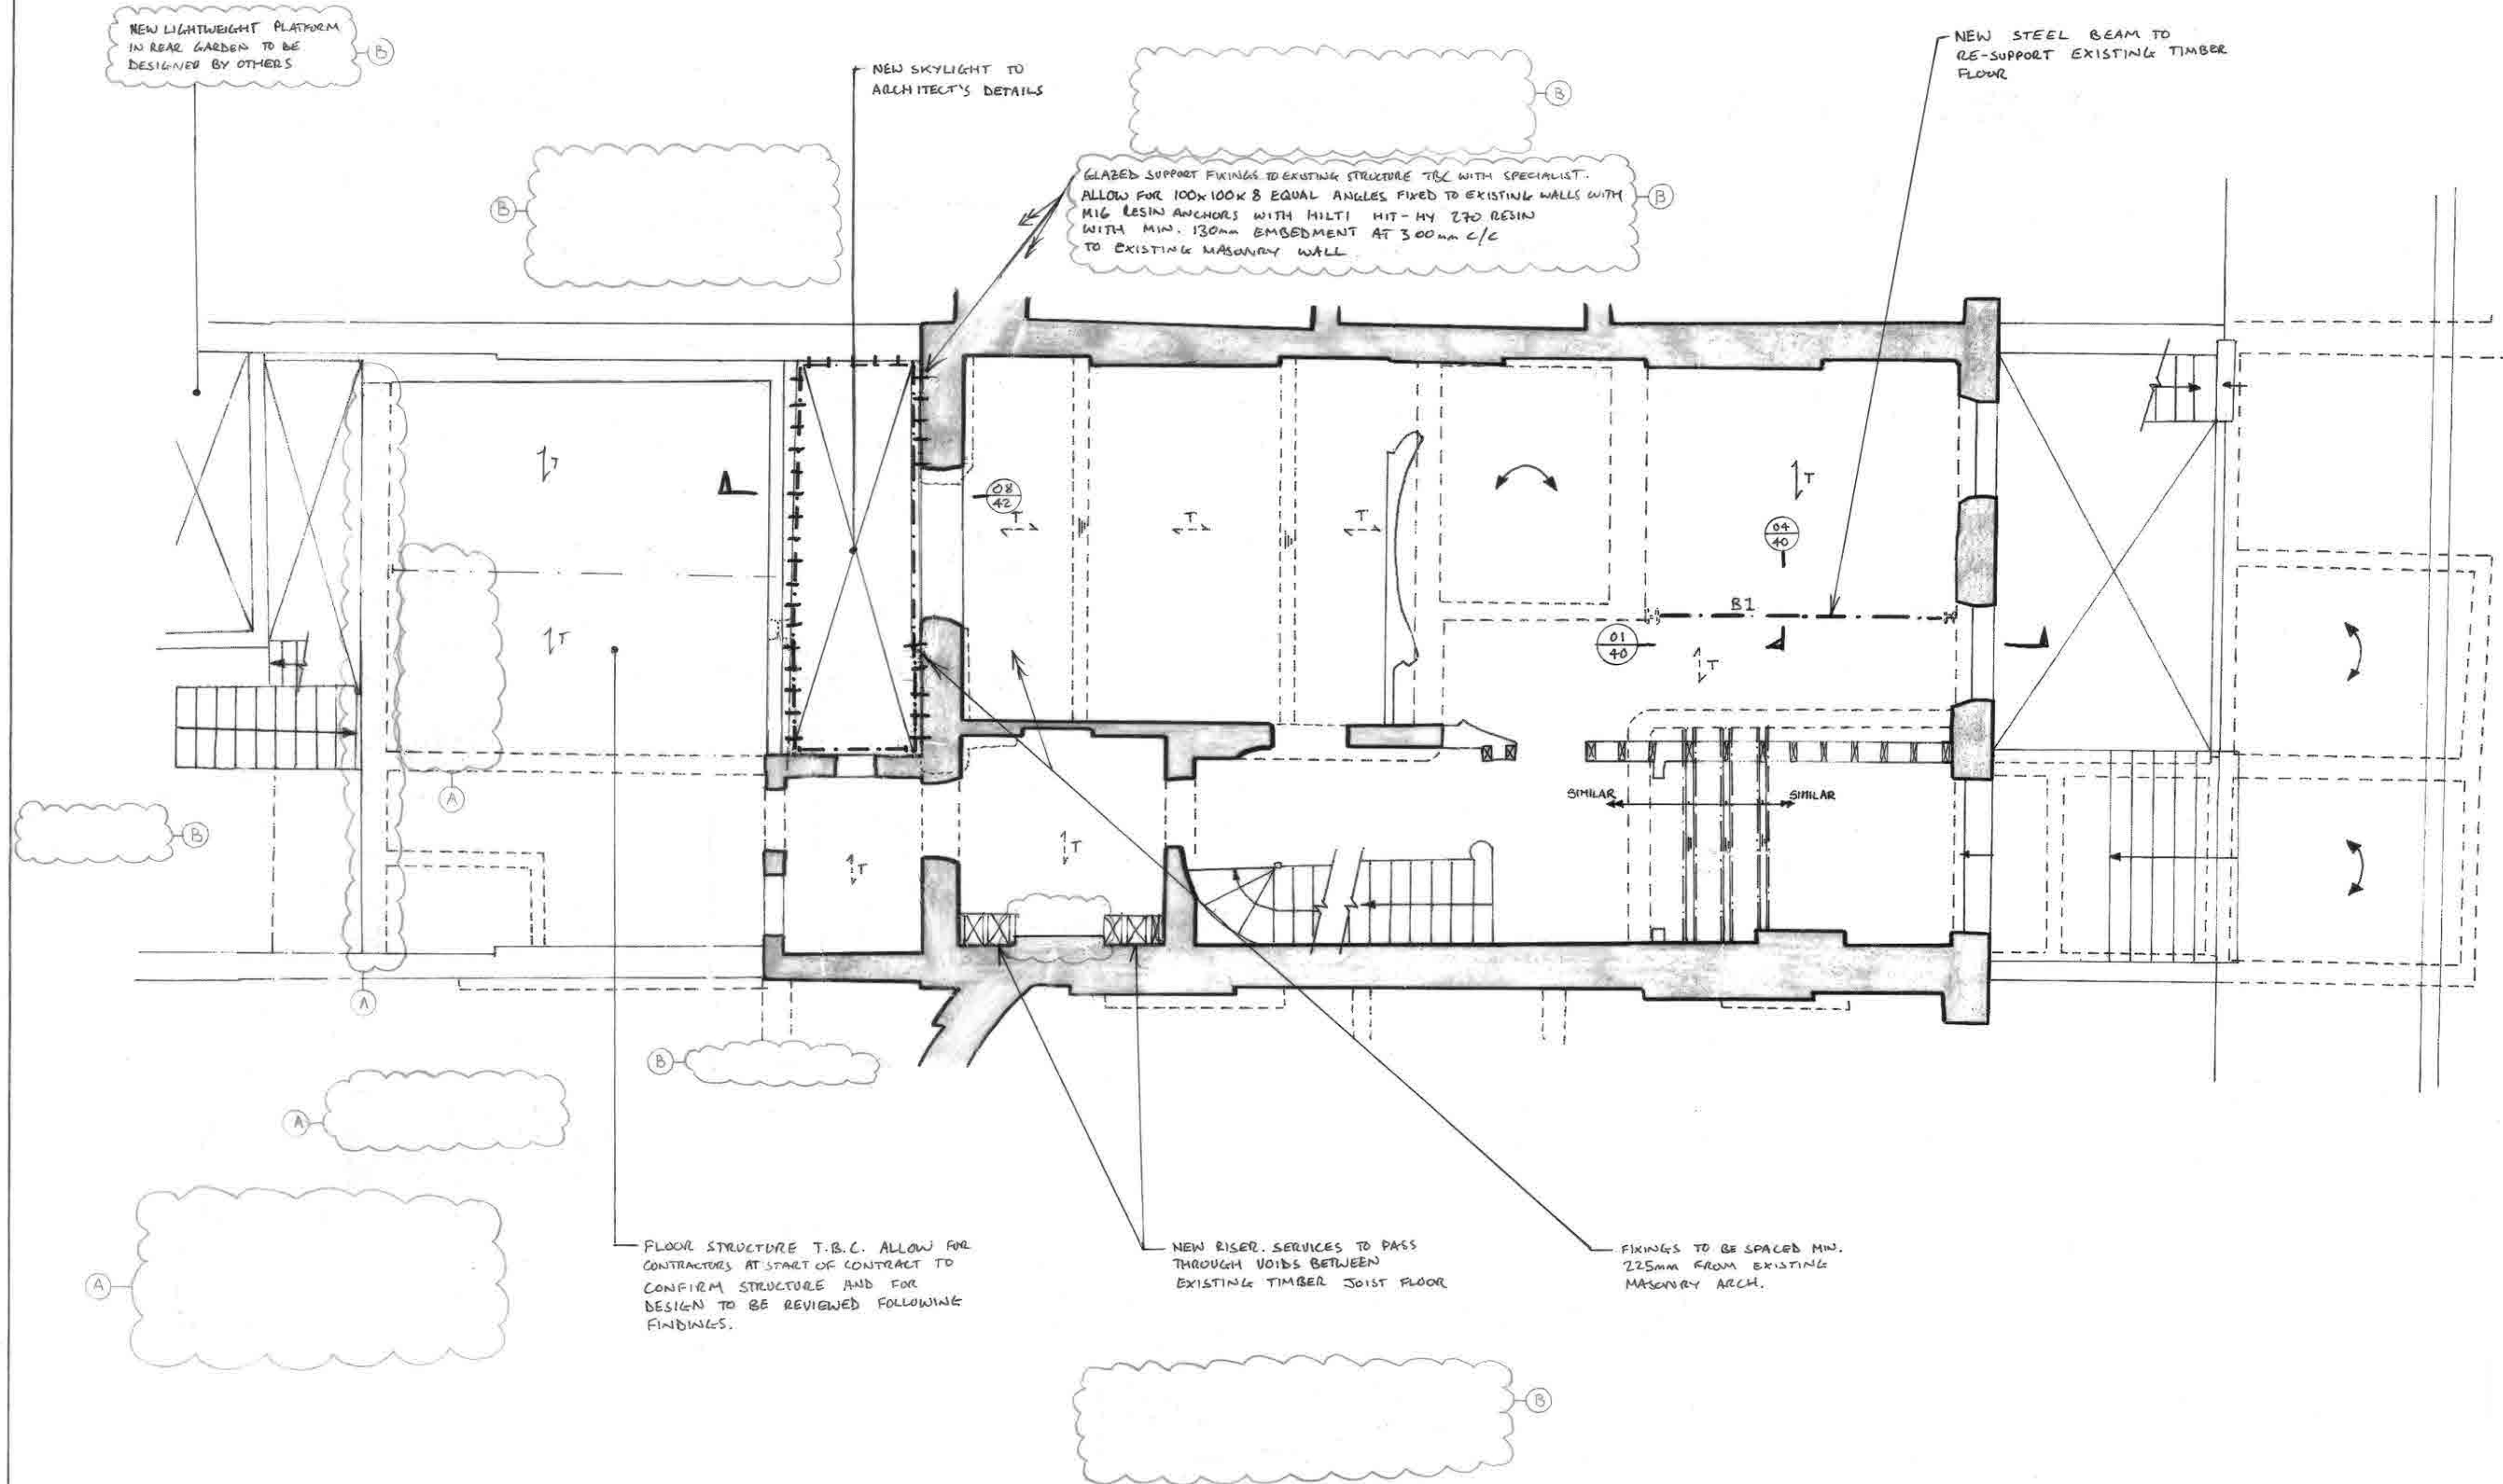
**PROPOSED STRUCTURE
GROUND FLOOR PLAN**

NEW LIGHTWEIGHT PLATFORM IN REAR GARDEN TO BE DESIGNED BY OTHERS

NEW SKYLIGHT TO ARCHITECT'S DETAILS

NEW STEEL BEAM TO RE-SUPPORT EXISTING TIMBER FLOOR

GLAZED SUPPORT FIXINGS TO EXISTING STRUCTURE T.B.C. WITH SPECIALIST. ALLOW FOR 100x100x8 EQUAL ANGLES FIXED TO EXISTING WALLS WITH M16 RESIN ANCHORS WITH HILTI HIT-HY 270 RESIN WITH MIN. 130mm EMBEDMENT AT 300mm C/C TO EXISTING MASONRY WALL

FLOOR STRUCTURE T.B.C. ALLOW FOR CONTRACTORS AT START OF CONTRACT TO CONFIRM STRUCTURE AND FOR DESIGN TO BE REVIEWED FOLLOWING FINDINGS.

NEW RISER SERVICES TO PASS THROUGH VOIDS BETWEEN EXISTING TIMBER JOIST FLOOR

FIXINGS TO BE SPACED MIN. 225mm FROM EXISTING MASONRY ARCH.

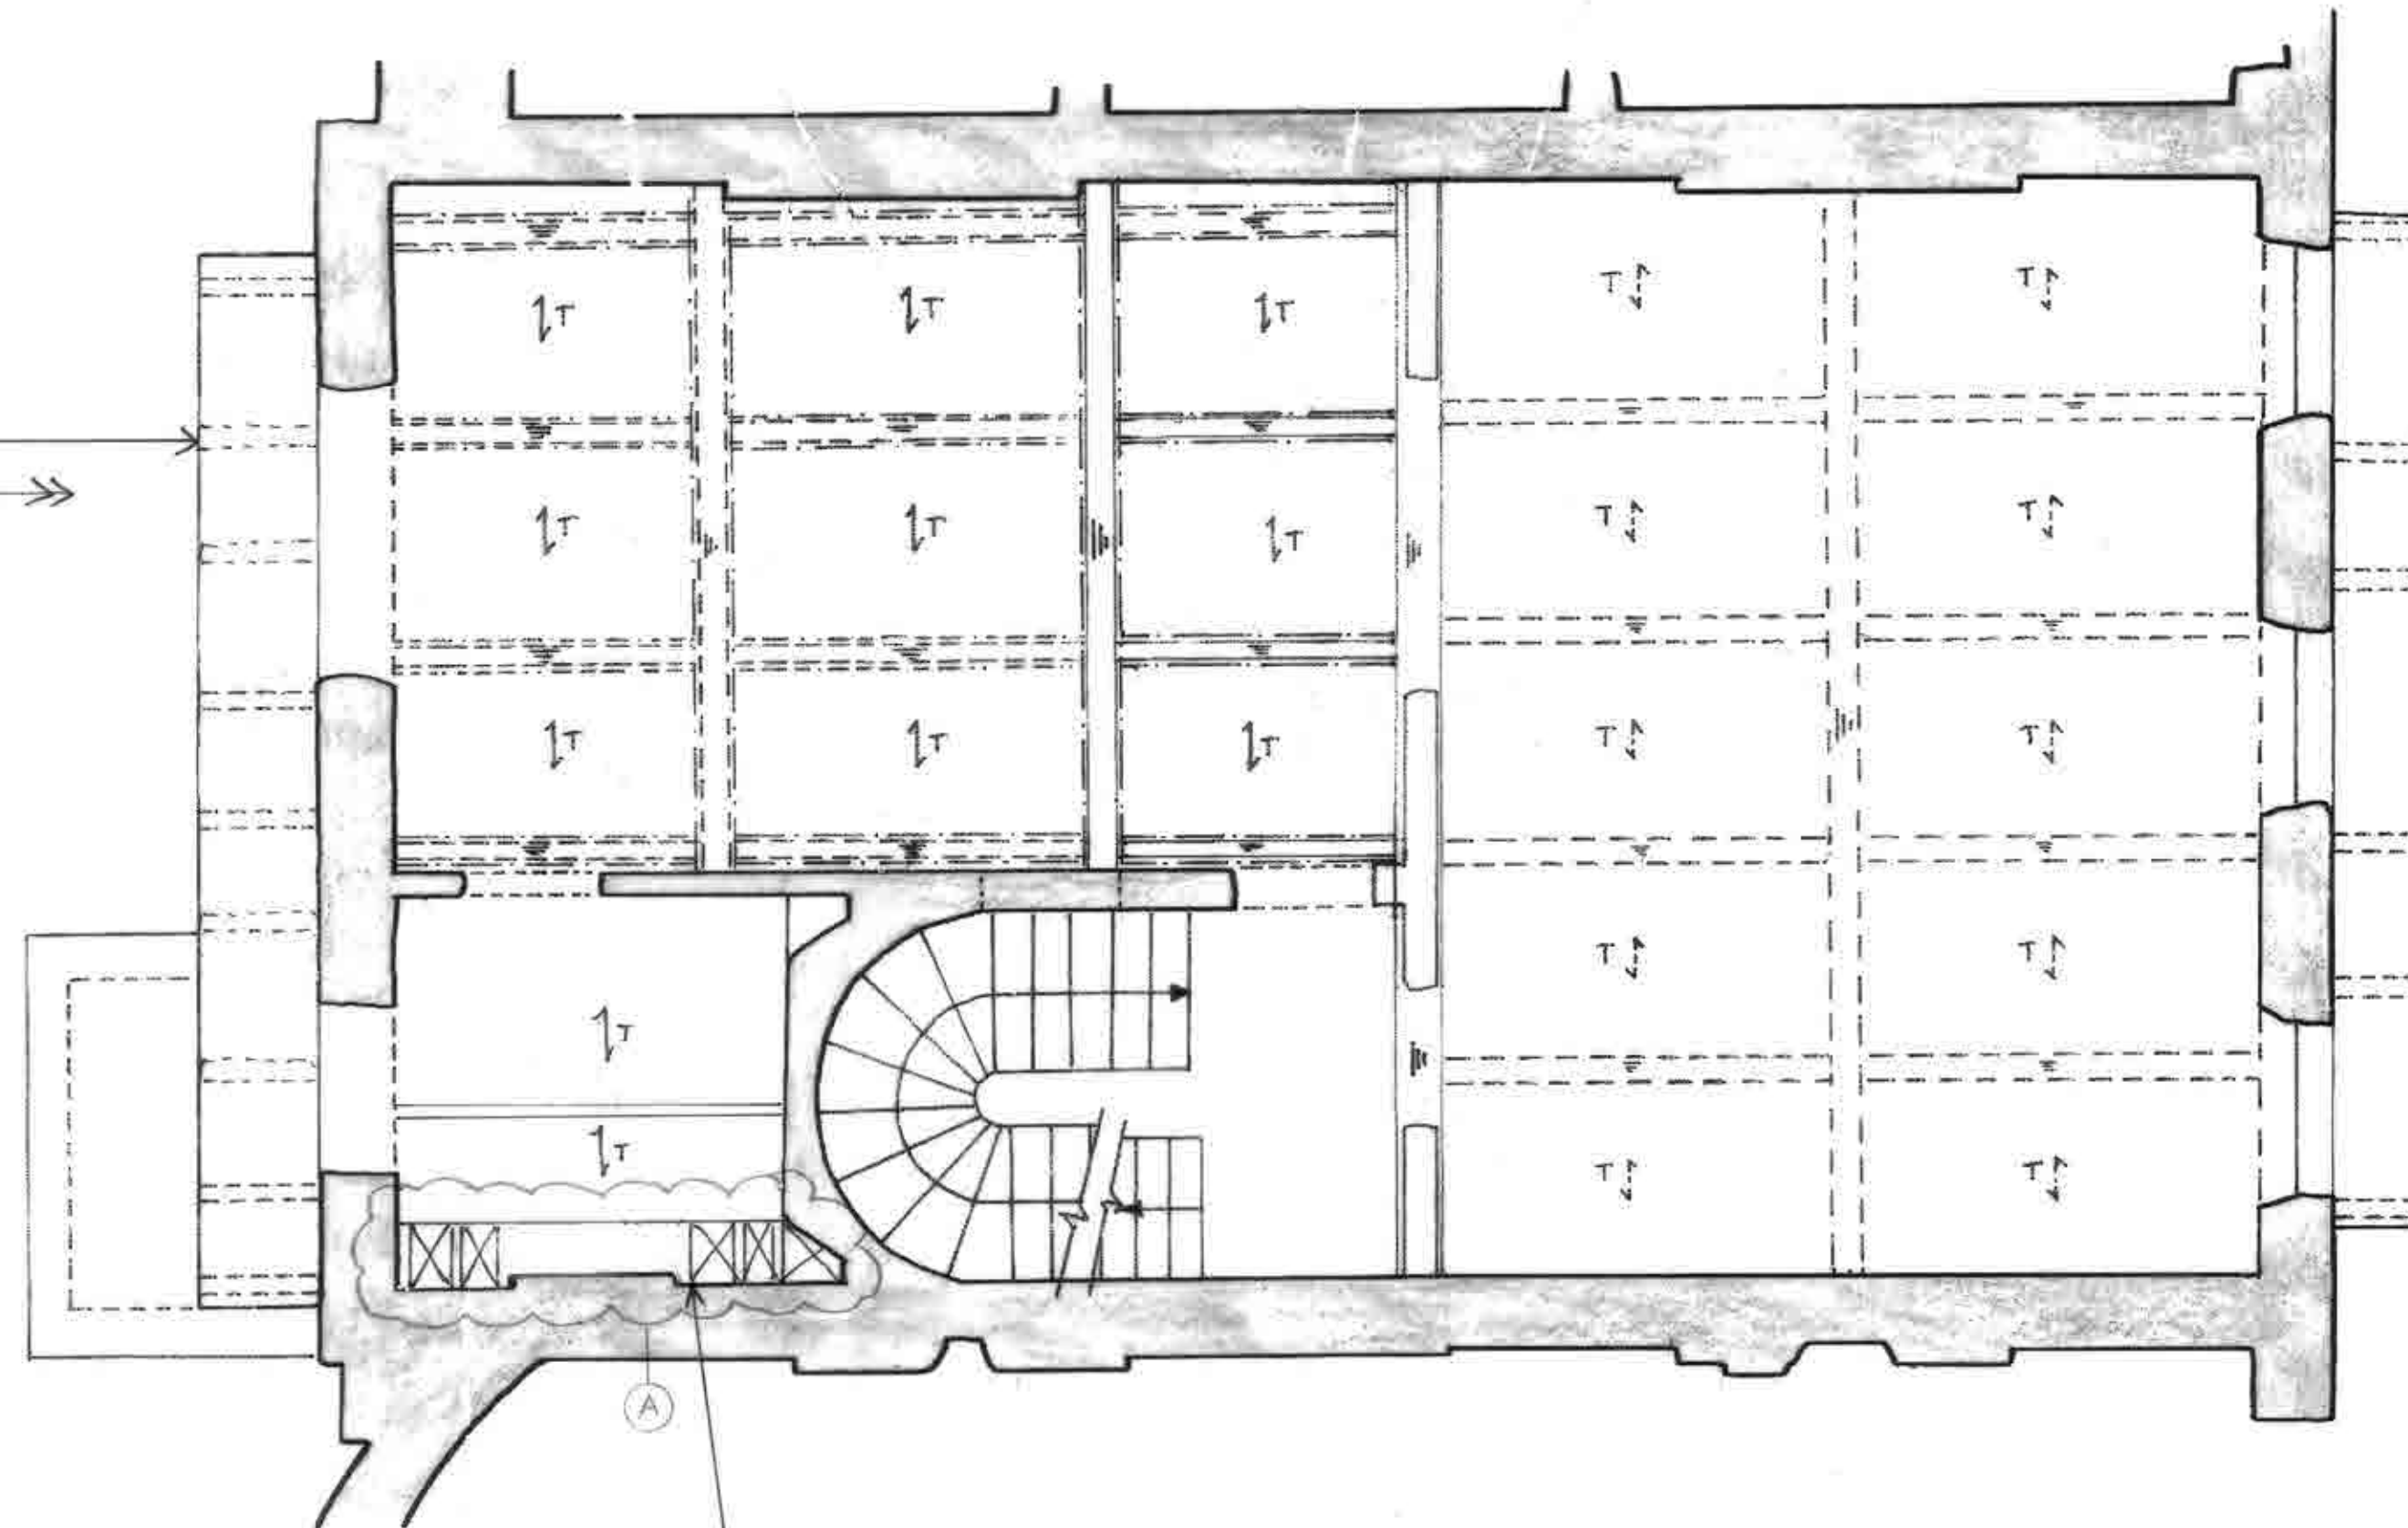
PROPOSED STRUCTURE
FIRST FLOOR PLAN

TIMBER BALCONY BEAMS TO BE REPAIRED. DETAILS TBC FOLLOWING A TIMBER SURVEY

NEW RISER SERVICES TO PASS THROUGH VOIDS BETWEEN EXISTING TIMBER JOIST FLOOR

We have viewed the rear balcony and we have noted that some of the ends of the timber beams are decayed. A timber survey is to be undertaken to confirm the extent of decay and new sections of timber are to be spliced in to replace decayed timber.

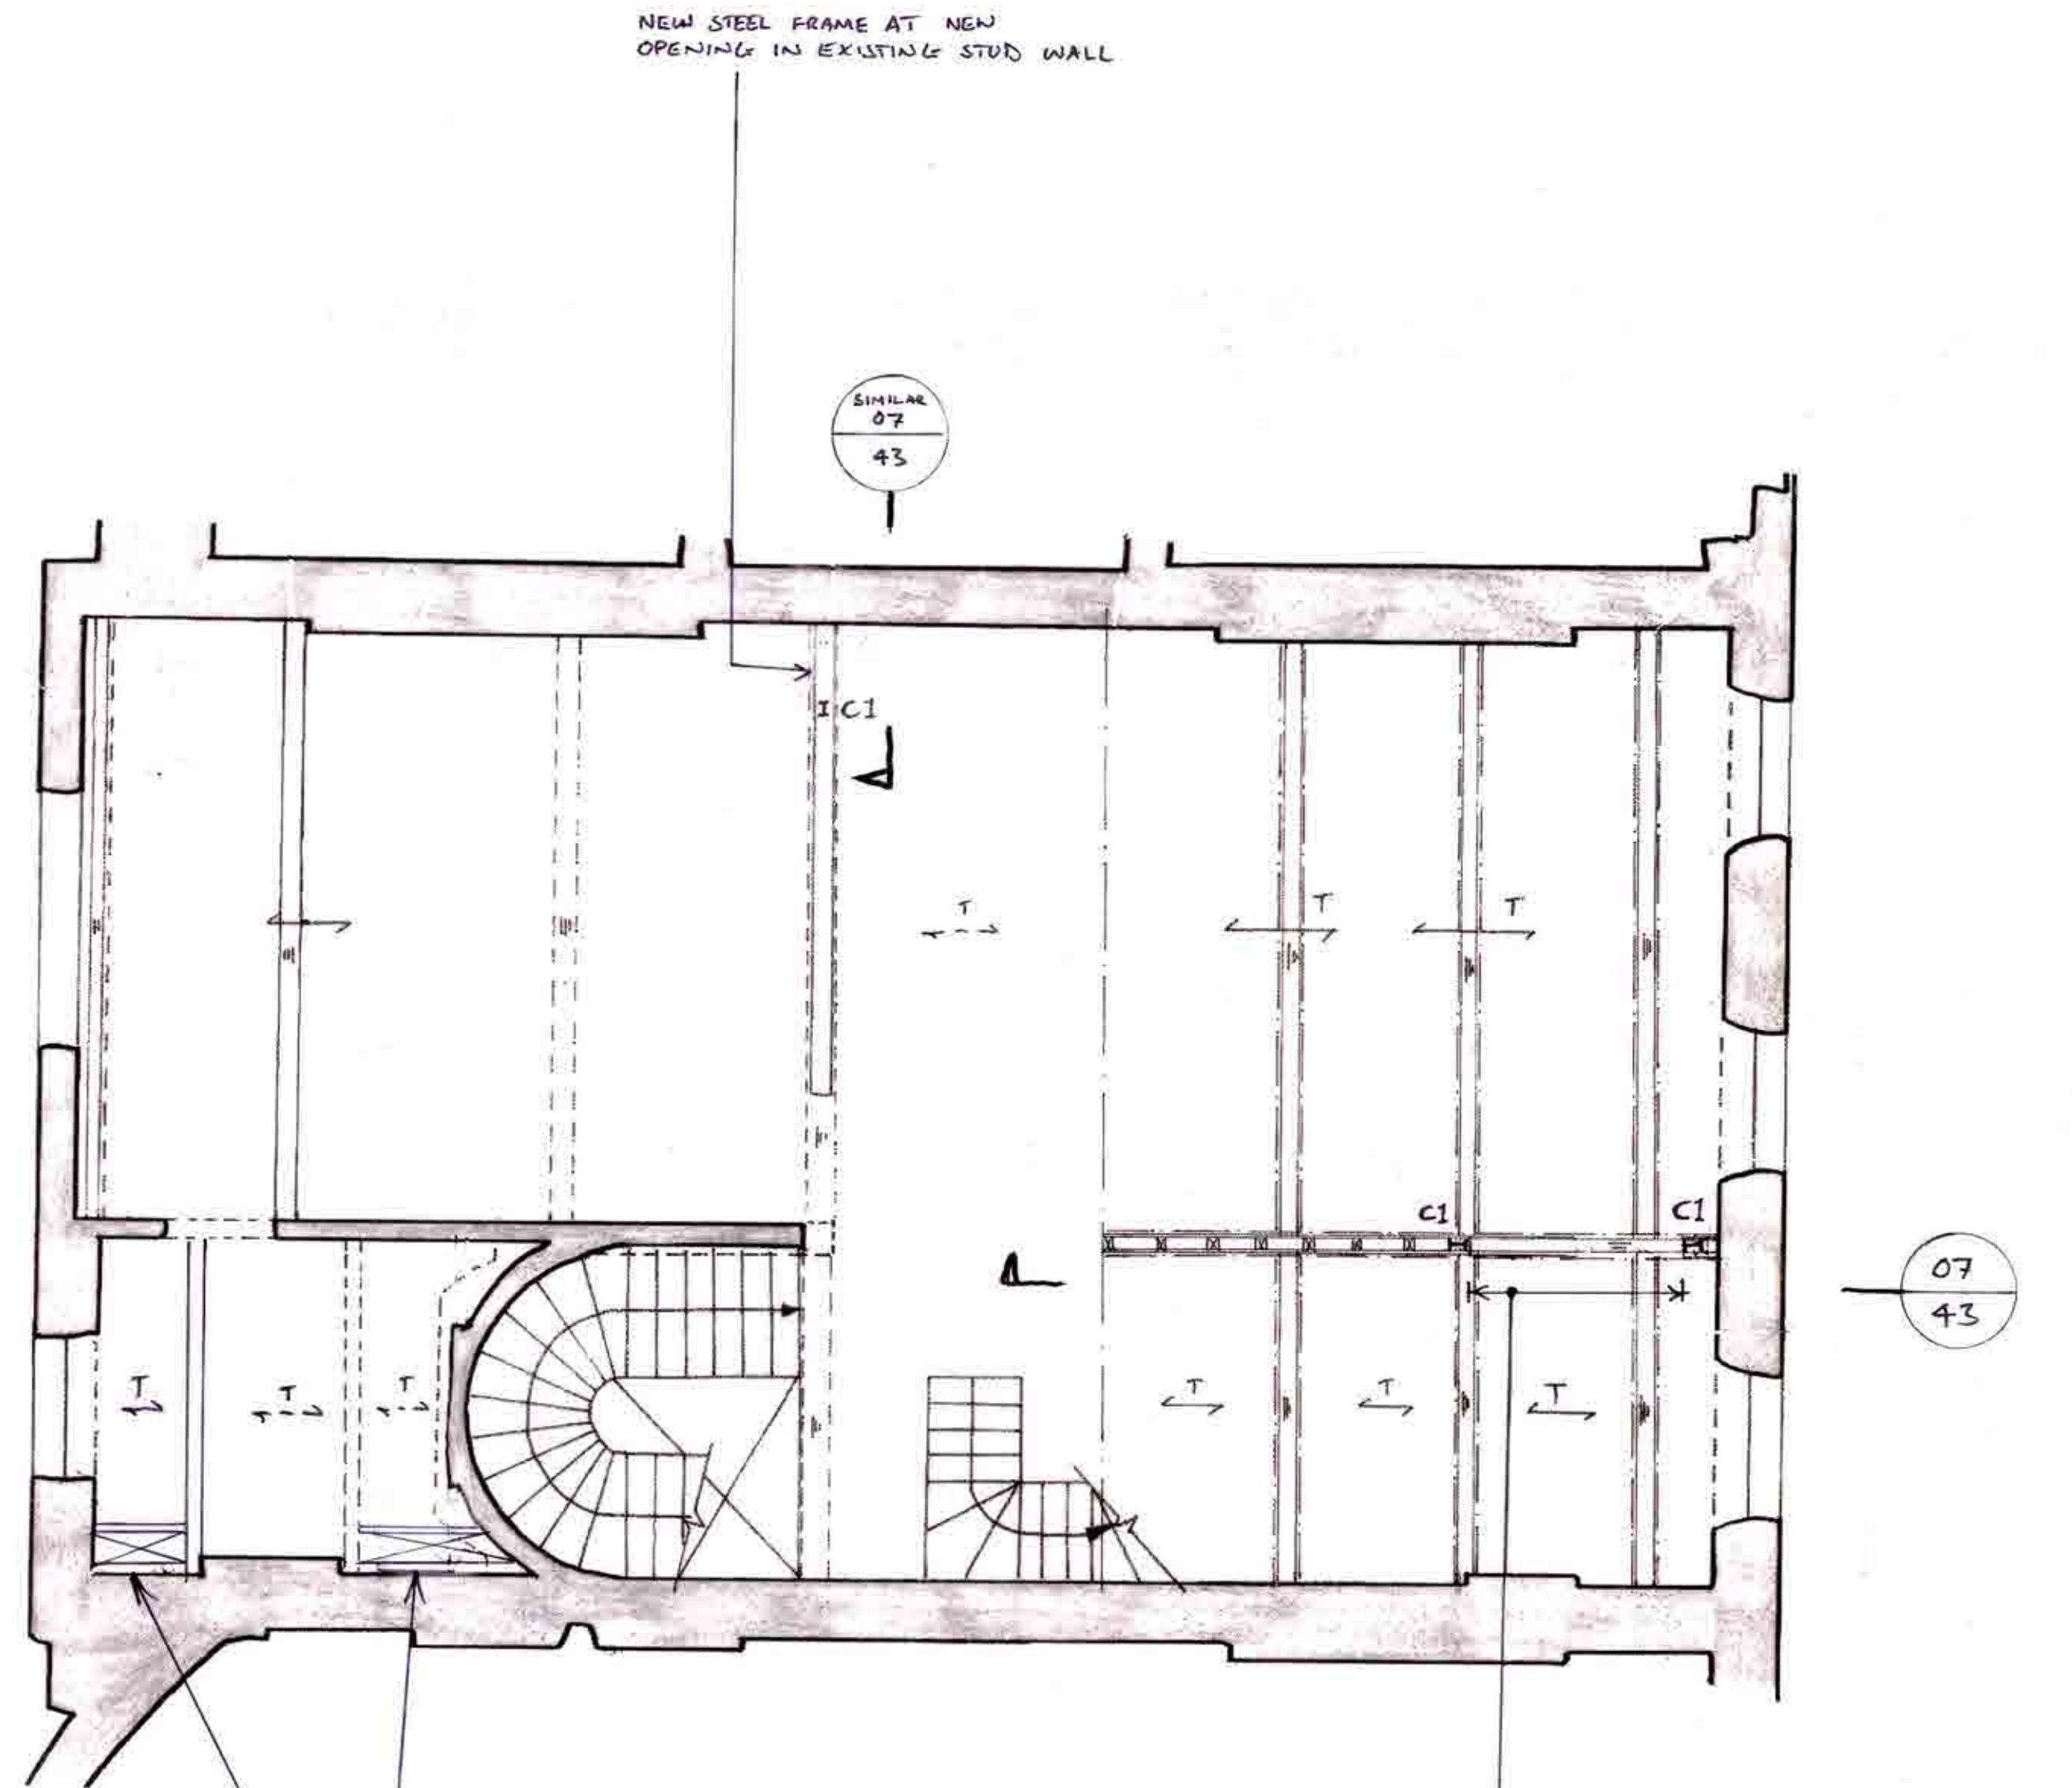
PROPOSED STRUCTURE
SECOND FLOOR PLAN

NEW STEEL FRAME AT NEW
OPENING IN EXISTING STUD WALL

NEW RISER SERVICES TO PASS
THROUGH VOIDS BETWEEN
EXISTING TIMBER JOIST FLOOR

OPENING TO BE FORMED IN
EXISTING STUD WALL. FOR FURTHER
DETAILS REFER TO DRAWING
1756/705/43

Some openings will be formed in loadbearing stud walls at level 2. New steel framing will be installed here to provide support to the timber floors above.

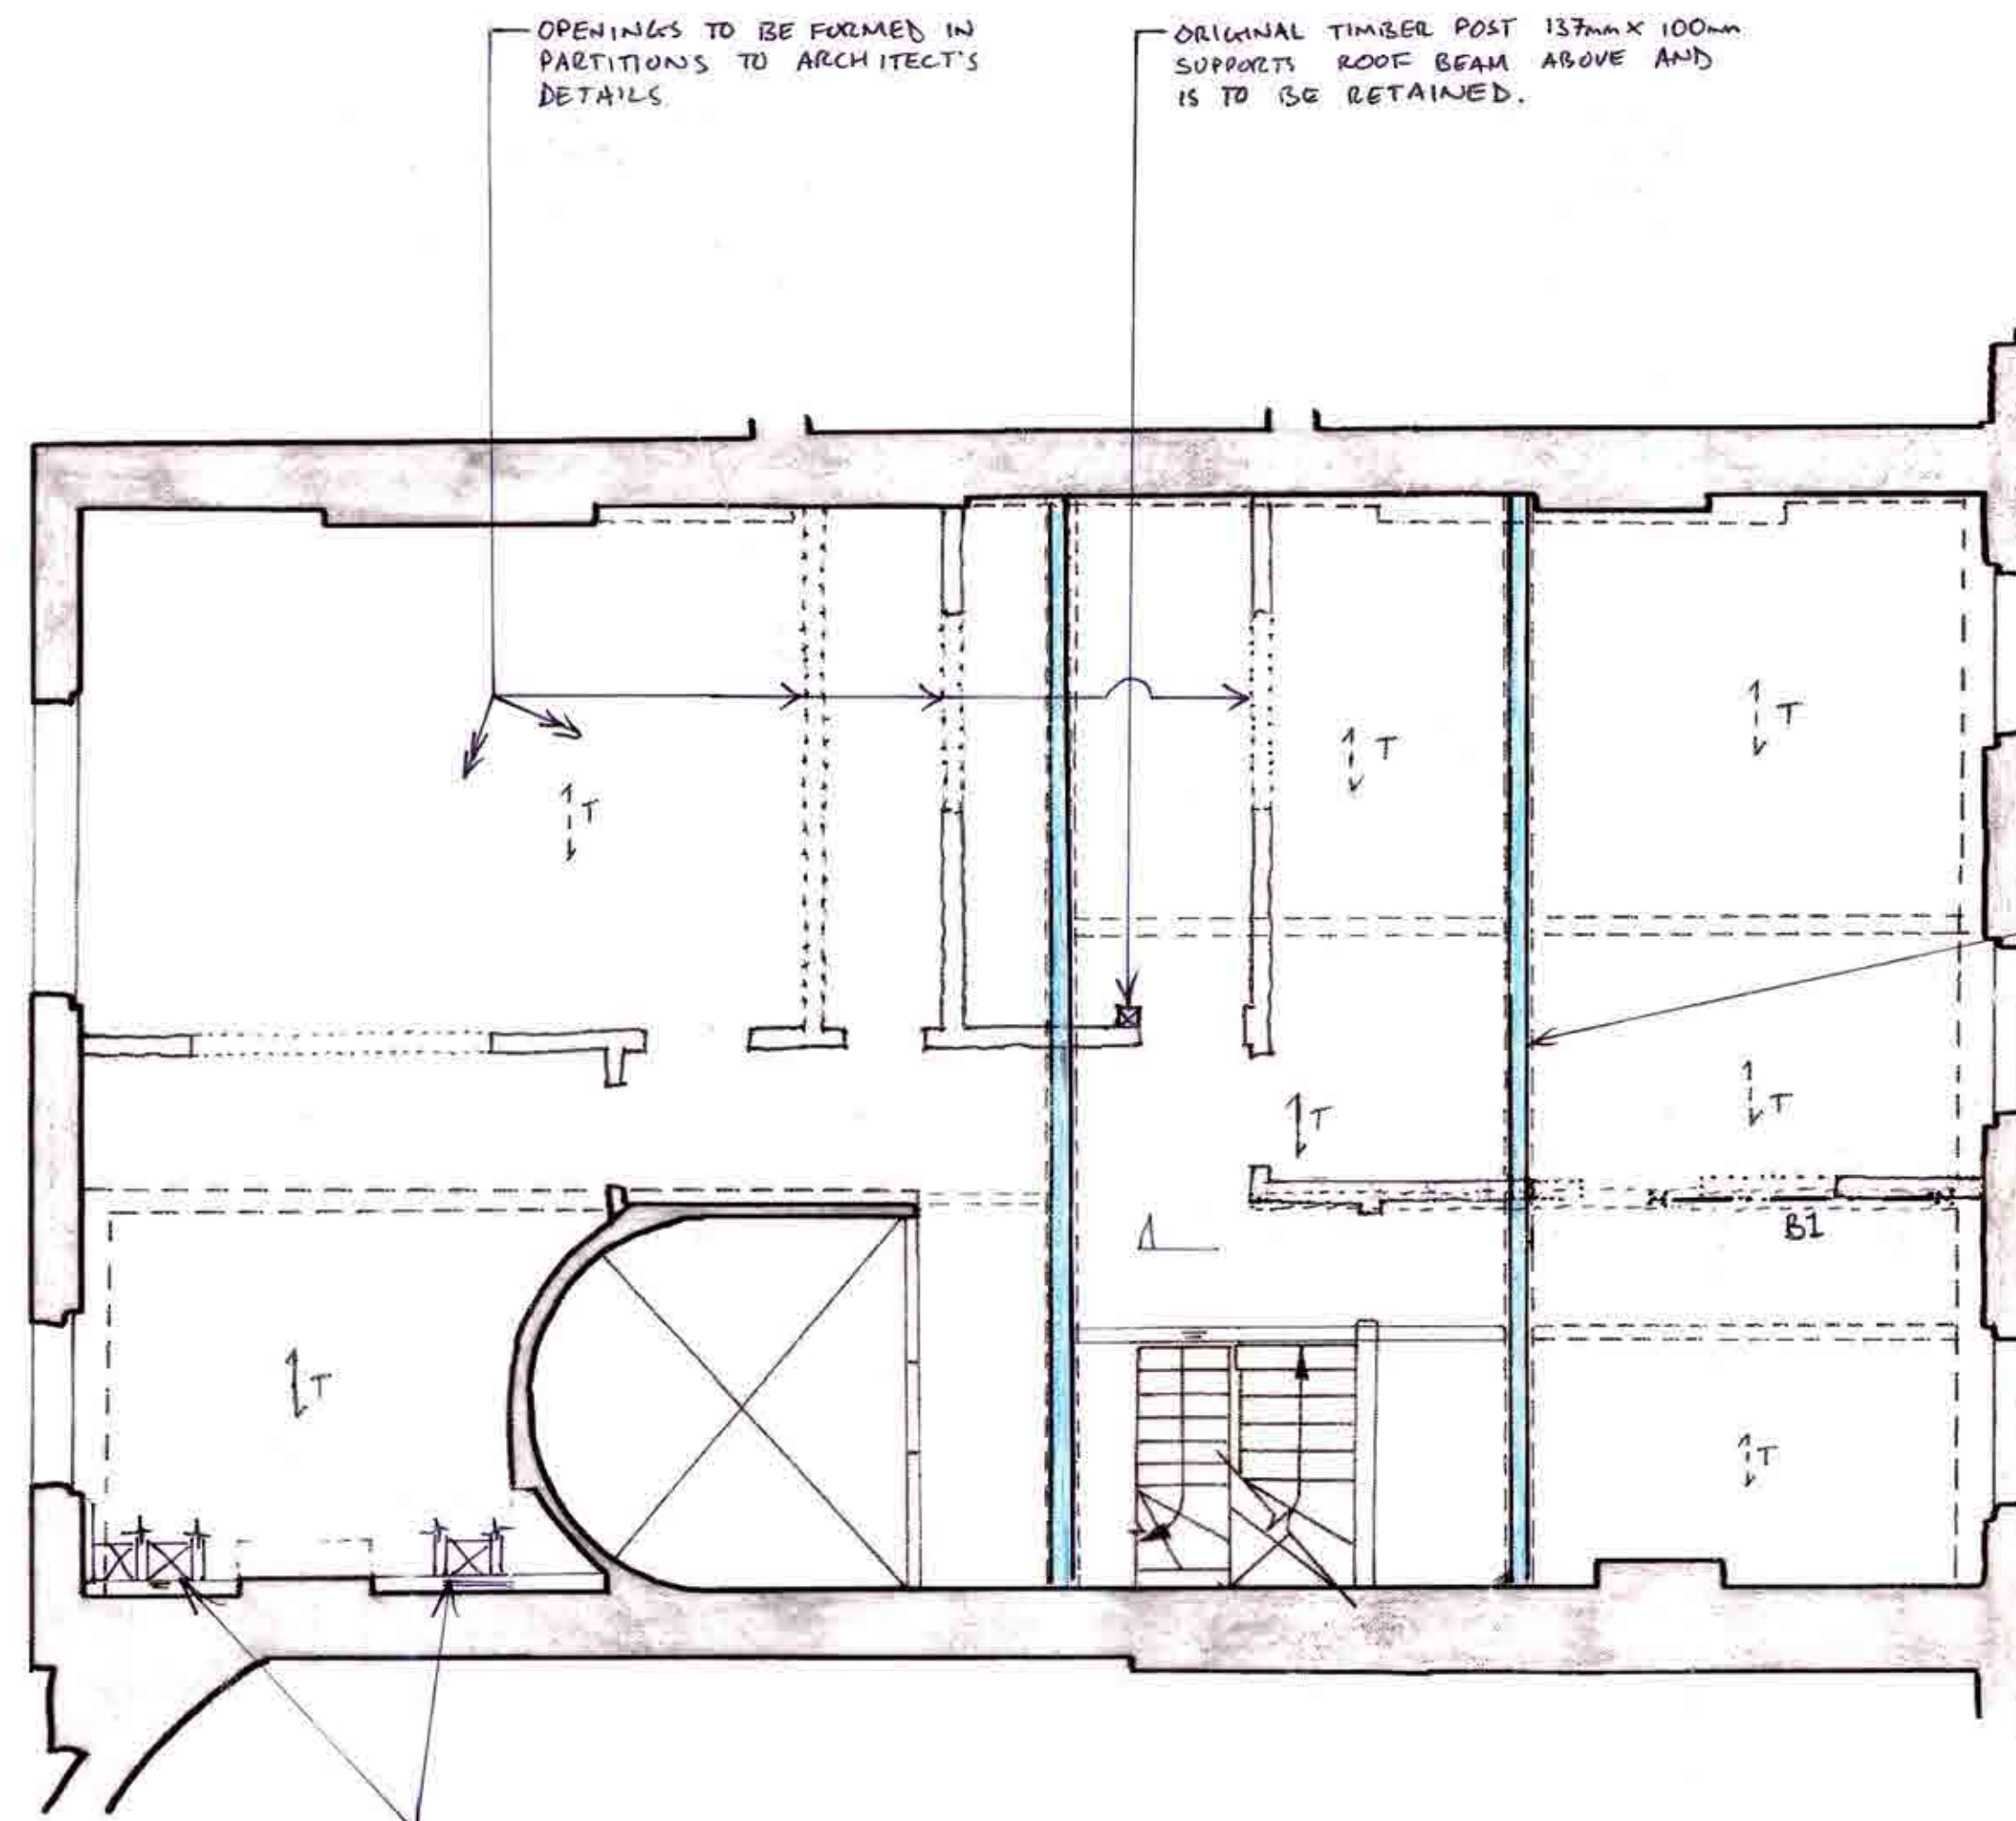
**PROPOSED STRUCTURE
THIRD FLOOR PLAN**

OPENINGS TO BE FORMED IN PARTITIONS TO ARCHITECT'S DETAILS.

ORIGINAL TIMBER POST 137mm x 100mm SUPPORTS ROOF BEAM ABOVE AND IS TO BE RETAINED.

ALLOW FOR STRENGTHENING EXISTING BEAM WITH STEEL PLATE AS PER DRAWING 1756/705/097. STRENGTHENING T.B.C. FOLLOWING CONFIRMATIONS OF EXISTING FLOOR ARRANGEMENT. CONTRACTOR TO CONFIRM AT START OF CONTRACT & ALLOW FOR 10 WORKING DAYS FOR DESIGN TEAM TO CONFIRM FINAL DETAILS.

NEW RISER SERVICES TO PASS THROUGH VOIDS BETWEEN EXISTING TIMBER JOIST FLOOR

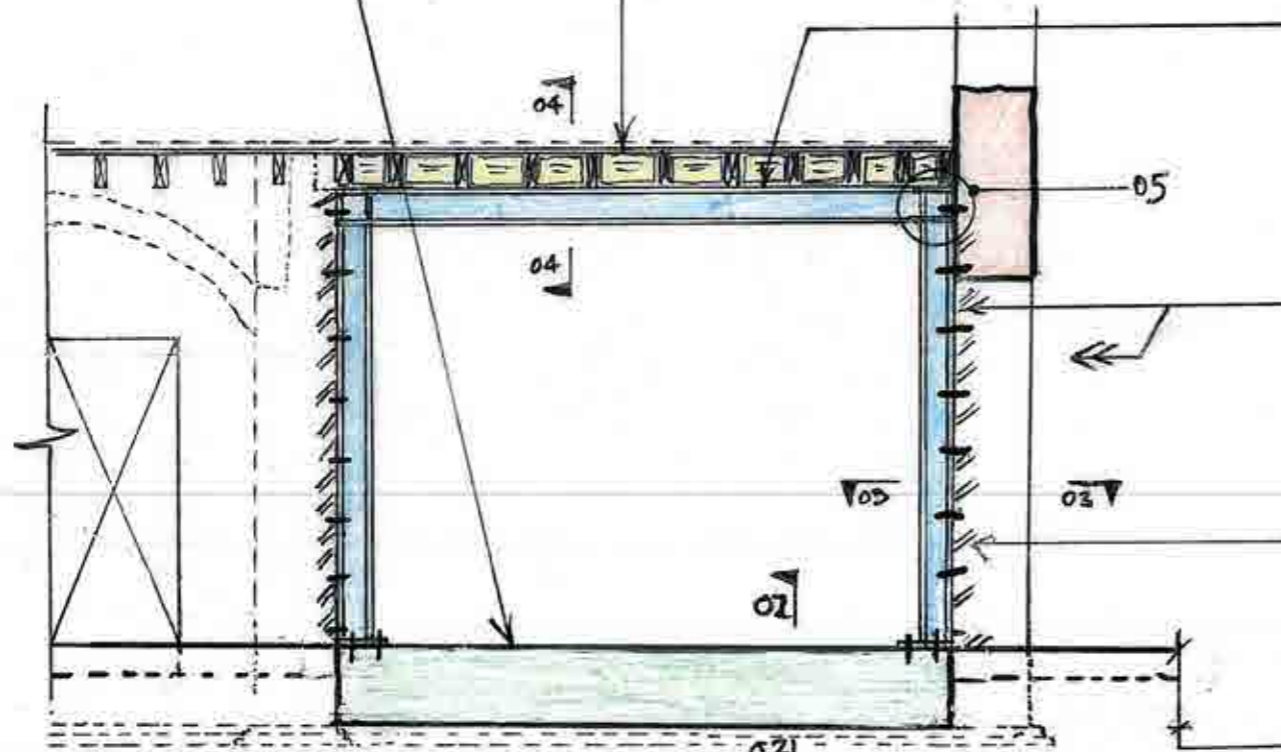
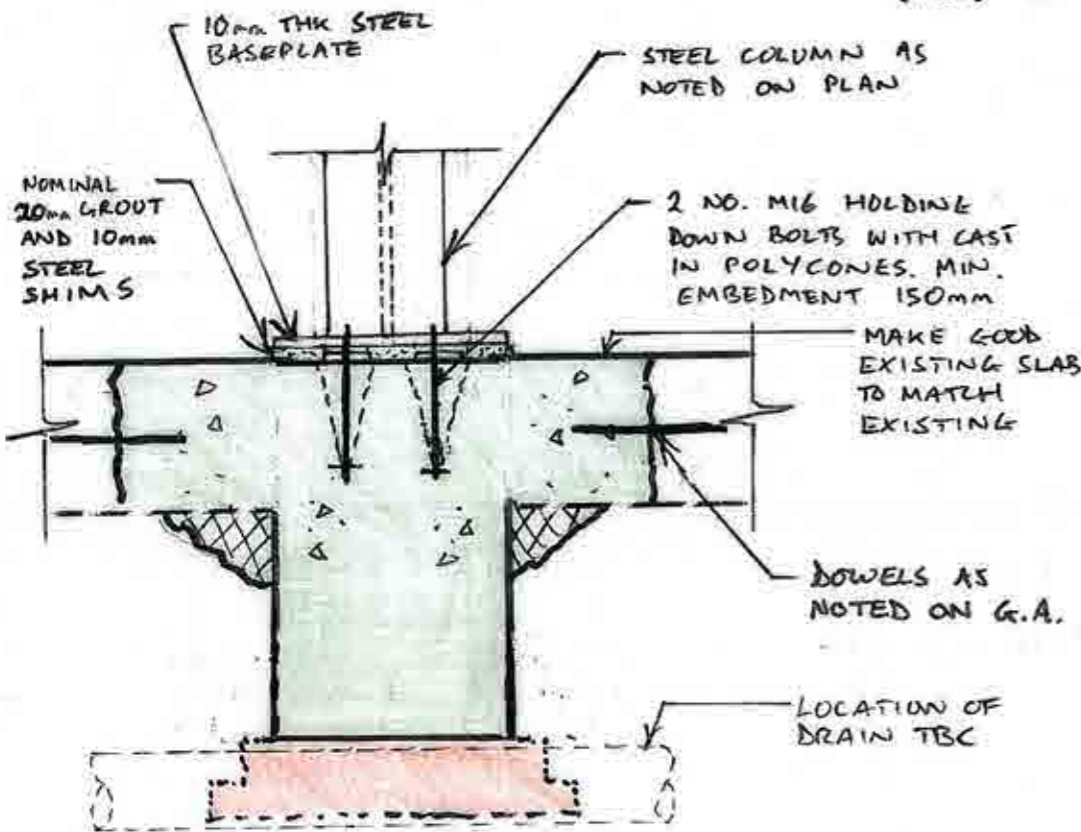
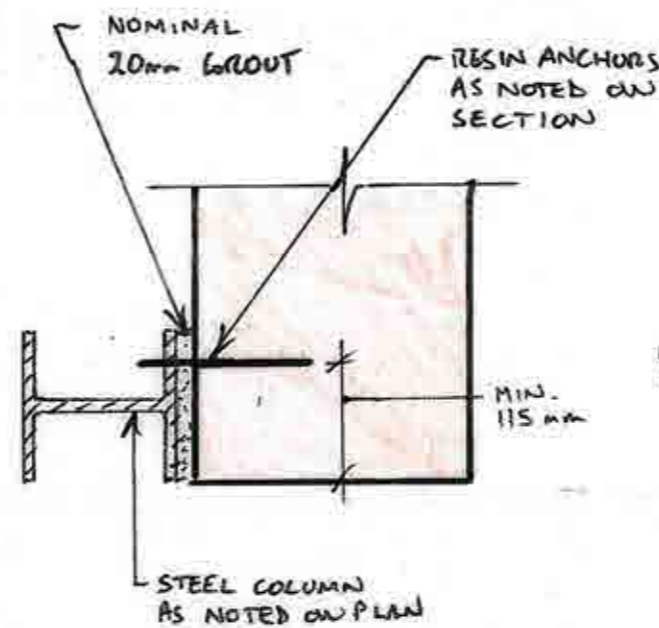
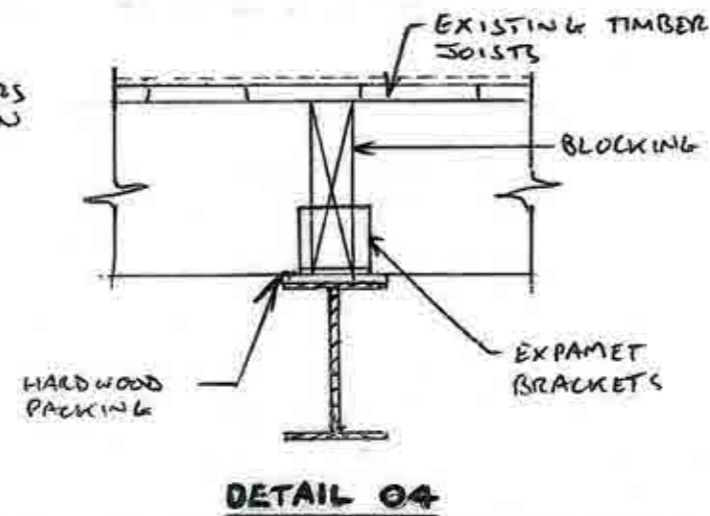
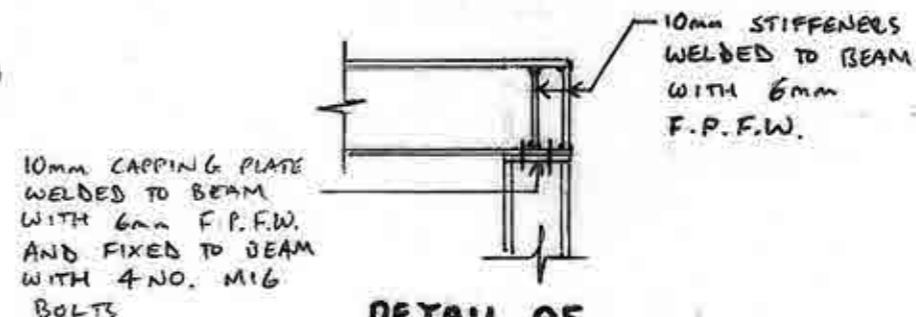
DETAILS SHEET 1

NEW R.C. BEAM AS NOTED ON PLAN

NEW FULL HEIGHT BLOCKING SIZED TO MATCH EXISTING JOISTS TO BE INSTALLED ABOVE NEW STEEL FRAME. JOISTS TO BE FIXED TO STEEL BEAM WITH PAIRS OF 90x90x90 EXPAMET BRACKETS AND FIXED TO STEEL BEAM WITH 4 NO. $\phi 4$ mm SELF-TAPPING SCREWS

NEW STEEL BEAM AS NOTED ON PLAN TO RE-SUPPORT EXISTING TIMBER FLOOR JOISTS. ALLOW FOR HARDWOOD PACKING BETWEEN TIMBER JOISTS AND STEEL BEAM. ALLOW FOR JOISTS TO BE PROPPED DURING WORKS.

NEW STEEL COLUMNS AS NOTED ON PLAN TIED TO THE EXISTING MASONRY WALL WITH M12 RESIN ANCHORS @ 400mm C/C. MIN. 130mm EMBEDMENT

MAKE GOOD EXISTING BRICKWORK TO OTHER & BONDED TO ARCHITECT'S DETAILS

DEPTH OF EXISTING CORBELLED FOOTINGS TO BE CONFIRMED BY CONTRACTOR AT START OF CONTRACT

New openings will be formed in the basement masonry walls. New steel frames will be installed locally to re-support floors above. The steel frames will be supported on reinforced concrete ground beams, which will maintain existing load paths by distributing the loads from the steel frame evenly into the ground at foundation level.
