British Museum – No. 41 Russell Square Planning Submission Statement Prepared for the British Museum July 2018

Planning Submission Statement

EXISTING STRUCTURE
BASEMENT PLAN

PROPOSED STRUCTURE
BASEMENT PLAN

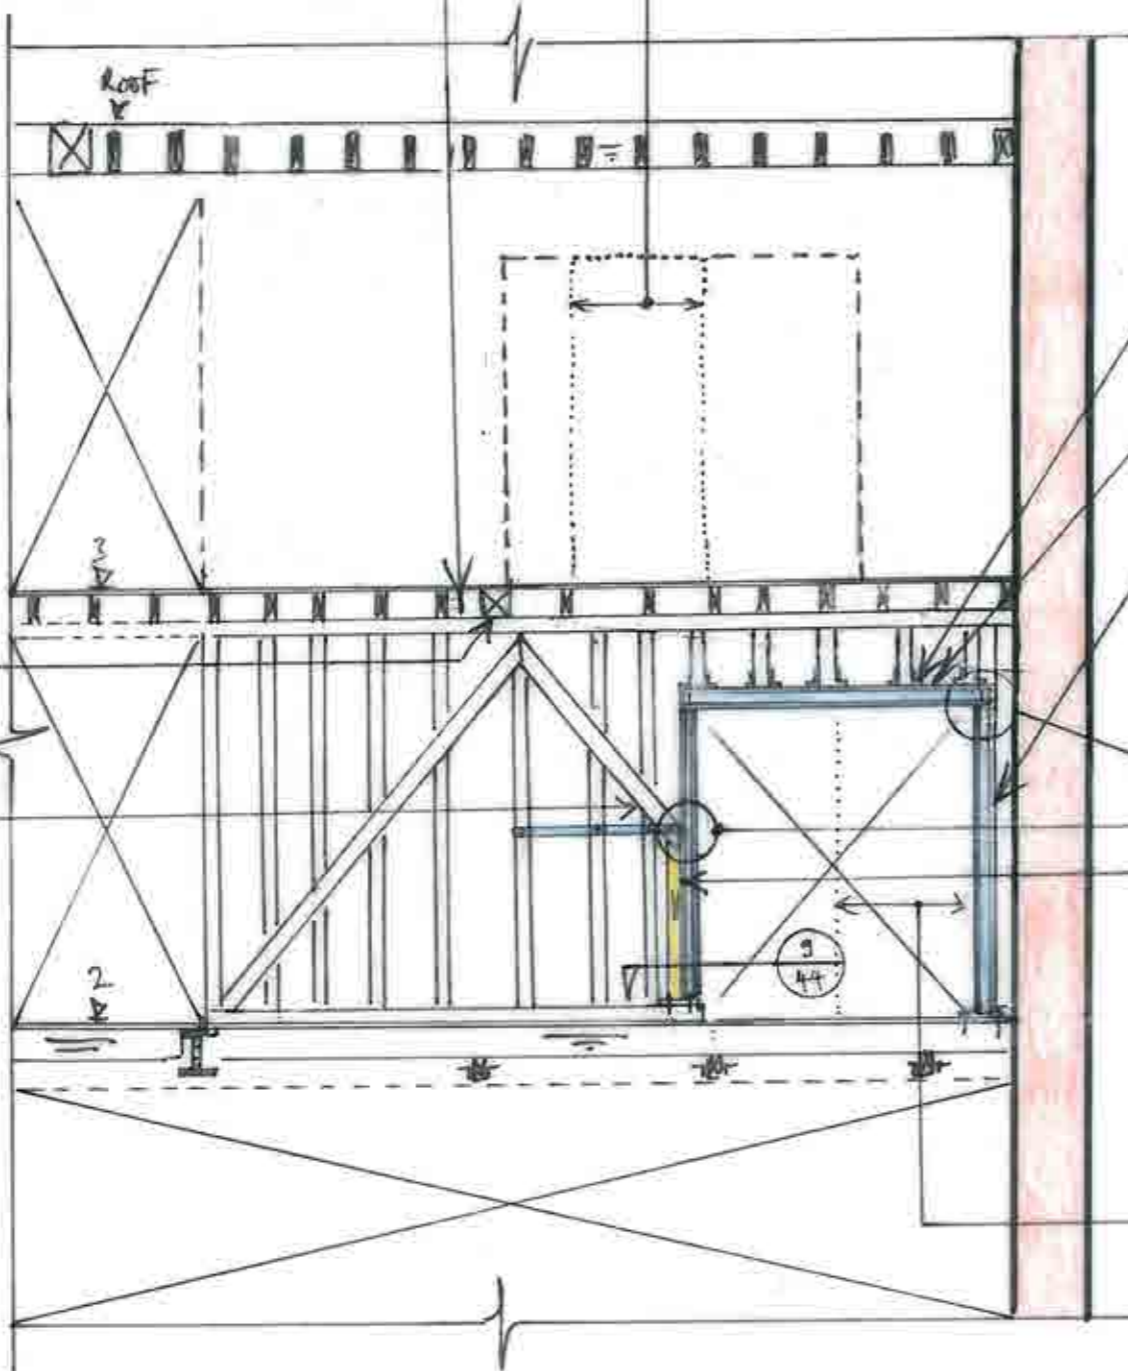
SECTION 07
(1:50)

ASSUMED TIMBER STUD WALL LAYOUTS BASED ON LIMITED OPENING OF WORKS. ALLOW FOR EXPOSING ENTIRE WALL AND FOR REVIEW OF DESIGN.

OPENING IN PARTITION

STUDS TO BE FIXED TO STEEL BEAMS WITH PAIRS OF 90x90x90 EXPANET BRACKETS FIXED TO STEEL BEAM WITH 4 NO. ϕ 4mm SELF-TAPPING SCREWS

NEW STEEL BEAMS AS NOTED ON G.A'S

NEW STEEL COLUMNS AS NOTED ON G.A'S

ASSUMED PRIMARY BEAM SPANNING ONTO STUD WALL

EXISTING BRACE FIXED TO STEEL POST AND STRAPPED TO EXISTING STUDS AS SHOWN ON DRAWING 44.

NEW TIMBER POST SIZED TO MATCH EXISTING (ALLOW FOR 100mm SILLING) TO BE INSTALLED UNDER EXISTING BRACE.

EXISTING OPENING IN ORIGINAL TIMBER STUD WALL TO BE EXTENDED

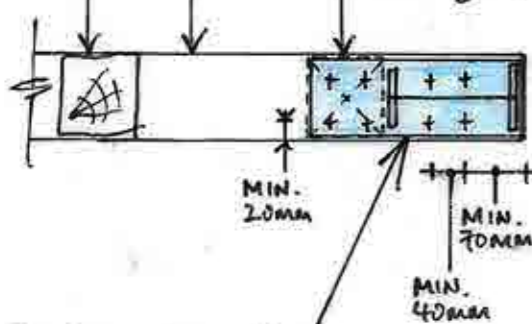
DETAIL 09 (PLAN)

EXISTING STUD
 EXISTING BASE PLATE
 NEW TIMBER POST AS SHOWN ON G18 (SHOWN DASHED FOR CLARITY OF BASE FIXINGS)

NEW STEEL POST FIXED TO EXISTING TIMBER WITH 8 NO. Ø10mm WASH SCREWS LENGTH 80mm, FIXED THROUGH 8mm THICK STEEL BASE PLATE WELDED TO STEEL POST WITH 6mm F.P.F.W.

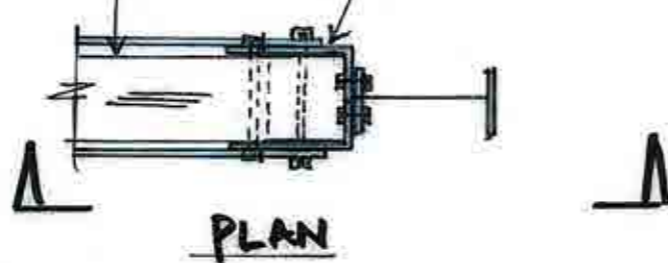
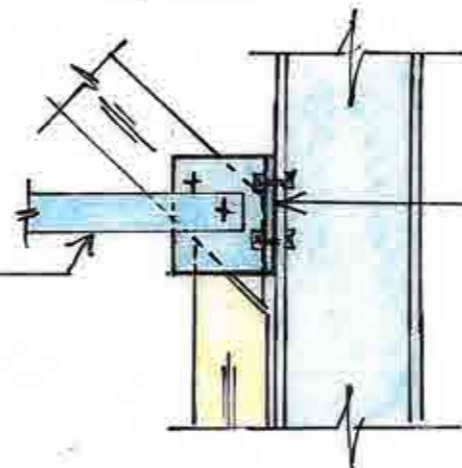
DETAIL 10

EXISTING BRACE
 NEW STEEL BRACKET FIXED THROUGH TIMBER BRACE WITH 2 NO. M10 BOLTS AT 50mm C/C.

NEW STEEL STRAPS 5mm x 30mm FIXED TO BRACKETS THROUGH M10 BOLT, AND FIXED TO MIN. 3 NO. EXISTING STUDS WITH M10 BOLTS.

EXISTING BRACE FIXED TO NEW STEEL POST WITH 2 NO. STEEL BRACKETS CUT FROM 150 x 75 x 10 UNEQUAL ANGLES. BRACKETS FIXED TO STEEL FRAME WITH 2 NO. M12 BOLTS.

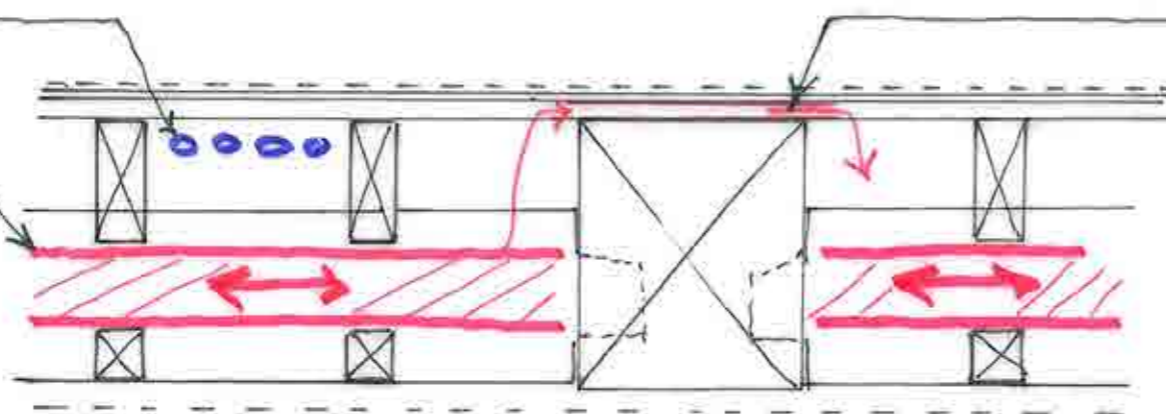
1. SERVICES STRATEGY - TYPICAL FLOOR

SERVICES ZONE PARALLEL TO JOISTS.

SERVICES ZONE BETWEEN LULLING JOISTS AND FLOOR JOISTS.

NO SIGNIFICANT SERVICES SHOULD CROSS PRIMARY TIMBER BEAMS. WHERE SINGLE SMALL DIAMETER PIPE NEED TO PASS PRIMARY BEAMS LOCALLY, PIPES TO RUN OVER BEAMS IN DEPTH OF FINISHES - ALTERNATIVELY, PIPES TO FOLLOW EXISTING SERVICES ROUTES.

The services distribution strategy is to generally avoid altering the existing fabric by re-using existing services routes where this is practical. Elsewhere the integration of new services will aim to work with the grain of the existing structure by passing services between existing timber floor joists and with careful coordination of the routes to limit notching to existing joists. Redundant services openings will be made good. The proposed services integration is summarised in more detail on drawing 1756/705/096 in Appendix 2.

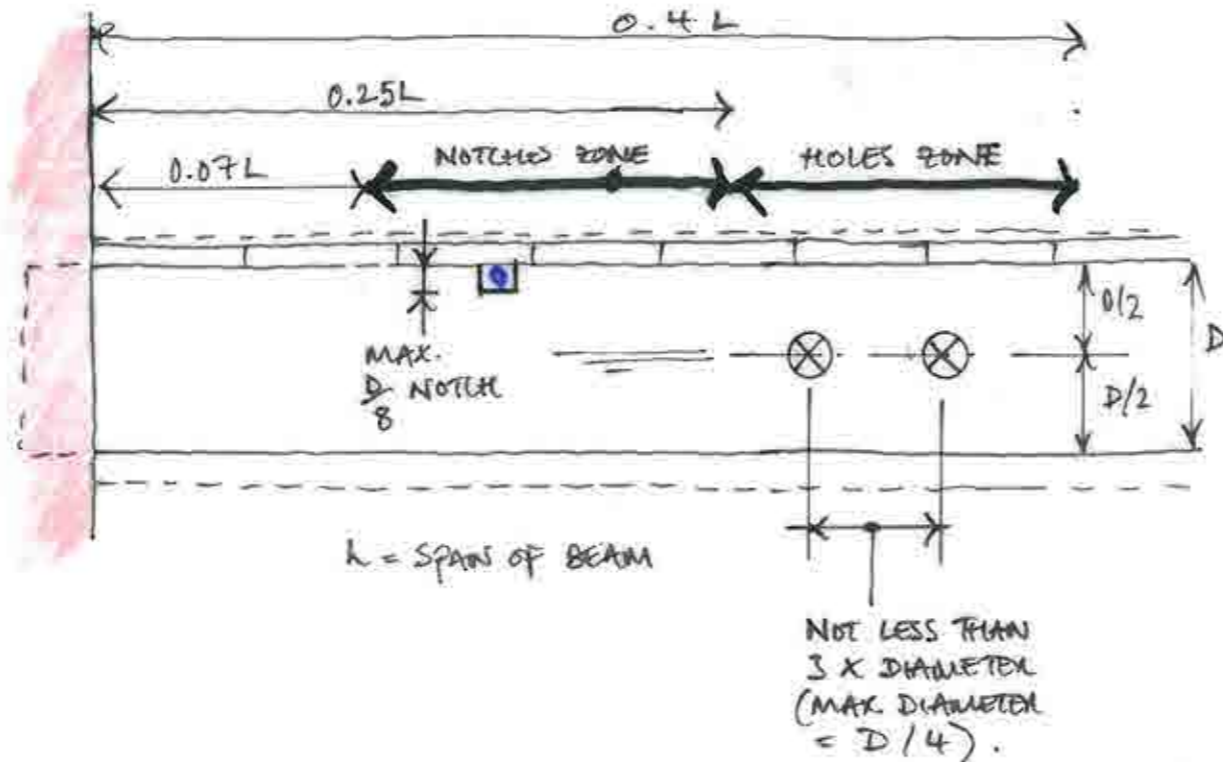
2. SERVICES STRATEGY - SINGLE TOISTED FLOOR

- SERVICES TO RE-USE EXISTING ROUTES WHERE POSSIBLE

- NOTCHING OF FLOOR BEAMS TO BE AVOIDED WHERE POSSIBLE AS SHOWN ABOVE FOR PRIMARY BEAMS.
