British Land plc

1 Triton Square

St Anne's
Ground Contamination Risk
Assessment and Remediation
Strategy

Issue 1 | 1 August 2018

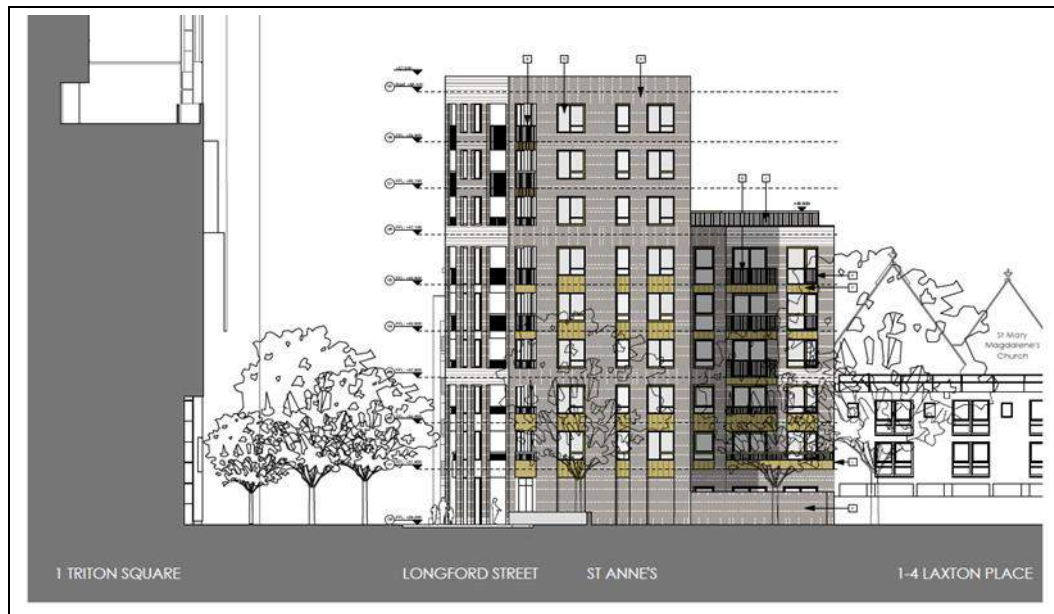
Table 2 Architectural drawing of the proposed development at St Anne's

Table 2 shows an architect's drawing of the proposed development at St Anne's.

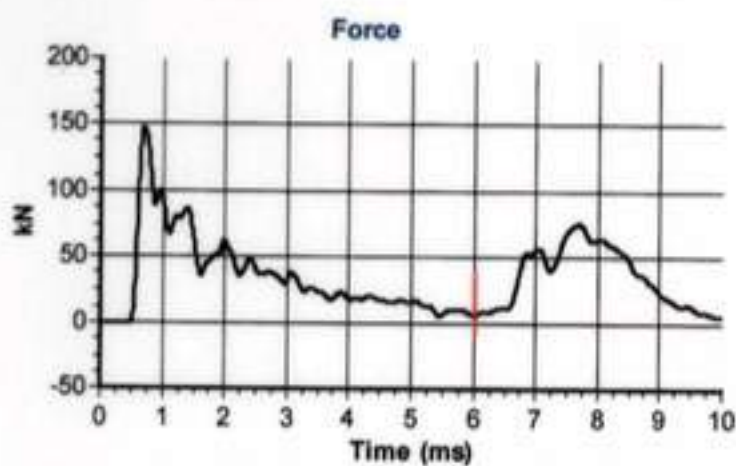
Calculations

Area of Rod A (mm²): 905
Theoretical Energy E_{theor} (J): 473
Measured Energy E_{meas} (J): 301

The recommended calibration interval is 12 months

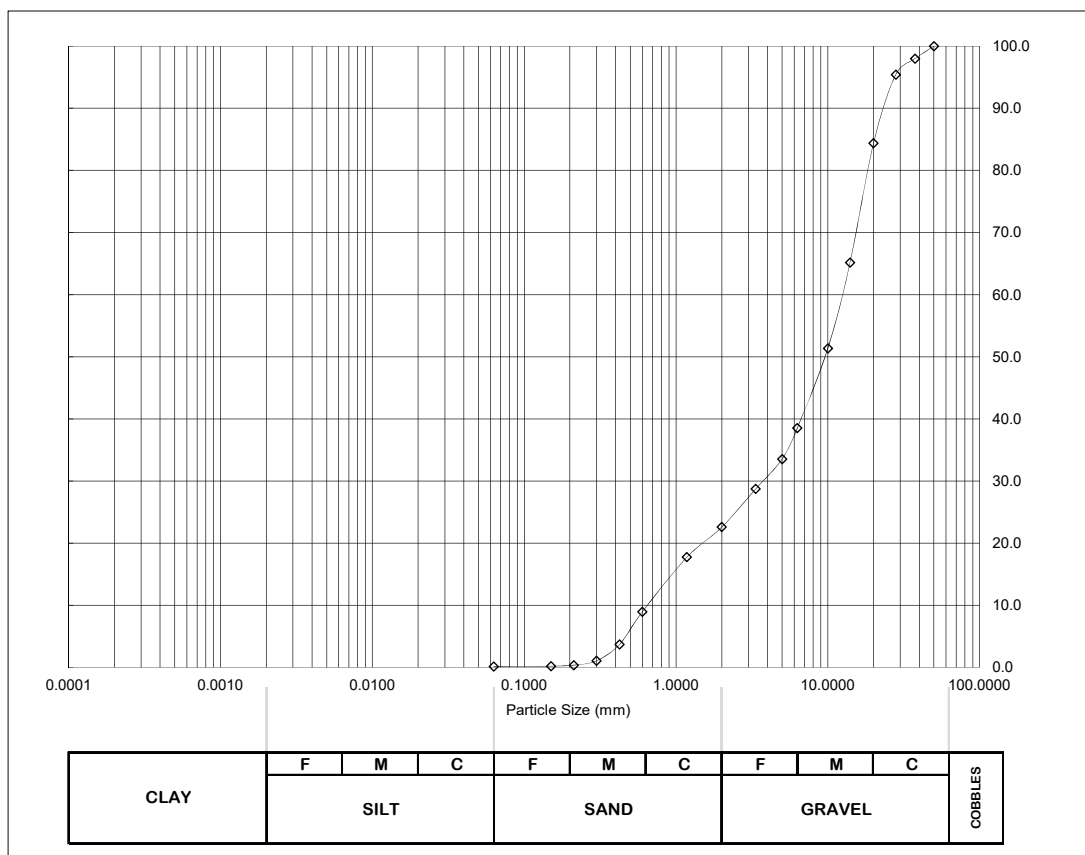
Yellowish brown very sandy fine to coarse flint GRAVEL

BS Test Sieves	
Size (mm)	% Passing
75.000	100
63.000	100
50.000	100
37.500	98
28.000	95
20.000	84
14.000	65
10.000	51
6.300	39
5.000	34
3.350	29
2.000	23
1.180	18
0.600	9
0.425	4
0.300	1
0.212	0
0.150	0
0.063	0

Method/type: Dry Sieving BS 1377: Part 2: Clause 9.3: 1990 Determination of particle size distribution - dry sieving method.
