# British Museum – Nos. 42–43 Russell Square Planning Submission Statement Prepared for the British Museum July 2018

**British Museum - No.'s 42 - 43 Russell Square**  
**Planning Submission Statement**

**1.0 Introduction**

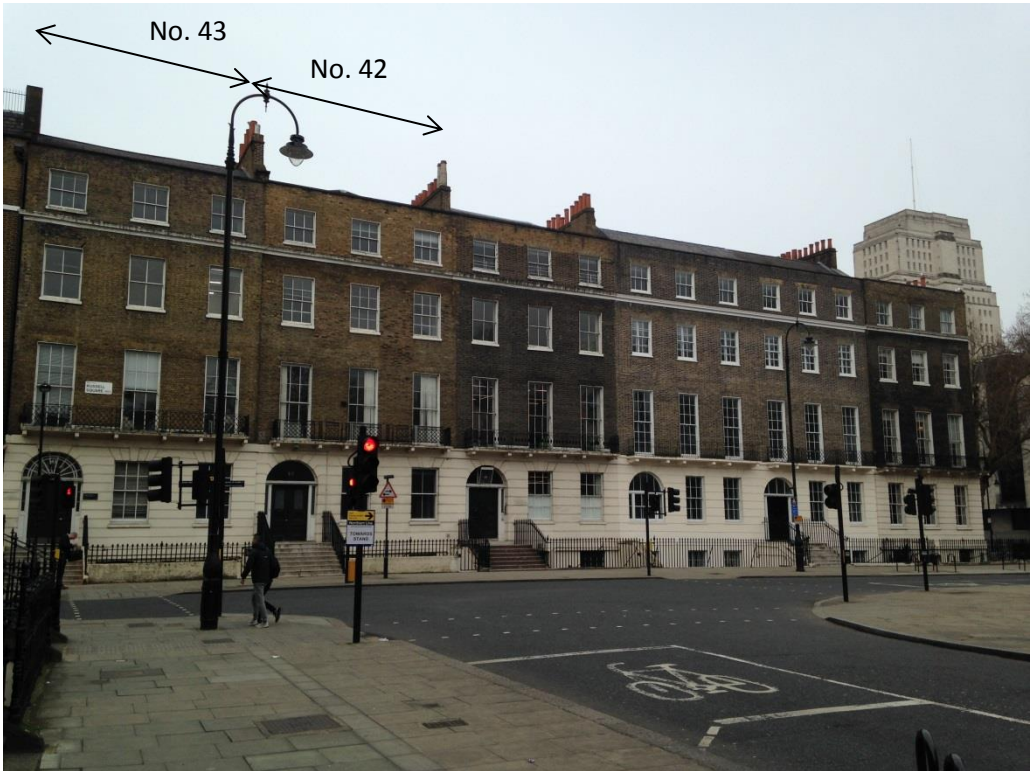
Figure 1: View of buildings from Russell Square

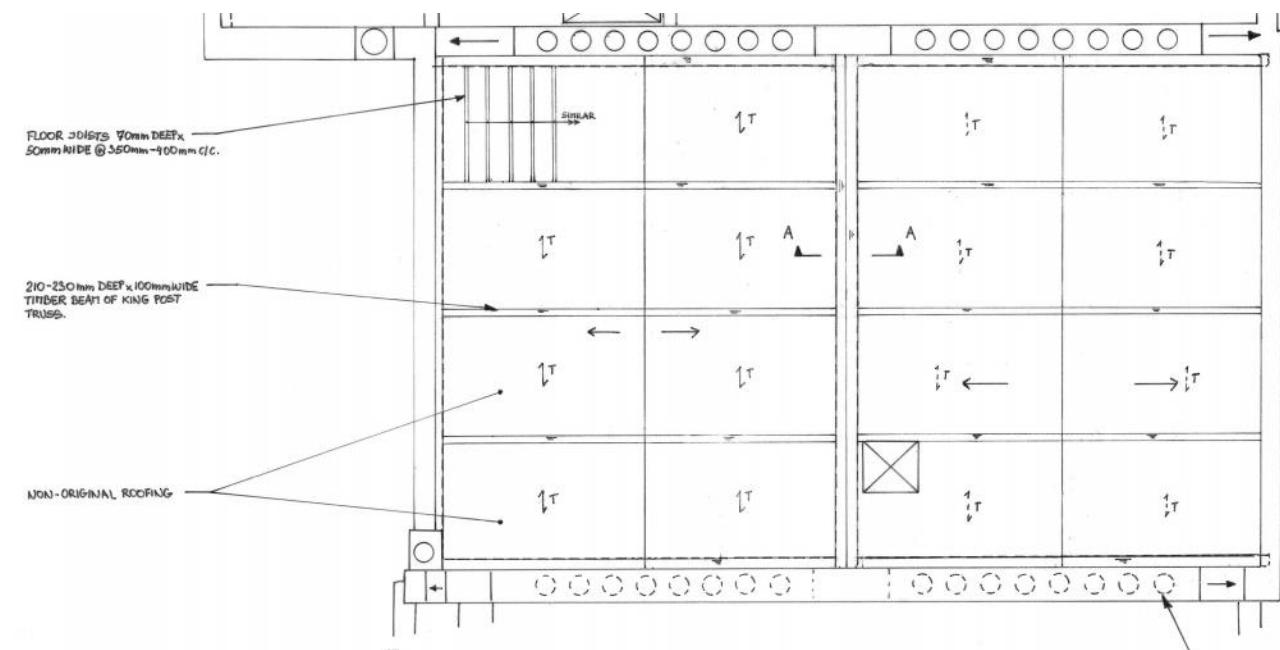
Figure 4: No. 43 roof plan

The roof structure consists of two pitched roofs and a central valley beam supporting the roof king post trusses internally. This beam has been strengthened in the past with a steel plate.

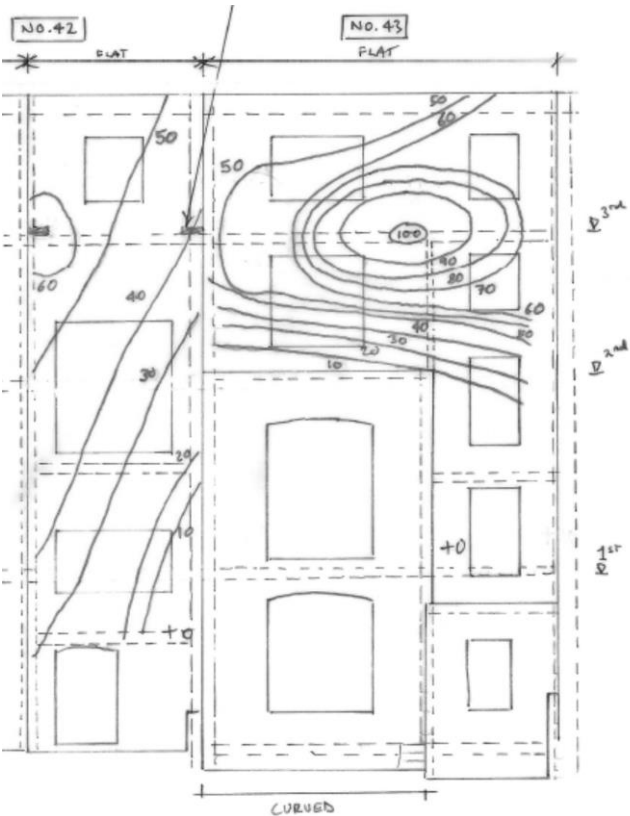
Figure 5: Rear elevations of Houses 42-43, showing movements of walls

Our appraisal of the external walls has found some issues with de-lamination of the outer skin of facing brickwork to House 43. The survey shows significant bulging at the upper levels, as shown on figure 5, which may indicate that the facing brick is separating from the backing brick. These issues need to be addressed in order to reinstate the robustness of these walls.

The proposed repairs to the façade involve pinning the facing brick back to the main body of the wall where practical and where there is limited de-lamination. Where there is significant de-lamination pinning would not be effective, and local areas of re-building may be needed. Existing bricks are to be carefully removed and reused for this.

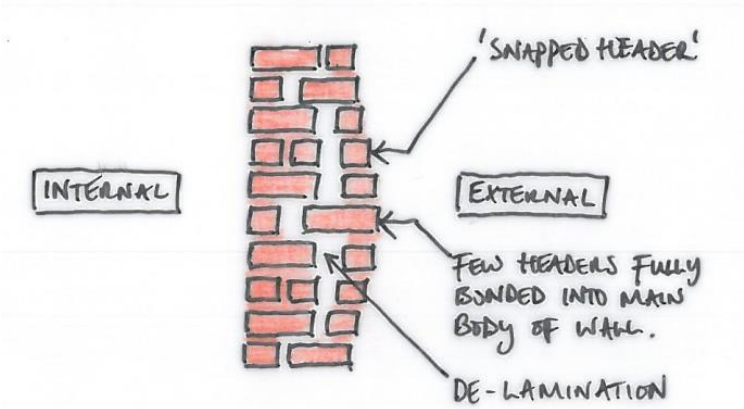
Figure 6: Sketch showing issues with de-lamination

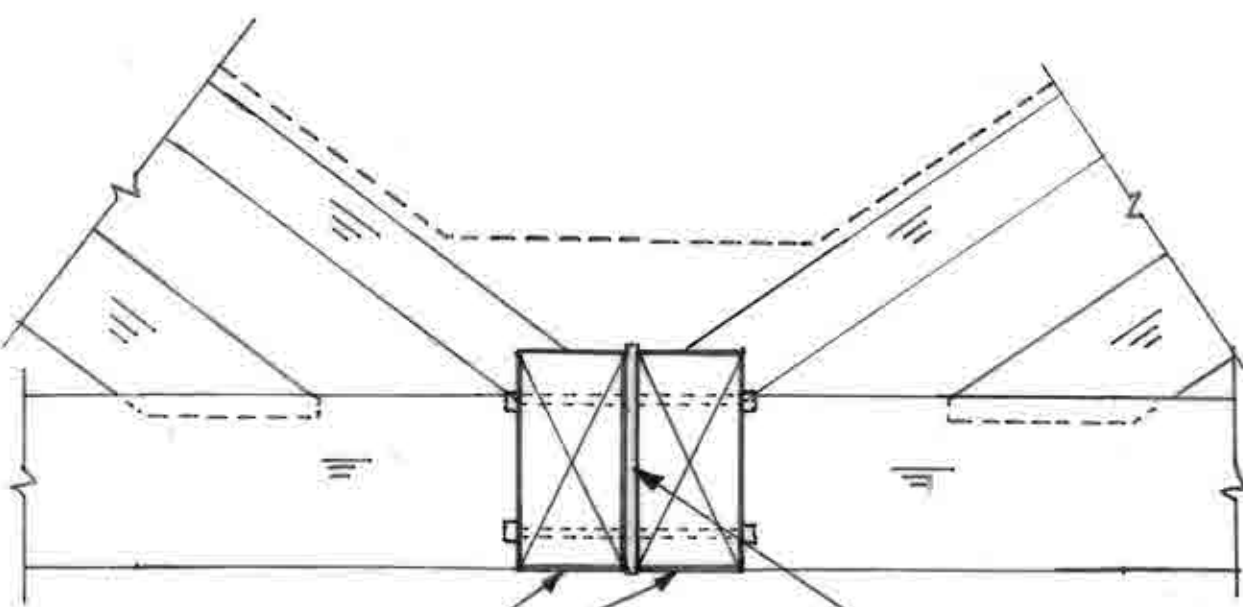
**DETAIL A-A**  
(1:10)

2 No. ORIGINAL TIMBER BEAMS 285mm DEEP x 140mm WIDE.

12-14mm STEEL PLATE BOLTED THROUGH AT STAGGERED CENTRES ~ 650mm C/C.

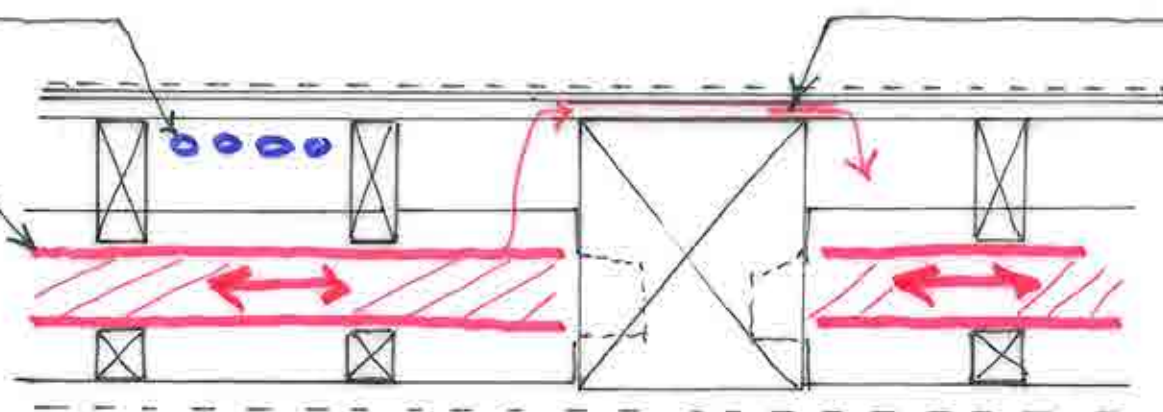
## 1. SERVICES STRATEGY - TYPICAL FLOOR

SERVICES ZONE  
PARALLEL TO JOISTS.

SERVICES ZONE  
BETWEEN CEILING  
JOISTS AND  
FLOOR JOISTS.

NO SIGNIFICANT SERVICES SHOULD CROSS  
PRIMARY TIMBER BEAMS. WHERE SINGLE  
SMALL DIAMETER PIPE NEED TO PASS  
PRIMARY BEAMS LOCALLY, PIPES TO  
RUN OVER BEAMS IN  
DEPTH OF FINISHES -  
ALTERNATIVELY, PIPES TO  
FOLLOW EXISTING  
SERVICES ROUTES.

The services distribution strategy is to generally avoid altering the existing fabric by re-using existing services routes where this is practical. Elsewhere the integration of new services will aim to work with the grain of the existing structure by passing services between existing timber floor joists and with careful coordination of the routes to limit notching to existing joists. Redundant services openings will be made good. The proposed services integration is summarised in more detail on drawing 1756/705/096 in Appendix 2.

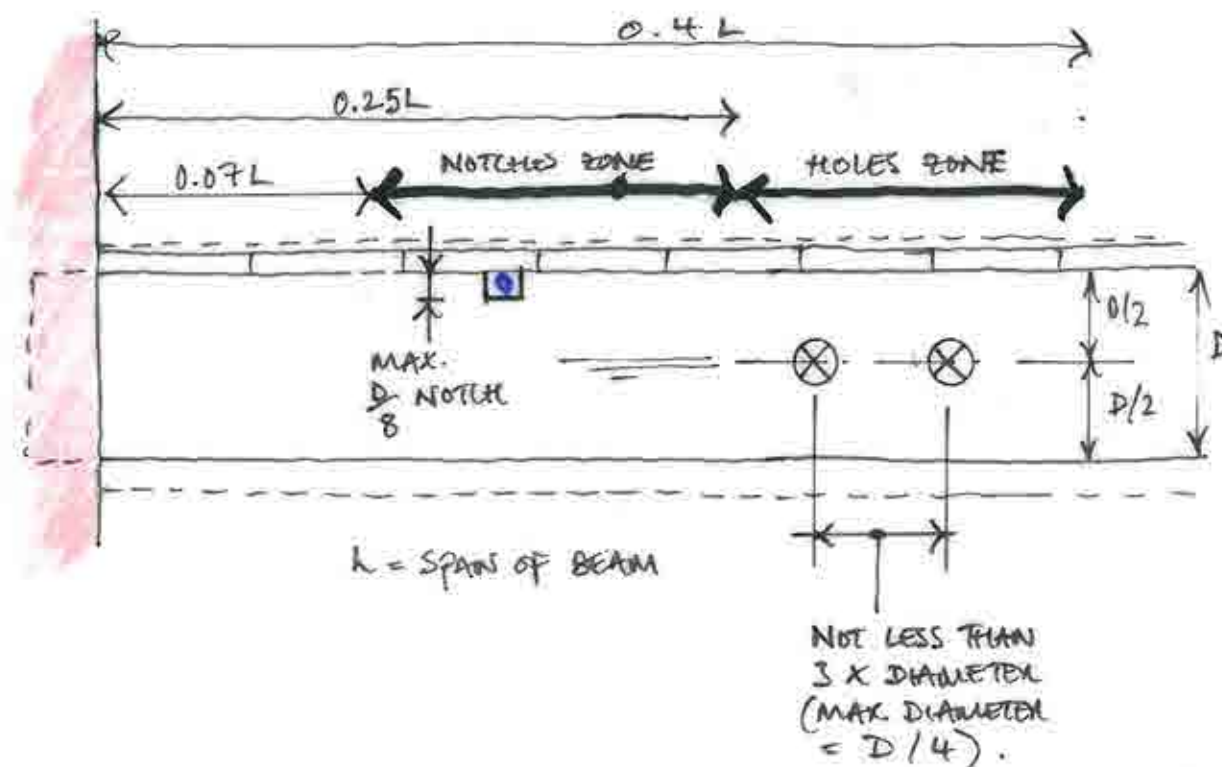
## 2. SERVICES STRATEGY - SINGLE JOISTED FLOOR

- SERVICES TO RE-USE  
EXISTING ROUTES  
WHERE POSSIBLE
- NOTCHING OF FLOOR  
BEAMS TO BE AVOIDED  
WHERE POSSIBLE  
AS SHOWN ABOVE FOR  
PRIMARY BEAMS.
