**GEO-ENVIRONMENTAL & GEOTECHNICAL ASSESSMENT
(GROUND INVESTIGATION)
& BASEMENT IMPACT ASSESSMENT
REPORT**

**138-140 HIGHGATE ROAD
HIGHGATE
LONDON
NW5 1PB**

Report Title: Geo-environmental & Geotechnical Assessment & Basement Impact
Assessment Report for 138-140 Highgate Road, Highgate, London NW5 1PB

Job No: P1323J1303/SL

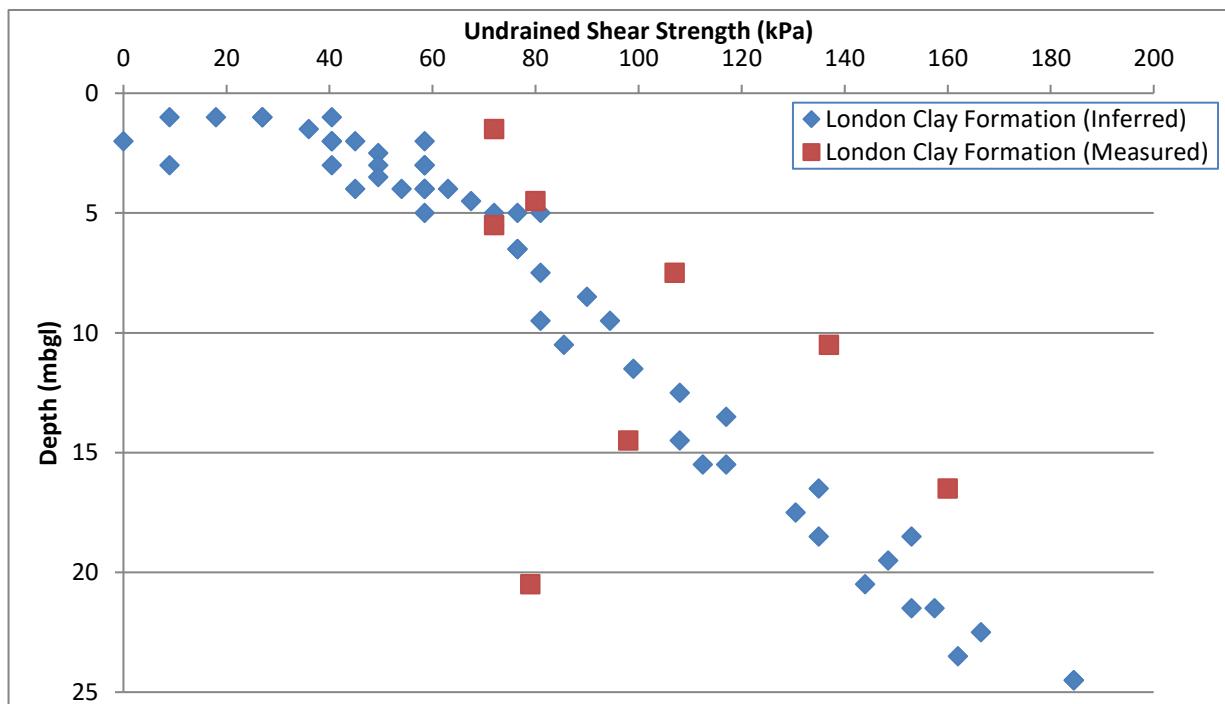
Figure 9.1: Undrained Shear Strength v Depth

9.4.4 The graph below shows the shear strength profile of the London Clay Formation encountered at the site, based on the SPT to shear strength correlation described above, as well as the results of undrained triaxial tests on undisturbed samples taken from the boreholes.

- 9.4.5 As can be seen from above using a f_1 of 4.5 provided a generally good correlation between the inferred undrained shear strengths and the measured results. A f_1 of 5 could be used but due to the conservative nature of using 4.5 this value has been kept.

- 9.4.6 It should be noted that some very low strengths were inferred at 1m - 3m in WS5. This location was located in close proximity to a known tank and at 4m the recorded SPT 'N' values (and thus the inferred undrained shear strengths) jump up to levels noted elsewhere. It is possible that the materials noted between 1m and 3m in WS5 are actually materials disturbed to allow the installation of the known tanks.

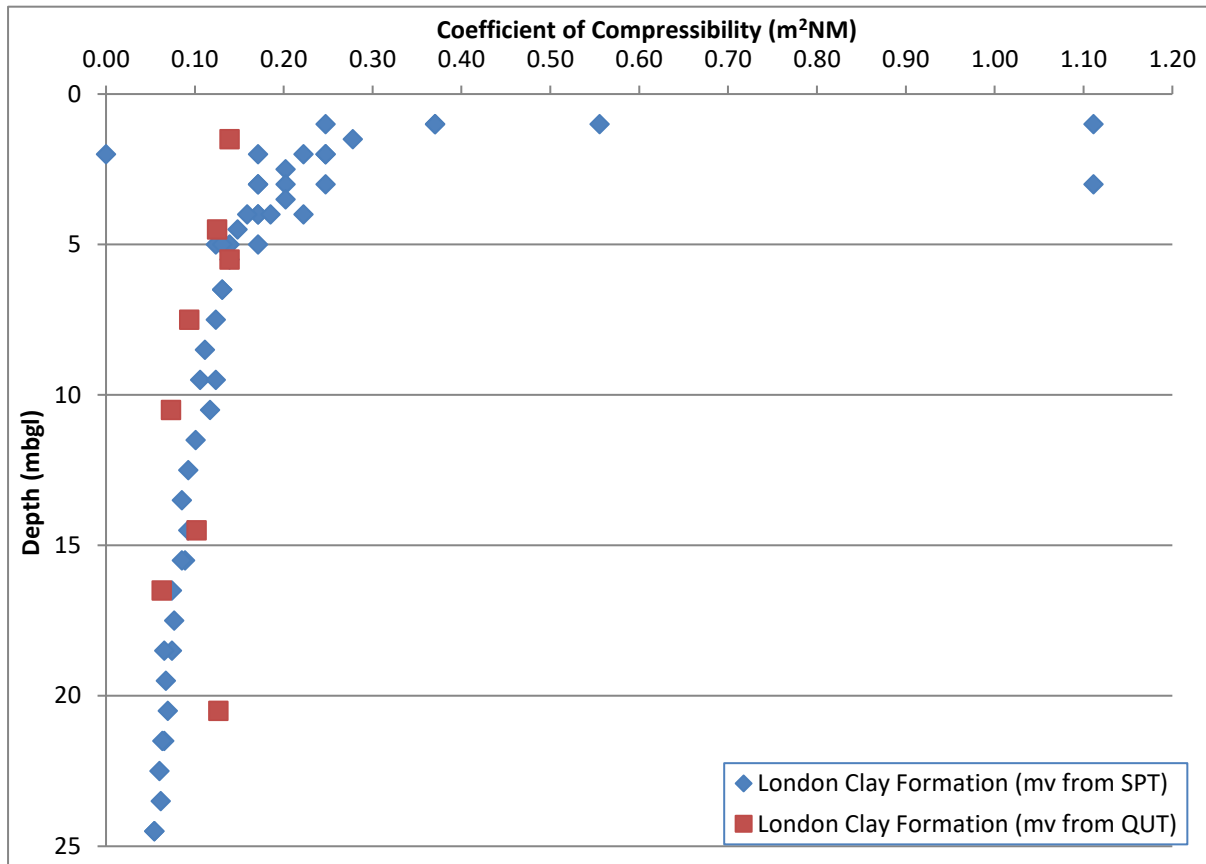
Figure 9.2: of Coefficient of Volume Compressibility (m_v) v Depth

- 9.5.3 Where the undrained shear strength of the clays was obtained using the quick undrained triaxial methodology the m_v value was used by rearranging the equations for f_1 and f_2 and the measured undrained shear strength.

9.5.4 As would be expected, the results reduce with depth as the clay increases in strength and the over burden increases, reducing the potential for compressibility.

9.5.5 As would be expected the results from of the London Clay are generally of “low” to “medium” compressibility. A number of near surface clays are noted to be of “high” compressibility. However this is considered to be due to the lack of overburden pressure allowing the clays to relax and so compress slightly as well as the potential for these materials to be disturbed / Made Ground.

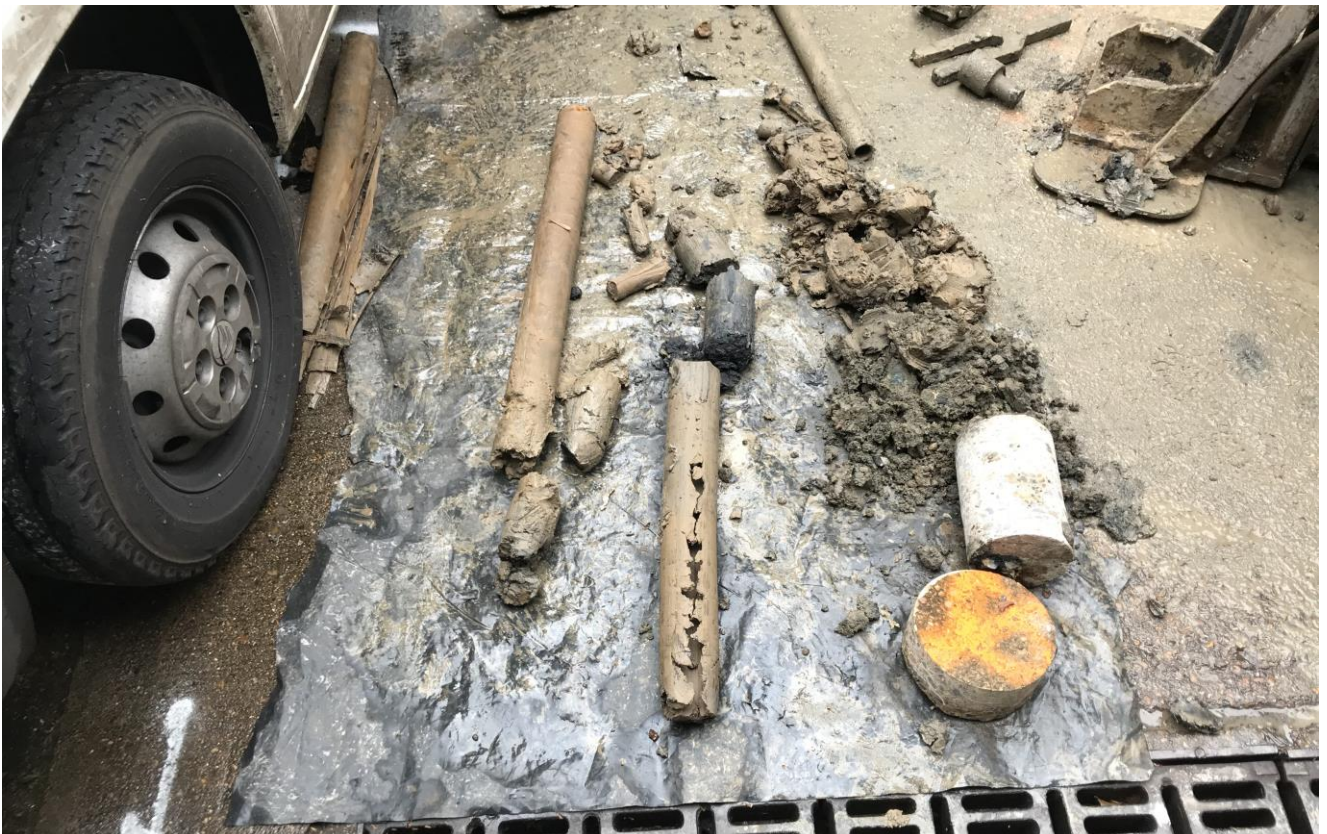
**Photo 4: WS5**

4.3.2 Made Ground recovered from WS5 (0.30m - 1.20m bgl) had some evidence of black staining and a hydrocarbon odour. Clay recovered from WS5 at 1.50m to 2.00m bgl had black staining and a “strong” hydrocarbon odour.

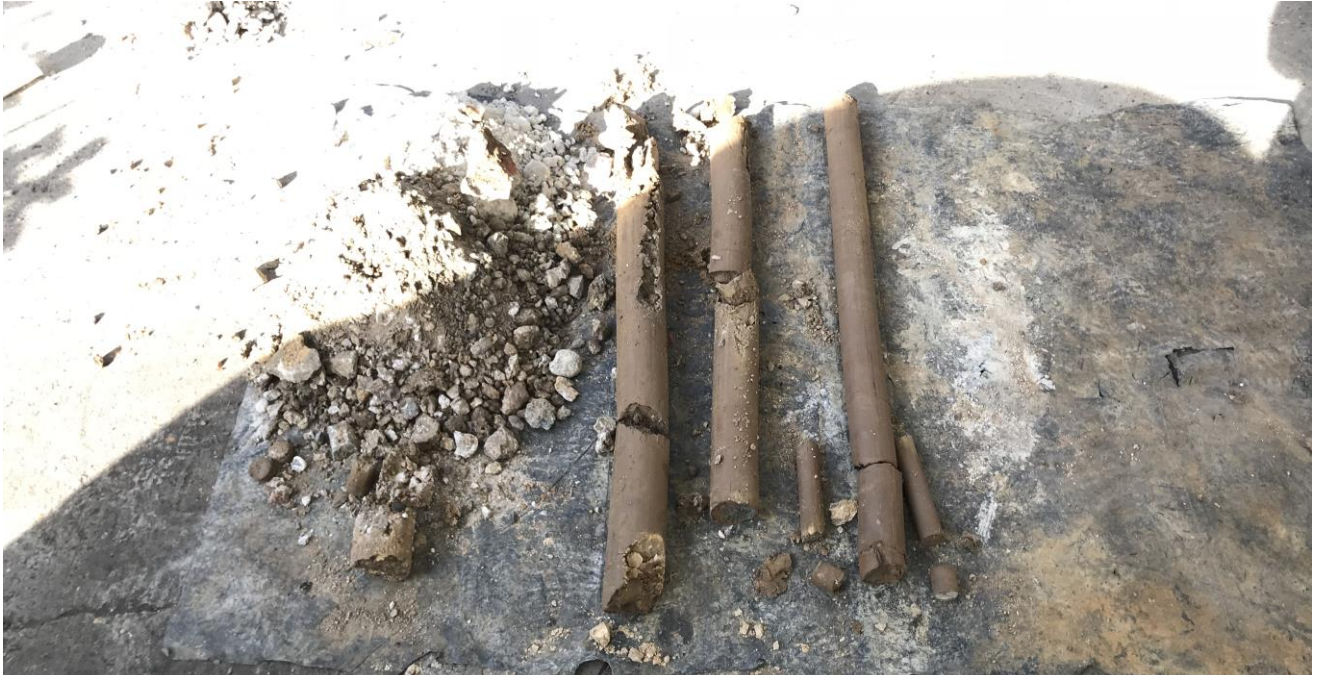
Photo 5:

Project Name	Highgate Road	Client	Design Ventures Highgate Ltd
Title	WS Drilling Photographic Log	Project No.	P1323J1303

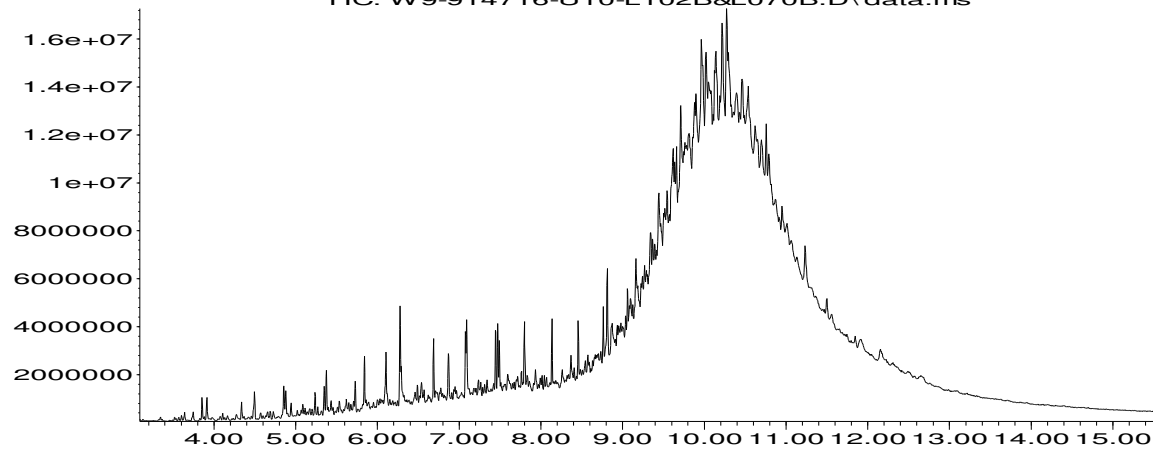
TIC: W9-914716-U10-L102B&L070B.D\data.ms

The total ion count (TIC trace) shows a carbon range from C10 to greater than C40
The sample TIC trace is complex, showing aromatic and aliphatic product sources.
The trace does not match the standard product profiles but is suggestive of lube oil.

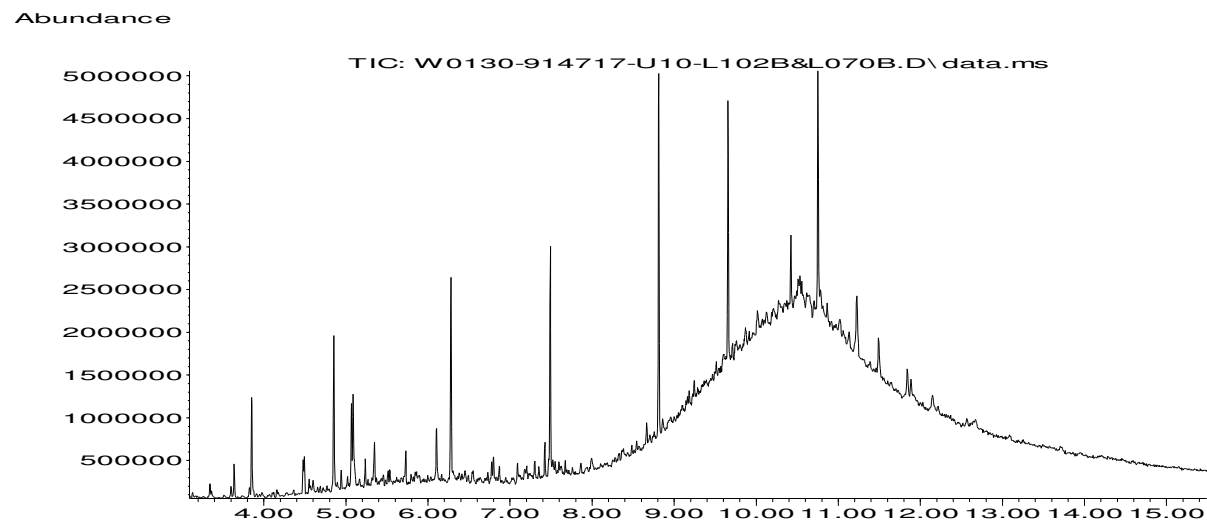
The total ion count (TIC trace) shows a carbon range from C10 to greater than C40
The sample TIC trace is complex, showing aromatic and aliphatic product sources.
The trace does not match the standard product profiles but is suggestive of lube oil.

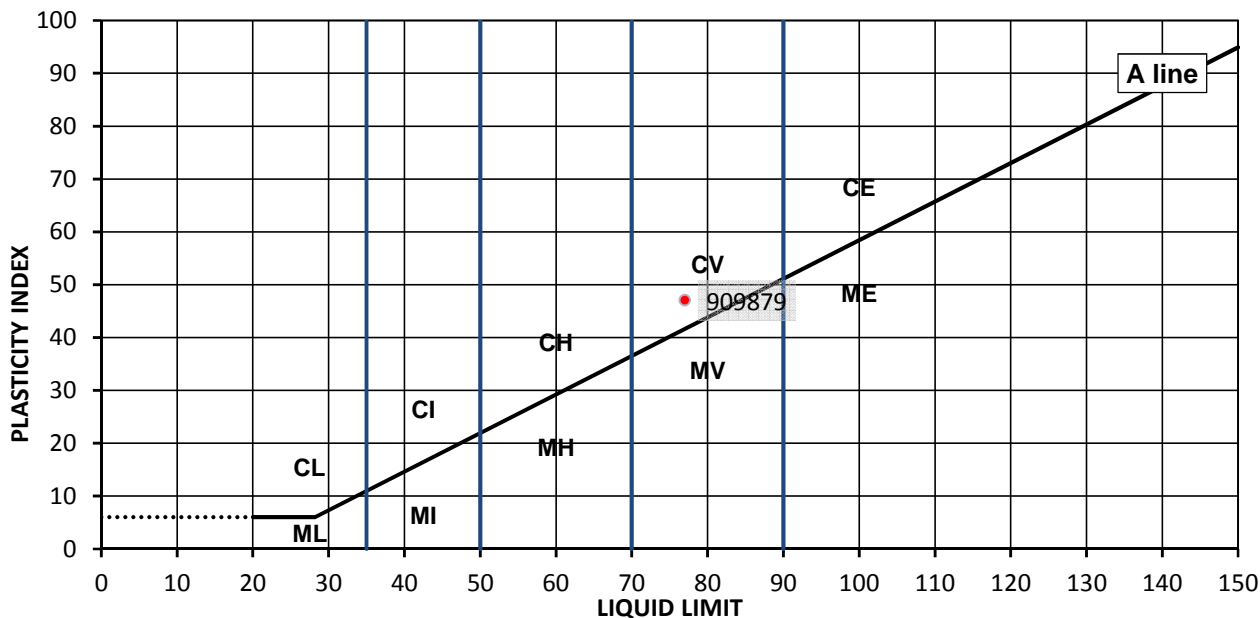
Sample Type: D
Depth Top [m]: 12.50
Depth Base [m]: Not Given

As Received Moisture Content [%]	Liquid Limit [%]	Plastic Limit [%]	Plasticity Index [%]	% Passing 425µm BS Test Sieve
26	77	30	47	100

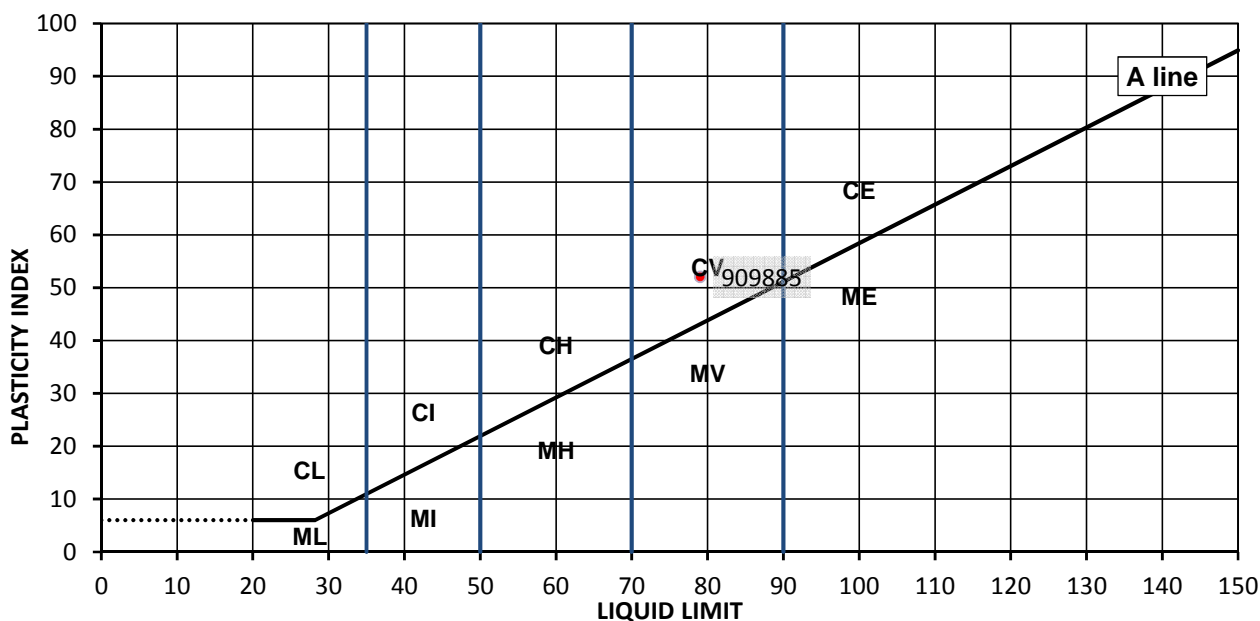
Sample Type: B
Depth Top [m]: 18.50
Depth Base [m]: Not Given

As Received Moisture Content [%]	Liquid Limit [%]	Plastic Limit [%]	Plasticity Index [%]	% Passing 425µm BS Test Sieve
26	79	27	52	100

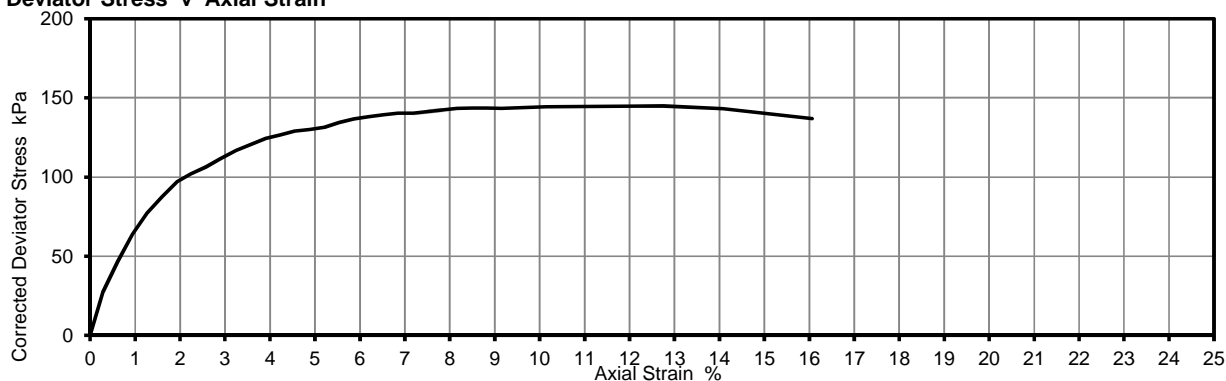
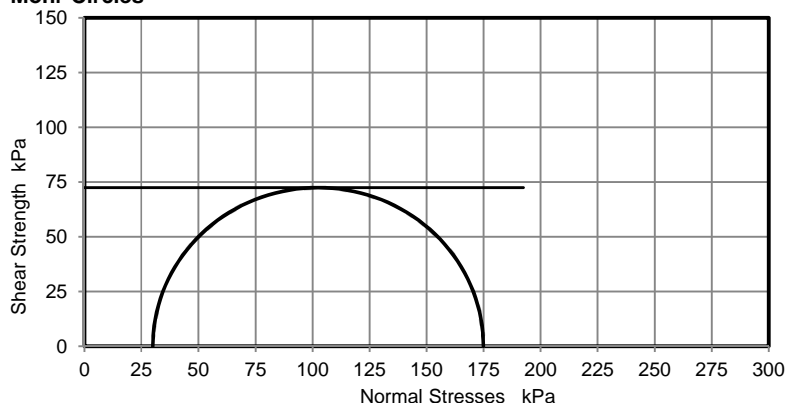
Deviator Stress v Axial Strain

Rate of Strain	2.00 %/min
Cell Pressure	30 kPa
Axial Strain at failure	12.8 %
Deviator Stress, $(\sigma_1 - \sigma_3)_f$	145 kPa
Undrained Shear Strength, c_u	72 kPa $\frac{1}{2}(\sigma_1 - \sigma_3)_f$
Mode of Failure	Brittle
Membrane thickness	0.30 mm

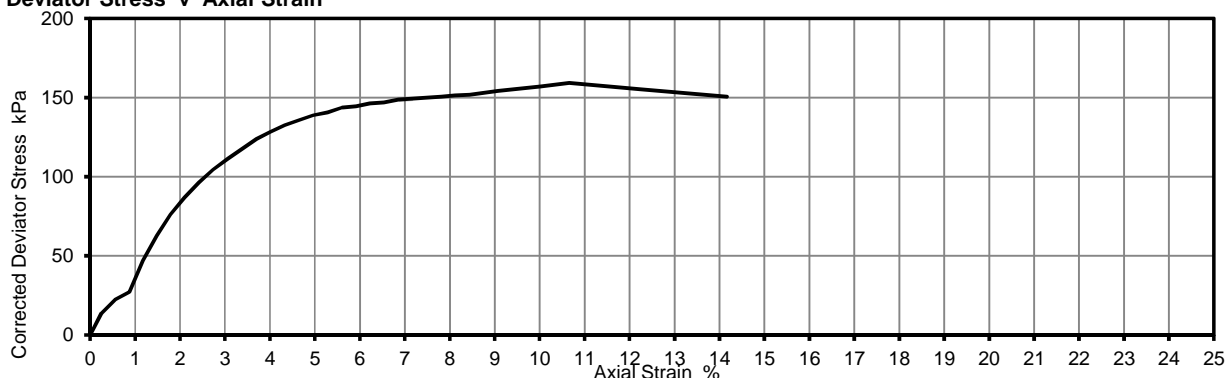
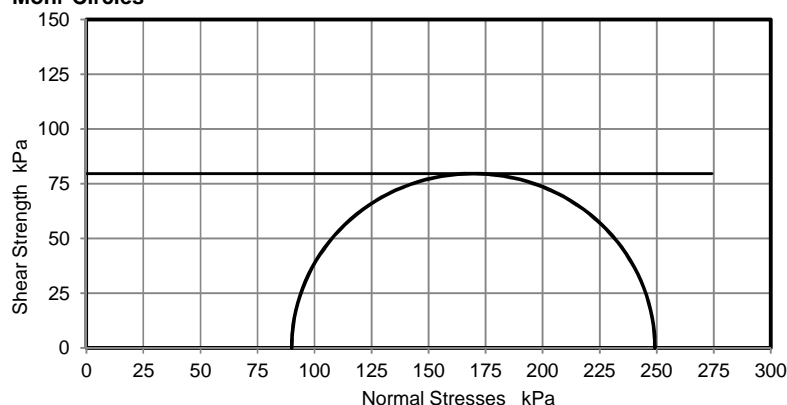
Deviator Stress v Axial Strain

Rate of Strain	1.94	%/min
Cell Pressure	90	kPa
Axial Strain at failure	10.7	%
Deviator Stress, $(\sigma_1 - \sigma_3)_f$	159	kPa
Undrained Shear Strength, c_u	80	kPa $\frac{1}{2}(\sigma_1 - \sigma_3)_f$
Mode of Failure	Brittle	
Membrane thickness	0.29	mm

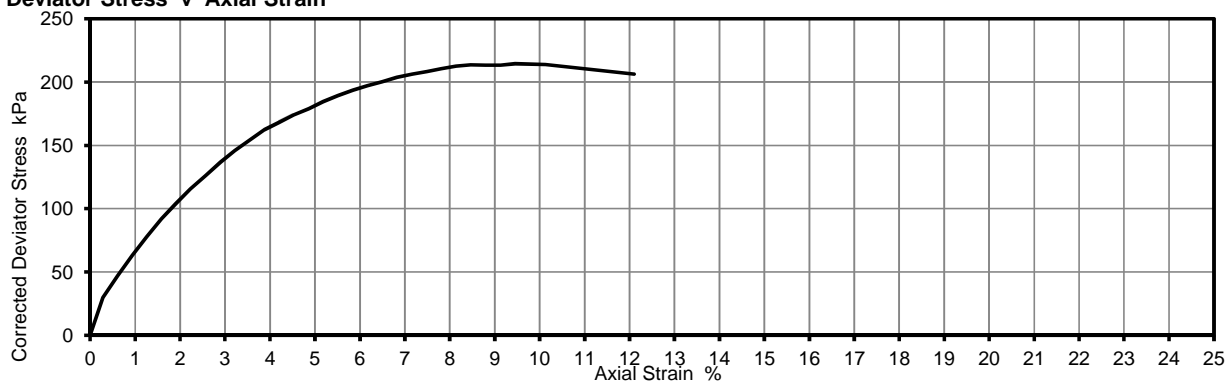
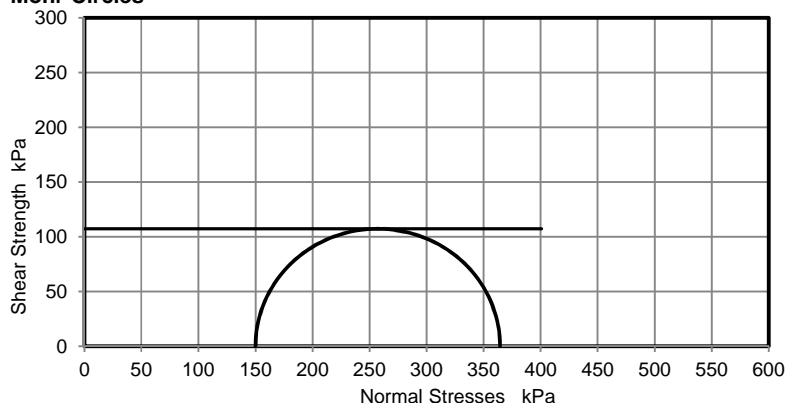
Deviator Stress v Axial Strain

Rate of Strain	2.00 %/min
Cell Pressure	150 kPa
Axial Strain at failure	9.5 %
Deviator Stress, $(\sigma_1 - \sigma_3)_f$	214 kPa
Undrained Shear Strength, c_u	107 kPa $\frac{1}{2}(\sigma_1 - \sigma_3)_f$
Mode of Failure	Brittle
Membrane thickness	0.29 mm

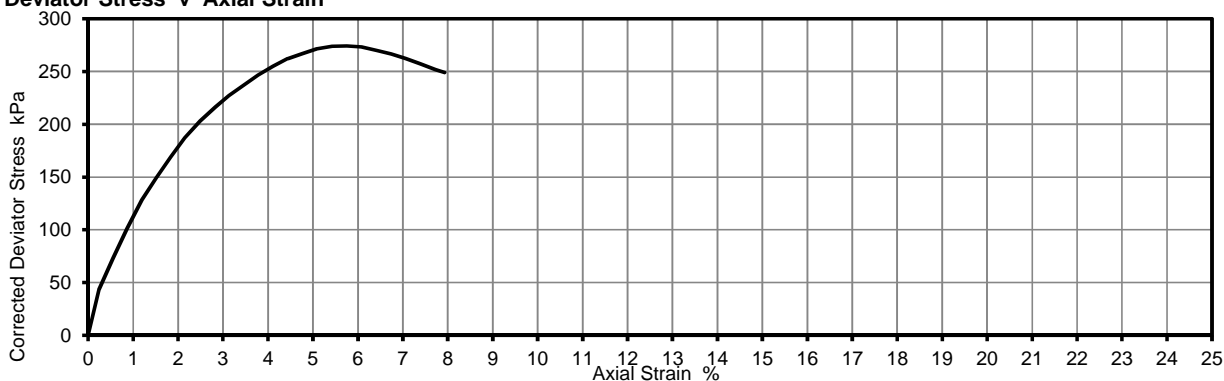
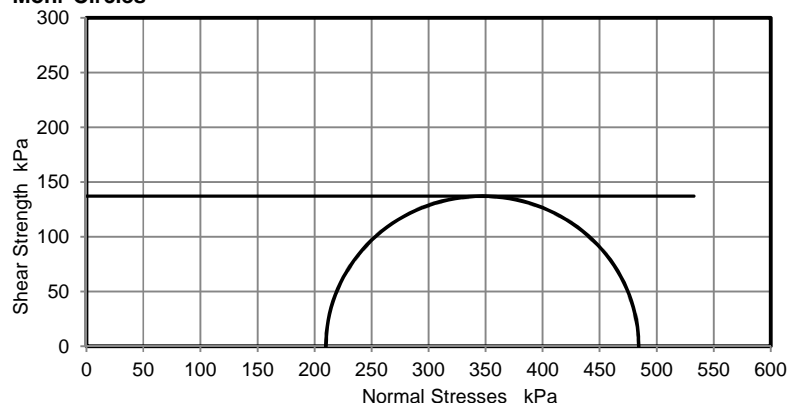
Deviator Stress v Axial Strain

Rate of Strain	2.00 %/min
Cell Pressure	210 kPa
Axial Strain at failure	5.8 %
Deviator Stress, $(\sigma_1 - \sigma_3)_f$	274 kPa
Undrained Shear Strength, c_u	137 kPa $\frac{1}{2}(\sigma_1 - \sigma_3)_f$
Mode of Failure	Brittle
Membrane thickness	0.28 mm

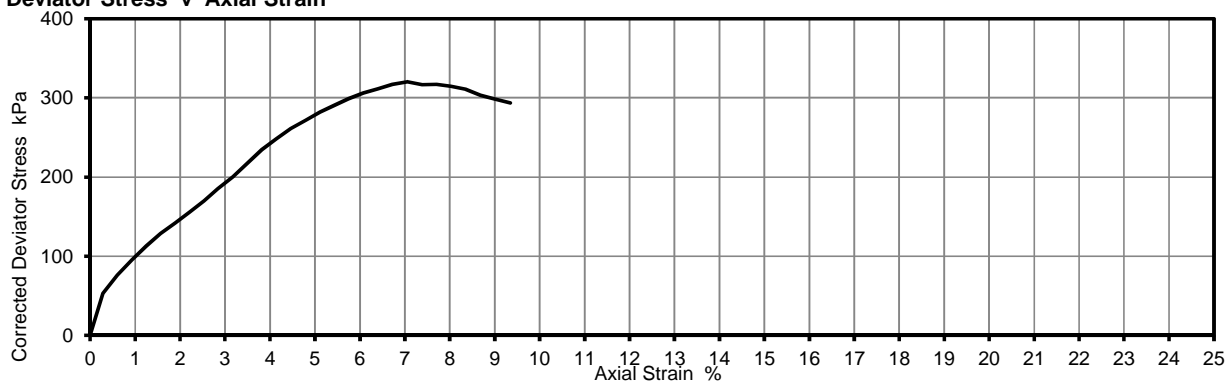
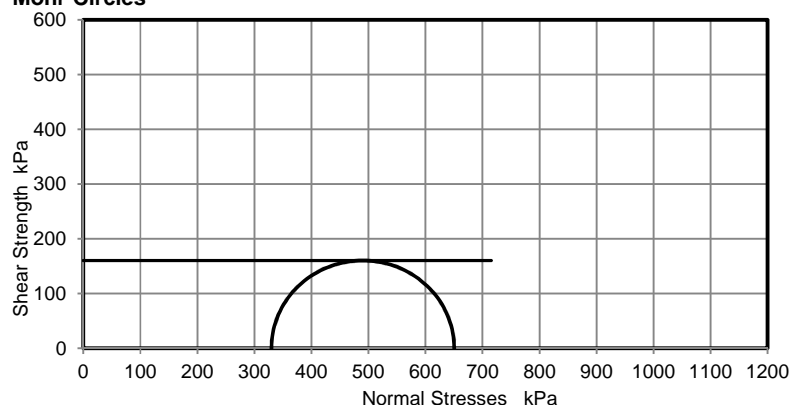
Deviator Stress v Axial Strain

Rate of Strain	1.98 %/min
Cell Pressure	330 kPa
Axial Strain at failure	7.1 %
Deviator Stress, $(\sigma_1 - \sigma_3)_f$	320 kPa
Undrained Shear Strength, c_u	160 kPa $\frac{1}{2}(\sigma_1 - \sigma_3)_f$
Mode of Failure	Brittle
Membrane thickness	0.29 mm

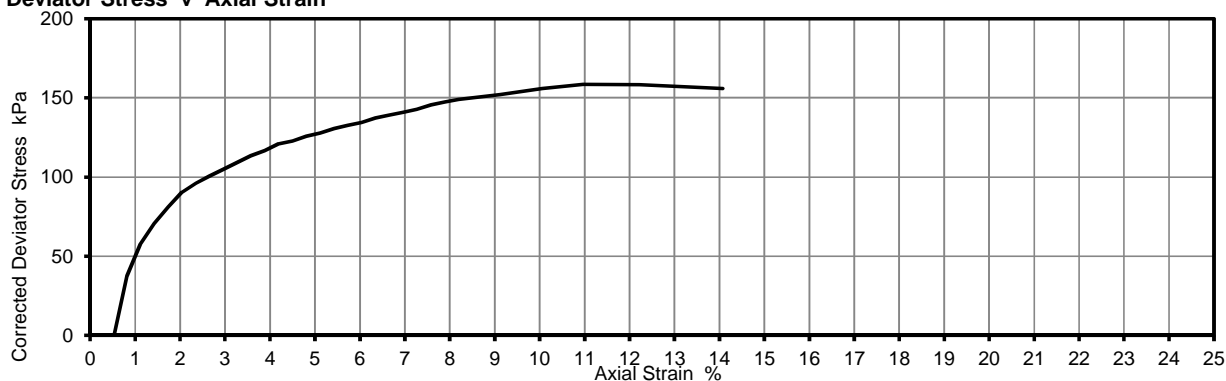
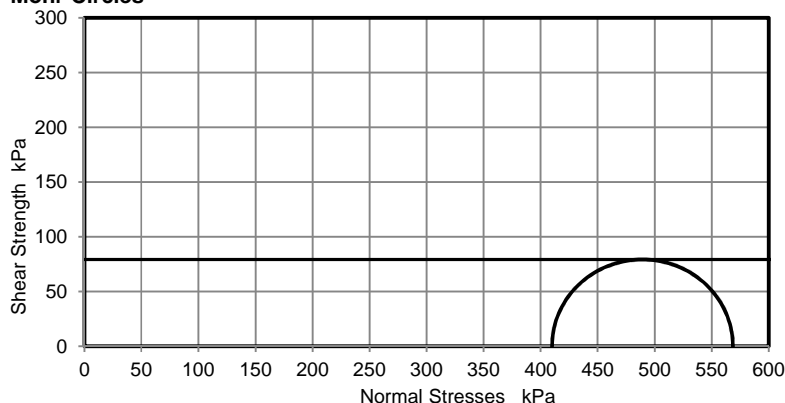
Deviator Stress v Axial Strain

Rate of Strain	1.88 %/min
Cell Pressure	410 kPa
Axial Strain at failure	11.0 %
Deviator Stress, $(\sigma_1 - \sigma_3)_f$	159 kPa
Undrained Shear Strength, c_u	79 kPa $\frac{1}{2}(\sigma_1 - \sigma_3)_f$
Mode of Failure	Brittle
Membrane thickness	0.28 mm

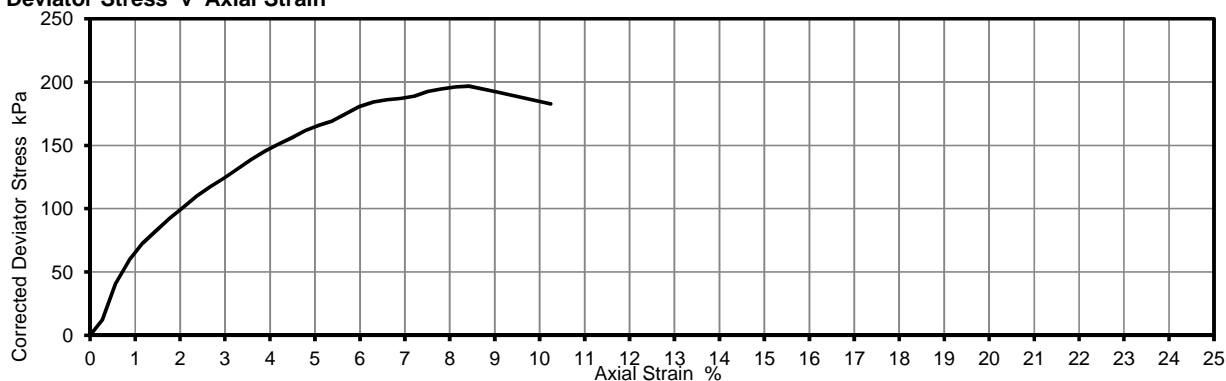
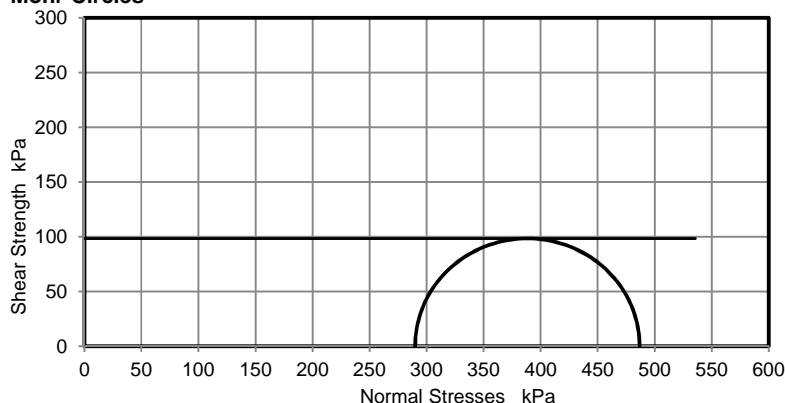
Deviator Stress v Axial Strain

Rate of Strain	1.84 %/min
Cell Pressure	290 kPa
Axial Strain at failure	8.4 %
Deviator Stress, $(\sigma_1 - \sigma_3)_f$	197 kPa
Undrained Shear Strength, c_u	98 kPa $\frac{1}{2}(\sigma_1 - \sigma_3)_f$
Mode of Failure	Brittle
Membrane thickness	0.27 mm

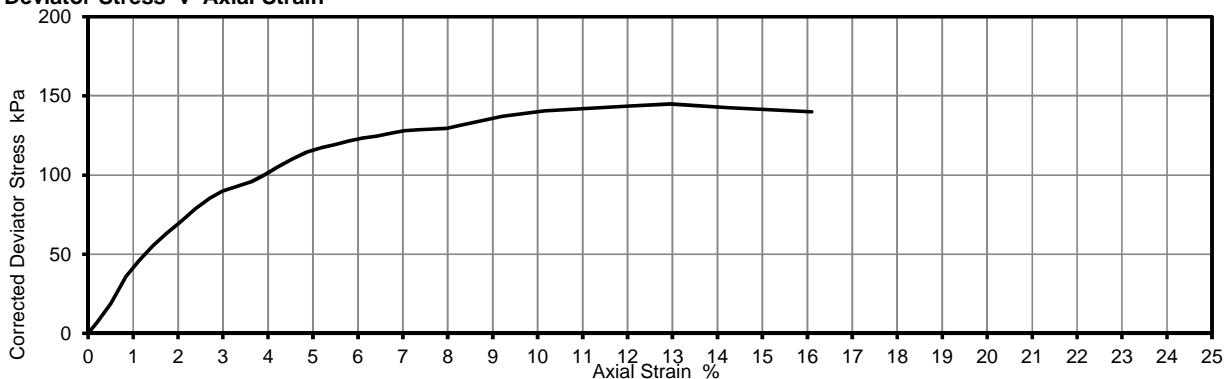
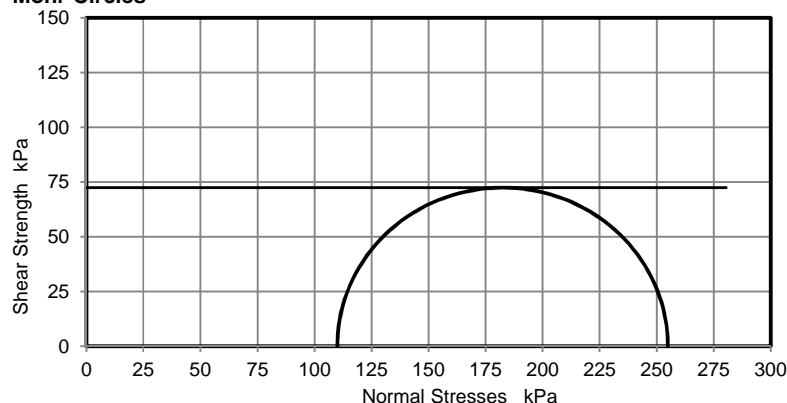
Deviator Stress v Axial Strain

Rate of Strain	1.90 %/min
Cell Pressure	110 kPa
Axial Strain at failure	13.0 %
Deviator Stress, $(\sigma_1 - \sigma_3)_f$	145 kPa
Undrained Shear Strength, c_u	72 kPa $\frac{1}{2}(\sigma_1 - \sigma_3)_f$
Mode of Failure	Brittle
Membrane thickness	0.27 mm
