PROPOSED SITE PLAN

Project	NO. 4 ETON VILLAS • LONDON • NW3 4SX
Drawing Title	PROPOSED SITE PLAN
Dwg No.	430 / 101
Scale	1:100 @ A3
Date	AUGUST 2018
Drawn by	RR

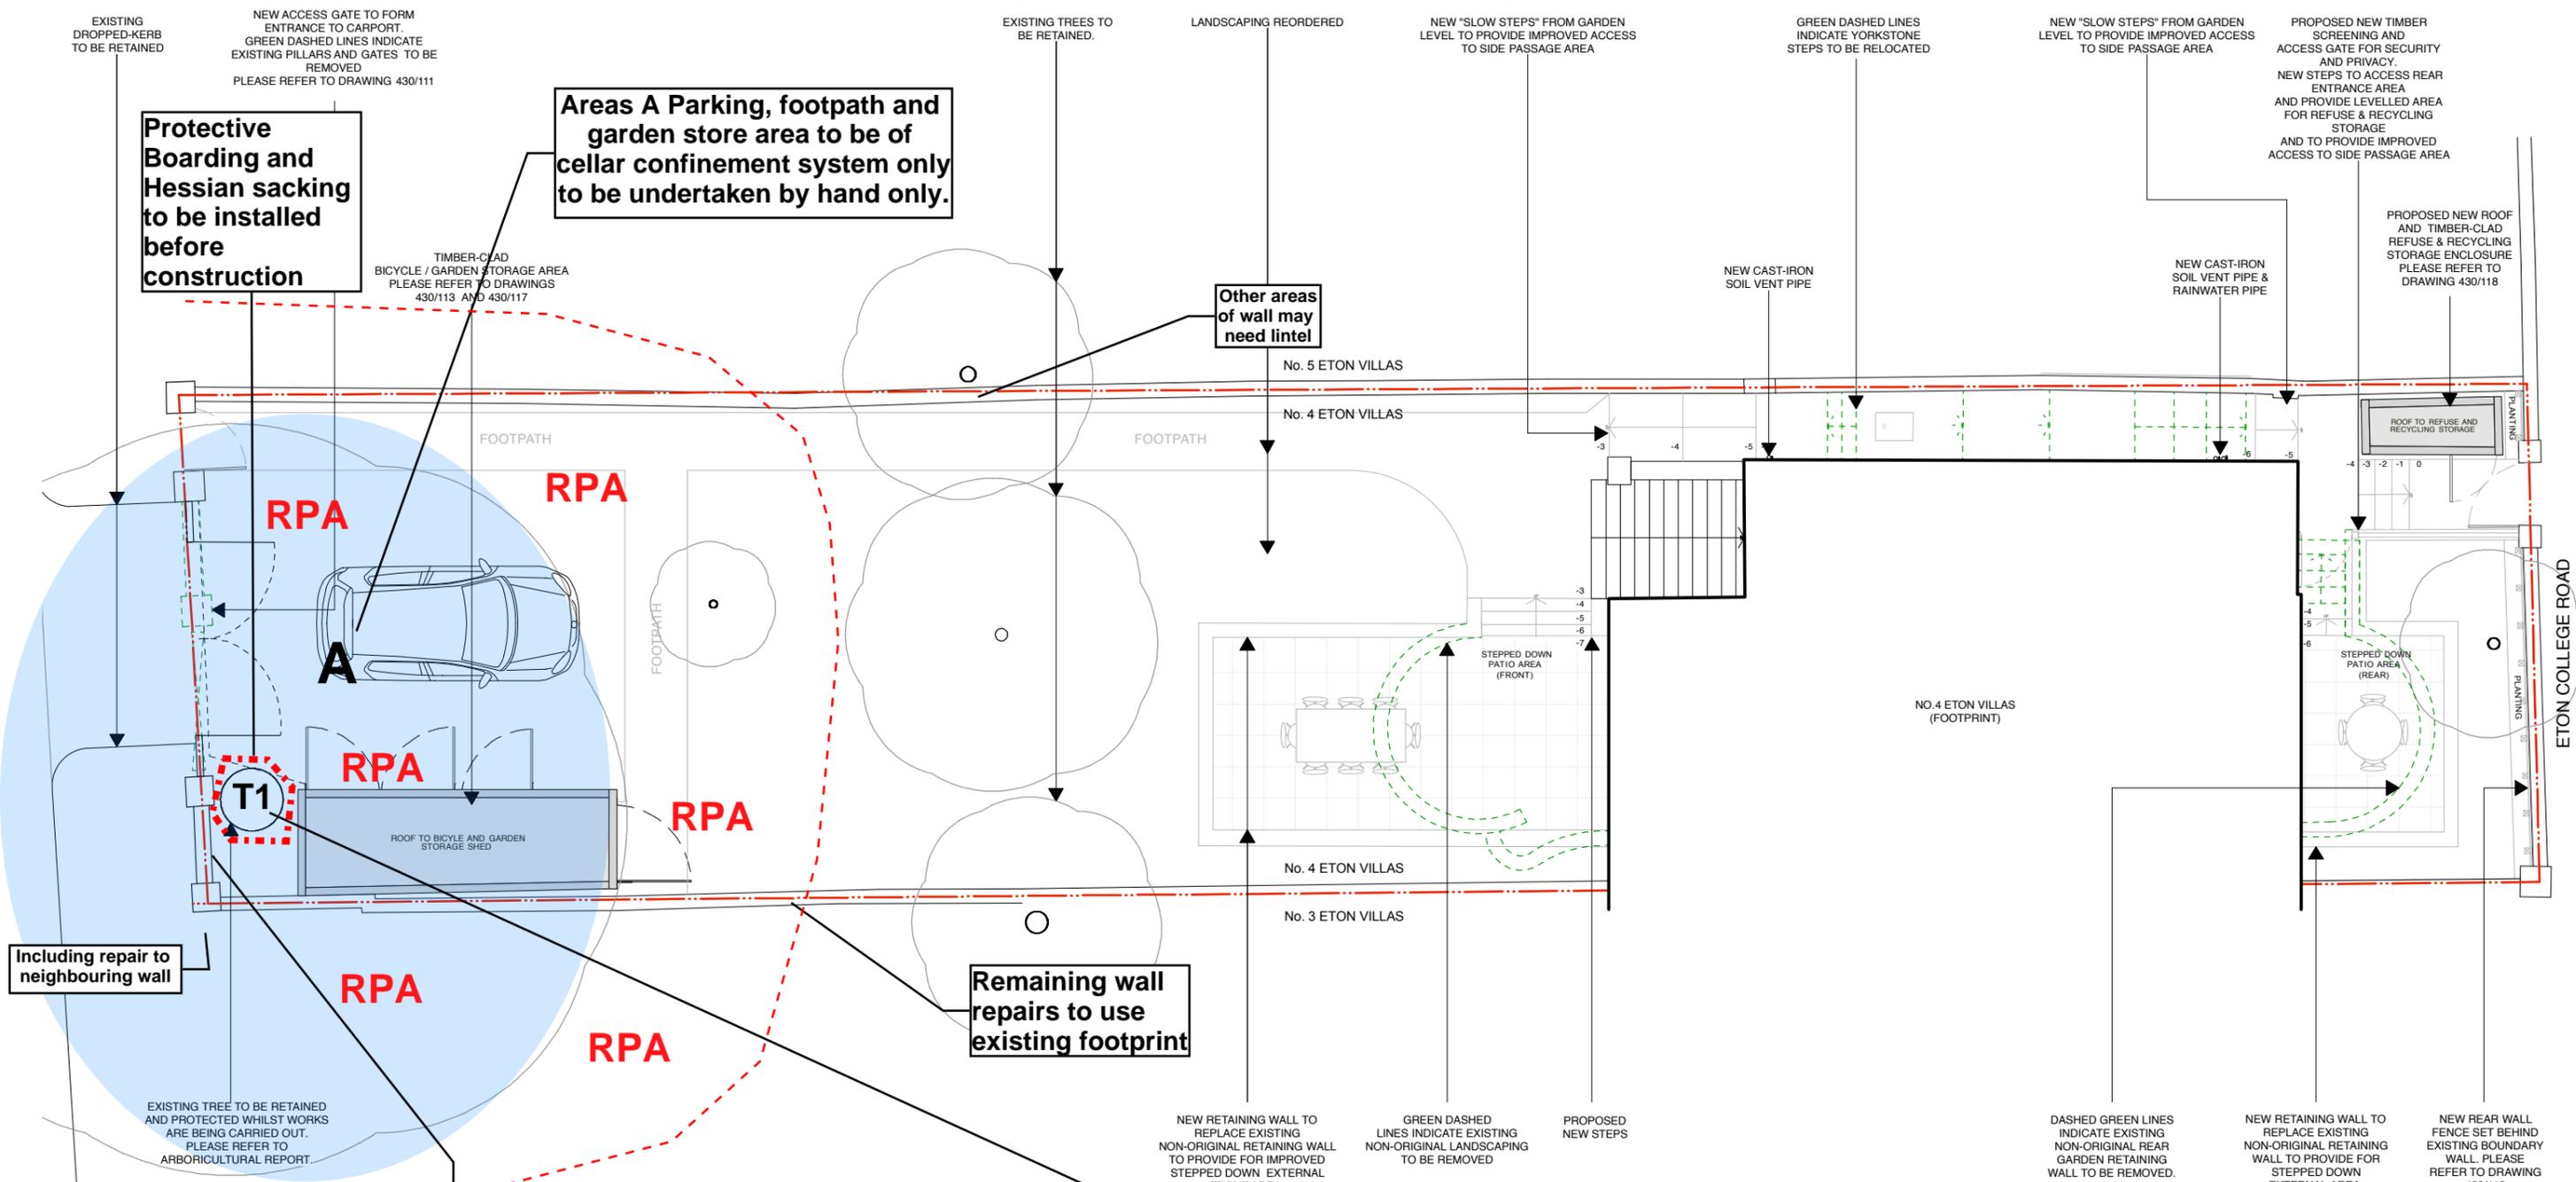
Protective Boarding and Hessian sacking to be installed before construction

Areas A Parking, footpath and garden store area to be of cellar confinement system only to be undertaken by hand only.

Other areas of wall may need lintel

Remaining wall repairs to use existing footprint

Including repair to neighbouring wall

1.5 Following demolition of the wall arboricultural inspection of the footing should undertaken to identify requirements needed minimise root loss. In particular the areas near the main root buttresses. These areas will require 'lintels' to bridge roots larger than 50mm leaving a gap for future growth. Foundation installation may require amendment once the existing wall foundation has been excavated and inspected. (within 3m of trunk)

- Tree Number: T1
- Species: Horse Chestnut (*Aesculus hippocastanum*)
- Height: 20m>
- Stem diameter: 1000mm
- Crown spreads: N7m E7m S7m W7m
- Clearance: 4m>
- Root Protection Radius: 12m
- RPA m2 = 482
- Age Class: Very Mature
- Physiological Condition: Normal, Root and buttresses directly pushing up wall and pillars (direct damage).
- Structural Condition: Normal, old pollard in the past, extensive crown.
- Estimate Life expectancy: 50>
- BS5837 Category: B

Recommendation: Specimen B category protection required. As detailed in TPP. Remedial pruning
