Oakwood International Investment
Corporation

**Land to the Rear of 222
Euston Road**
Basement Impact Assessment

October, 2018

Reference	CG/28583	Revision	0	Issue Date	October 2018

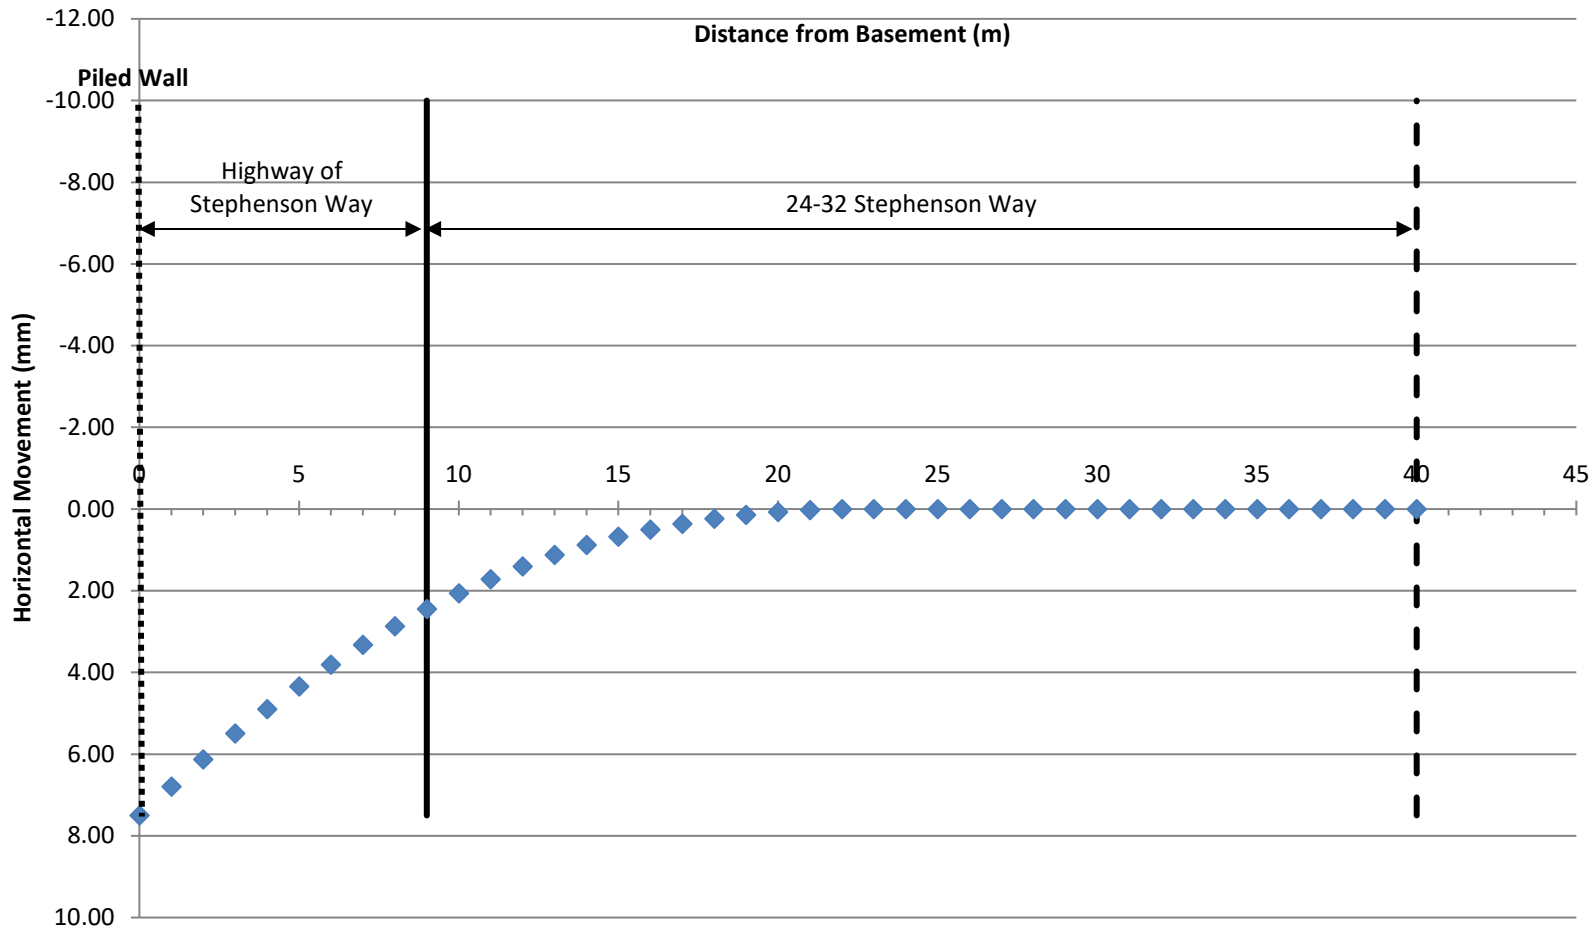
Title
**Horizontal Ground Movements
(Critical Section 1: 24-32 Stephenson Way)**

Figure 9 to Figure 16 show the combined vertical and horizontal ground movement profiles across each of the critical sections and their respective damage categories are summarised in Table 10.

Critical Section	Horizontal Movement (mm)	Vertical Deflection (mm)	Horizontal Strain ϵ_h (%)	Deflection ratio Δ/L (%)	Damage category	Corresponding Figures
Critical Section 1: 24-32 Stephenson Way	2.45	0.3	0.008	0.001	Category 0 ('negligible')	Figure 9 & Figure 10
Critical Section 2: 210 Euston Road	0.15	4.0	0.0004	0.012	Category 0 ('negligible')	Figure 11 & Figure 12
Critical Section 3: 222 Euston Road	2.52	0.5	0.015	0.003	Category 0 ('negligible')	Figure 13 & Figure 14
Critical Section 4: 152 to 156 North Gower Street	5.57	0.5	0.039	0.004	Category 0 ('negligible')	Figure 15 & Figure 16

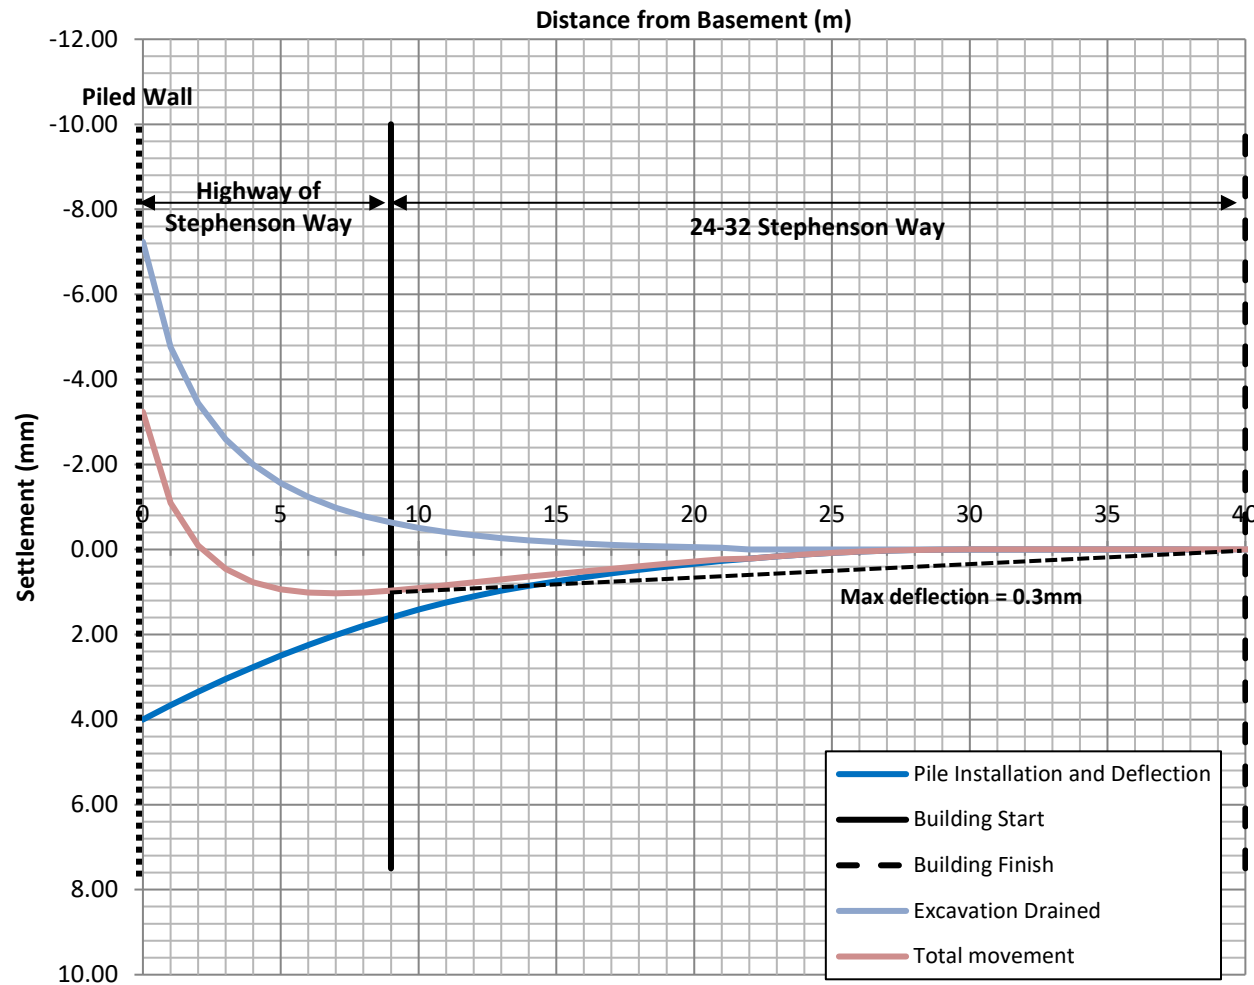
Figure 10

Title
**Vertical Ground Movements
(Critical Section 1: 24-32 Stephenson Way)**

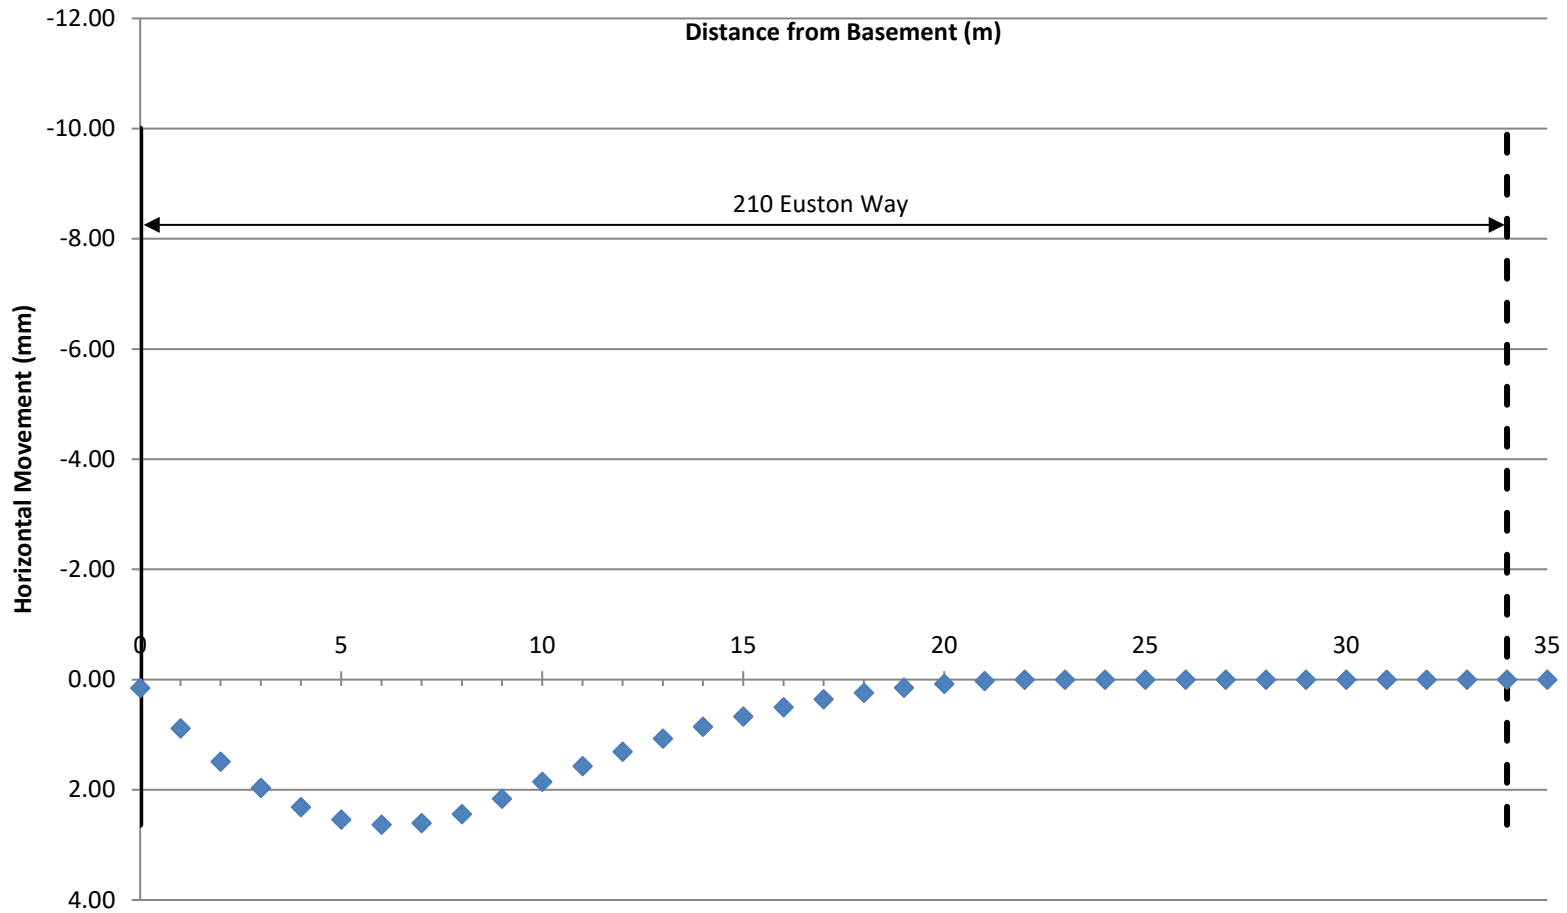
Figure 11

Title
**Horizontal Ground Movements
(Critical Section 2: 210 Euston Way)**

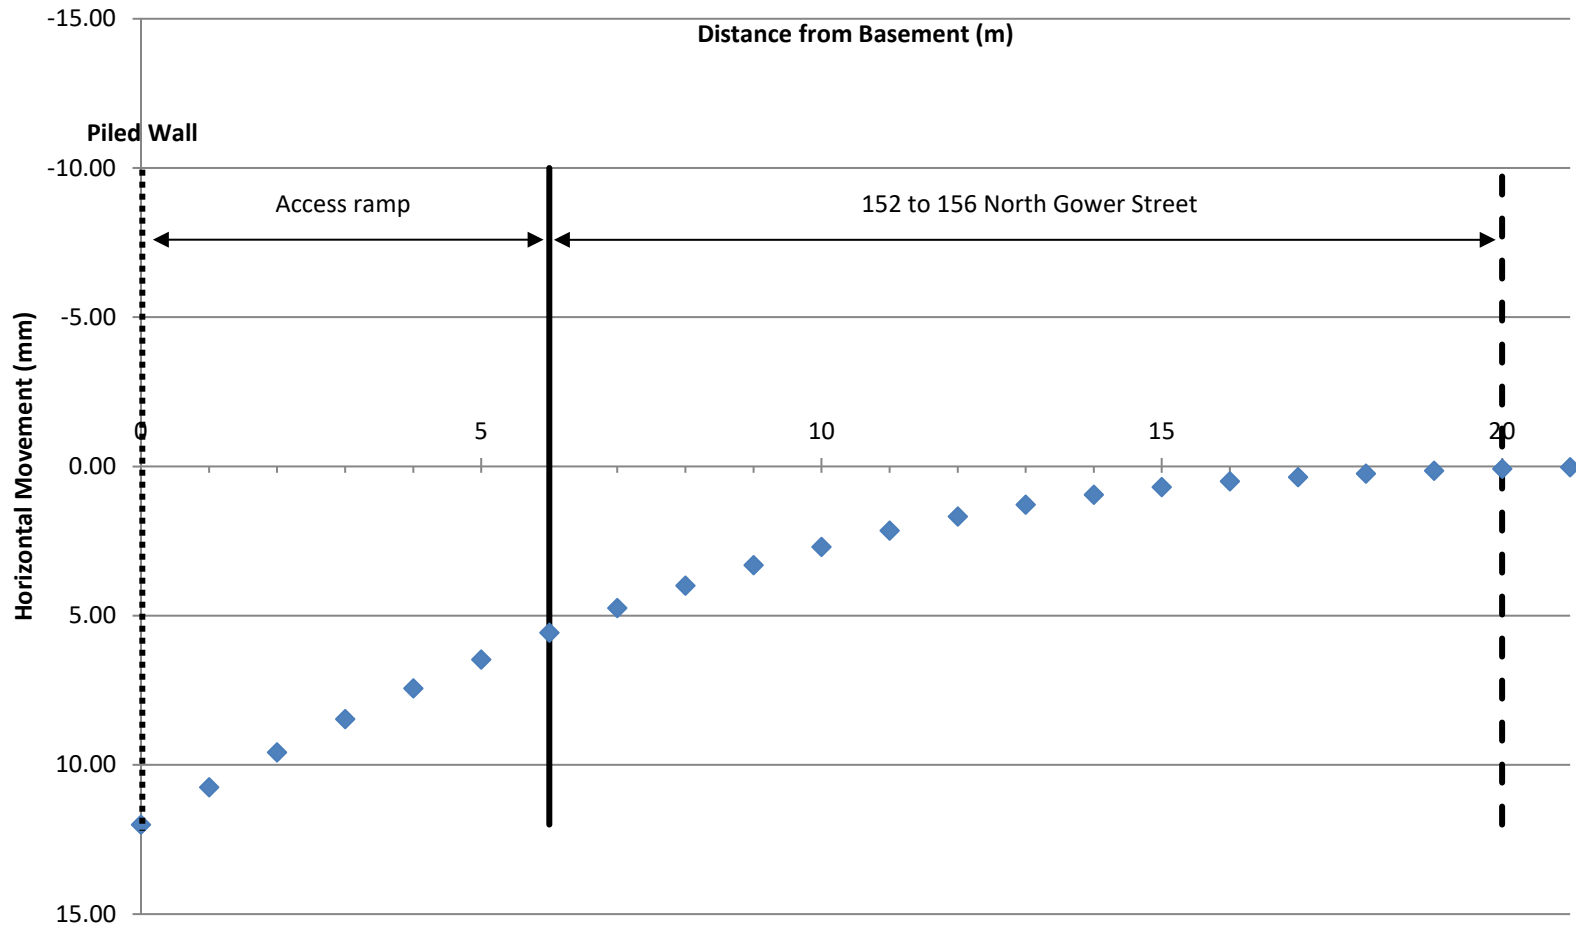
Figure 15

Title
**Horizontal Ground Movements
(Critical Section 4: 152 to 156 North Gower Street)**

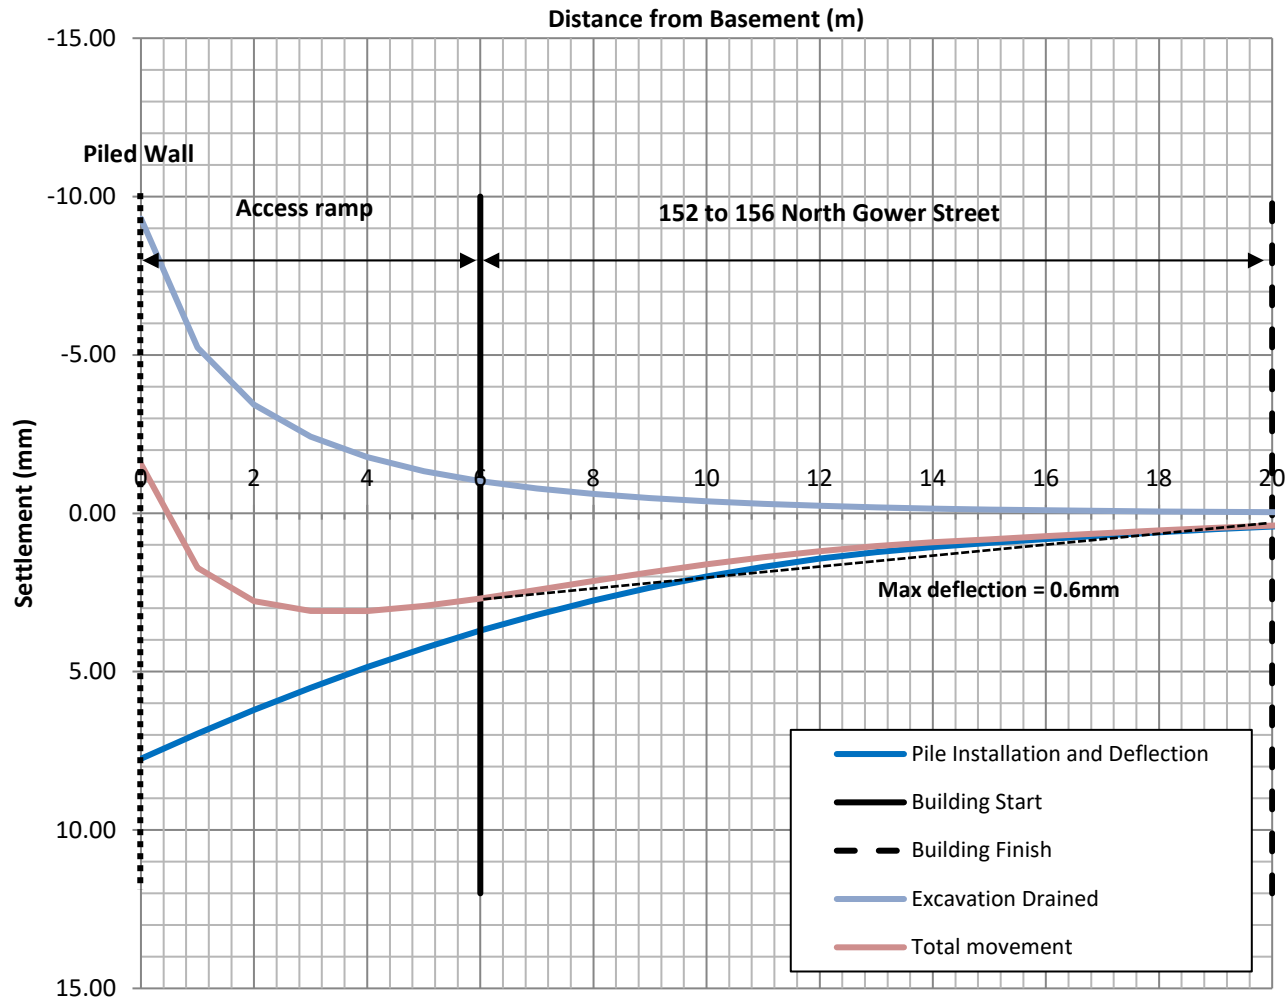
Figure 16

Title
**Vertical Ground Movements
(Critical Section 4: 152 to 156 North Gower Street)**
