OMC Associates

BSi 5837 Report for Development

SITE: Flat 2 – 92 Greencroft Gardens, London NW6
3PH

DATE OF REPORT: 30th April 2018

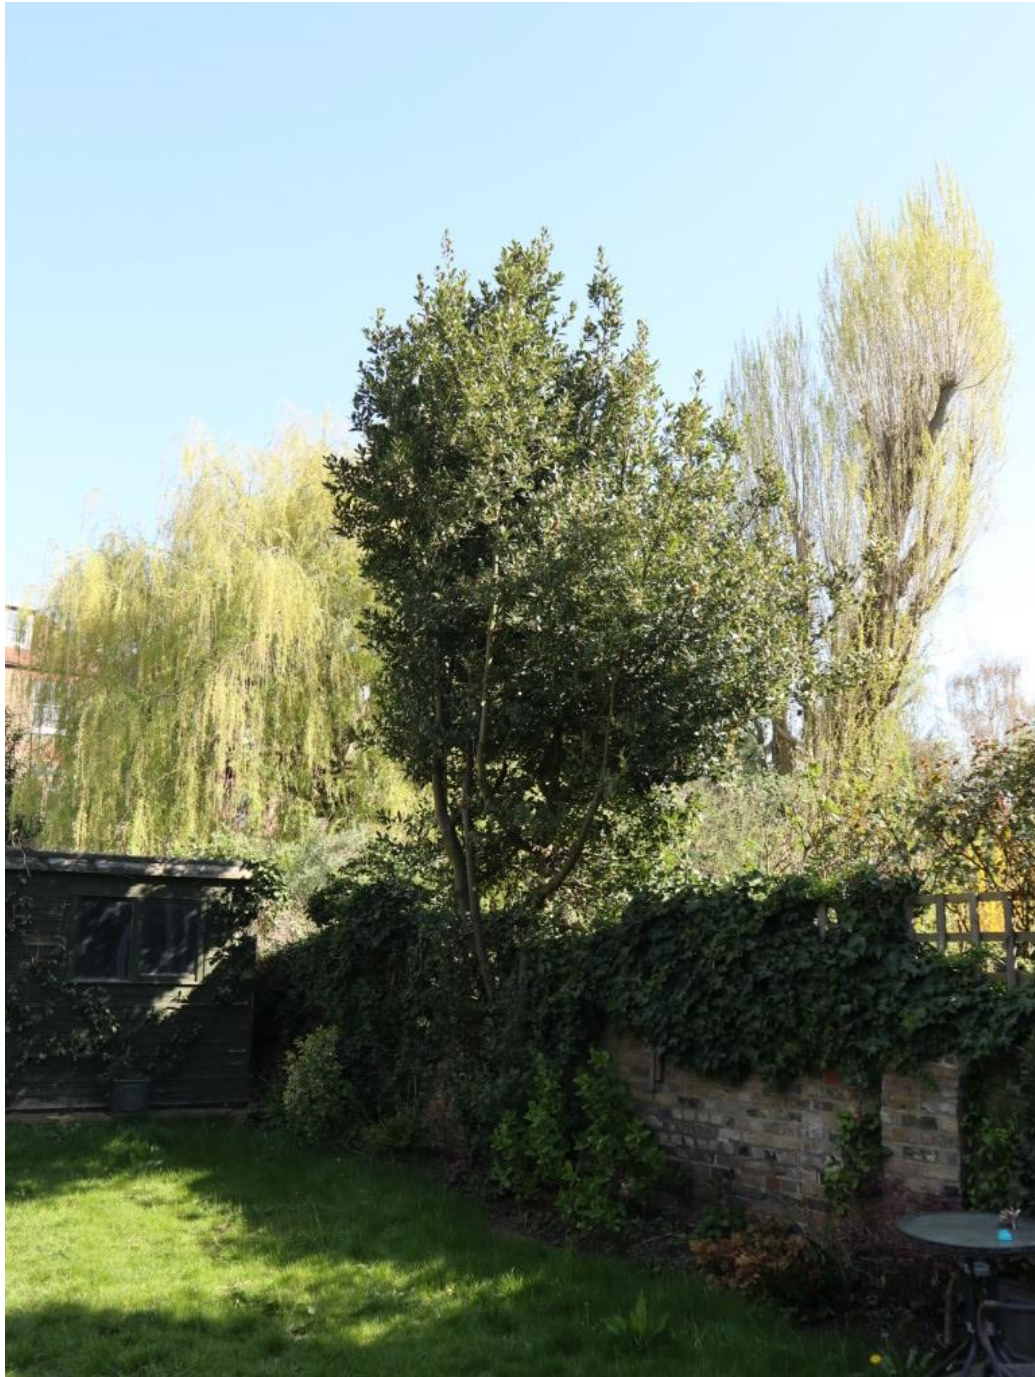
Above: T1

One single tree exists within the property's garden (T1), a mature bay laurel of fair overall condition.

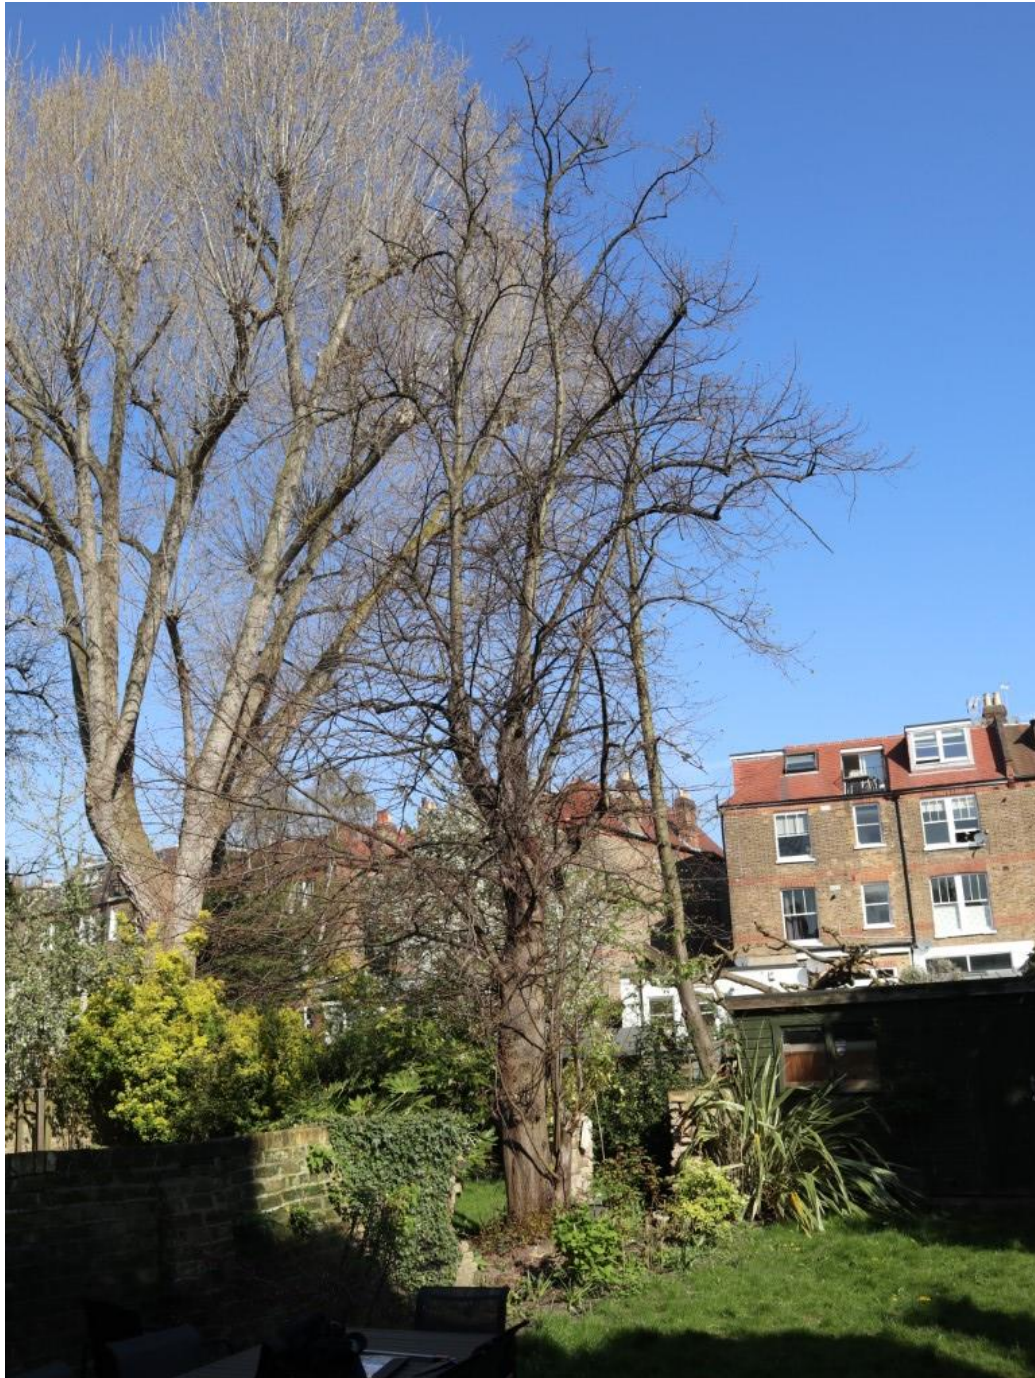
Above: T2 (foreground) and T3 (behind)

Two lime trees (T2 and T3) are located close to the property's southern boundary in the neighbouring garden (no. 90 Greencroft Gardens). T3 is maturing regrowth from a historically removed tree, the degraded stump of which is still present.

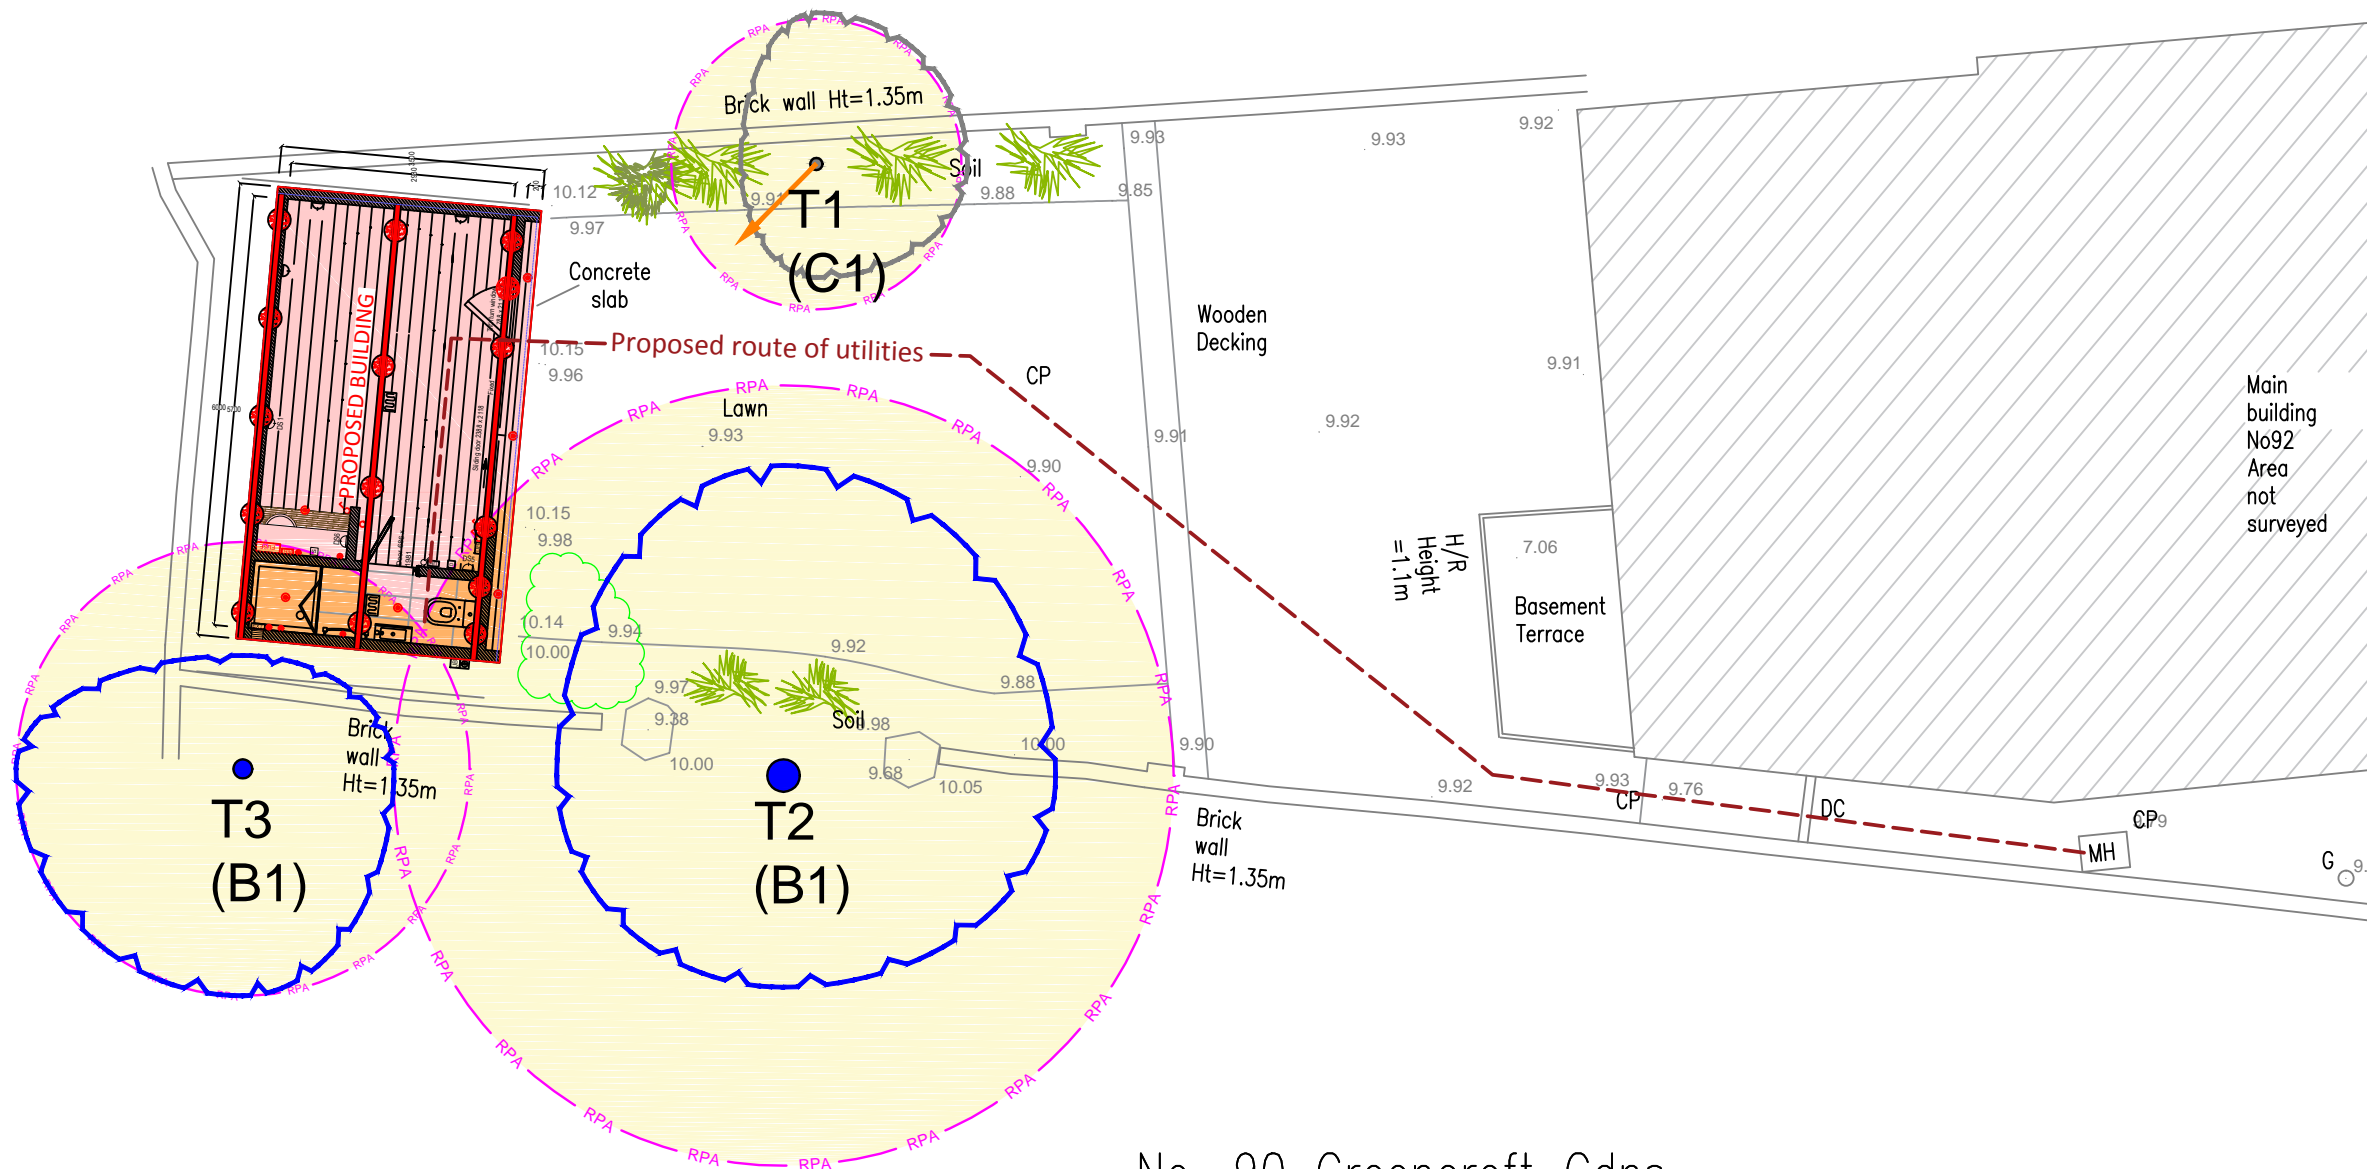
Title Tree Constraints Plan	
Client Adam & Manda Greenblatt	
Project Flat 2 -92 Greencroft Gdns, London NW6 3PH	
Date April 2018	Drawn by CS
Project Ref. 1329_TCP	Scale 1:100 @ A3

Upon assessment, the site conditions will not have affected the trees' root spread. The trees' RPAs are illustrated within the Tree Constraints Plan at Appendix 2.

Appendix 2: A Tree Constraints Plan (TCP) indicating root protection areas (RPAs) of retained trees with the proposed scheme superimposed to indicate location and extent of encroachment;

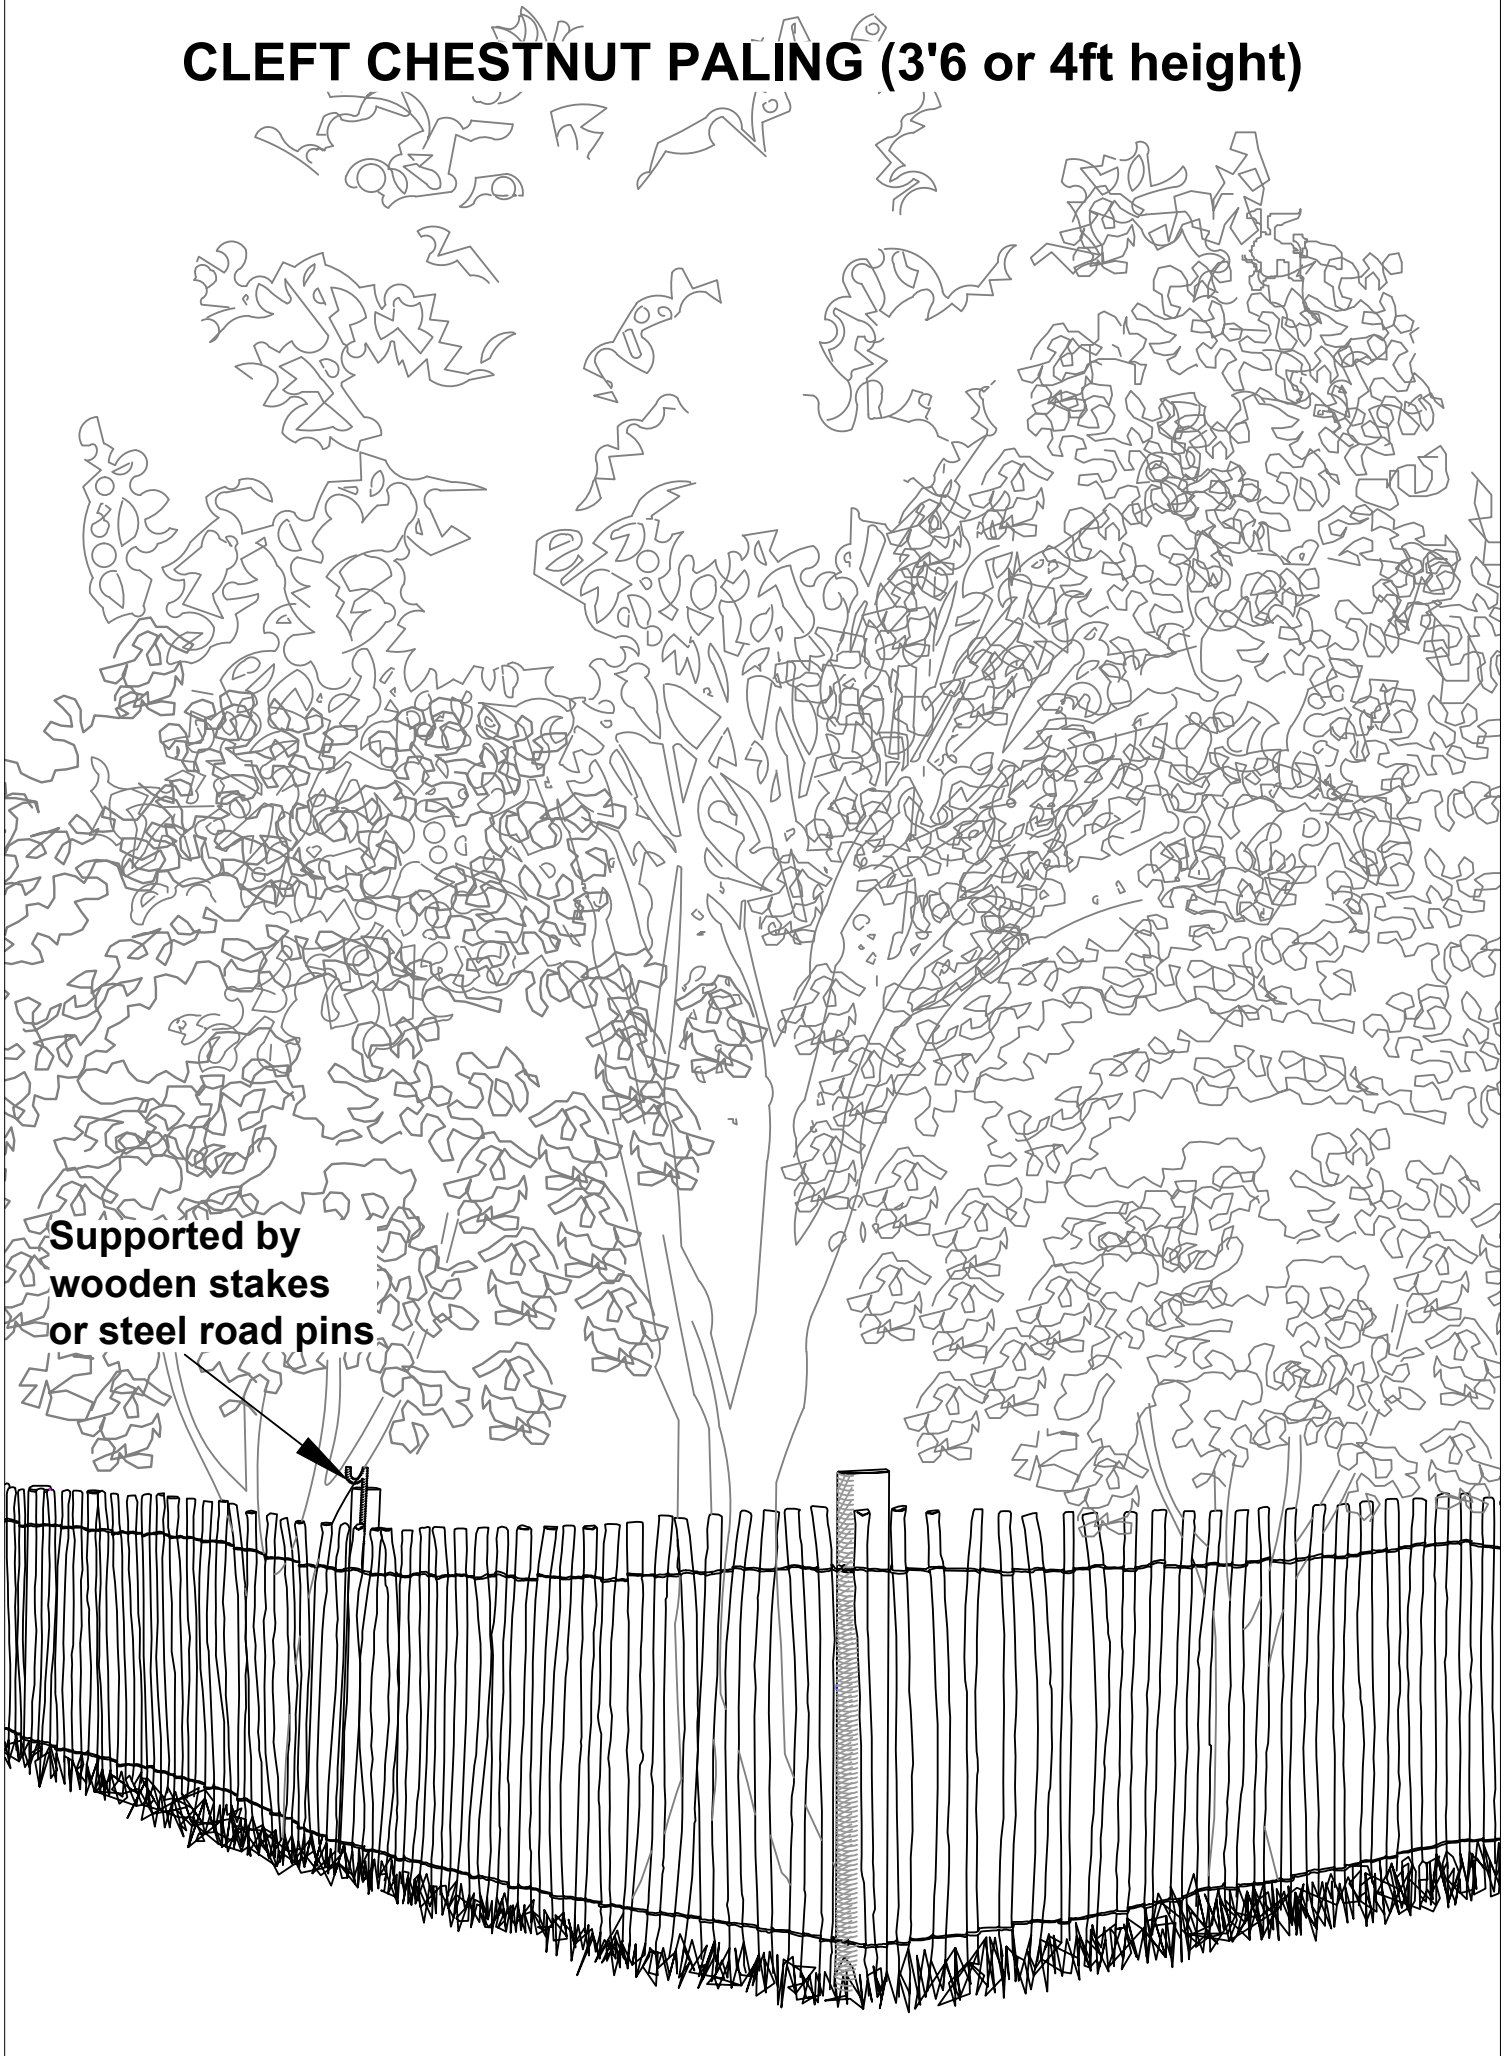
Appendix 4 Specification for Protective Fencing (chestnut paling)

CLEFT CHESTNUT PALING (3'6 or 4ft height)

**Supported by
wooden stakes
or steel road pins**

All damage types can be avoided through the establishment of Construction Exclusion Zones (CEZ) with the use of protective barriers; all protection measures must be fit for purpose. The default protective barrier specification within BS 5837:2012 is weld mesh (Heras)-type panels secured firmly to a scaffold framework (scaffold clamps are recommended) and braced with diagonal stabilizer struts. Heras-type panels mounted on rubber feet and diagonal stabilizer struts is also acceptable, secured to the ground with metal pins.

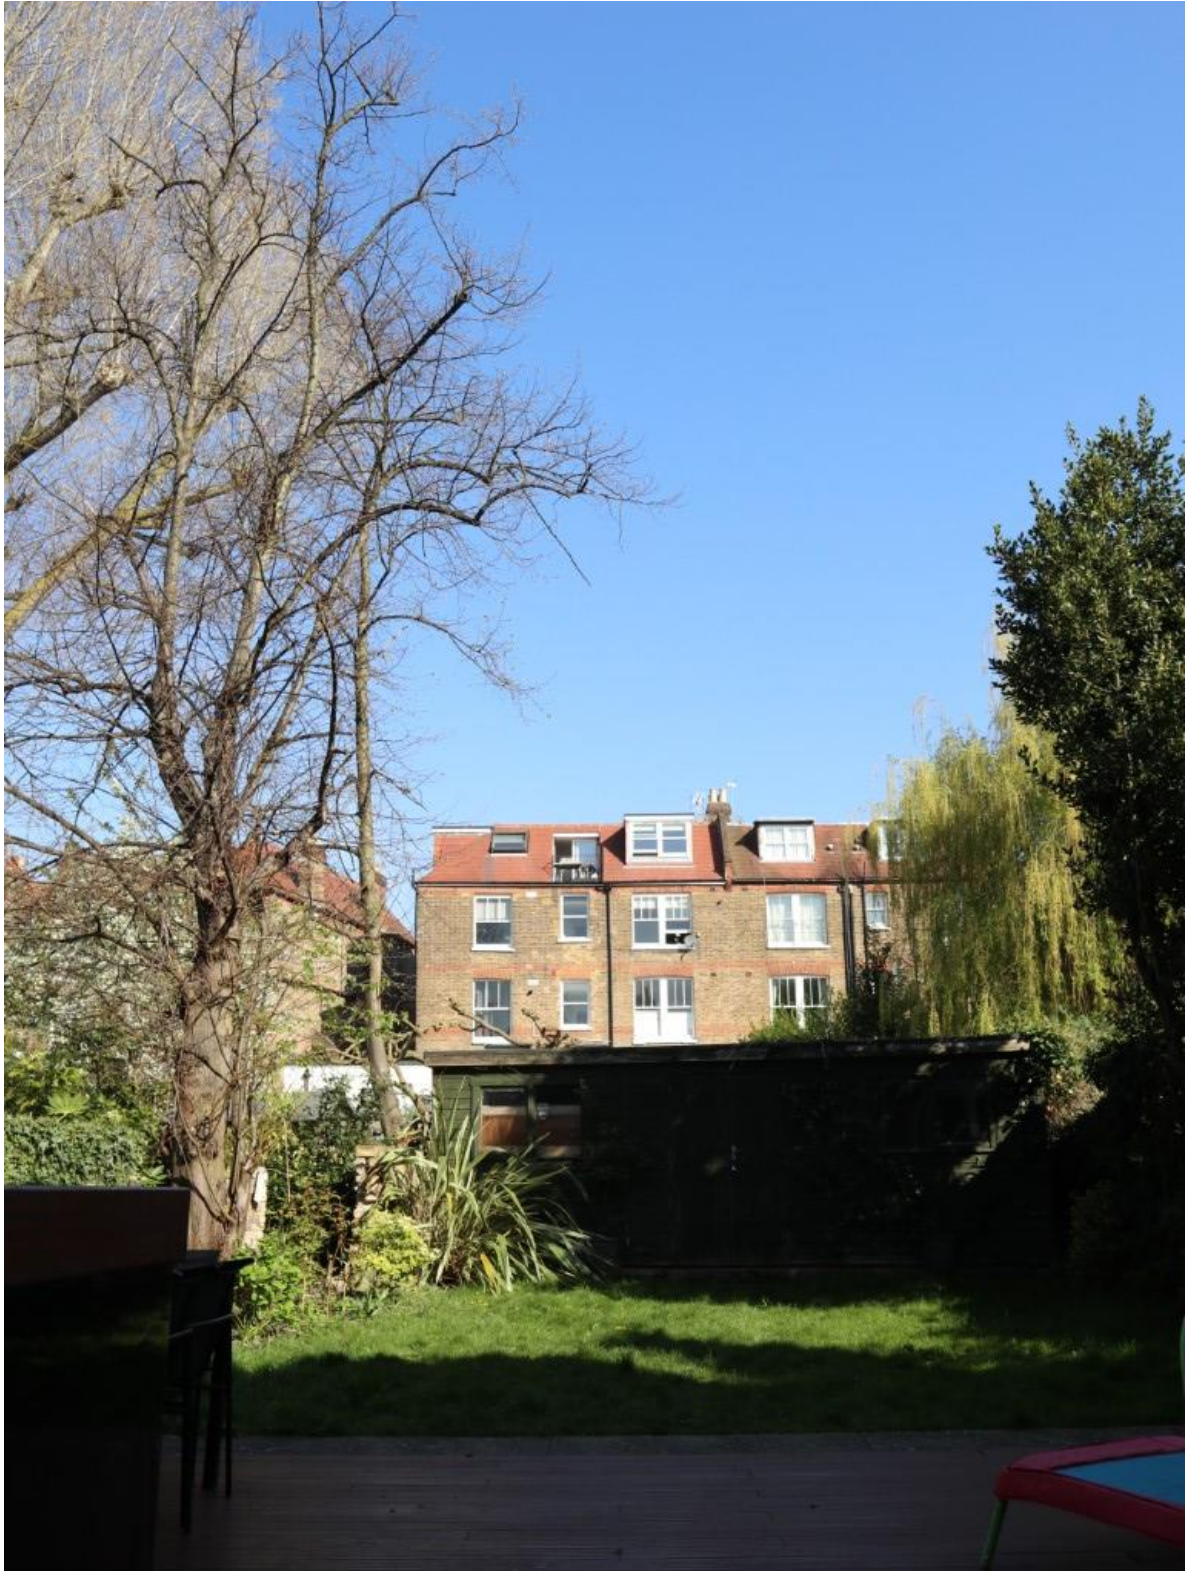
Above: Area where building will be constructed, currently occupied by a large shed. T2 and T3 are to the left.

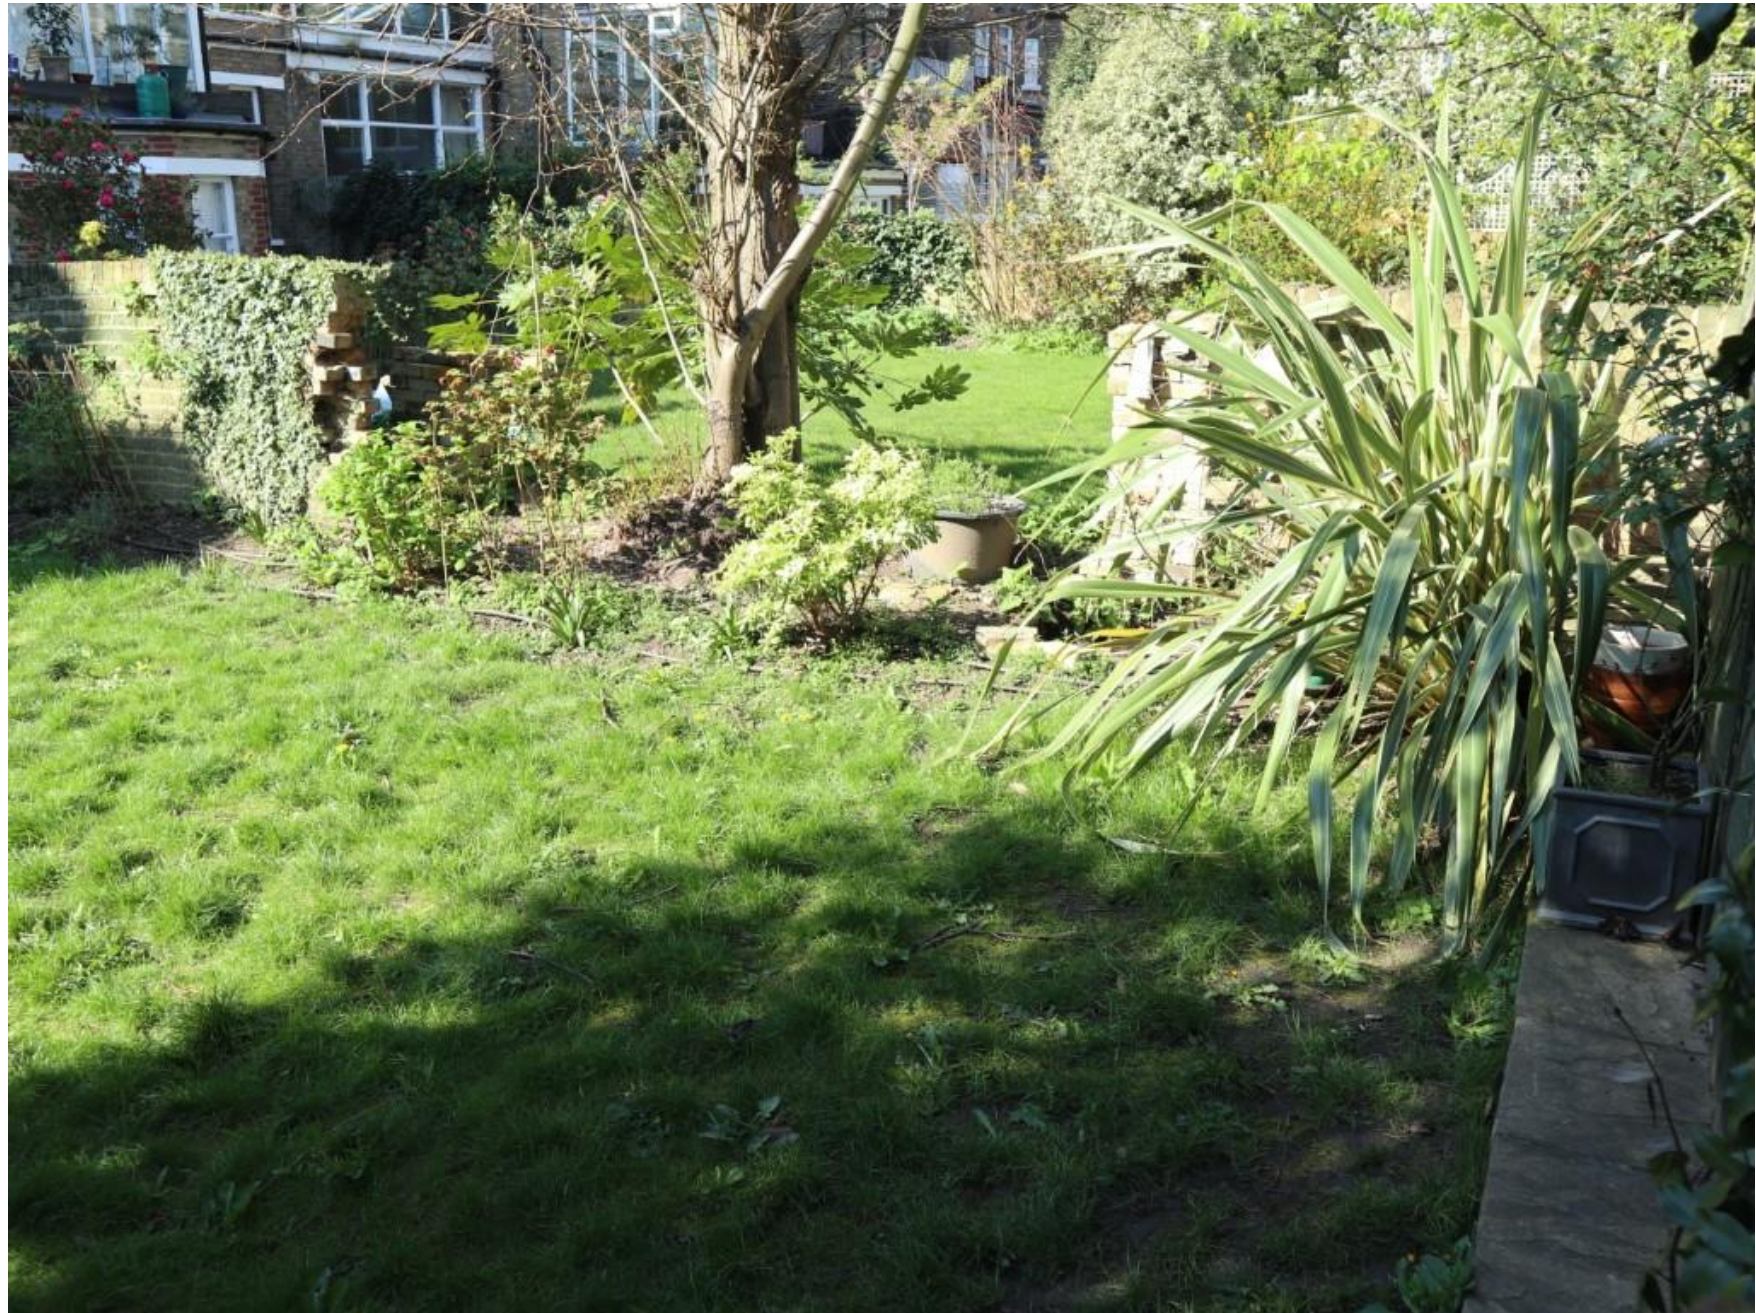
Above: southern boundary where proposed service trench will be excavated
