# <sub>Job Name</sub> High Holborn Estate 18-21 Hand Court

Drawing Title Proposed Section A-A

This report summarises the findings of the trial pit inspection carried out by HTS on 27/04/17. Please see appended location plan for trial pit locations.

# 18-21 Hand Court, High Holborn Estate, Holborn, London

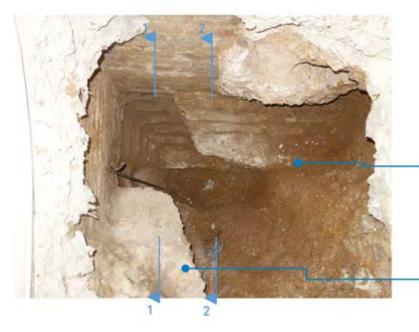
#### Trial Pit 1 - 18-21 Hand Court/Caroline House Party Wall

The contractor has exposed the interface between the party wall and the strip footings below.

The top of the strip footing was found approximately 1560mm below floor level and it is approximately 880mm deep. The base of the footing tapers, with the depth increasing towards the wall. Maximum depth is unknown.

The lower strip footing was found to extrude approximately 370mm from the party wall. This was measured on the 18-21 Hand Court side of the wall only.

The top of the upper footing was found at 1280mm below SSL. The footing is approximately 160mm deep at its thinnest. This increases to 280mm where it joins the lower strip.

No footing was found below the retaining wall.

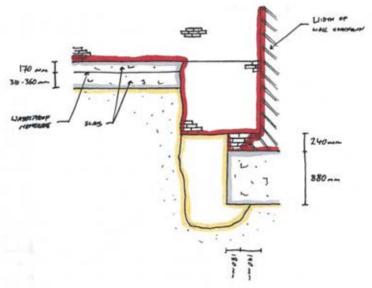
Section 2-2

No water was found within the pit suggesting that the wall is founded above the water table.

- 170mm concrete (top)
- Waterproof membrane -
- 310-360mm concrete  $\sim$ (bottom)

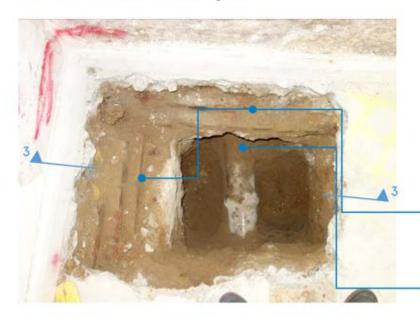
#### Trial Pit 2 - Hand Court Retaining Wall

The contractor has exposed the interface between 2 masonry piers and their footings along the Hand Court retaining wall within 18-21 Hand Court.

The top of the footing was found at approximately 330mm below floor level and it is approximately 600mm deep. The base of the footing tapers, increasing towards the wall. Maximum footing depth is unknown.

A similar depth footing was also found below the neighboring pier, but was not fully exposed.

No water was found within the pit suggesting that the piers are founded above the water table.

The top of the pipe is 910mm below floor level and it has an approximate diameter of 180mm.

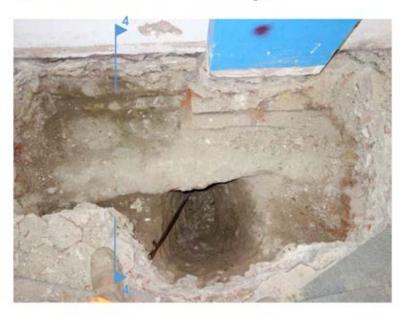
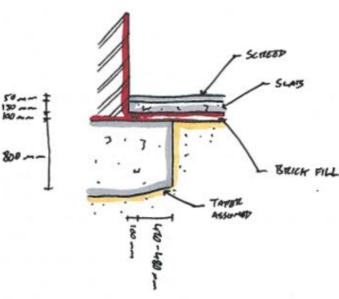
Section 4-4

The contractor has exposed the interface between the masonry wall, a masonry pier, and their footings along the retaining wall to the rear of 22-23 Hand Court.

The top of the footing was found 320mm below the top of the screed. and it is 800mm deep. The base of the footing tapers, increasing towards the wall. Maximum depth of footing is unknown.

The corbel extrudes 100mm from the wall with the foundation extruding a further 420-480mm. At the pier, the slab extrudes 240-290mm further than the corbels.

No water was found within the pit suggesting that the wall is founded above the water table.

- 50mm screed (top)
- -130-150mm concrete
- 100mm brick fill (bottom)

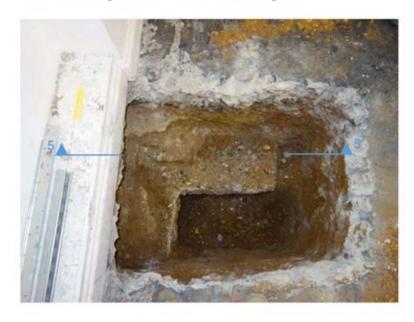
#### Trial Pit 4 - High Holborn House Retaining Wall

The contractor has exposed the interface between the masonry wall, a masonry pier, and their footings along the retaining wall to the rear of High Holborn House.

The footing is a strip foundation which is assumed to run along the length of the wall. The footing extends away from the wall in the pier location. The width of this extension could not be found due to access constraints. We assume that the pier is located centrally above the footing.

The top of the footing was found 515mm below the top of the screed, and it is 320mm deep. The base of the footing tapers, increasing towards the wall. Maximum depth is unknown.

The corbel extrudes 240mm from the wall with the foundation extruding a further 150mm. At the pier, the slab extrudes 500mm beyond the corbels.

No water was found within the pit suggesting that the wall is founded above the water table.

- 25mm screed (top)
- 100mm concrete (bottom)

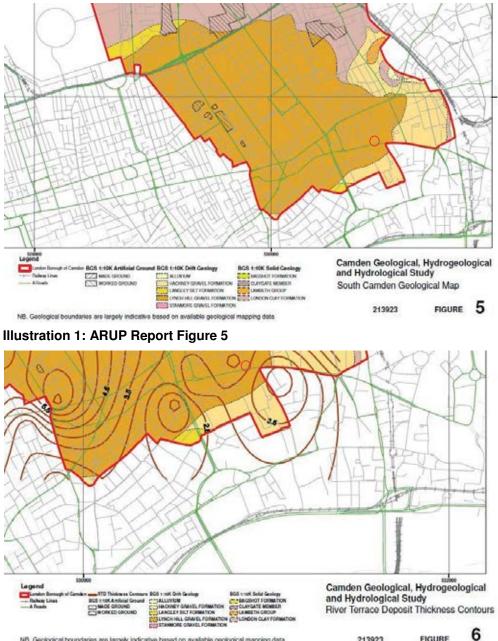
**Illustration 2: ARUP Report Figure 6**

NB. Geological boundaries are largely indicative based on available geological mapping data

A number of images such as Illustrations 1 and 2 below have been inserted into this report from the 'Camden Geological, Hydrogeological and Hydrological Study' produced for Camden by ARUP in November 2010. This report has been referenced and any pertinent figures reproduced and included and where relevant these figures have been discussed during the screening and scoping stages.

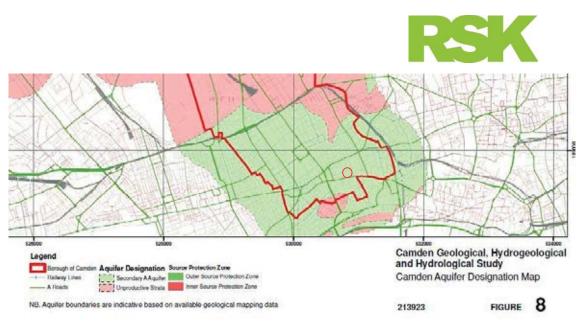
#### **Illustration 3: ARUP Report Figure 7**

Confined by the London Clay Formation is a deep aquifer, comprising a sequence of deposits consisting of the lower part of the Lambeth Group and Thanet Sands (Basal Sands) and the White Chalk. These units are expected to be in hydraulic continuity.

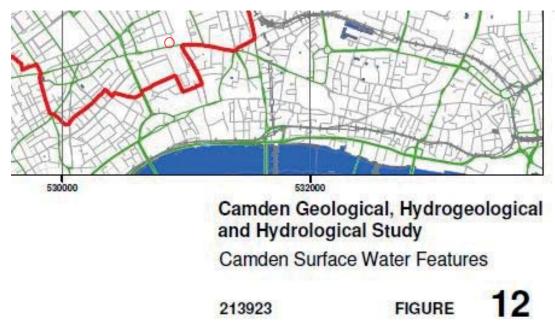
#### **Illustration 4: ARUP Report Figure 12**

The base flow of the River Thames is likely to be recharged by groundwater in the shallow aquifer in the site area. A linkage between the river and any ground or groundwater contamination beneath the site may therefore exist.

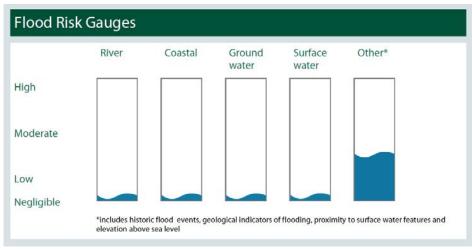
#### **Illustration 8: Flooding potential findings**

The flooding records held by Thames Water and included within Appendix F indicate that there have been no incidents of flooding in the requested area as a result of surcharging public sewers.

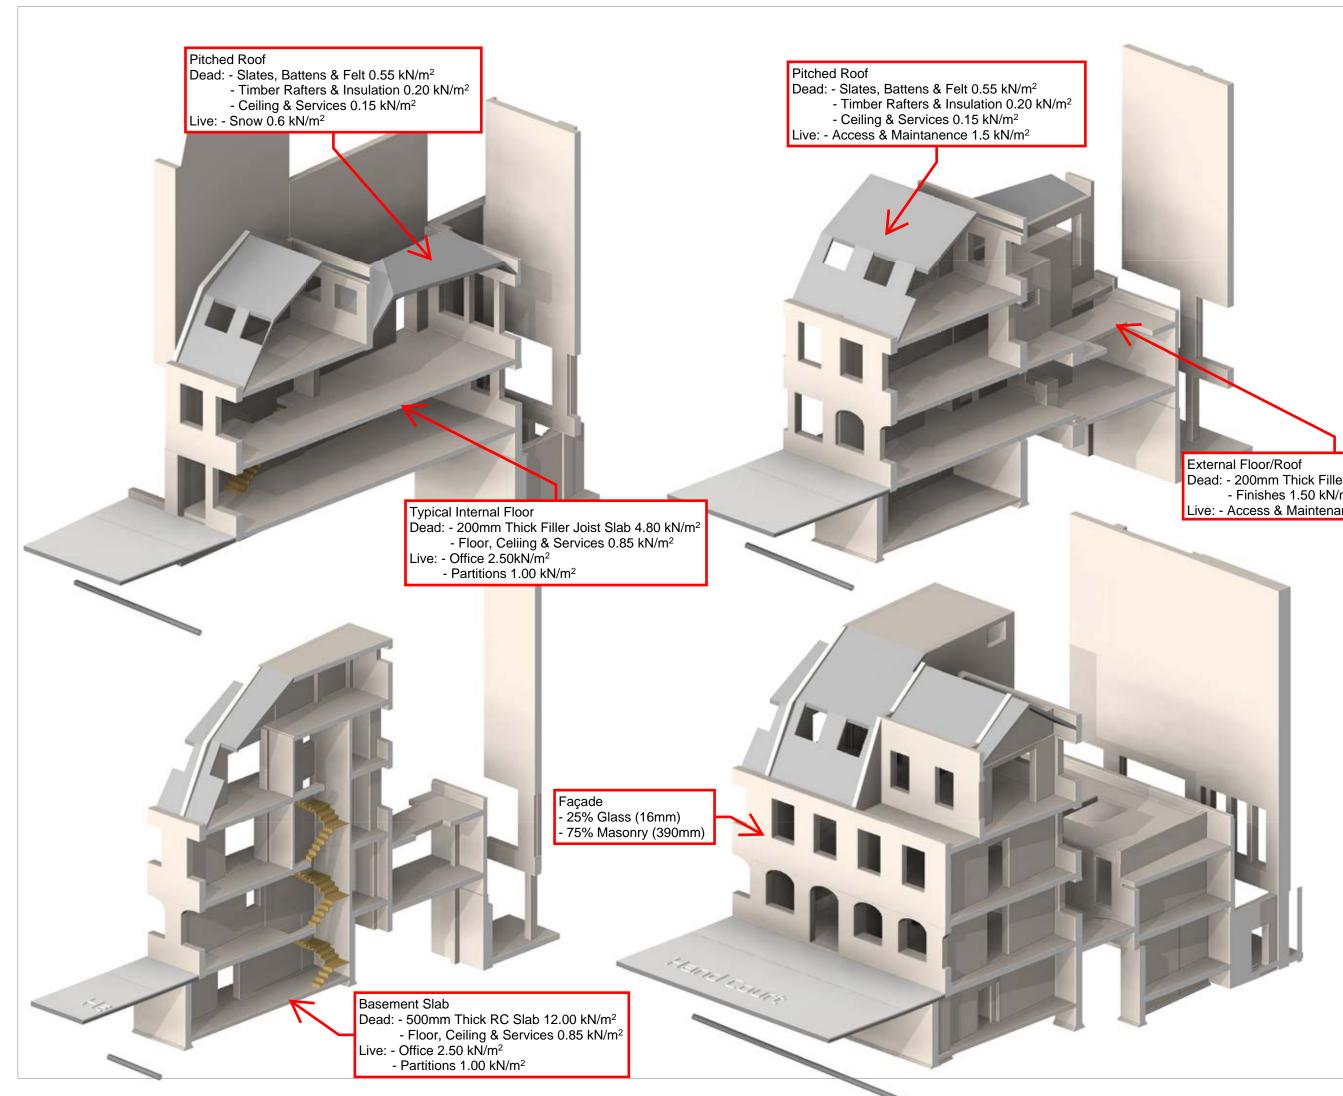
Drawing No 1508/HC/SK065 Rev P1

Basement slab thickness based on trial pit investigation.
