Ref: PJB8492/18253

UNIT 3, 86-88 DELANCEY STREET, NW1 7SA

Further to your instruction, Spectrum have investigated the acoustic issues associated with the above property and assessed the requirements of two noise-related planning conditions associated with the building. Our findings are described in this technical letter.

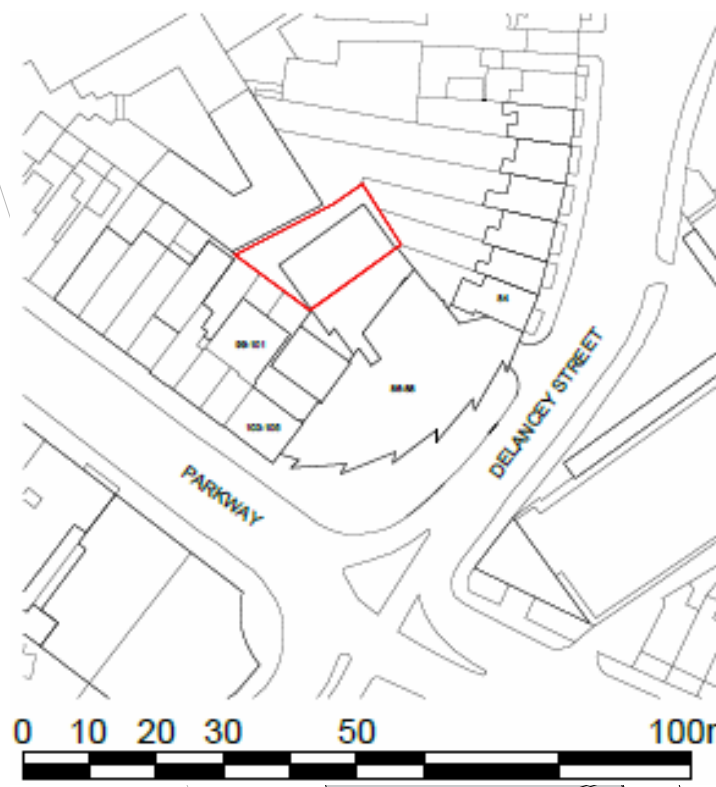
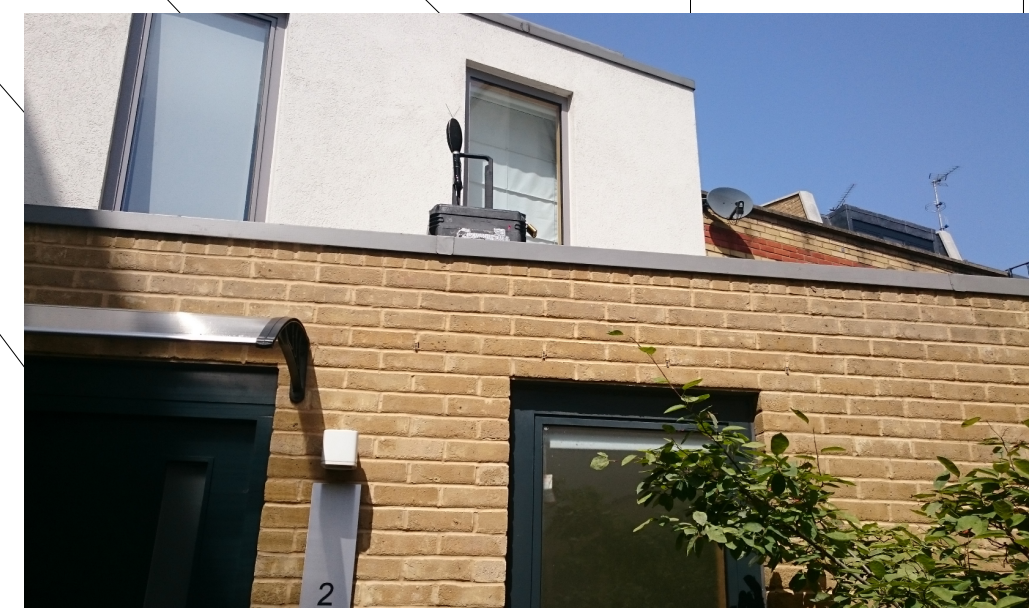
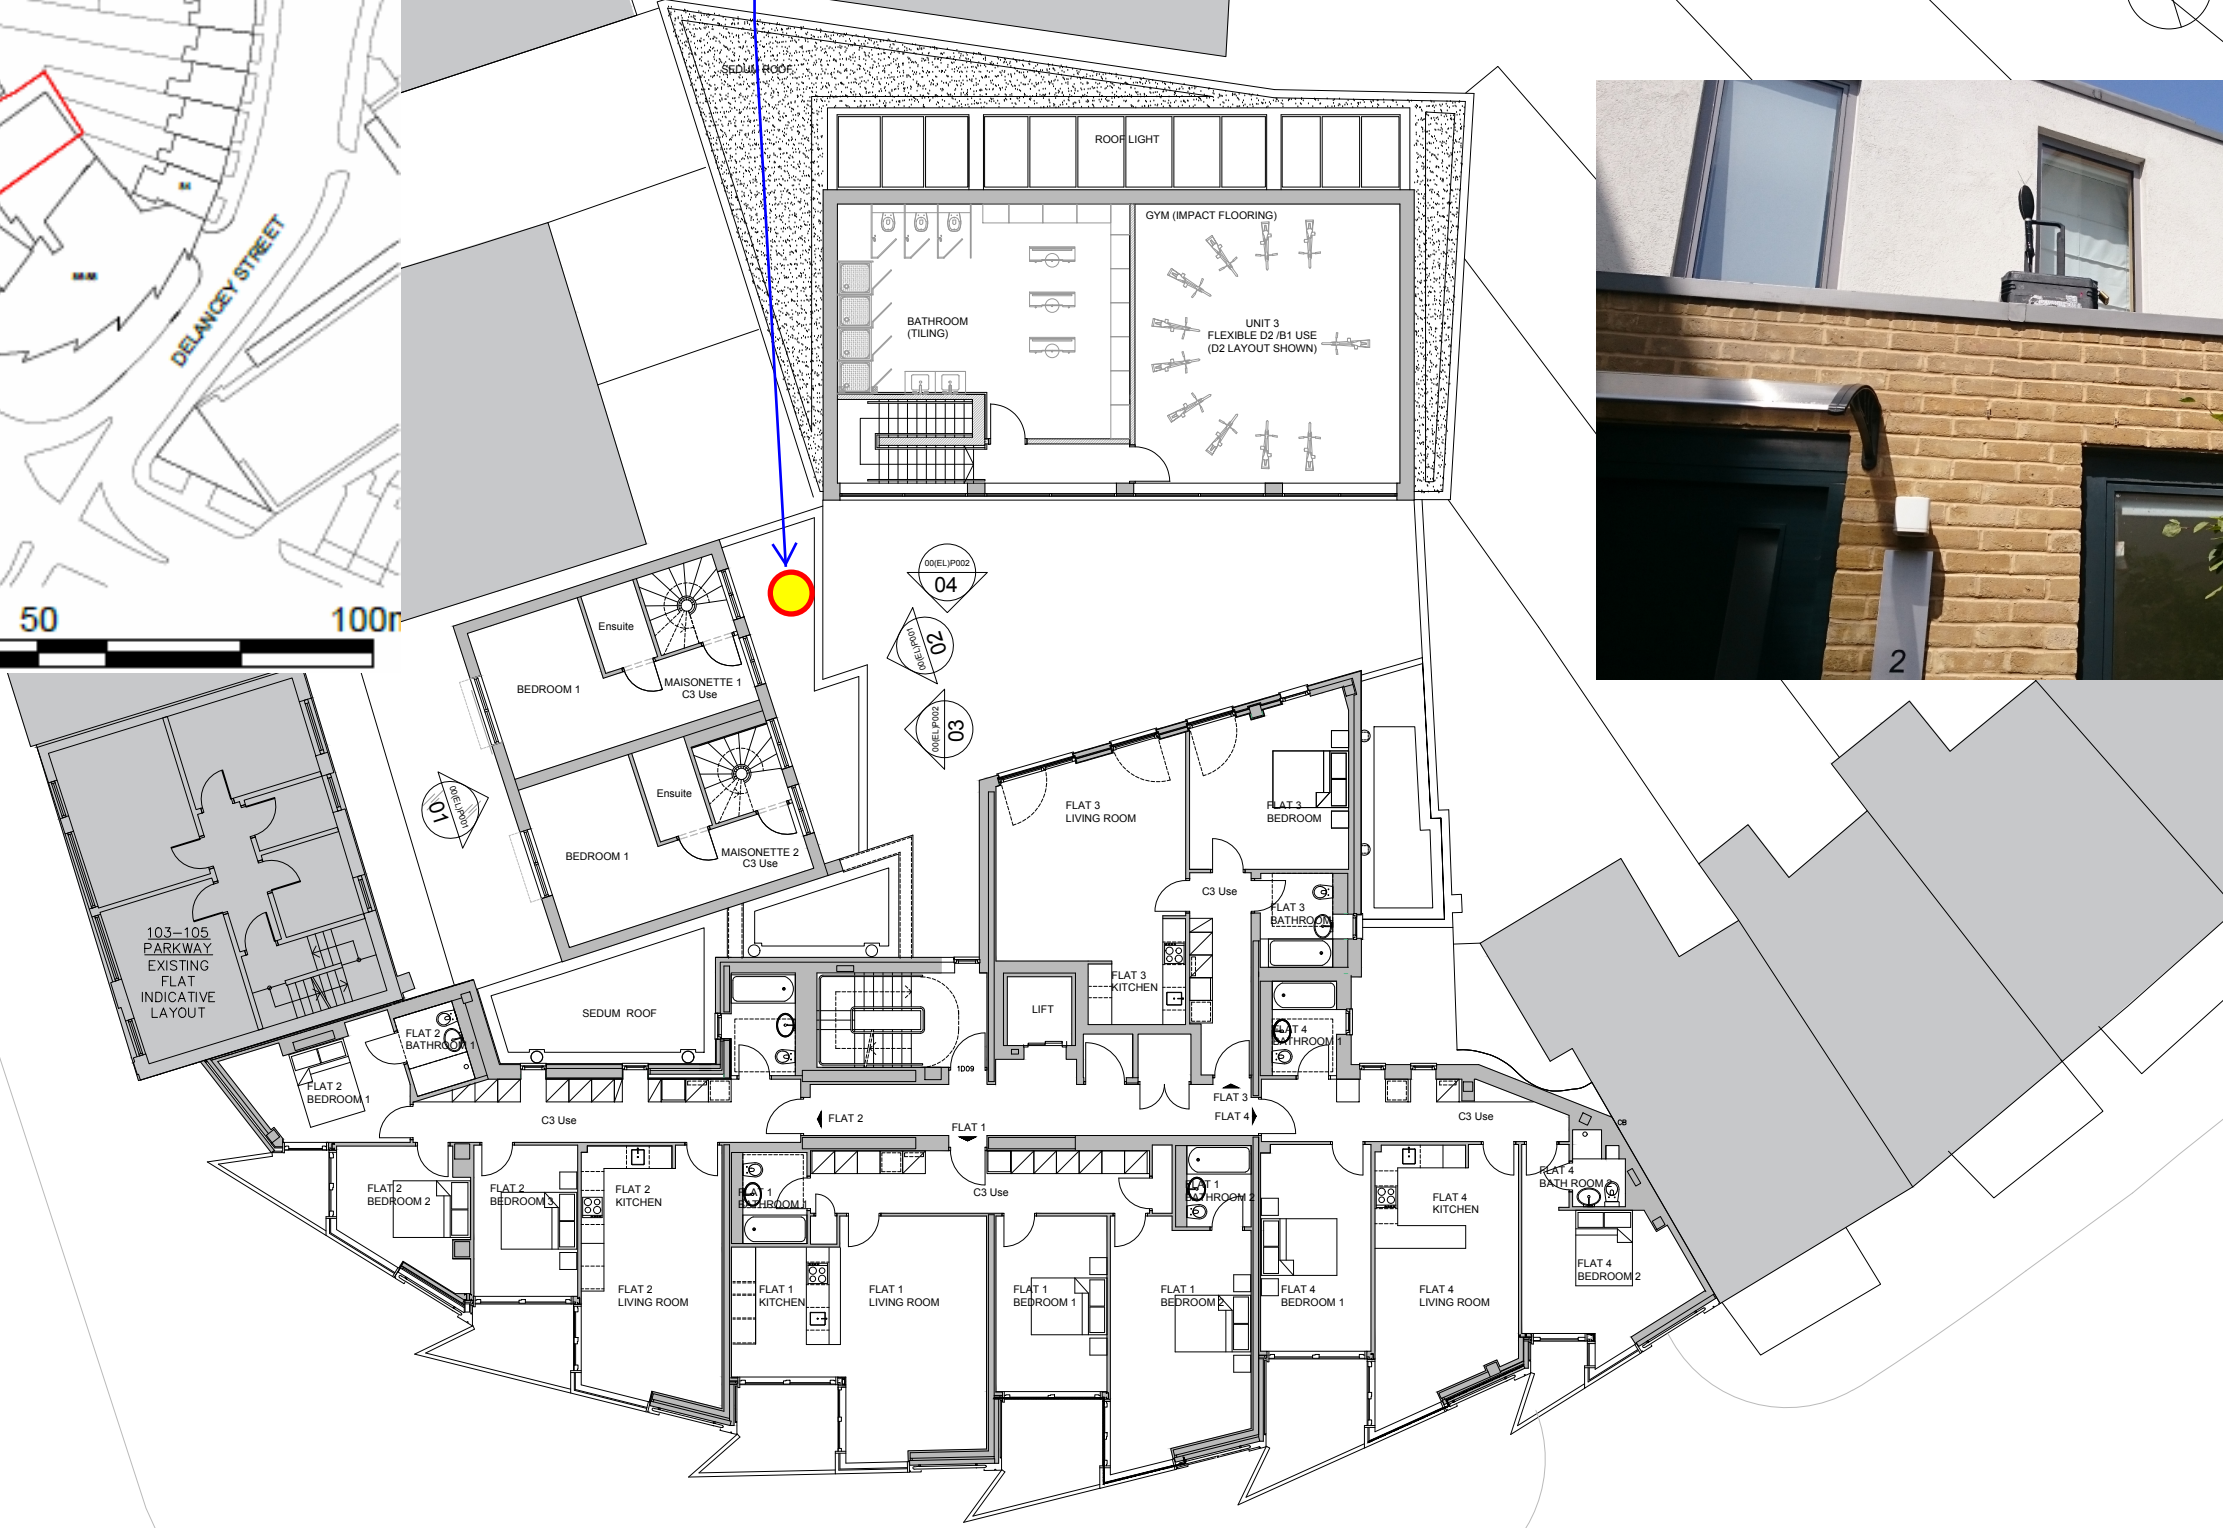
Attachment 1 - 1 page

Spectrum have conducted an ambient noise measurement survey at the subject site over the period 7th to 9th August, 2018. The survey consisted of long-term, unattended noise measurements at one location on site. A site location plan and photograph of the location are shown in Attachment 1.

The measurement location was within the rear courtyard area, on the small first floor flat roof in front of residential unit 2, between Unit 3 and the residence. This site was selected to obtain representative ambient noise data specifically of the prevailing levels that currently occur outside the residence.

Noise monitoring location

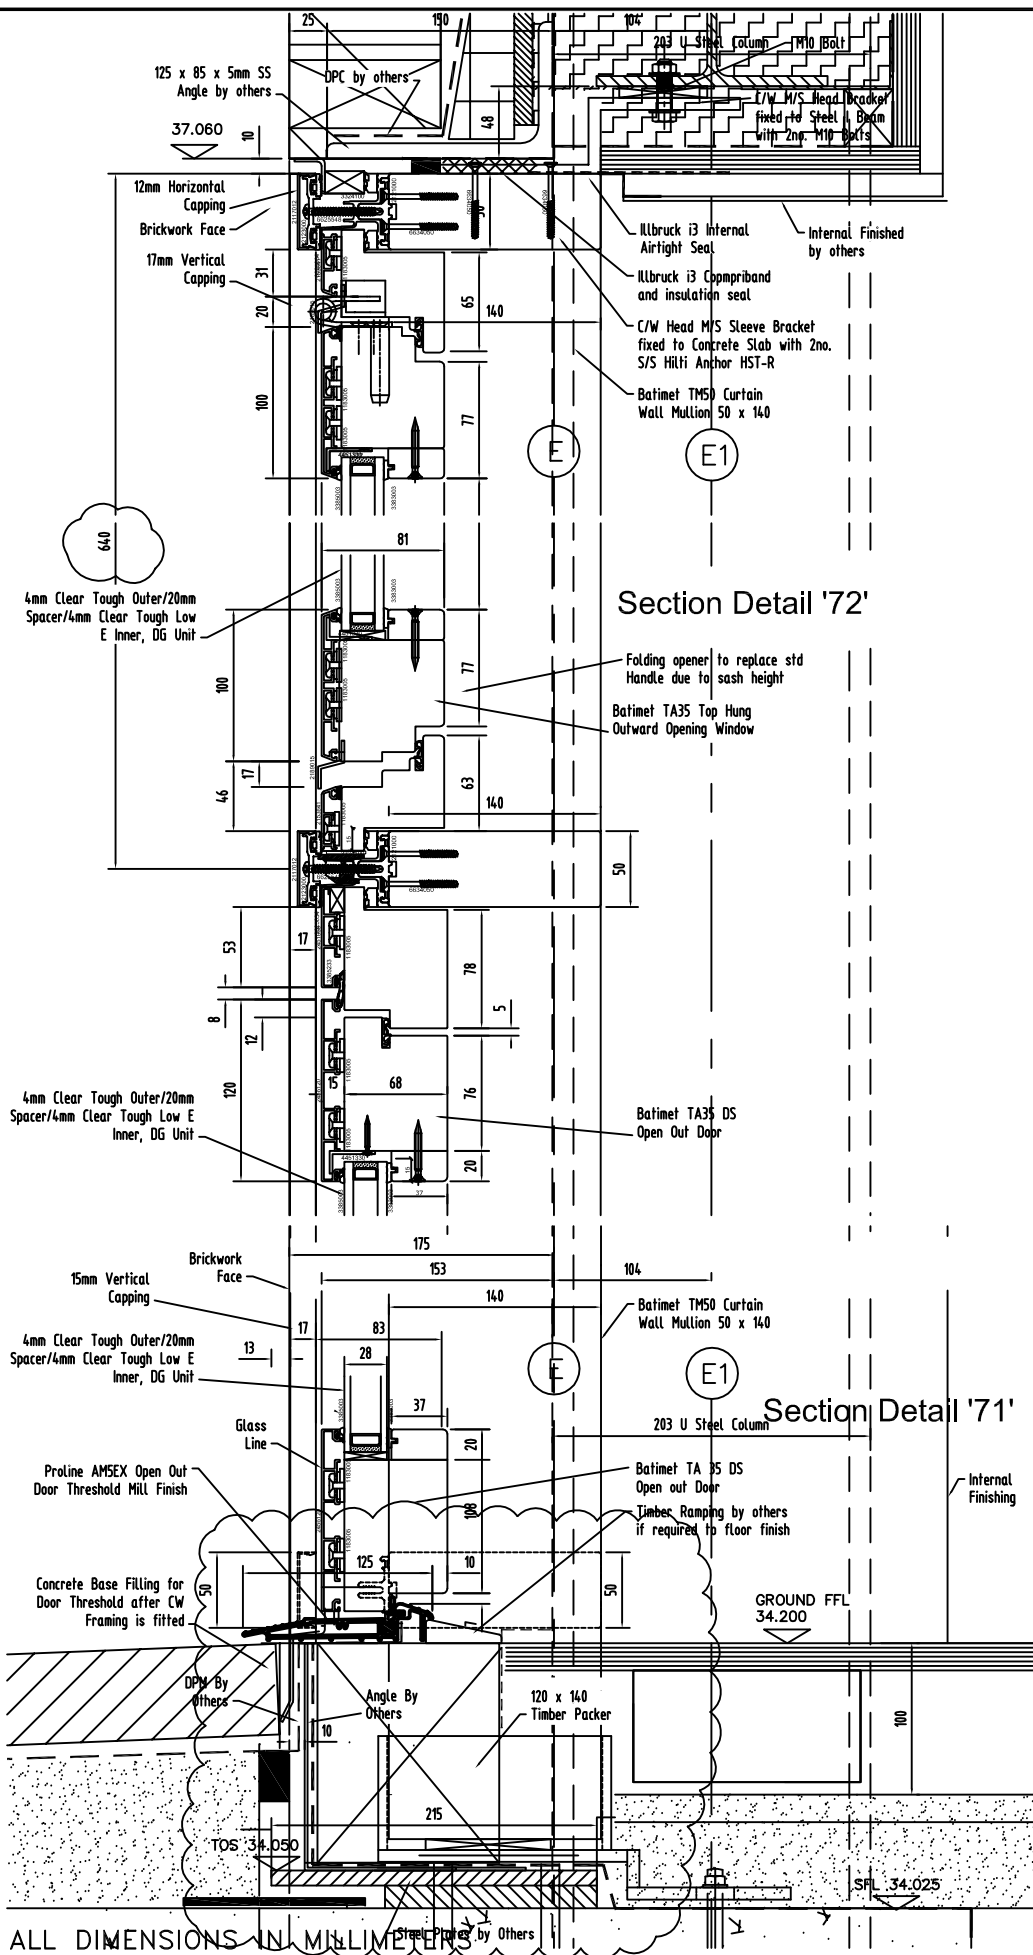
DRAWING DESCRIPTION:
 Unit 3 Screen Details

Bike store door (not shown) Dw 23dB

Batimet TM50 Curtain wall Section
 Batimet TA35 DS Door Section
 Batimet TA35 Opening Out Section
 Internal Timber - Engineered Softwood
 Internal Finish - Clear Lacquer
 External - Aluminium Capping 17mm and 12mm
 External Finish - RAL 7016 Anthracite Grey

Low E Double Glazed Units to U Value 1.1W/m²K

The bike store door appears to be a temporary installation, with poor perimeter seals. Hence, this was the most significant source of sound leakage. Second to this in significance were the glazed personnel doors, with the large glazing and spandrel panel also a significant noise breakout path. The masonry external walls were not a significant breakout path.

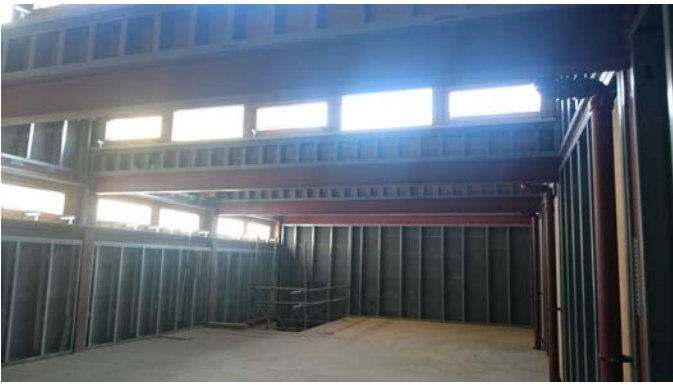
At present, Unit 3 has external walls and glazing in place. The saw-toothed roof to the first floor has glazing on the vertical elements and there is a sloping rooflight at the rear of the ground floor. However, there is no finished floor, no internal partitions (other than the first floor slab) and no internal linings to the external walls or roof. Photos indicating this are shown in Attachment 6.

First floor level showing roof lights

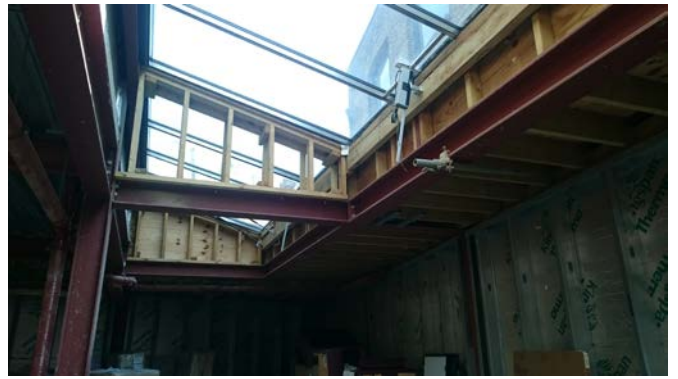
Ground floor roof lights

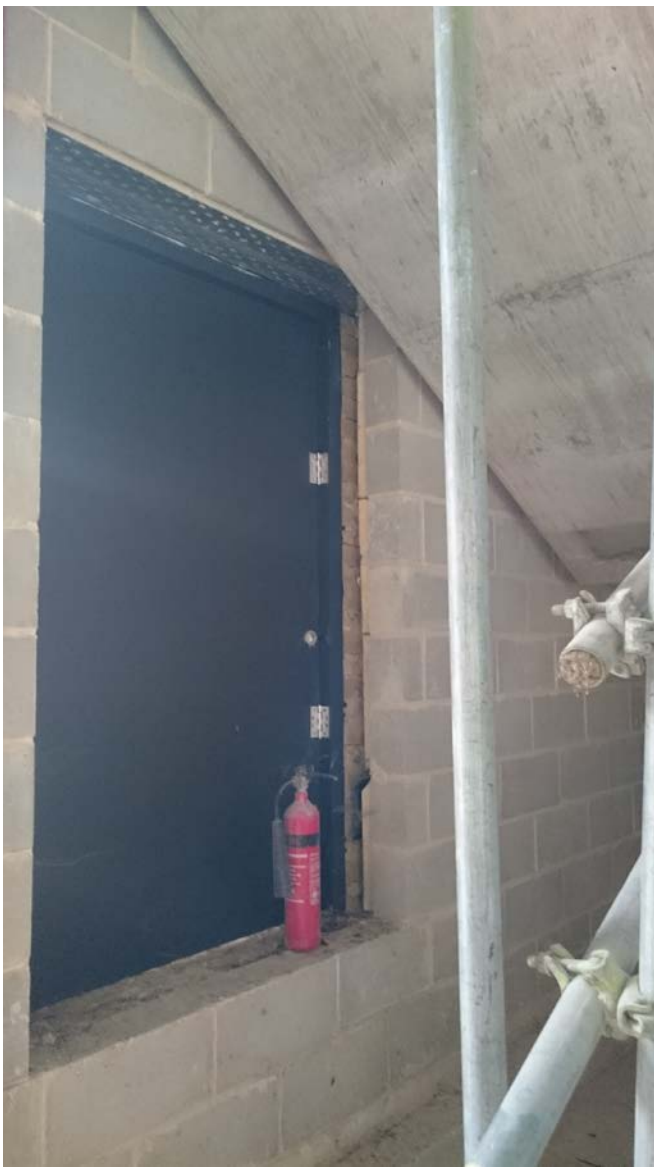
Current bike store door

- Separation of the bike store from the Unit 3 stairwell by internal wall partitions.
- Separation of the stairwell from the ground floor occupied areas by internal wall partitions.
- Separating of the ground floor foyer / reception area from the studio space by a door.
- Location of WC/ changing areas near the external wall closest to residential unit 2 at ground floor level.
- Location of the office areas near the external wall closest to residential unit 2 at first floor level.

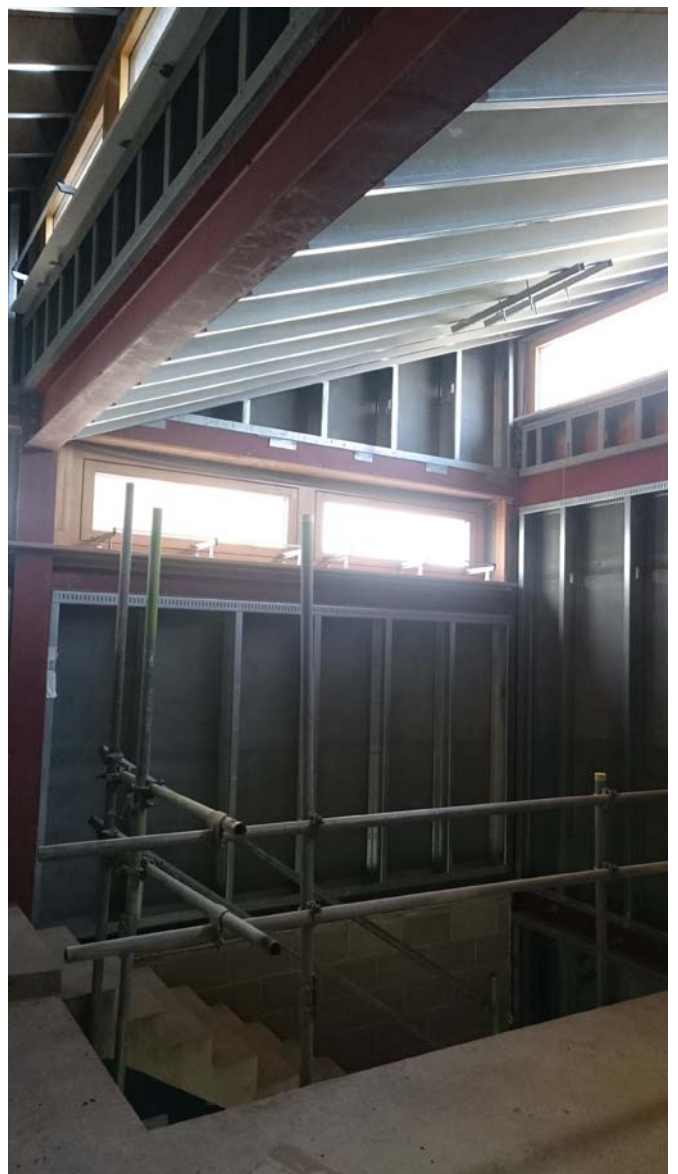
Stairwell at first floor level
