TREE RADAR ROOT SCAN REPORT

“The Water House”, Millfield Lane, London, N6 6HQ

31 July 2018

Our Ref: 55928

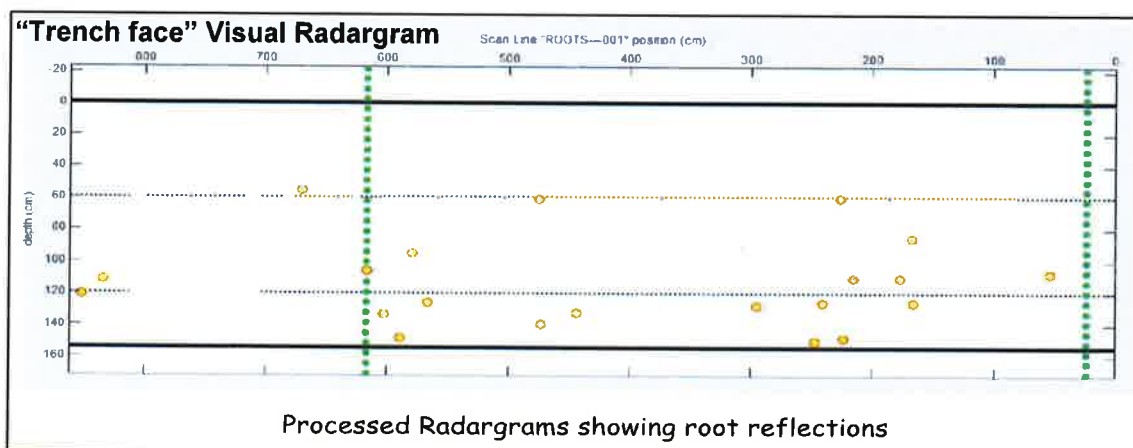
Scaled "trench face" visual radargrams provide a below the scan line scaled spatial view and display the depth and distance of roots in a virtual trench face. There is a distance scale along the top, and depth scale down the left axis. The green broken line shown below is a fixed site marker point - corner of buildings, tree, fence post etc.

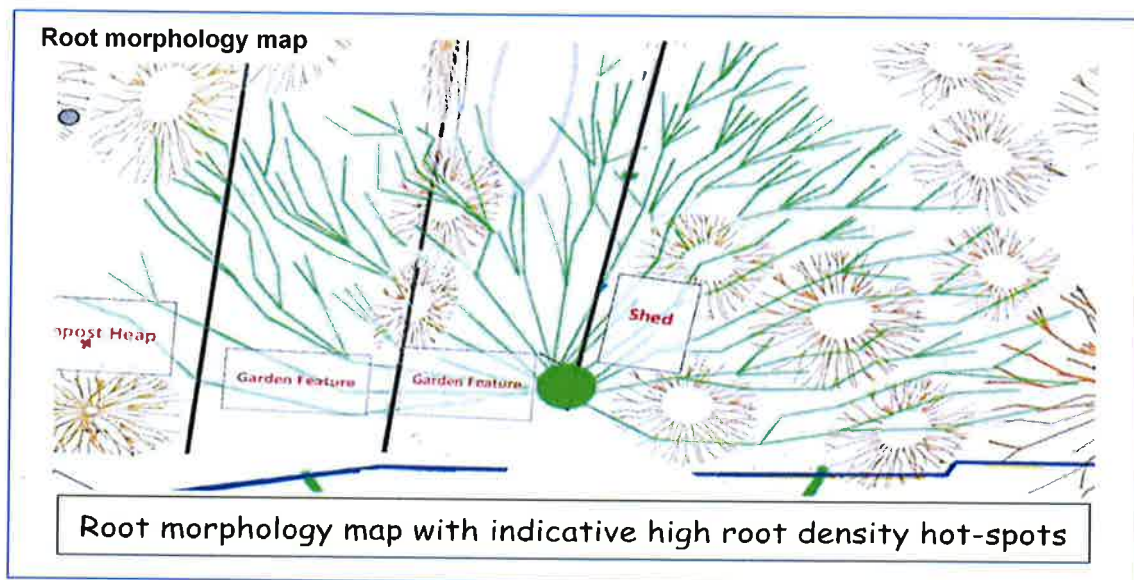
Root morphology maps can also be provided. These are generated automatically by the bespoke software for circular/radial scan line surveys. For linear surveys, the root morphology is plotted to the root spread and pattern of the roots as given in the Top Down View (TDV) maps above. Root morphology maps give a detailed view of the spread and density of roots. For linear scanlines, it is possible to plot high root density hot-spots associated with other woody plants as shown below.

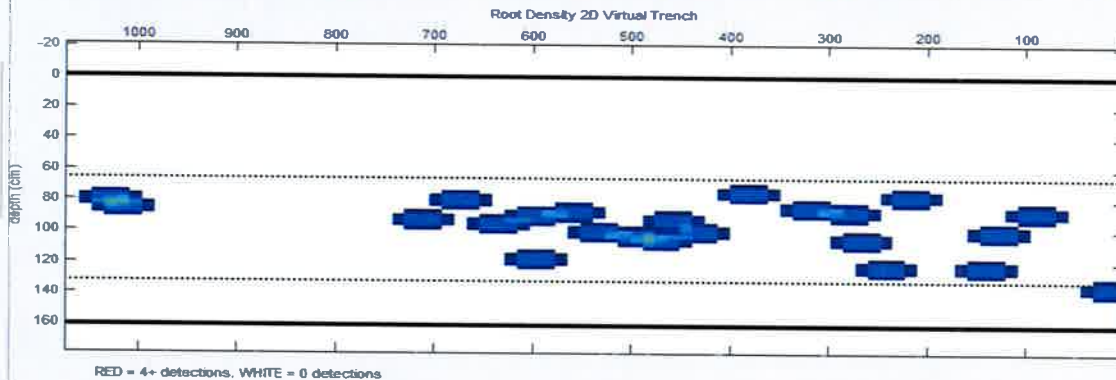
Inset: Scan-Line 1(6)
Radargram showing distribution of roots about 10mm diameter in the top 100cm soil depth.

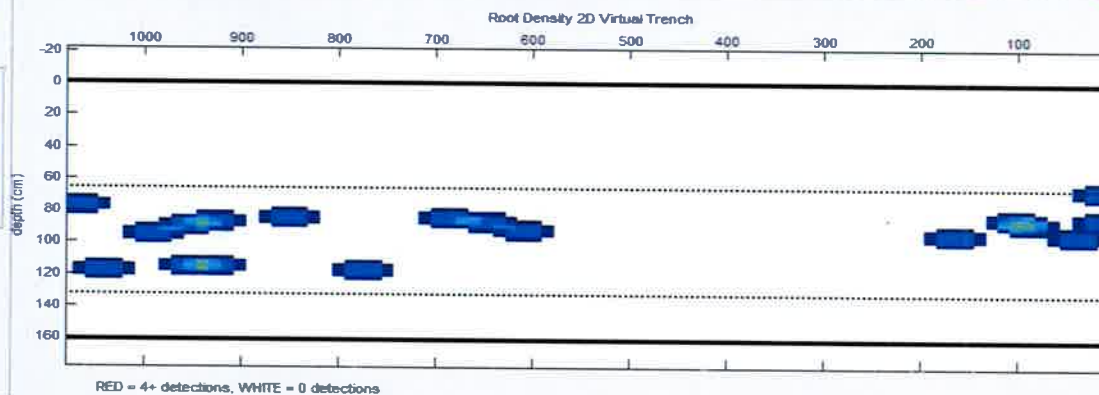
Inset: Scan-Line 3(8)
Radargram showing distribution of roots about 10mm diameter in the top 100cm soil depth.

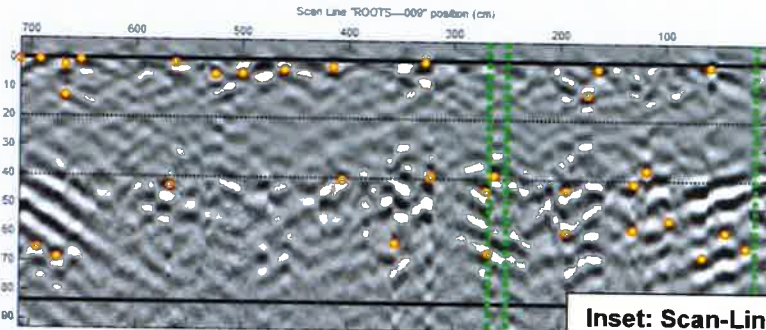
Below: Scan-Line 4

Radargram showing below ground spatial depth (2m) profile. Majority of roots have exploit a 50cm band width. There is one root indicator for roots over 20mm diameter in the top 70cm soil depth. There are some indications of excavations towards end of line. Root density: 3.00 ARDM.

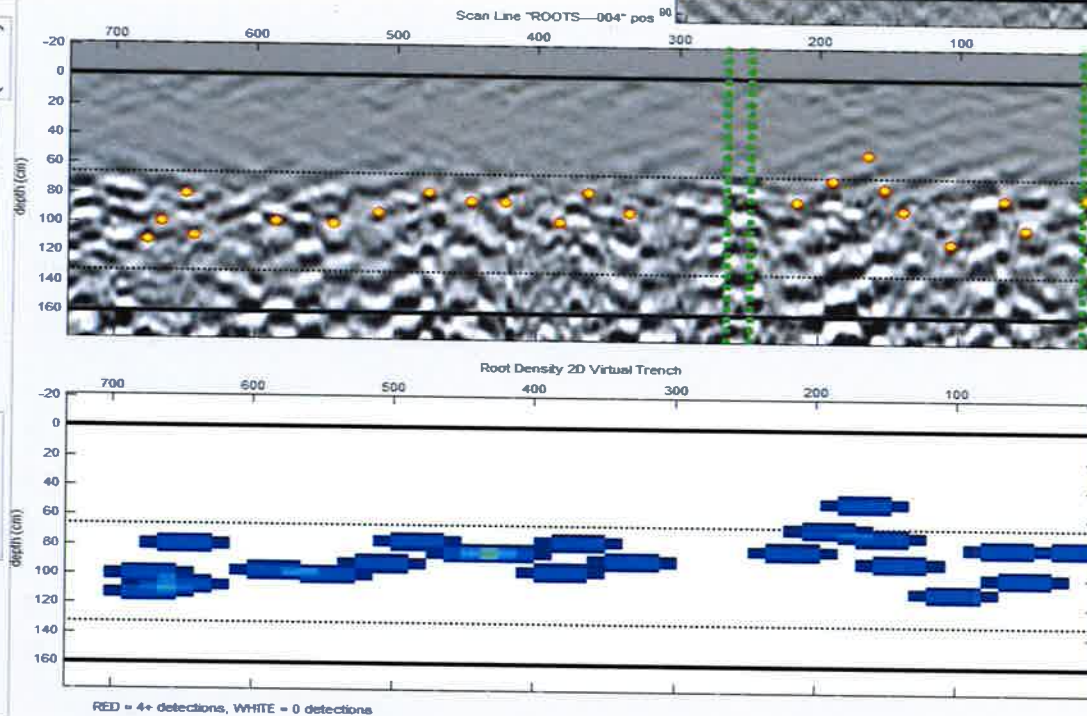
Inset: Scan-Line 4(9)
Radargram showing distribution of roots about 10mm diameter in the top 100cm soil depth.
