DESIGN AND ACCESS STATEMENT

WELBECK MANSIONS, Inglewood Road, West Hampstead, London, NW6 1QX

Rev A

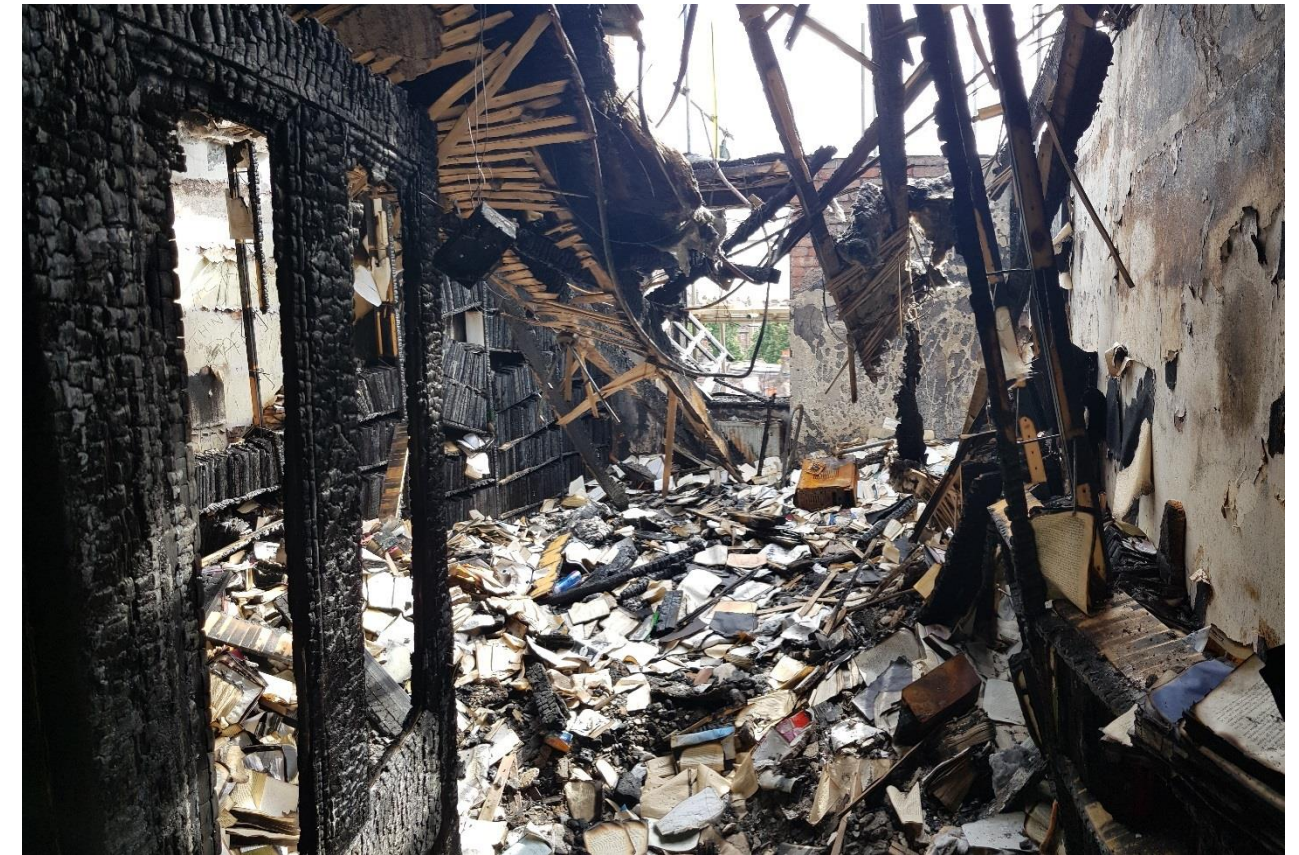
Photo taken from Flat 4F to display the extent of damage to the 4th Floor

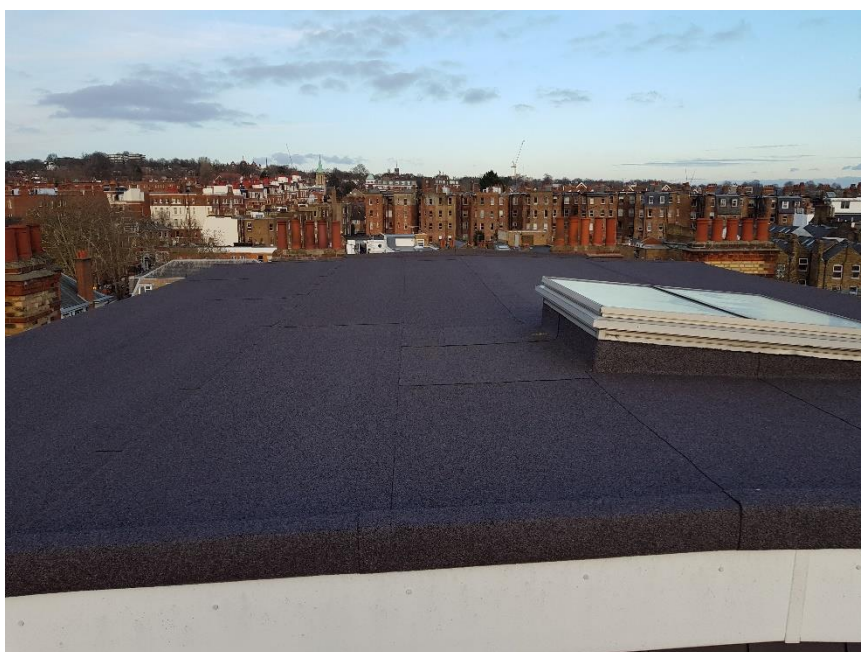
10. Roof – 5th floor penthouse flat roof

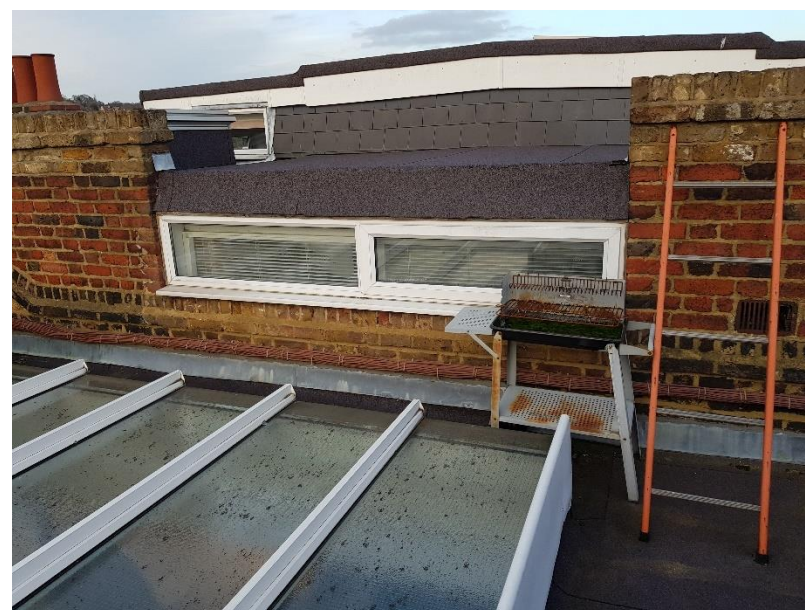
11. Roof – view from central core to 5th floor roof

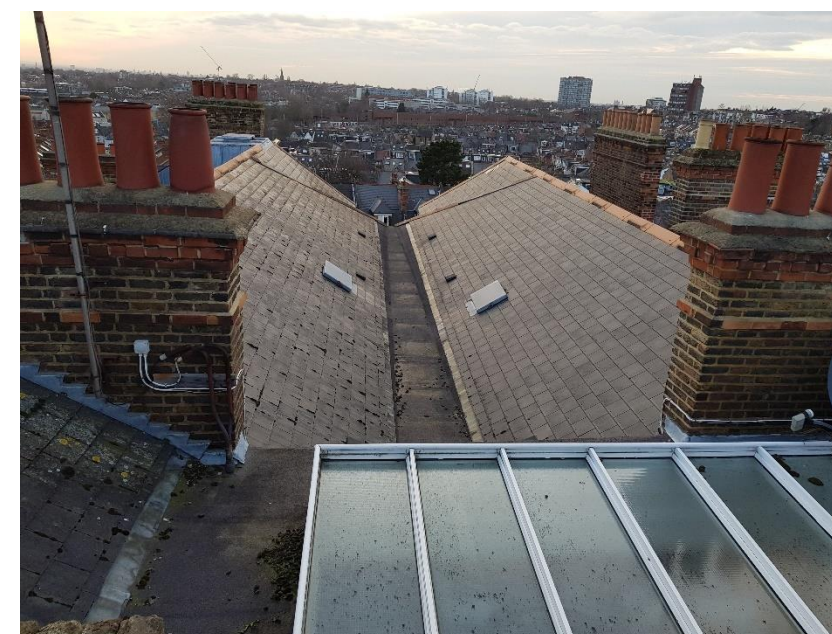
12. Roof – view from 5th floor flat roof to the LHS of the building

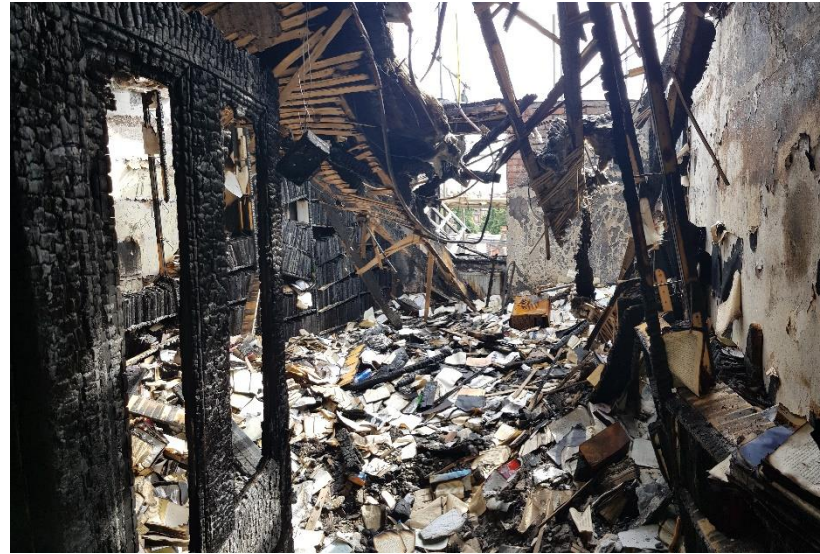
1. 4th Floor

A detailed photographic record following the fire has been prepared by tmd Building Consultancy to assist with the like-for-like reinstatement of the block. A select number of images taken of the fourth floor can be found in Section 6.2 displaying the extent of damage to this floor.
