11. Non-technical Summary – Stage 4

Project:

8 Agamemnon Road, London, NW6 1DY

Title: **Photographs - Sheet 1**

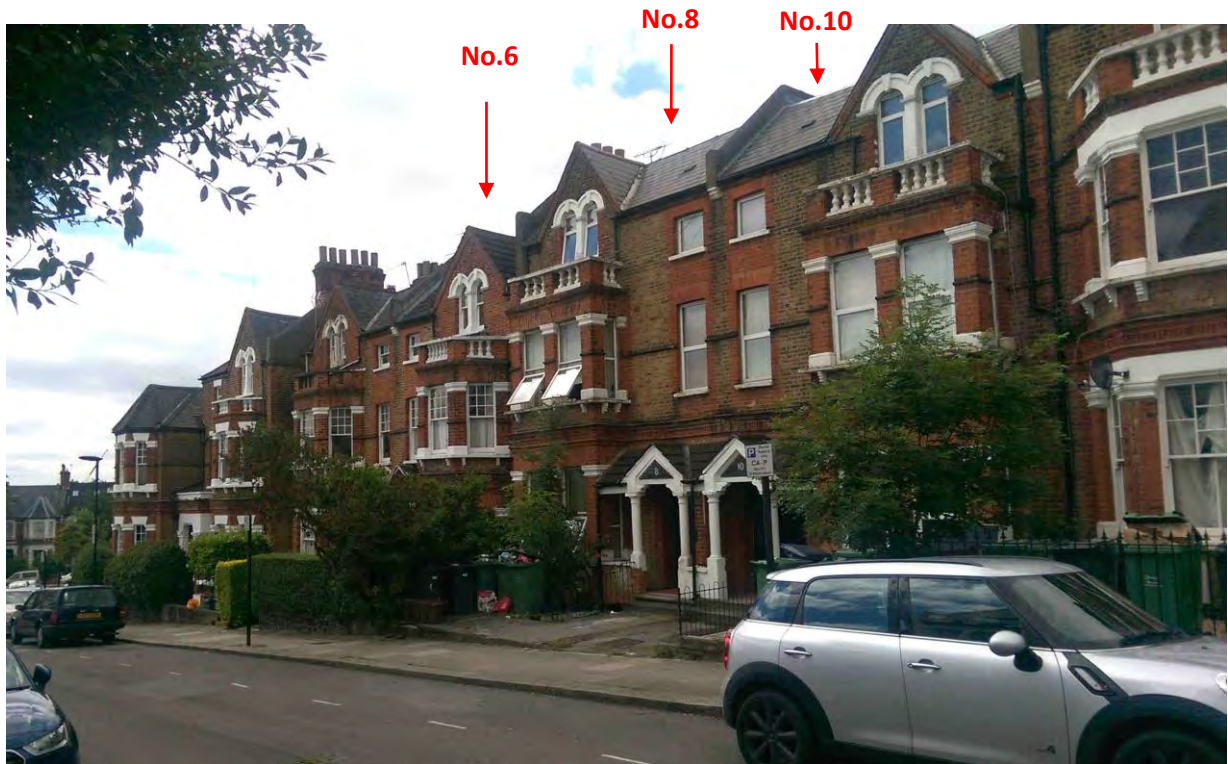
Photo 1: Front elevation, looking south. Note the consistent gentle southerly fall of the Agamemnon Road carriageway, and the change in level between No's 8 and No.6. Houses on Hillfield Road are visible at the extreme left of the photo.

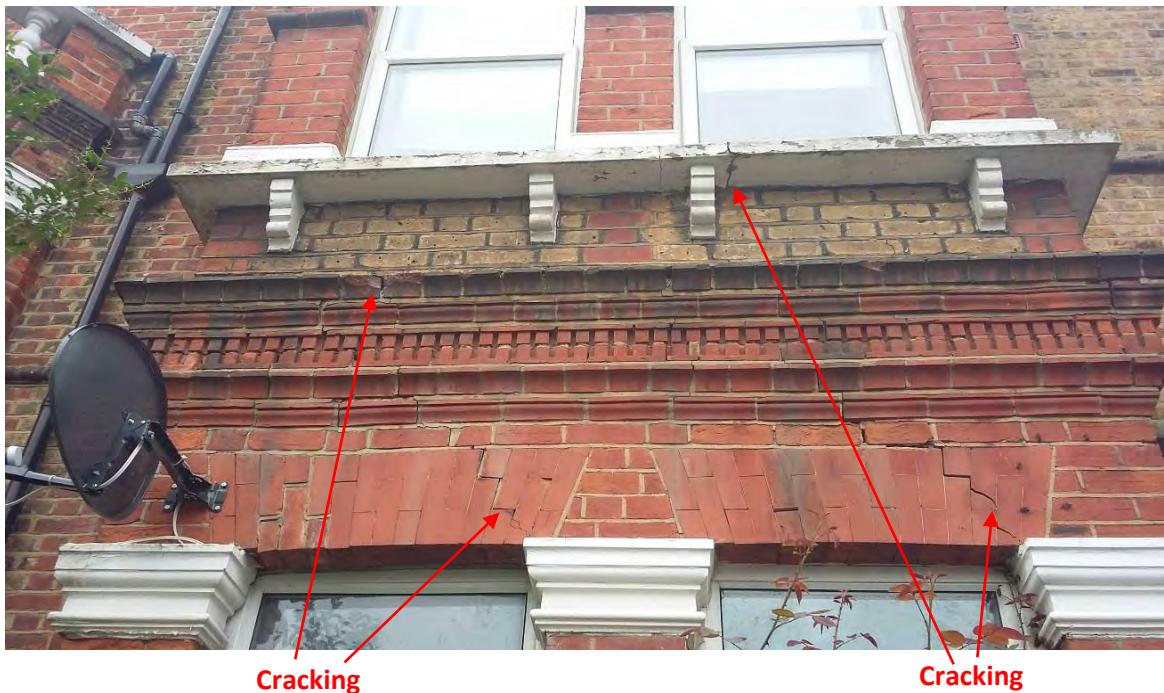
Photo 2: View of the front bay of No.8. Extensive crack damage is visible around the windows of the front bay, including in the side windows (not visible here).

- 11.11 Damage category assessments indicated that, provided best practice construction methods are employed, and provided that the structural damage to No .8 is repaired in advance, the worst case predicted deformation (in the internal transverse walls to the adjoining properties on both sides of No.8) is likely to fall within Burland Category 0, on or close to the boundary with Burland Category 1 termed **'very slight'** (Section 10.6).

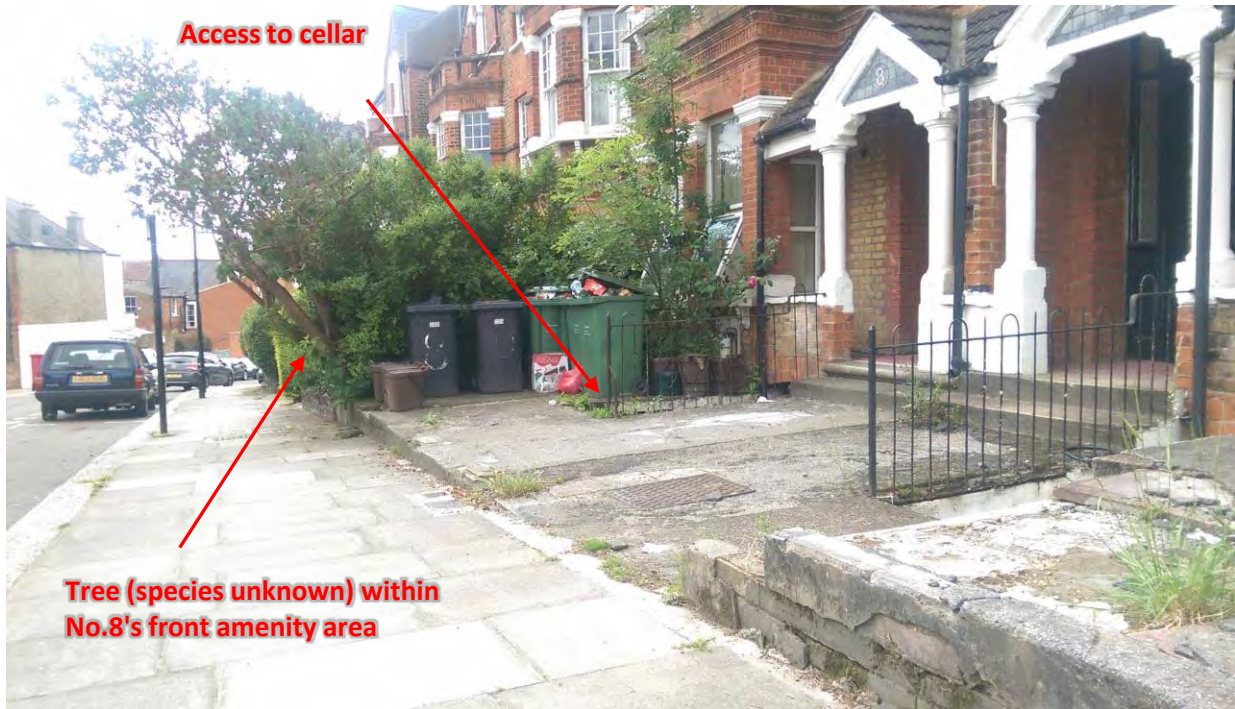
Photo 3: At the front of the house, the amenity area is almost fully paved. Also shows steps up to the main front entrance porch and steps down to the cellar

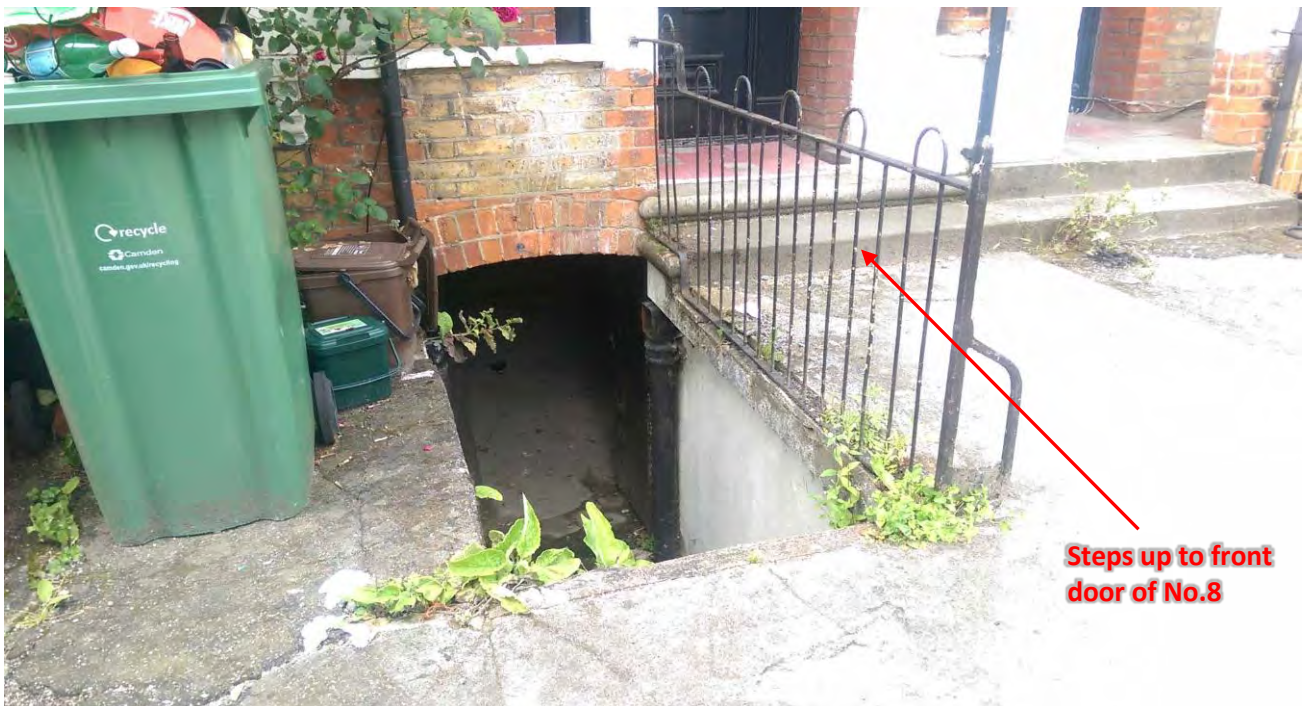
Photo 4: Access to the existing basement store is via external stairs only.

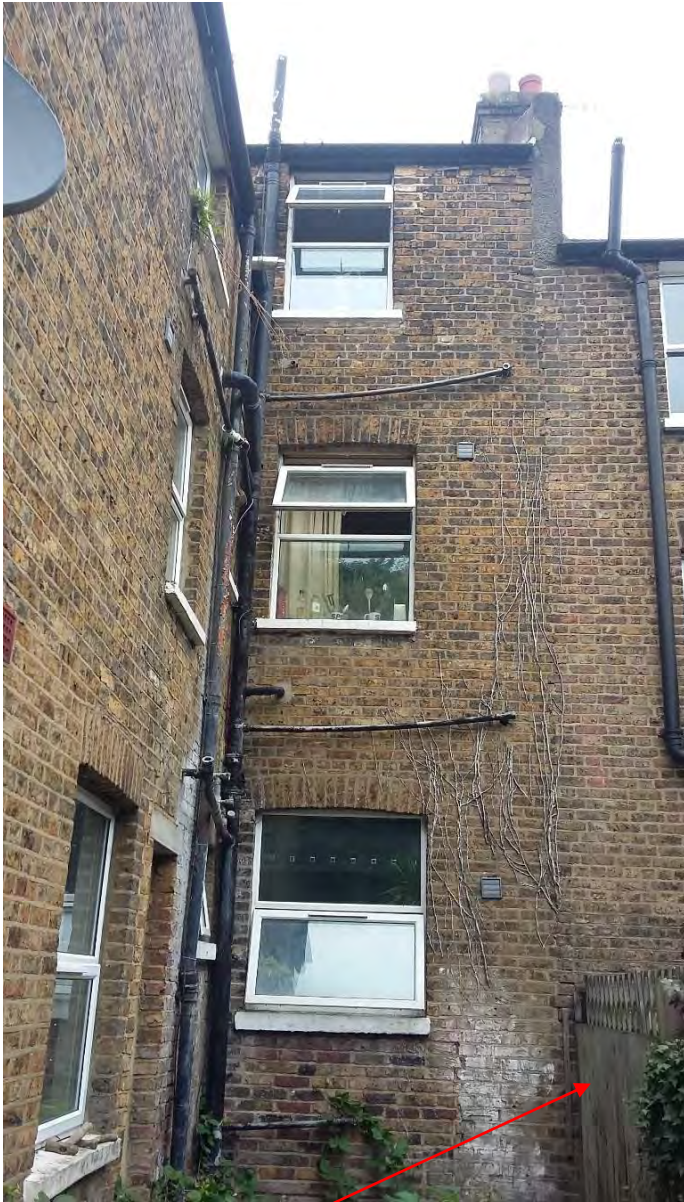
**Boundary fence
between No.8 and No.6**

**Severe instability of
brickwork above first
floor window**

Cracking of lintel

Photo 5a (left): Rear of No.8, looking north-east, showing flank wall of rear projection and rear wall of main house.

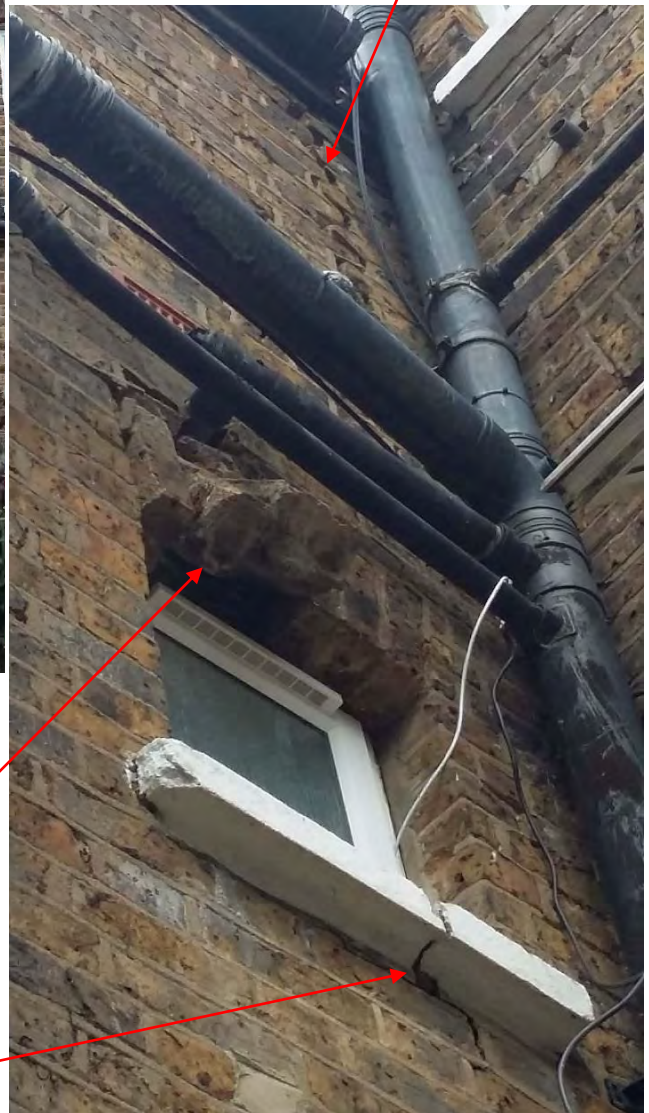
Photo 5b (below): Closer view of crack damage between rear wall and rear projection.

**Cracking of rear
projection brickwork**

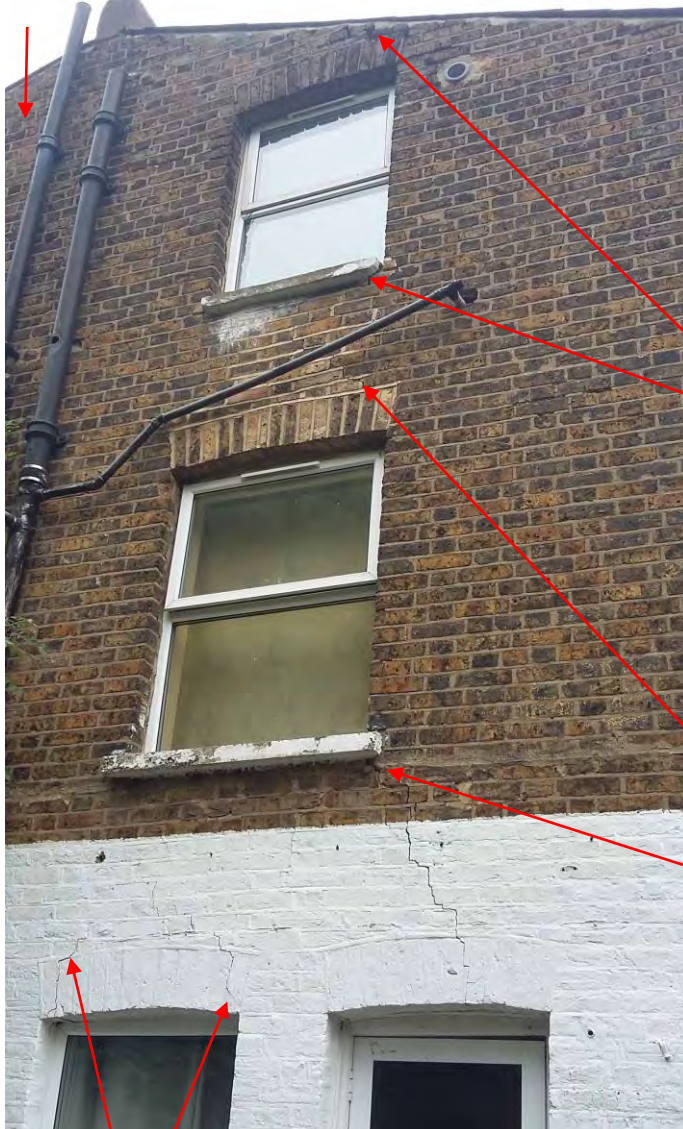
Photo 6: Rear wall of rear projection, looking north-east. Crack damage is visible above and below every window.

Cracking
