DESK STUDY, GROUND INVESTIGATION, BASEMENT IMPACT ASSESSMENT & GROUND MOVEMENT ASSESSMENT REPORT

**35 TEMPLEWOOD AVENUE
LONDON
NW3 7UY**

Report Title: Geotechnical Desk Study, Ground Investigation, Basement Impact Assessment & Ground Movement Assessment for 35 Templewood Avenue, London, NW3 7UY

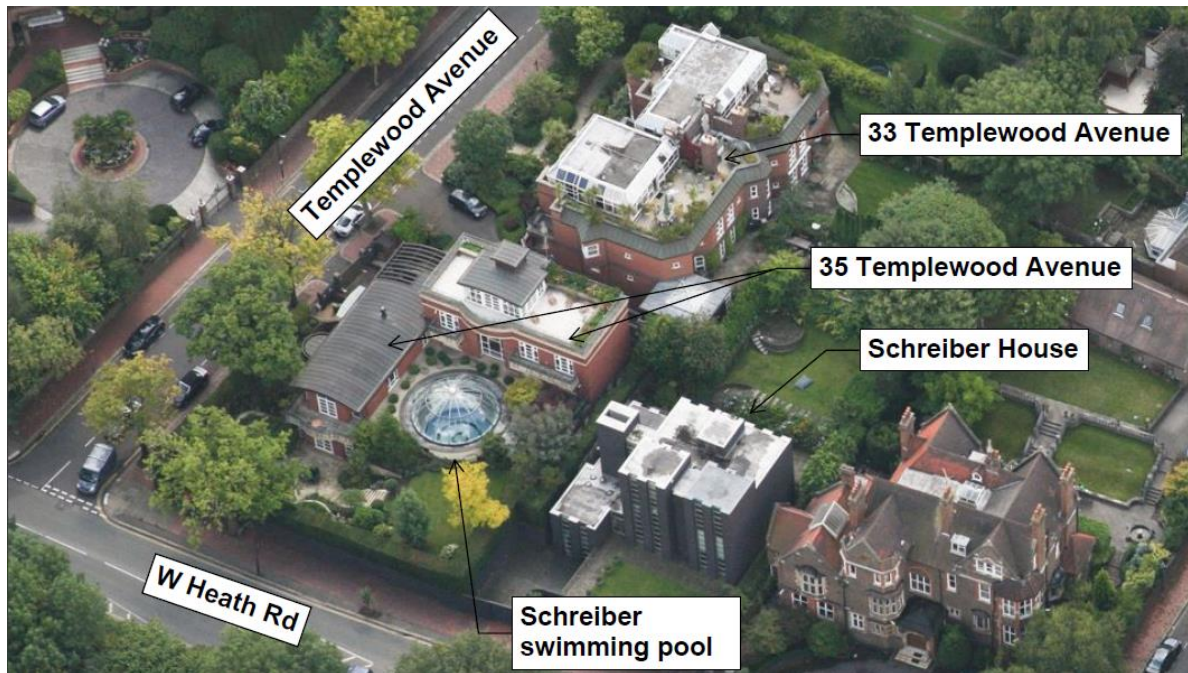
Figure 16.1 Development site under consideration.

- 16.1.1 The proposed development involves the construction of a new single-storey basement, which will deepen and locally extend the footprint of the existing basement at 35 Templewood Avenue. As indicated in Figure 16.1, the site under investigation is bounded to the north and east by West Heath Road and Templewood Avenue, respectively. The properties located at 9 West Heath Rd (Grade II listed - Schreiber House) and 33 Templewood Avenue form the western and southern boundaries, respectively.

- 16.1.4 The GMA presented herein is concerned with the impact of the proposed development on:
1. the properties immediately adjacent to the site, namely the Schreiber House and 33 Templewood Avenue.

2. the Thames Water assets running adjacent to the site under West Heath Road and Templewood Avenue

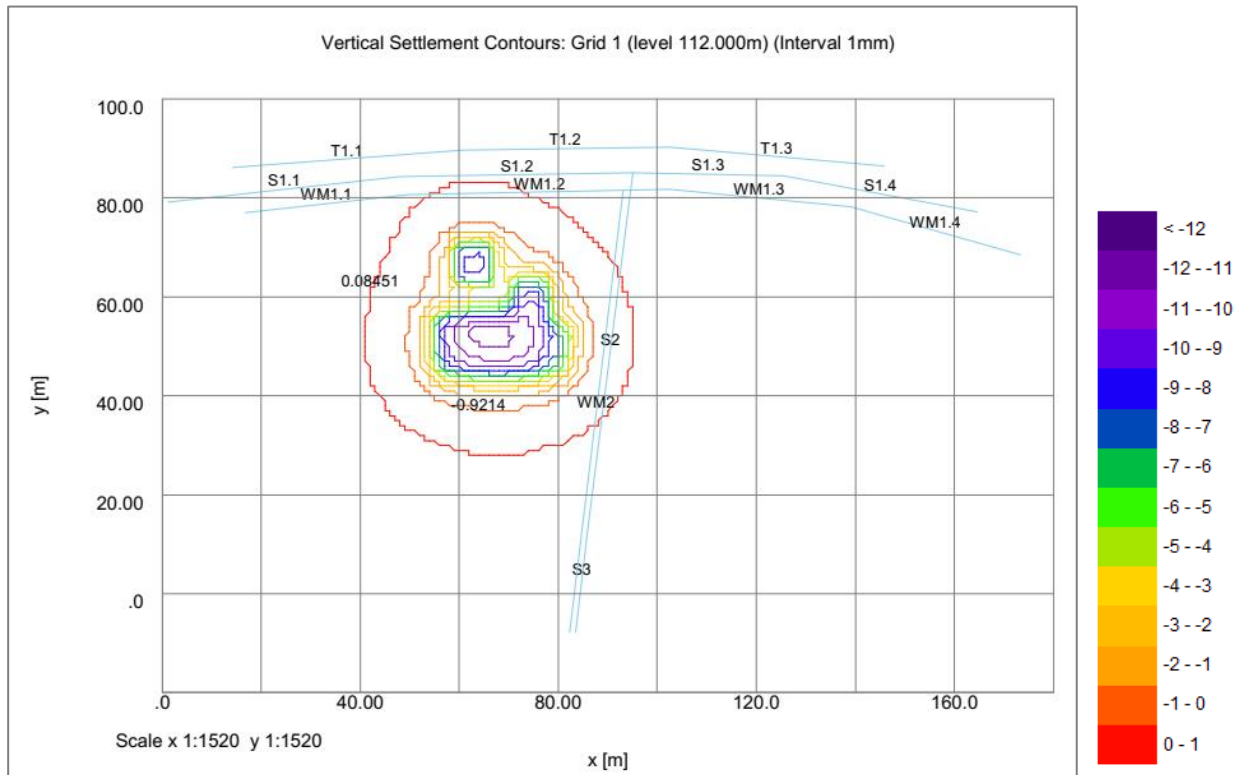
METHOD 1 - Post-excavation

All assets are within Thames Water screening criteria.

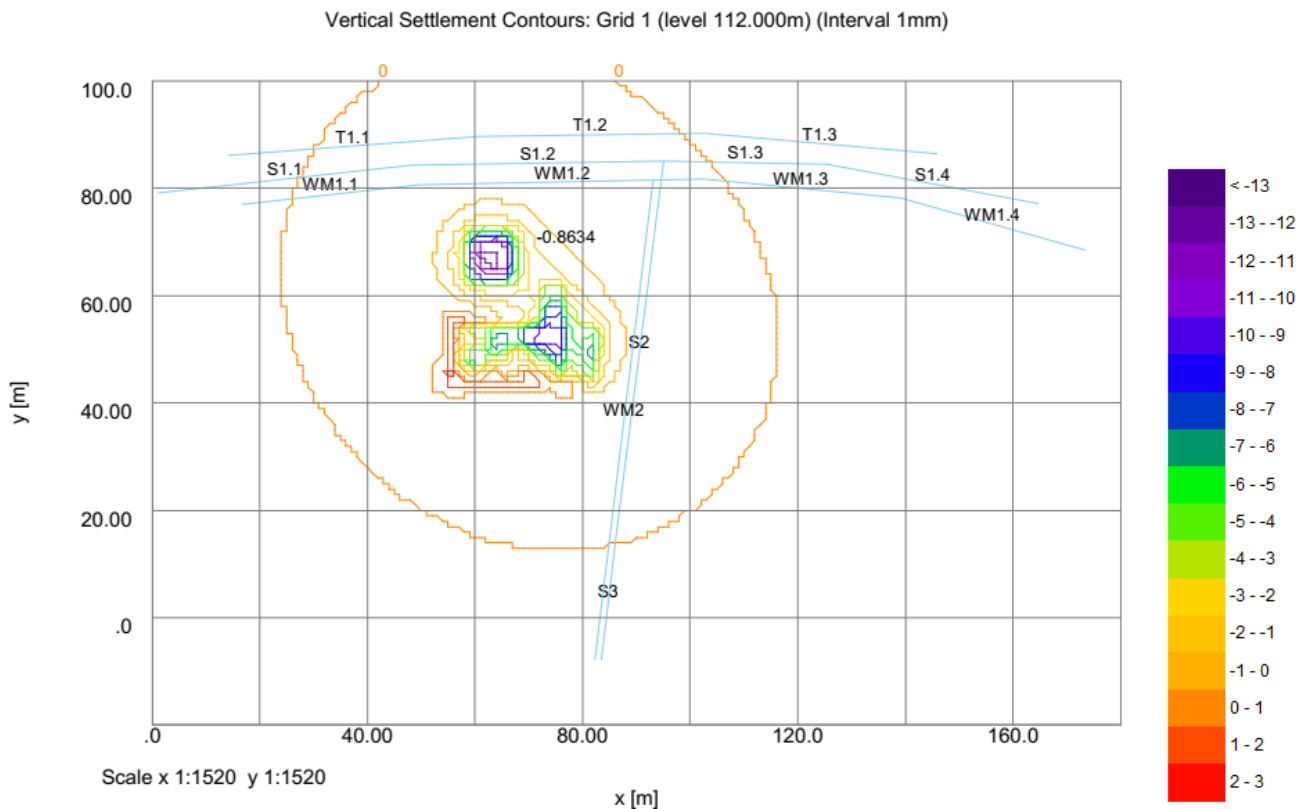
Figure 16.13: Vertical Movement – Method 1 Long-term

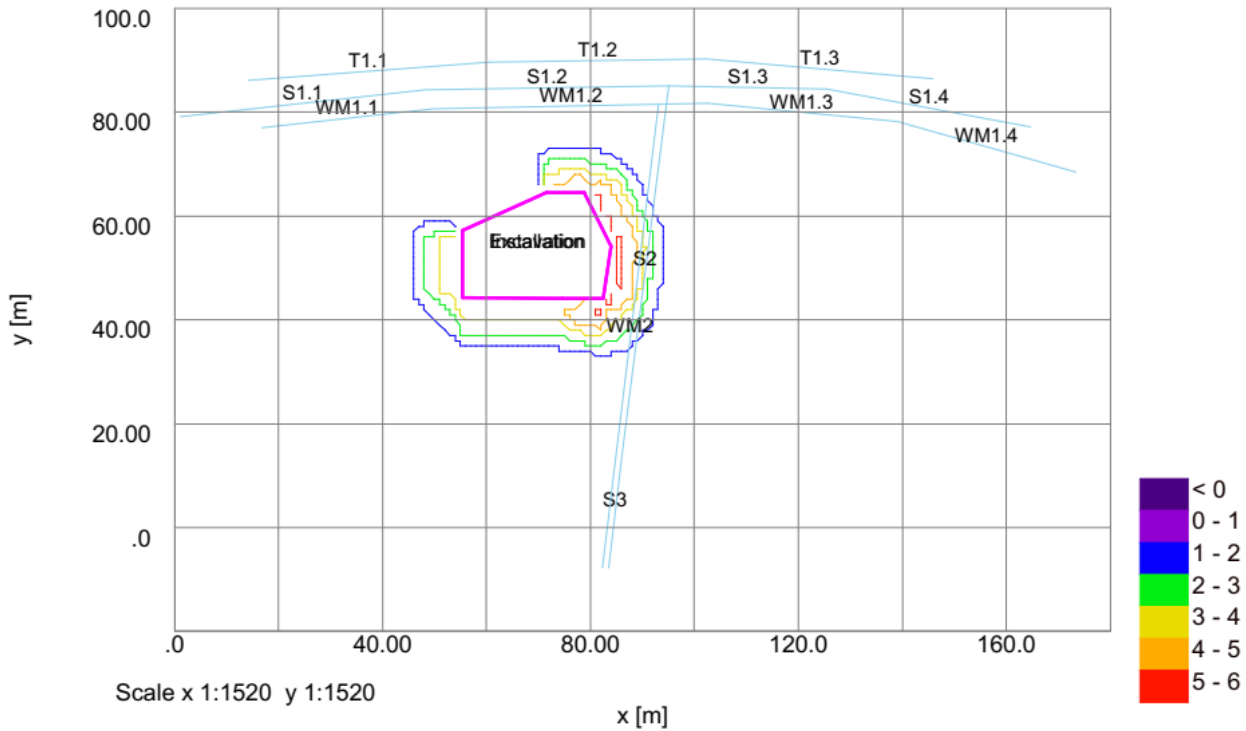
Vertical Settlement Contours: Grid 1 (level 112.000m) (Interval 1mm)

Figure 16.14: Vertical Movement – Method 2 CIRIA Excavation and Installation

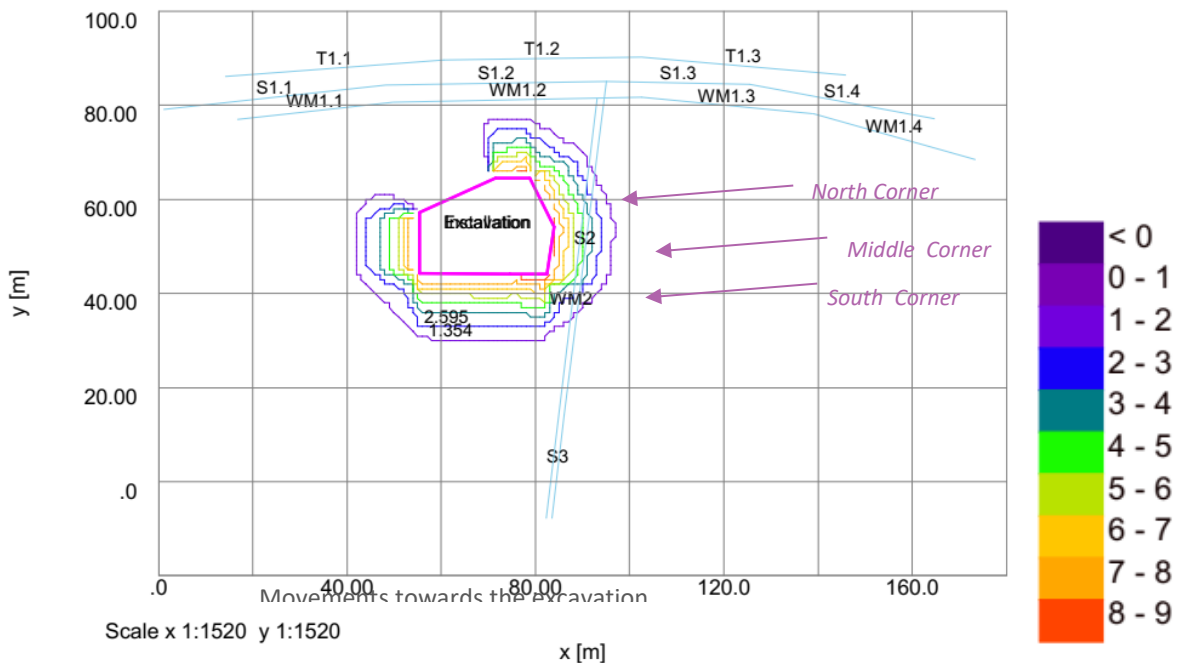
Horizontal Displacement Contours: Grid 1 (level 112.000m) Interval 1mm

Figure 16.15: Horizontal Movement – Method 2 CIRIA Excavation and Installation

The horizontal movements at this stage are the same as the previous stage (Figure 16.15) since the movements of the PDISP long-term movements are only vertical movements (settlement). The figure below shows the cumulative vertical movements of XDISP using CIRIA curves and the PDISP Long-term loading.

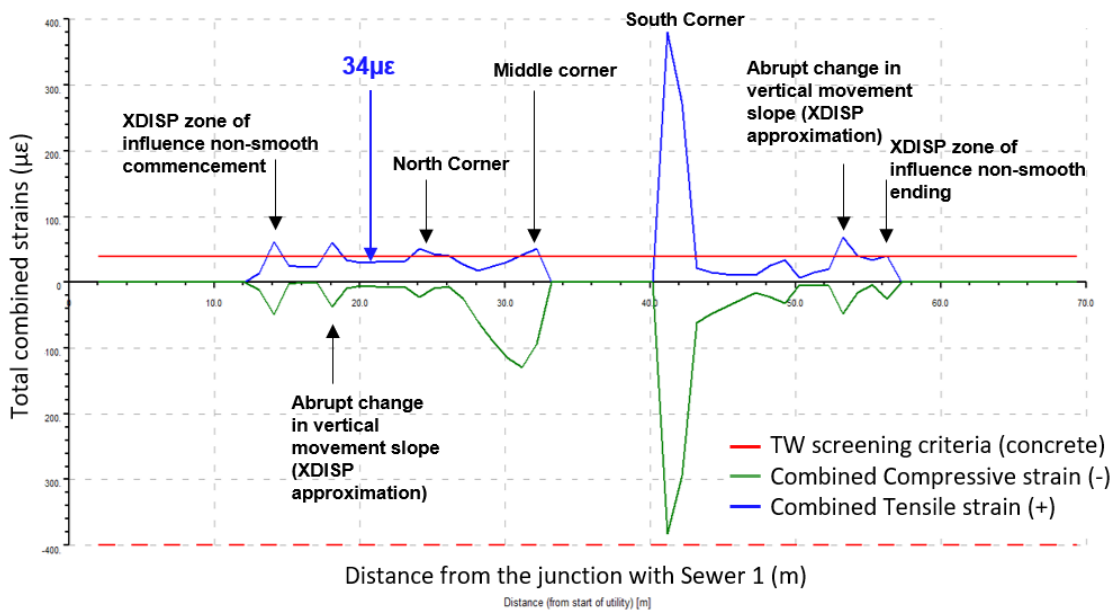
All assets are within Thames Water screening criteria. Sewer 2 that runs below Templewood Avenue has recorded spikes in the data which exceed the Thames Water screening criteria for the tensile strain for unreinforced concrete pipes. These spikes also occur in the compression strain profile, indicating that they are due to flexural strain, related to bending of the pipe. These spikes have been ignored as they result from modelling simplifications described previously. The highlighted value quoted in the table above was considered to be the most representative value of the maximum tensile strain. Figure 16.16 and Figure 16.17 show the movement and combined strains profile of this asset.

Figure 16.17: Combined Strain profile of Sewer 2 – Method 2 CIRIA Excavation and Installation

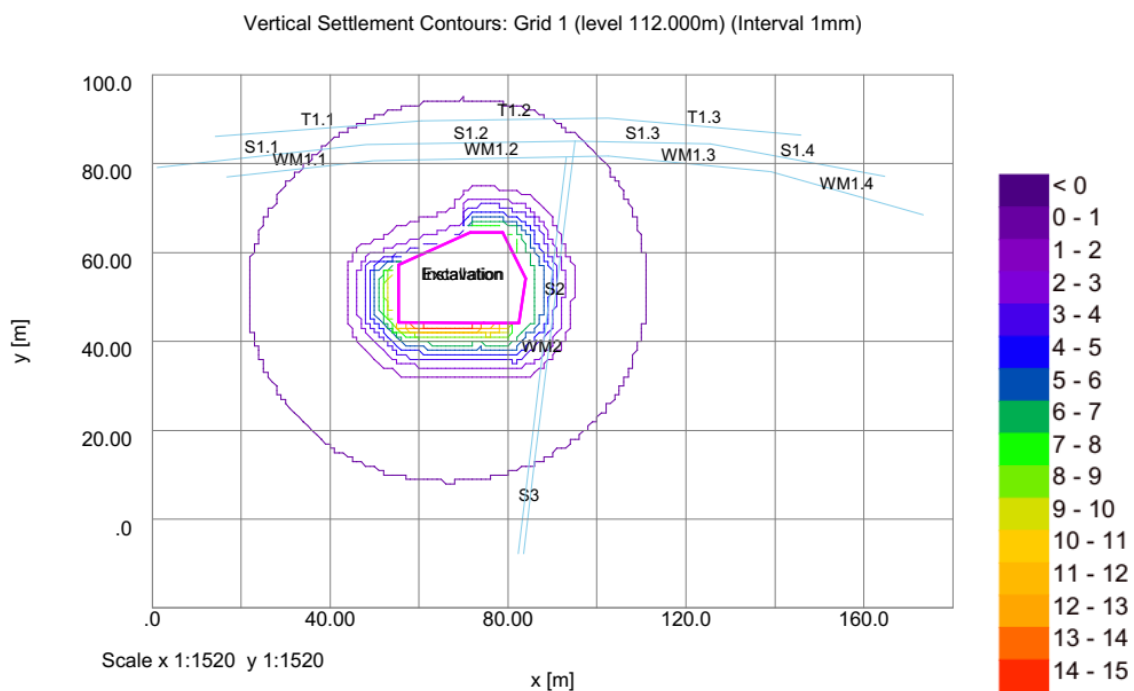
Figure 16.18: Vertical Movement – Method 2 – CIRIA curves + Long-term loading

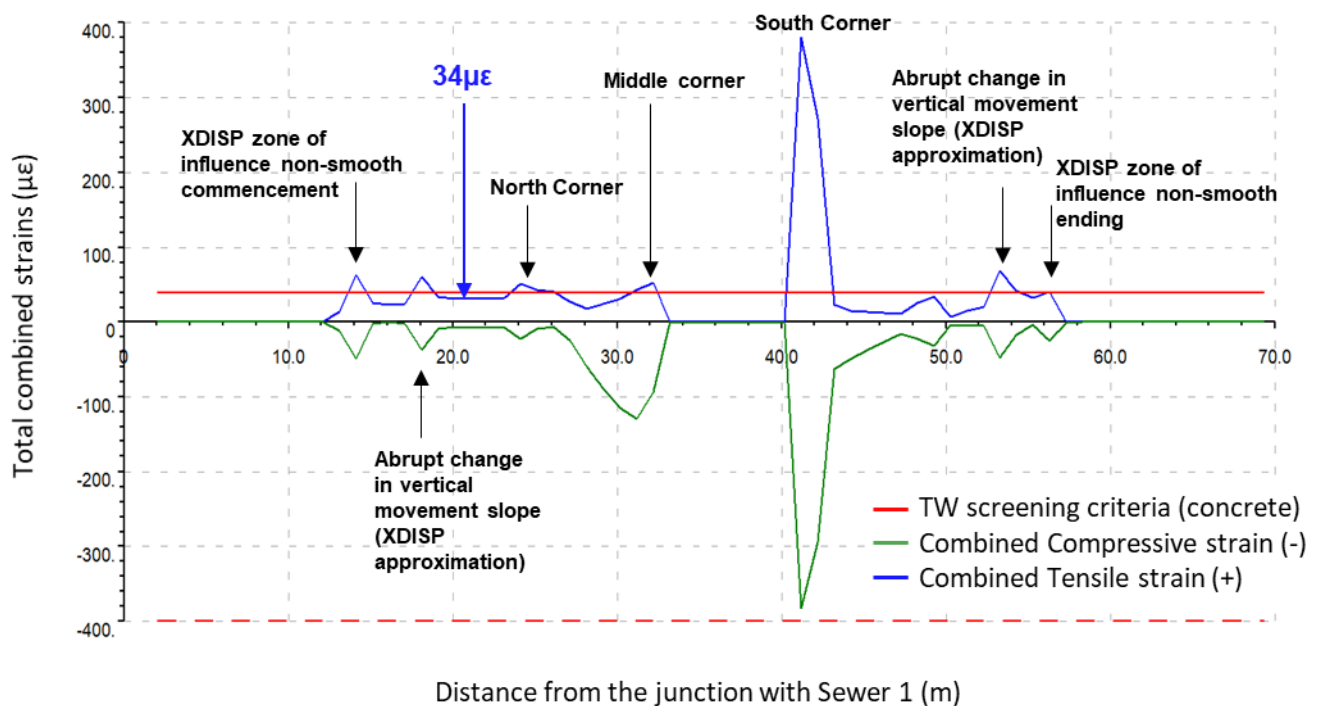
Figure 16.19 and Figure 16.20 show the movement and combined strains profile of this asset.

Figure 16.20: Combined strain profile of Sewer 2 – Method 2 – CIRIA curves + Long-term loading

16.6.6 It should be noted that Sewer 2 was assumed to be of concrete construction, which is the most conservative assumption in terms of performance criteria. If the asset is proven to be of vitrified clay construction, the tensile strain screening criterion increases to 80µε.
