UCL Wilkins Building - Cloister Doors

Design & Access Statement : September 2018

Revision	Date	Amendment
P1	17.09.18	Planning & Listed Building Consent Issue

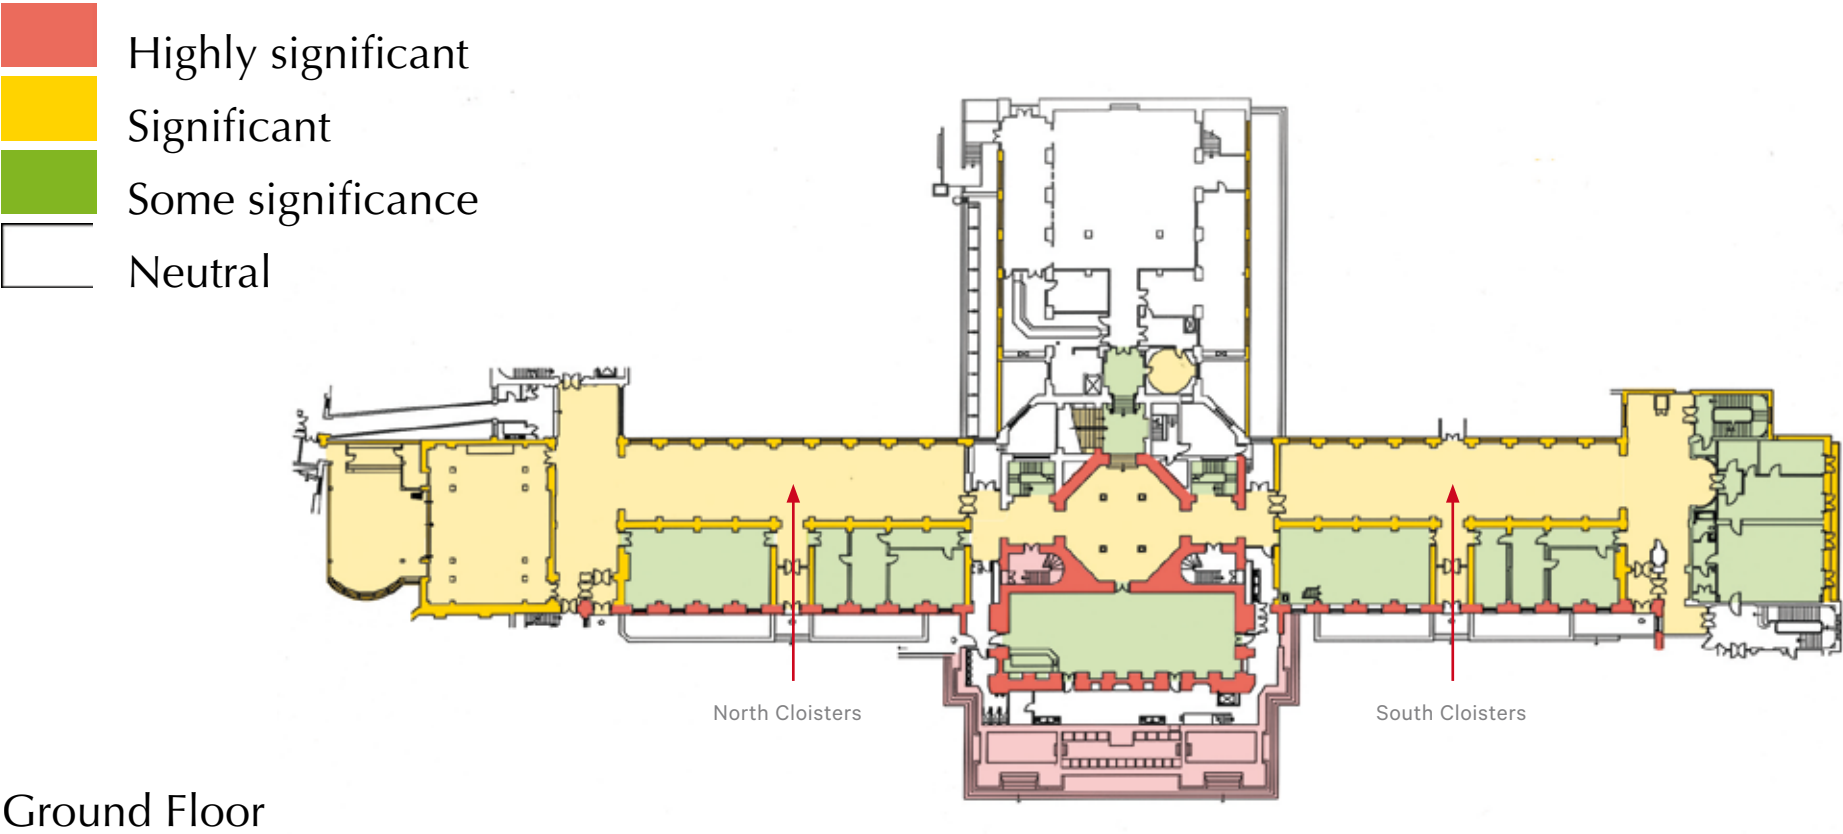
Ground Floor

The adjacent plan shows the architectural and historical significance of the various elements within the Wilkins Building.

Source: Alan Baxter Associates Draft Gazetteer. 2003

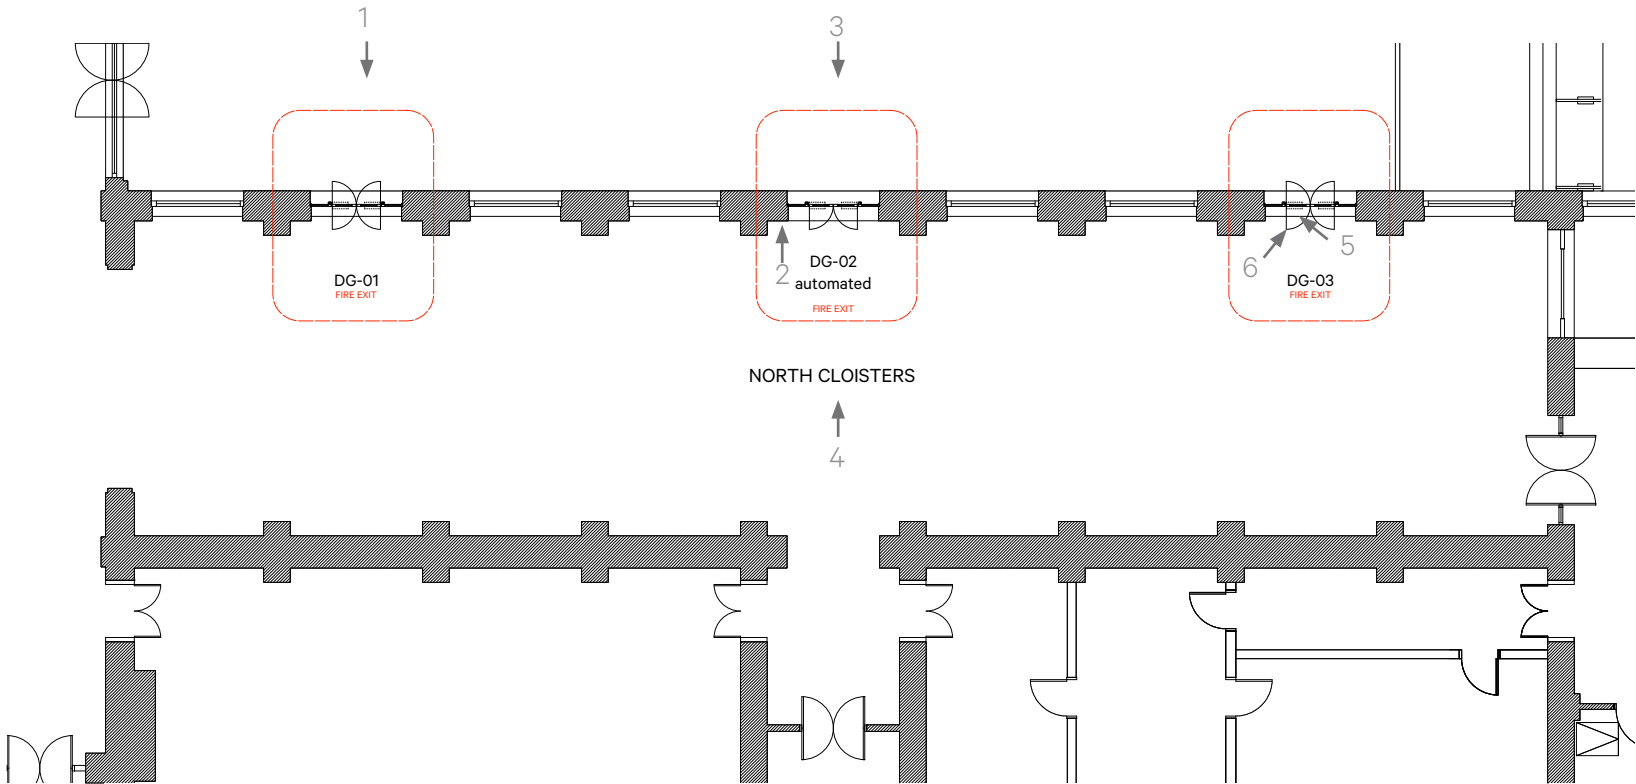
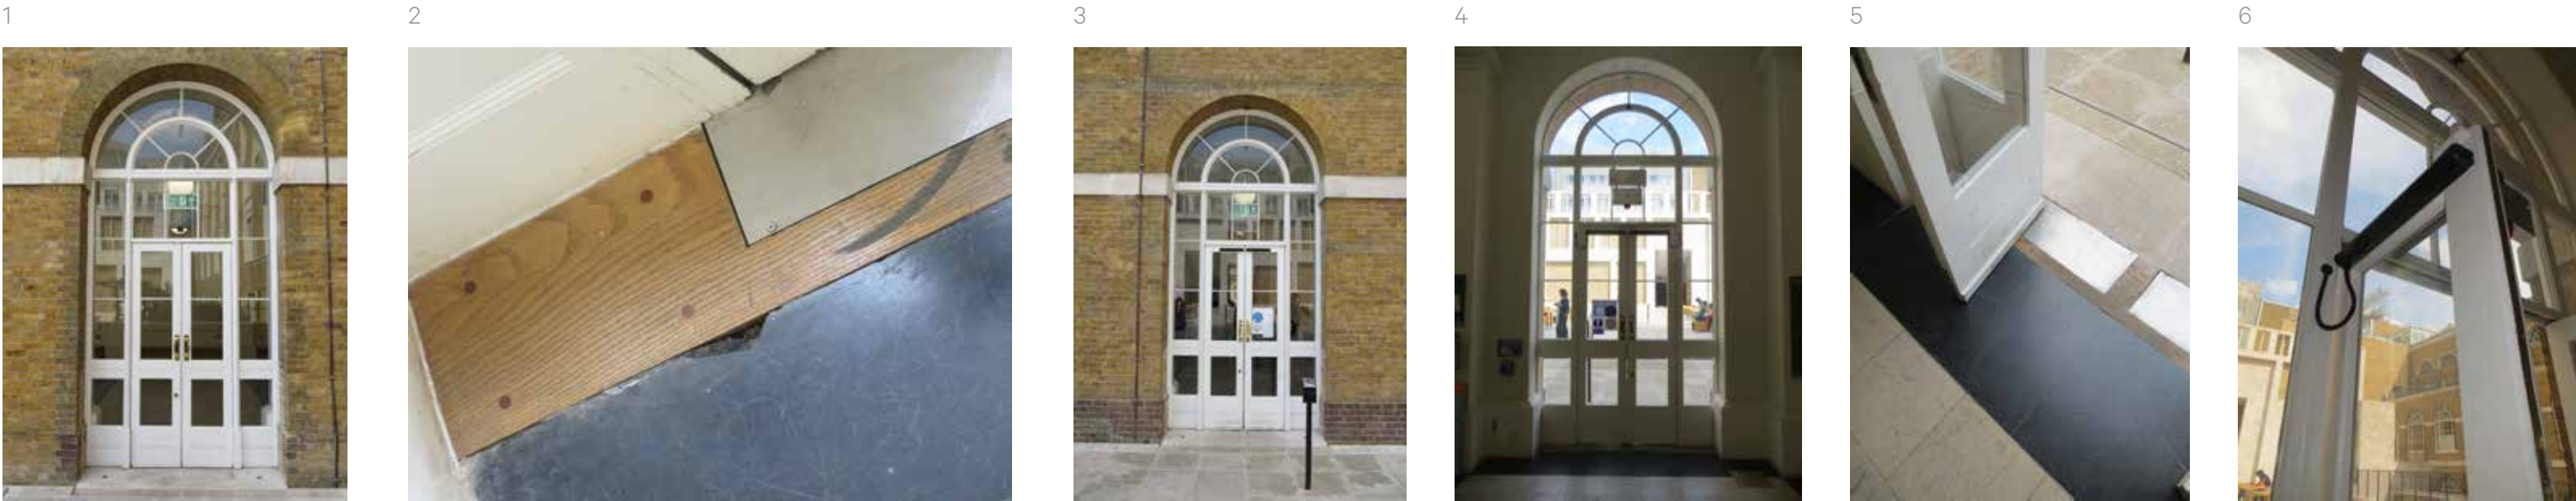
3.1 Existing Condition - North Cloisters

The existing white painted glazed timber double doors were replaced as part of the Wilkins Terrace works, however their operation has remained unsatisfactory resulting in restricted traffic flow and a compromised fire escape route.

The threshold to DG-02 (automated door) has been poorly executed with large stainless steel floor box plates dominating the transition.

The existing black limestone has been damaged at the edges during the previous installation of the doors.

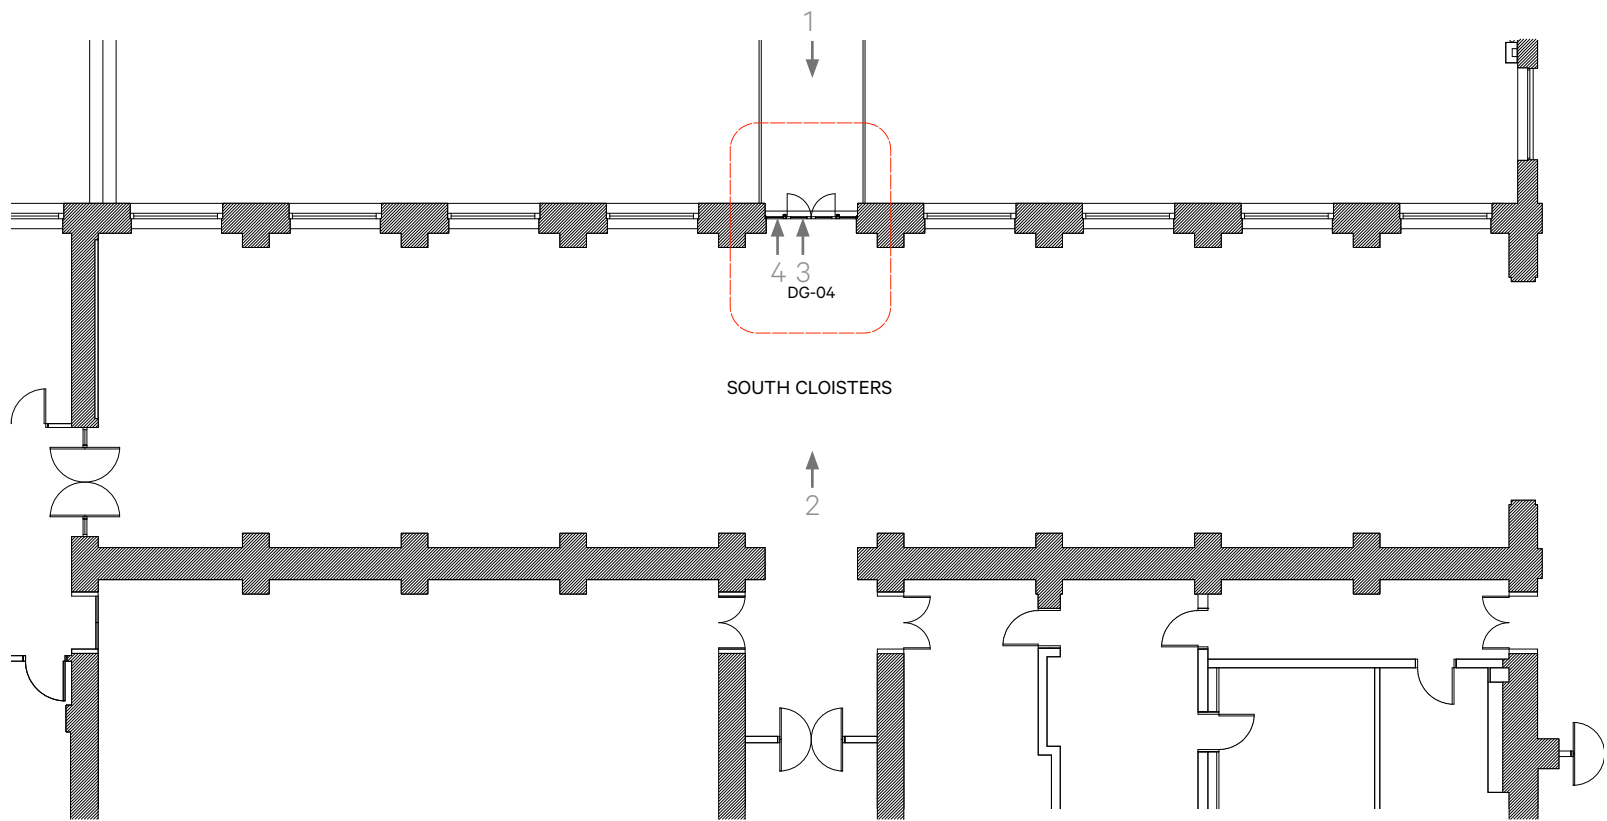
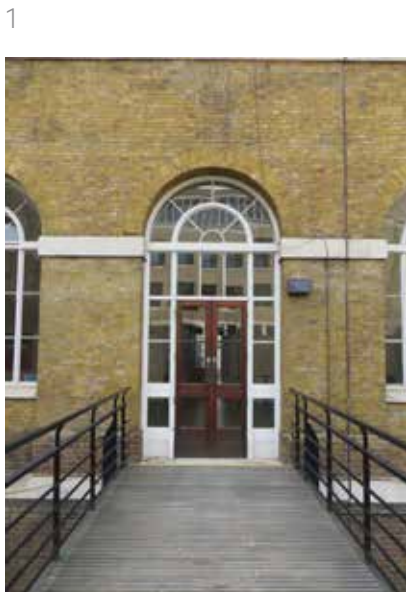
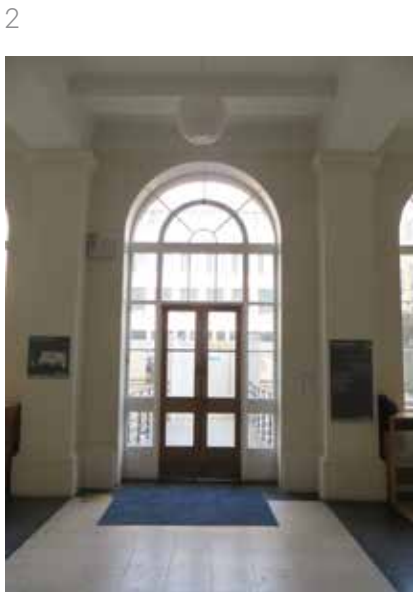
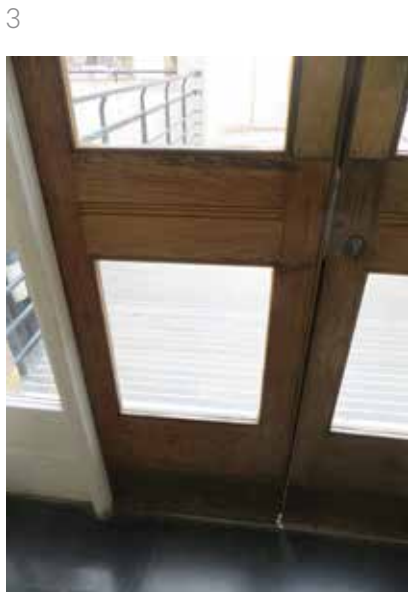
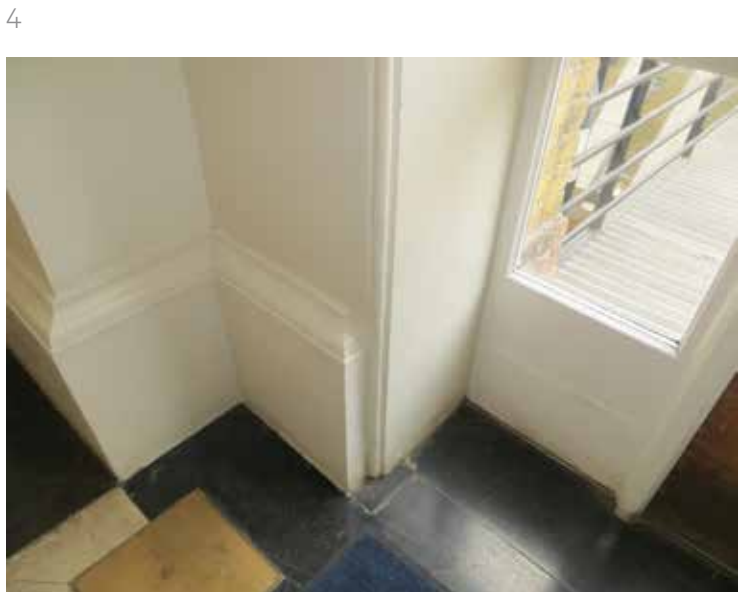
3.1 Existing Condition - South Cloisters

The existing timber door is in a poor state of repair and is different in appearance from those in the North Cloisters.

The black limestone at the threshold has damaged edges.

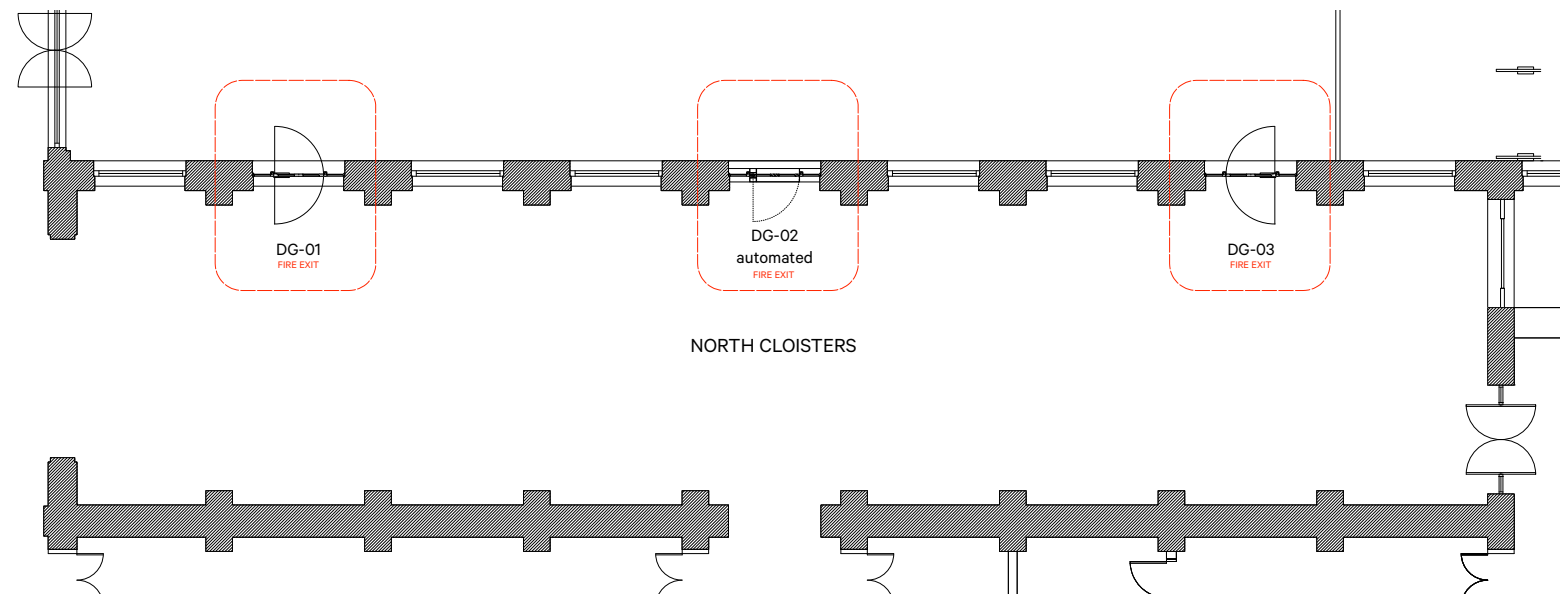
Three new single leaf doors within existing frames.

- Replace the double doors with single leafs with profiles to match existing. Existing frames, sidelights and fanlights are to be retained.
- Replace the door controls with more discreet units with improved functionality.
- Improve the threshold details by replacing the timber with stone and have stone inserts to the floor box cover plates.
- Repair the damaged black limestone flooring where necessary.

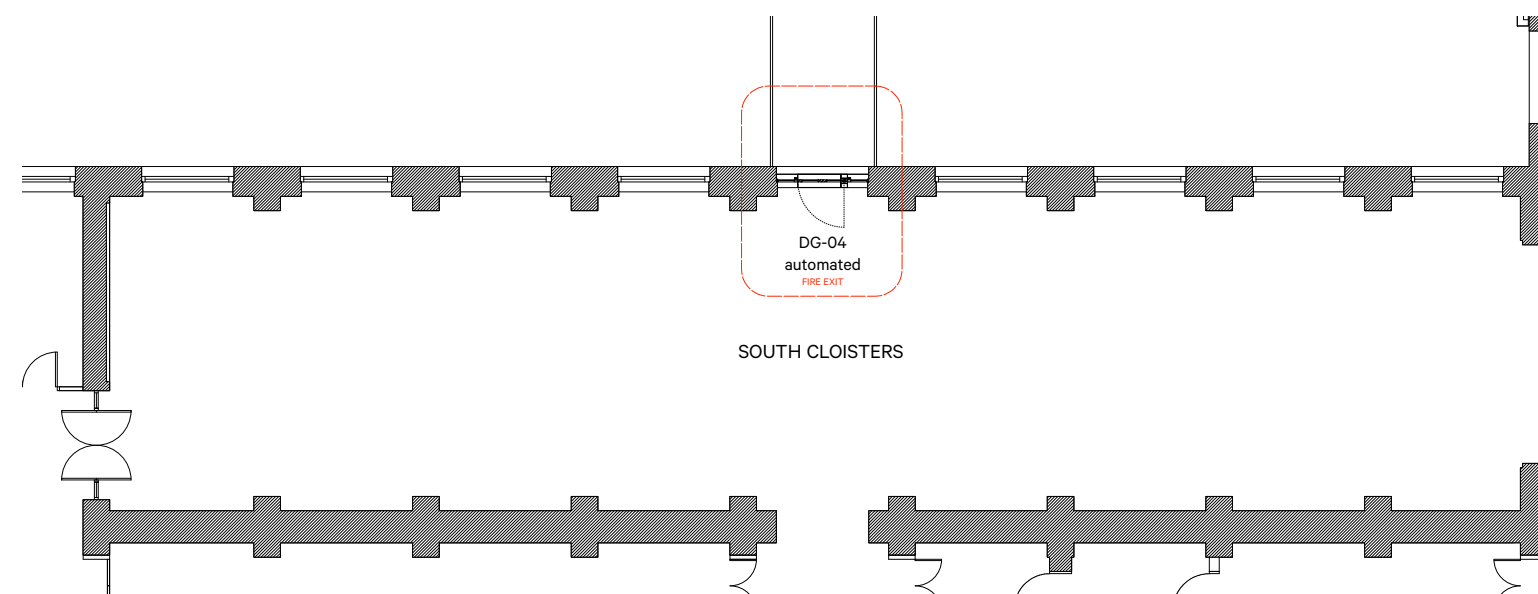
New single leaf door within existing frames.

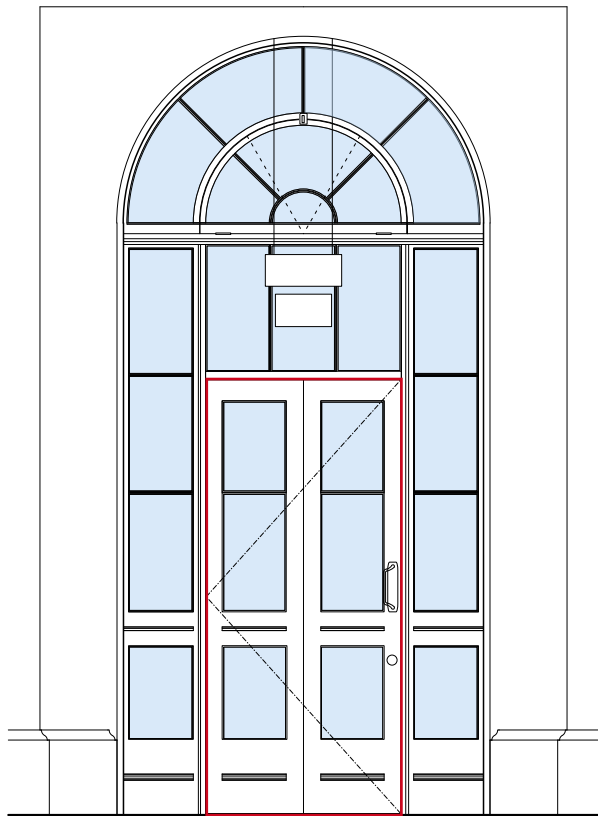
Internal elevation as proposed

Four new doors are proposed, three to the north cloisters and one to the south cloisters. It is the intent that two of these doors (D.02 & D.04) will be automated to allow DDA access to the Wilkins Terrace and the Japanese Garden.

By matching the existing profiles the proposed doors reflect the existing historic fabric.

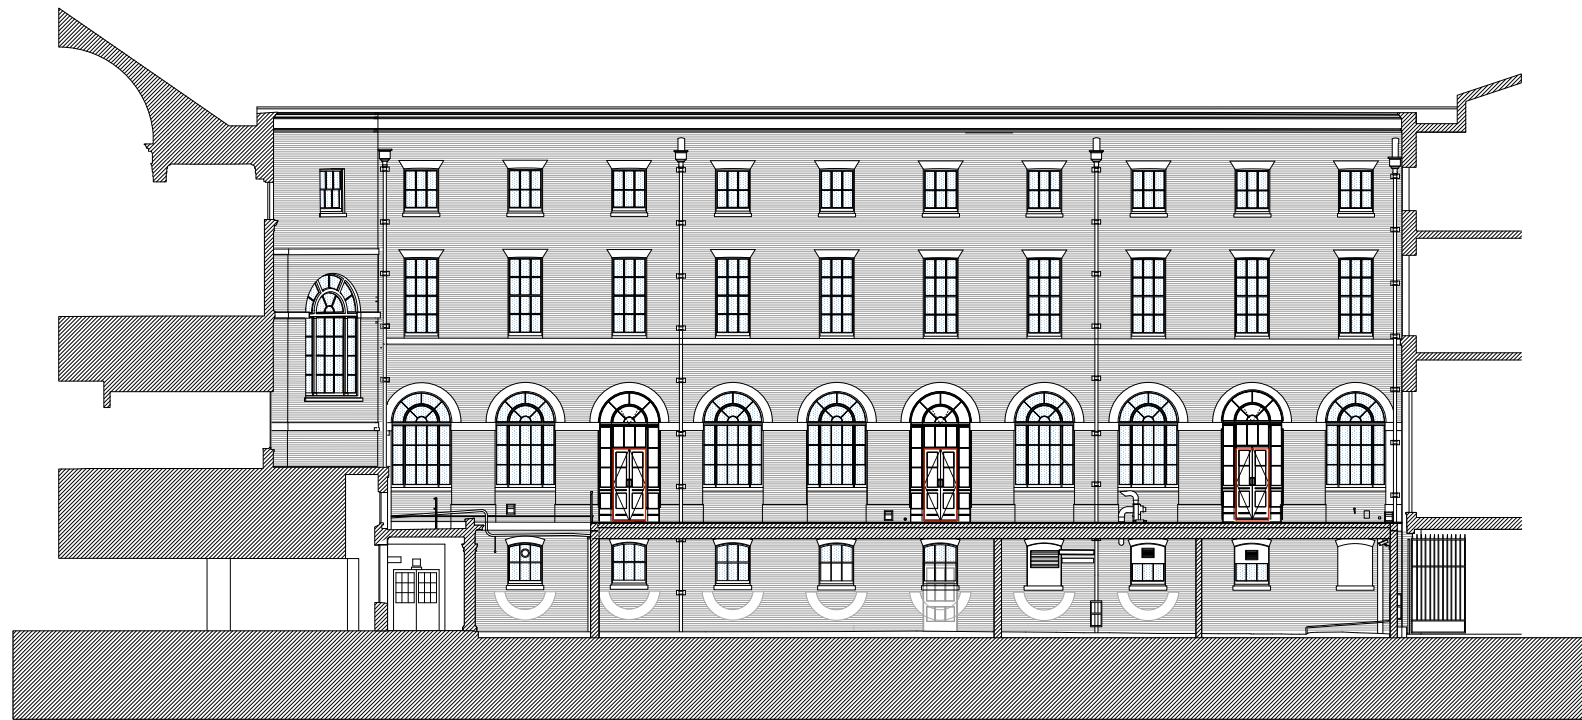
North Cloisters Elevation as Existing

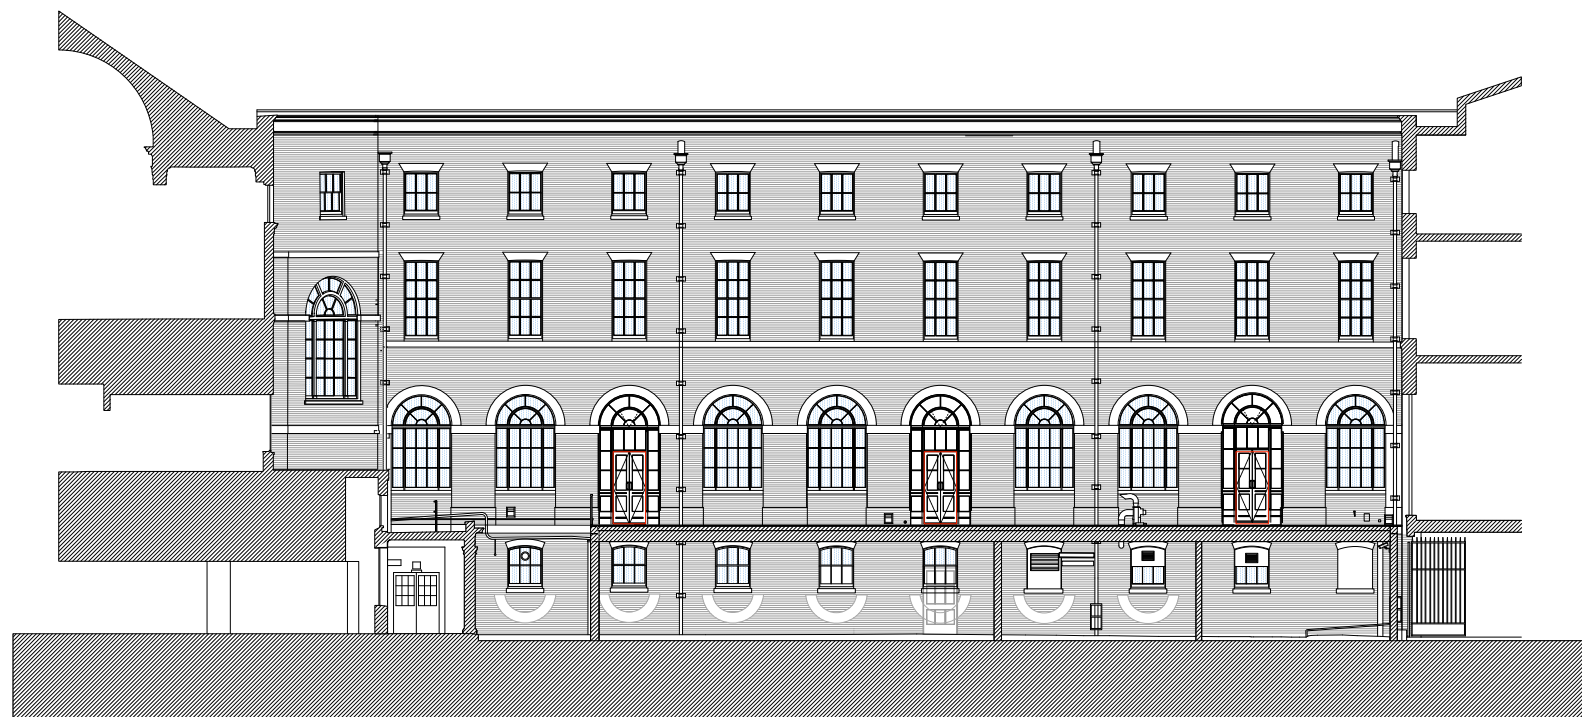
North Cloisters Elevation as Proposed

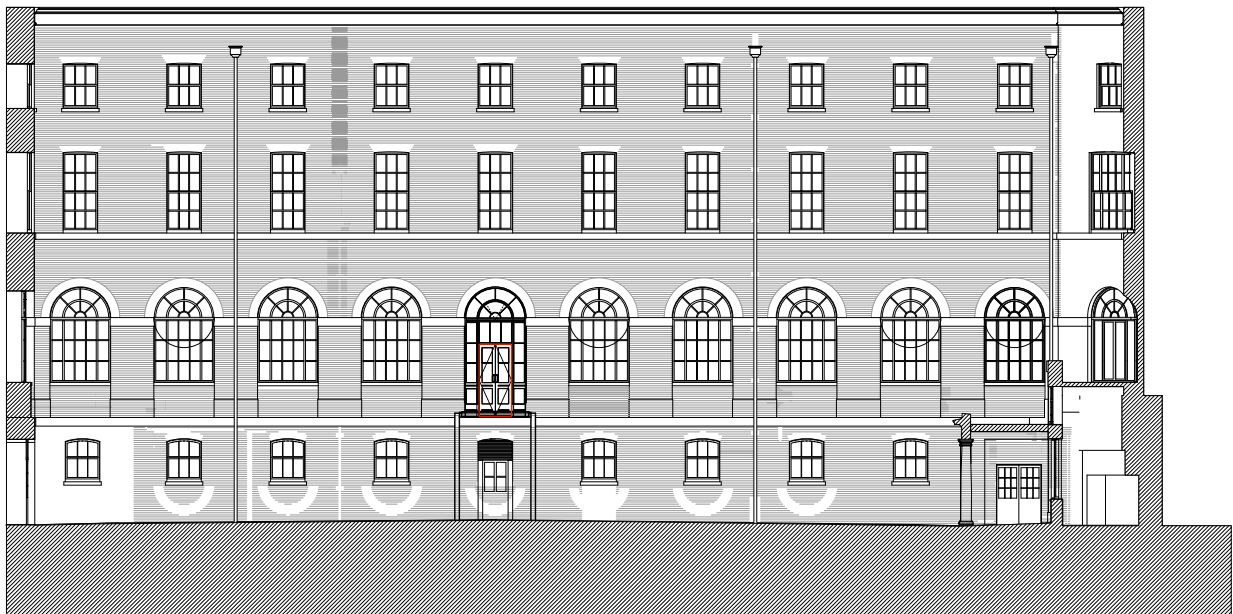
South Cloisters Elevation as Existing

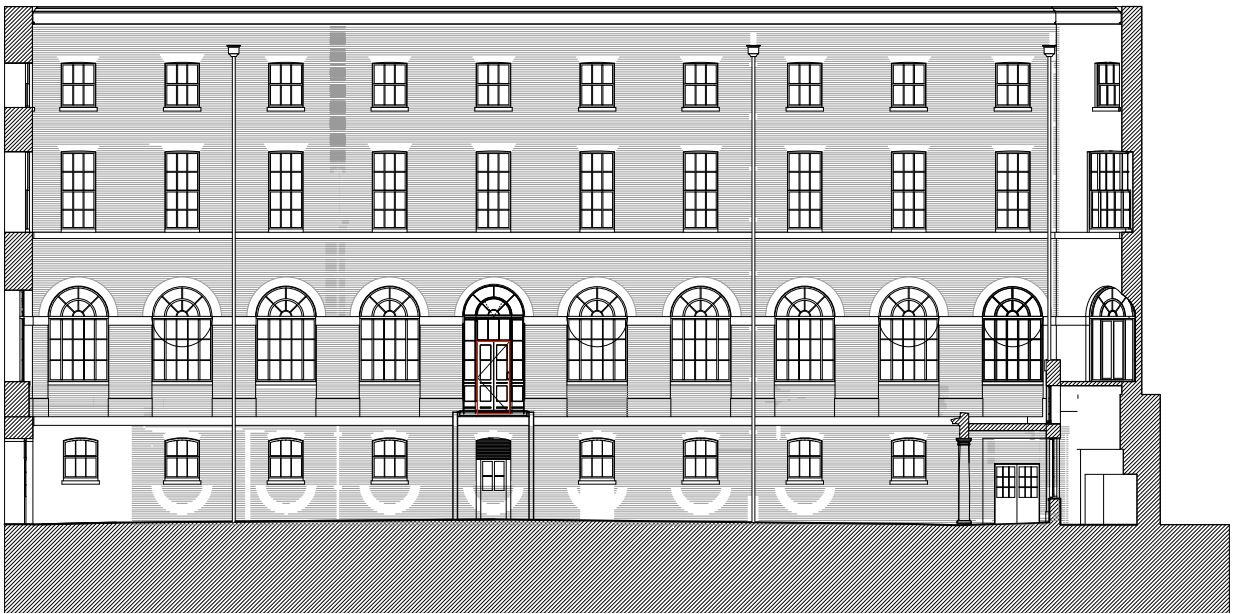
South Cloisters Elevation as Proposed
