5.1 _ The Building's History and Form

5.2 _ The Building's External Appearance Red Lion Square

5.3 _ The Building's Internal Appearance Ground and Upper Floors

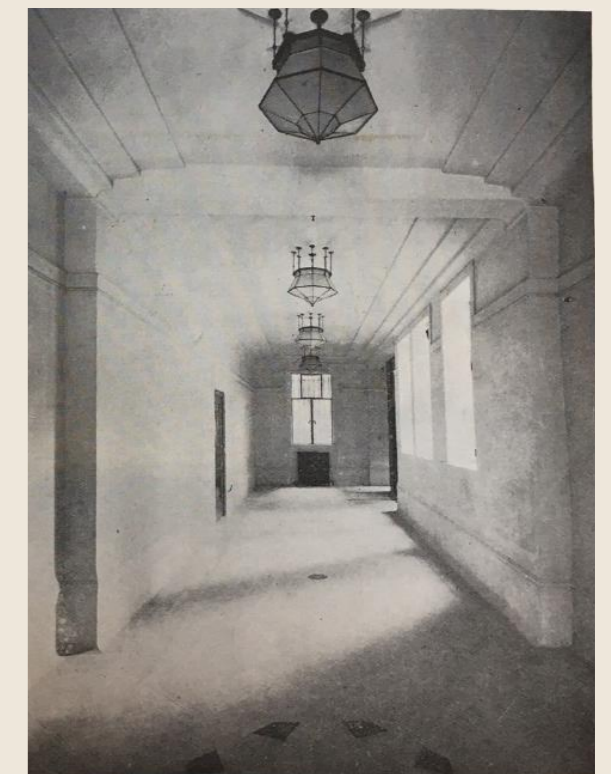
5.1.C The Entrance Hall 1925

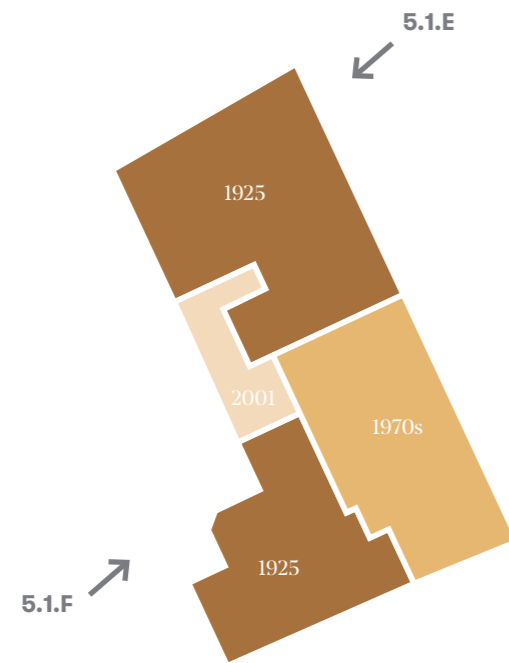
5.1.D Diagram showing the existing building form and construction phases - Plan

Diagram 5.1.D to 5.1.F illustrate the current form of the building and its phased construction. The site comprises the single building: it is of six storeys in height, including the basement / lower ground floor level, but not including taller services housing and lift overrun structure at roof level. The current building remains in the use for which it was originally constructed, although now for a new occupier - TOG.

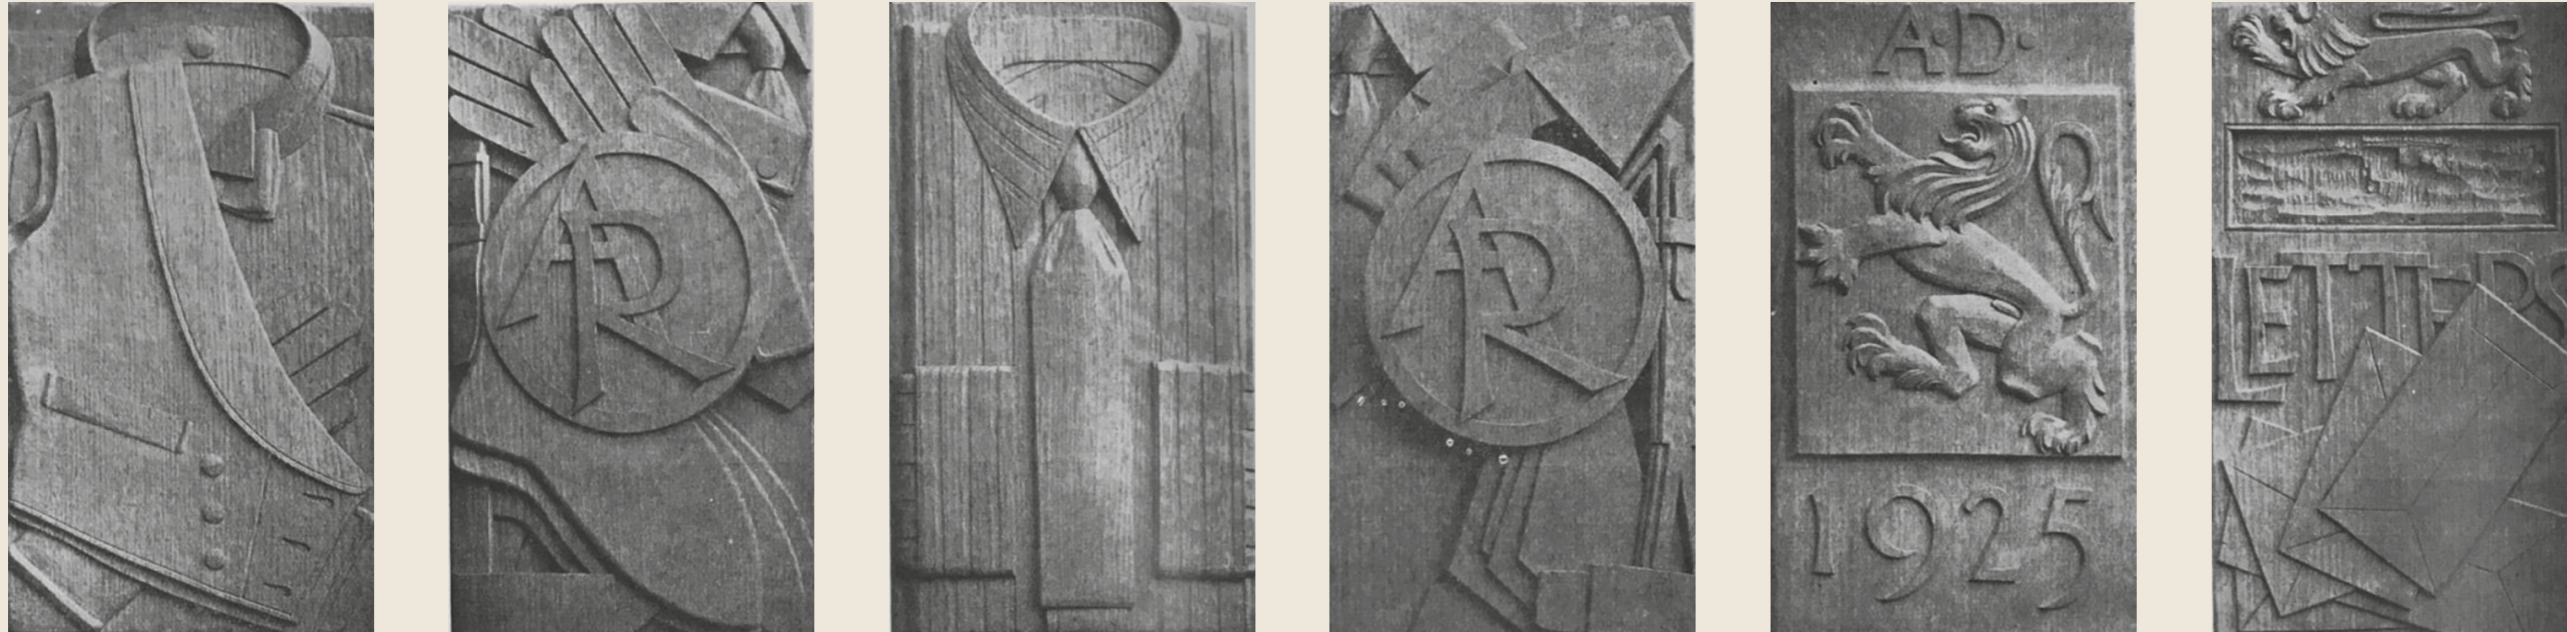
5.1.G The original carved panels to the entrance doors by Percy Metcalfe, 1925. Two remain today,

At ground floor the central main entrance door is two window bays in width. The facade projects to boldly frame this entrance, with timber, double doors recessed from the main facade placing further emphasis on the entrance. These timber entrance doors incorporate two of the carved panels by Percy Metcalfe from the original entrance doors. These carvings denoted Austin Reed products and can be seen in figure 5.1.G. "Summit House No.12" is picked out in applied black metal lettering above this entrance.

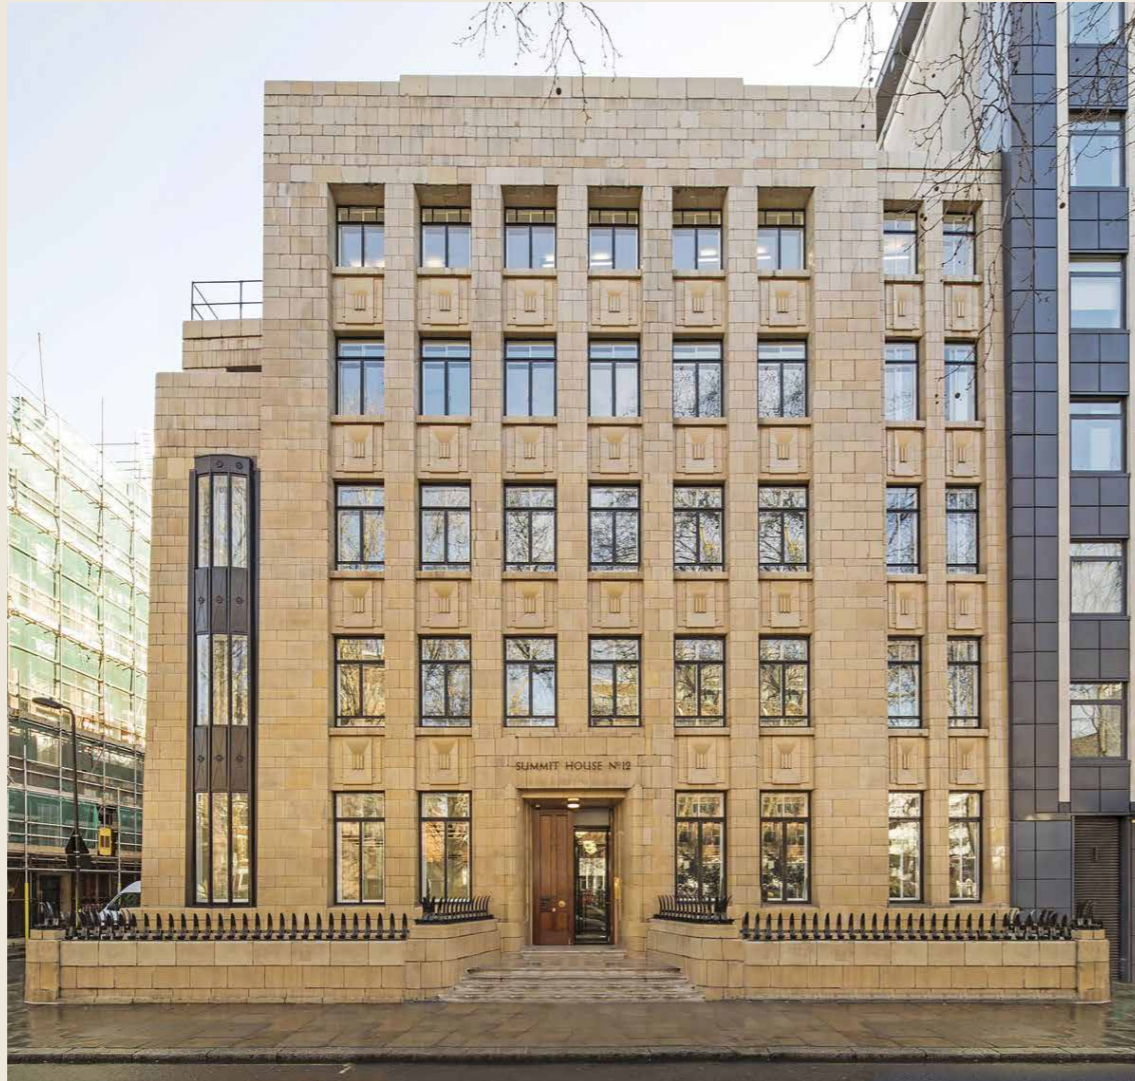
5.2.A Red Lion Square facade

The principal facade of the building to Red Lion Square is in a modernist, Art Deco style, characterised by cubic massing with inset, vertical fenestration bays. The yellow faïence cladding is punctuated by the fenestration bays which have geometrically decorated spandrel panels between the black painted metal framed windows. The central elevation is six bays in width and up to fourth floor level, with a flanking recessed two bay element to the west. Similarly recessed in depth, but only three storeys in height, is a full height metal framed bay window feature to the east. This marks the corner of the building. The elevation has a strong vertical emphasis, accentuated by these windows.

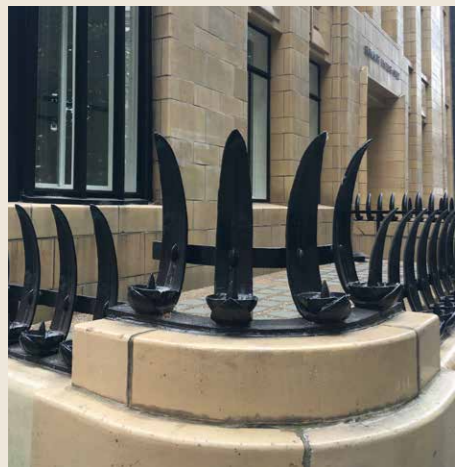
5.2.B Iron railings

At street level on Red Lion Square a low-wall encloses the lower ground floor. The wall includes decorative iron railings, in a 'lotus' leaf style with lotus leaf finials at each corner and either side of the main entrance. These walls bound light wells to the lower ground floor, which were enclosed and roofed with concrete pavement lights in the late 1930s. Integral stone steps from street level provide access to the main entrance at the raised ground floor.

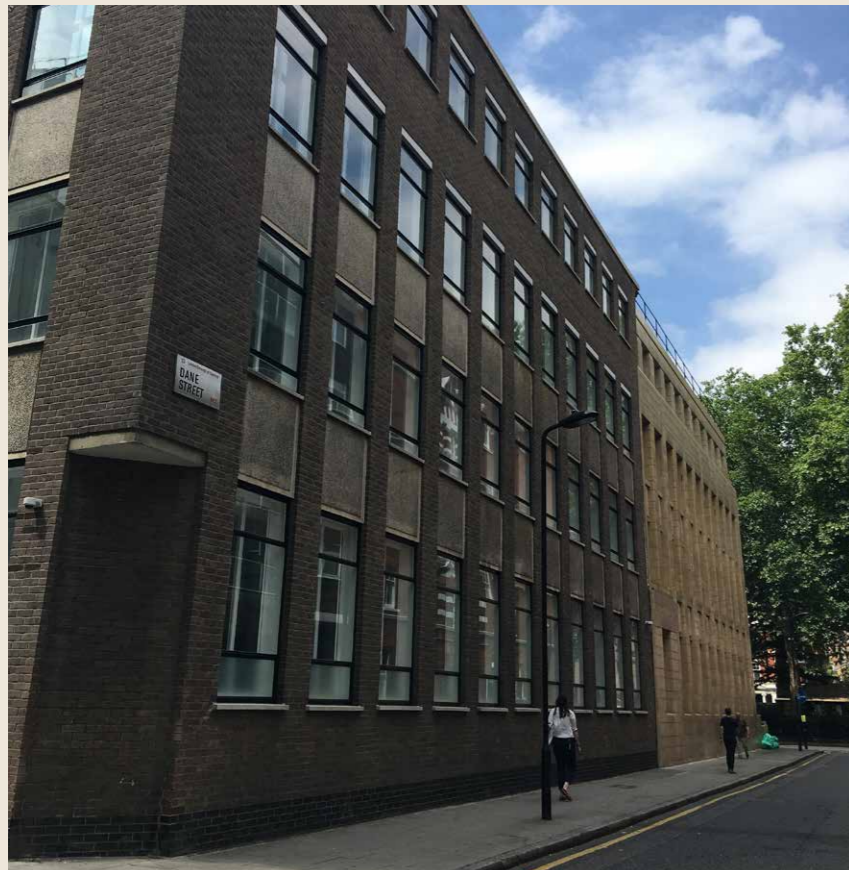
5.2.F Dane Street facade - looking towards Red Lion Square

The original 1925 building that fronts Red Lion Square continues along Dane Street. This elevation is again clad in yellow faïence with matching geometric detail, inset vertical fenestration bays and black painted metal window frames, as the main facade. Window bays are just three storeys high to this facade, with the third and fourth stories each setback from the floors below.

This original facade extends eleven bays to the south, however at ground floor the southernmost pair of bays have been combined to frame a single window opening. This is the original position of a secondary entrance from Dane Street in-filled in 1967.

There is a distinct differentiation between old and new along Dane Street. Beyond the original facade, the southern part of the elevation along Dane Street, is the 1970's extension. This follows the original massing and form as well as the window pattern. This element of the facade is simpler in detail and brick clad, with concrete spandrels between the black painted metal window frames. This facade also extends eleven bays along Dane Street and then turns the corner onto Eagle Street and extends four bays westward. At ground floor the brick facade is chamfered at this corner.

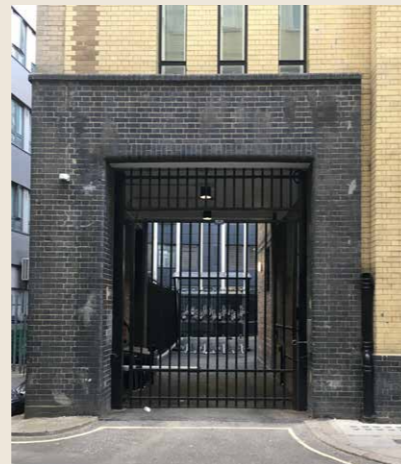
5.2.I Rear entrance

The 1970s elevation to Eagle Street meets the original elevation to the west, noted by its Art Deco styling again. Its elevational treatment is much simpler in design to the faïence façades, with the use of a mix of dark brickwork to the ground floor and yellow glazed bricks above. Later alterations are again evident to this elevation, such as the infill of the former door entrance. This elevation also includes a single loading bay to the west end, with narrow strip windows to the supported building above it.

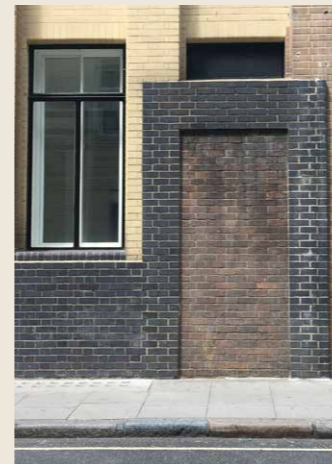
5.2.J Brick details

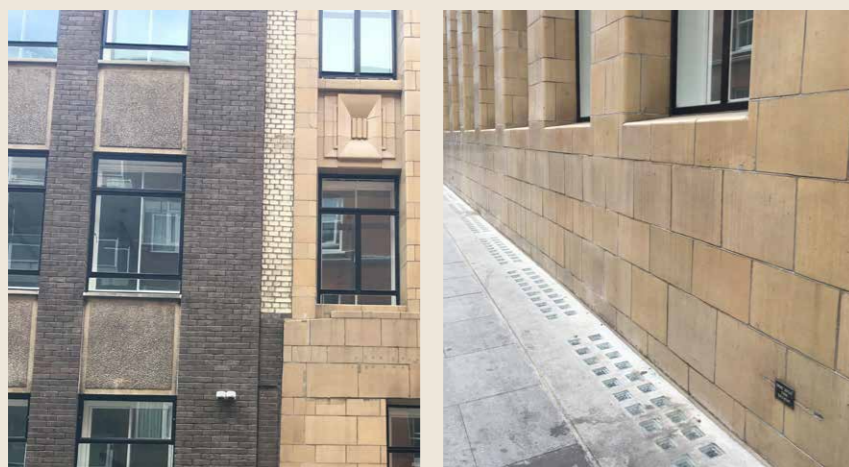
5.2.G Facade details

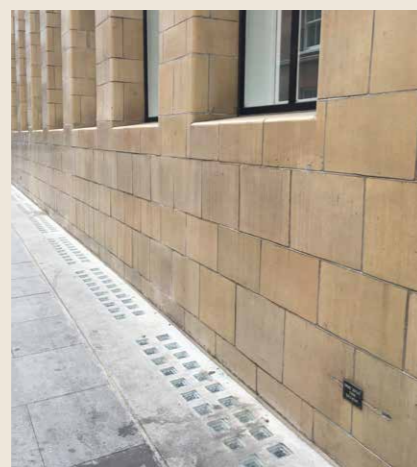
5.2.H Dane Street pavement lights

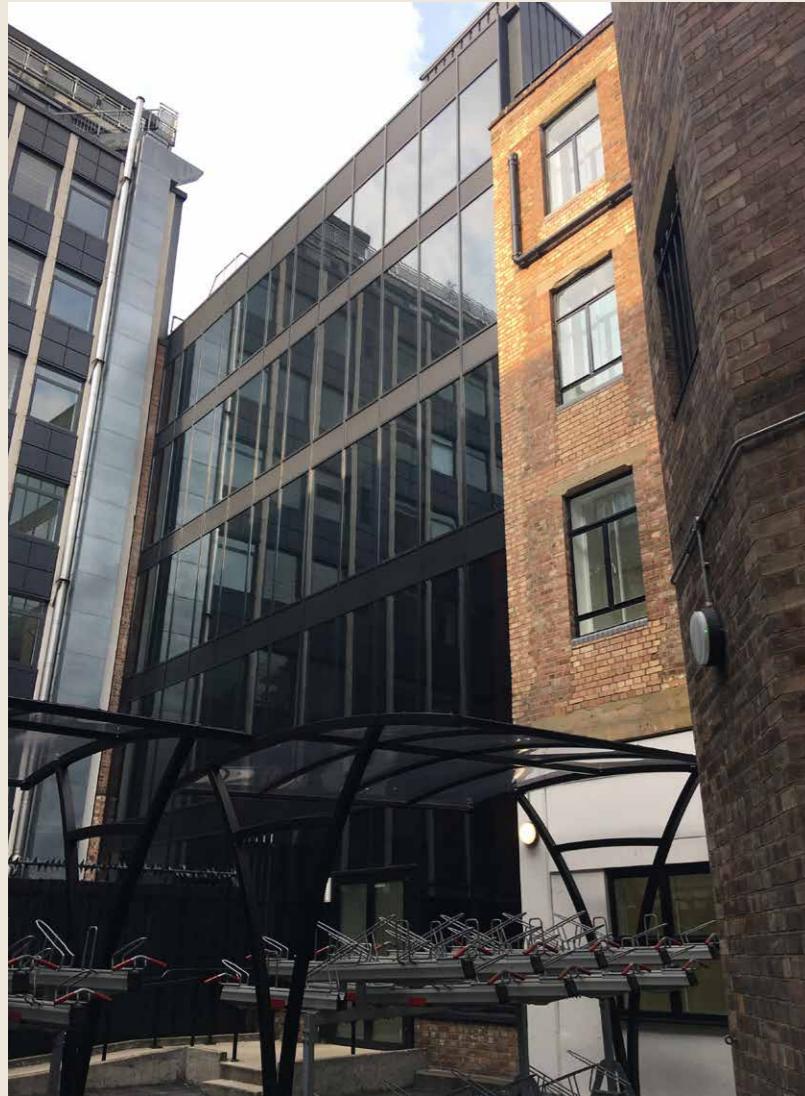
5.2.L East facade to service yard

This elevation of the original building to this yard is utilitarian in character with fletton brickwork and simple fenestration with black painted, metal framed windows. This sits alongside the 2001 extension with black framed and black, back painted glass, curtain wall cladding. These façades are secondary in character and interest.

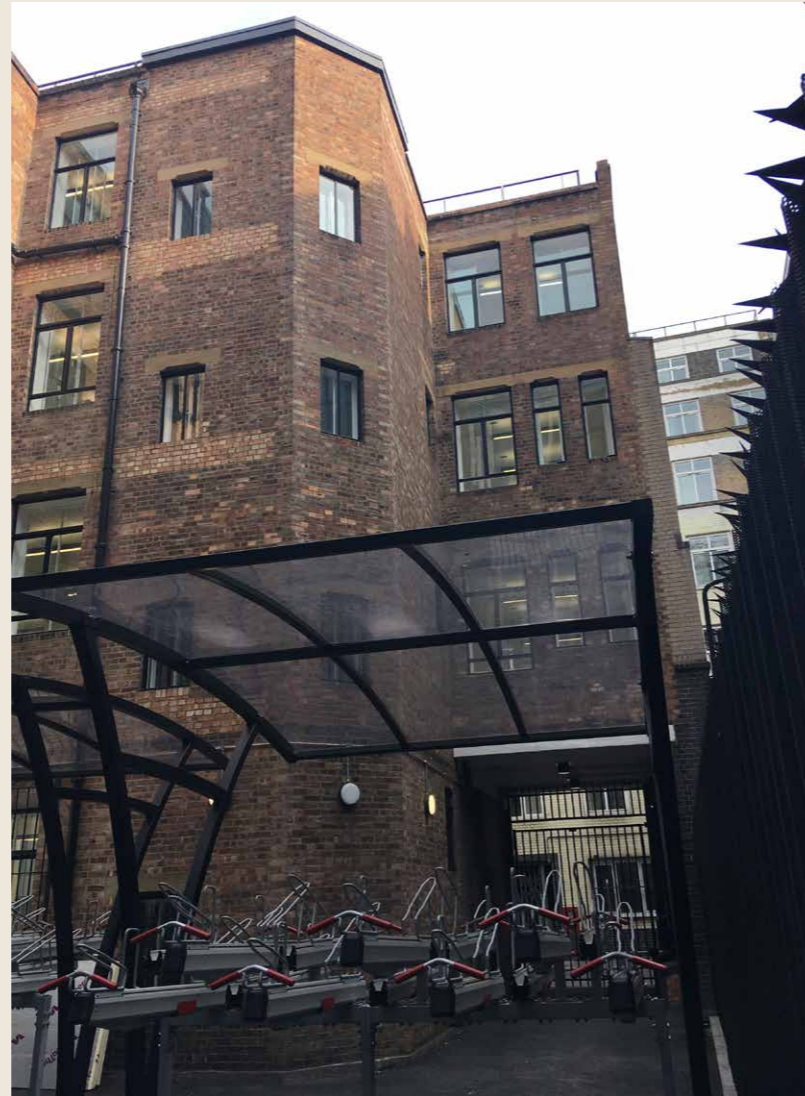
5.2.M View of southern building from service yard

The surface of the courtyard is tarmac and the perimeter boundary is a tall, black metal fence with a spin guard anti-climb system above. When the building was extended in 2001, a concrete ramp and stair was built in the north west corner of the yard to provide level access to the building. These have a black metal, key-clamp balustrade.

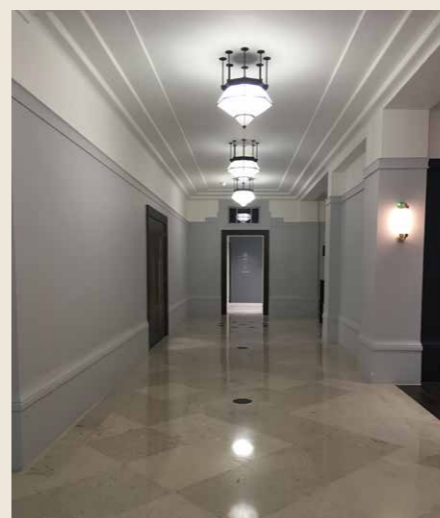
5.3.A Ground floor entrance hall

It is to the ground floor entrance lobby and hall and the main stair core that some of the original features and details have been retained - albeit in fragmented guises (figures 5.3.A, B and C). The lobby and hall maintain their original stone flooring, with contrasting black inlaid patterns. These areas have typical Art Deco style mouldings, to the cornice, picture rail and skirtings, although this is possibly a recreation as doorways off this hall have been created and in-filled over time. The current main entrance doors, lobby doors and doors leading from the hallway are all new from the 2017 refurbishment. The lobby and hall also contain ceiling hung pendants. These are replicas, from the 2001 fit out, that echo the look of the original 1920s fittings. Directly off this hall is a new reception area with new wall, floor and ceiling finishes.

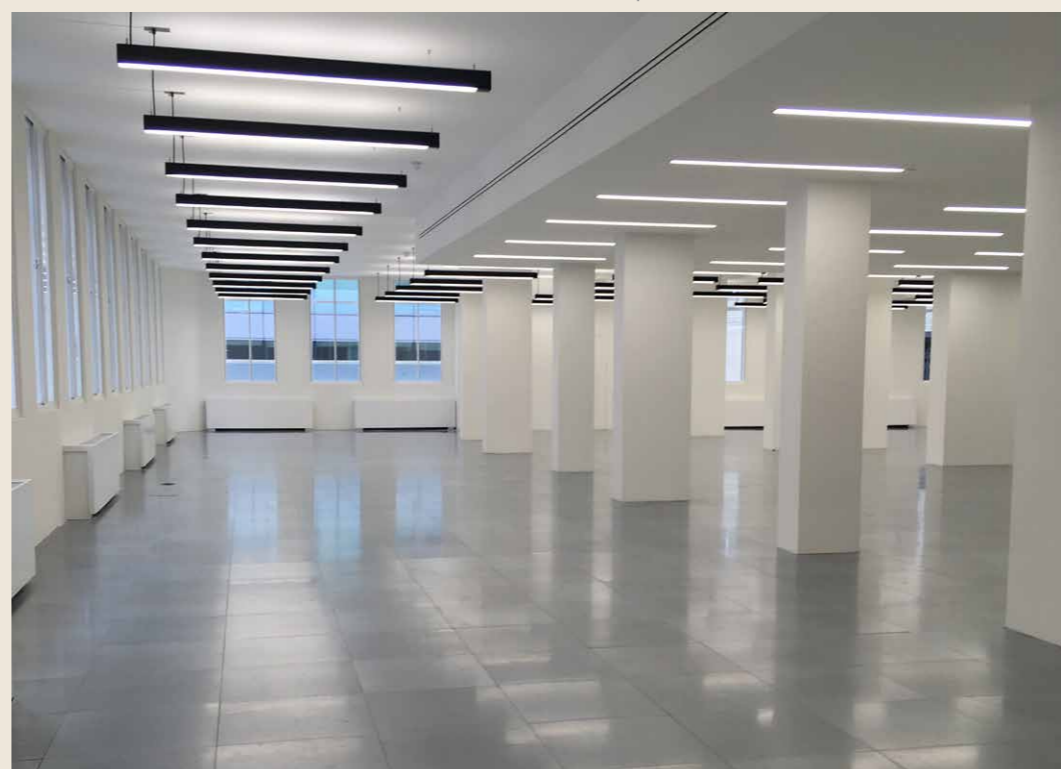
5.3.D Internal office spaces (L-R) Ground floor, First floor, Fourth floor

The recent refurbishment has created modern, cat. A office space. The main office spaces throughout are white painted plasterboard, walls and ceilings, with suspended black linear fittings and metal raised access floors, as images 5.3.D illustrate. Floor plates have been opened up, with new structure inserted in 2017 to create the current large open plan spaces.

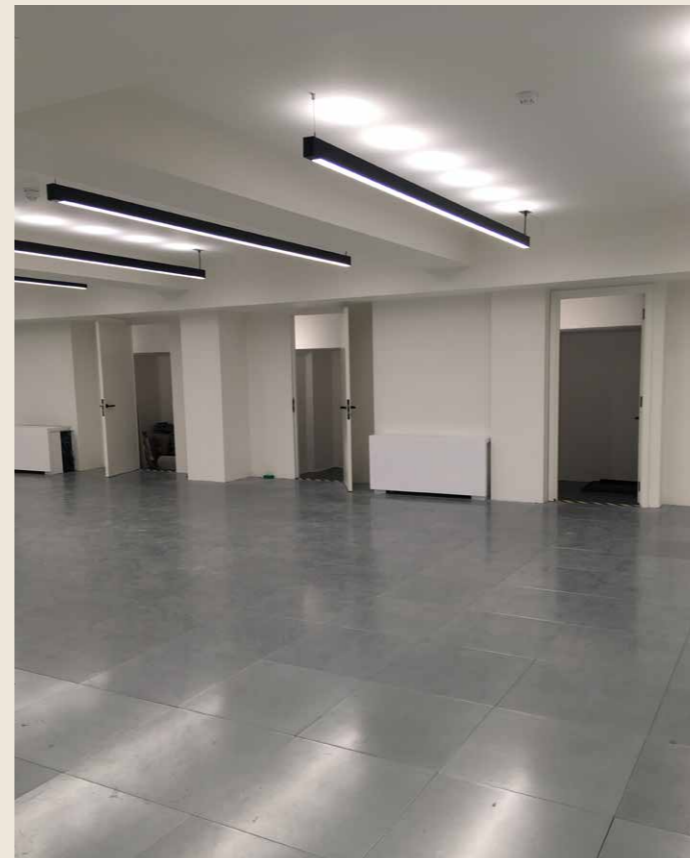
5.3.F Lower ground floor enclosed pavement lights to north

There is little natural light to this floor. To the southern office space four small pavement lights from Eagle Street provide the only natural light to this deep space, as illustrated in figure 5.3.E. To the northern office space there is no natural light. Six pavement lights existing along Dane Street, however these are tenant store rooms and are blocked off from the main office via solid partitioning (figure 5.3.F).

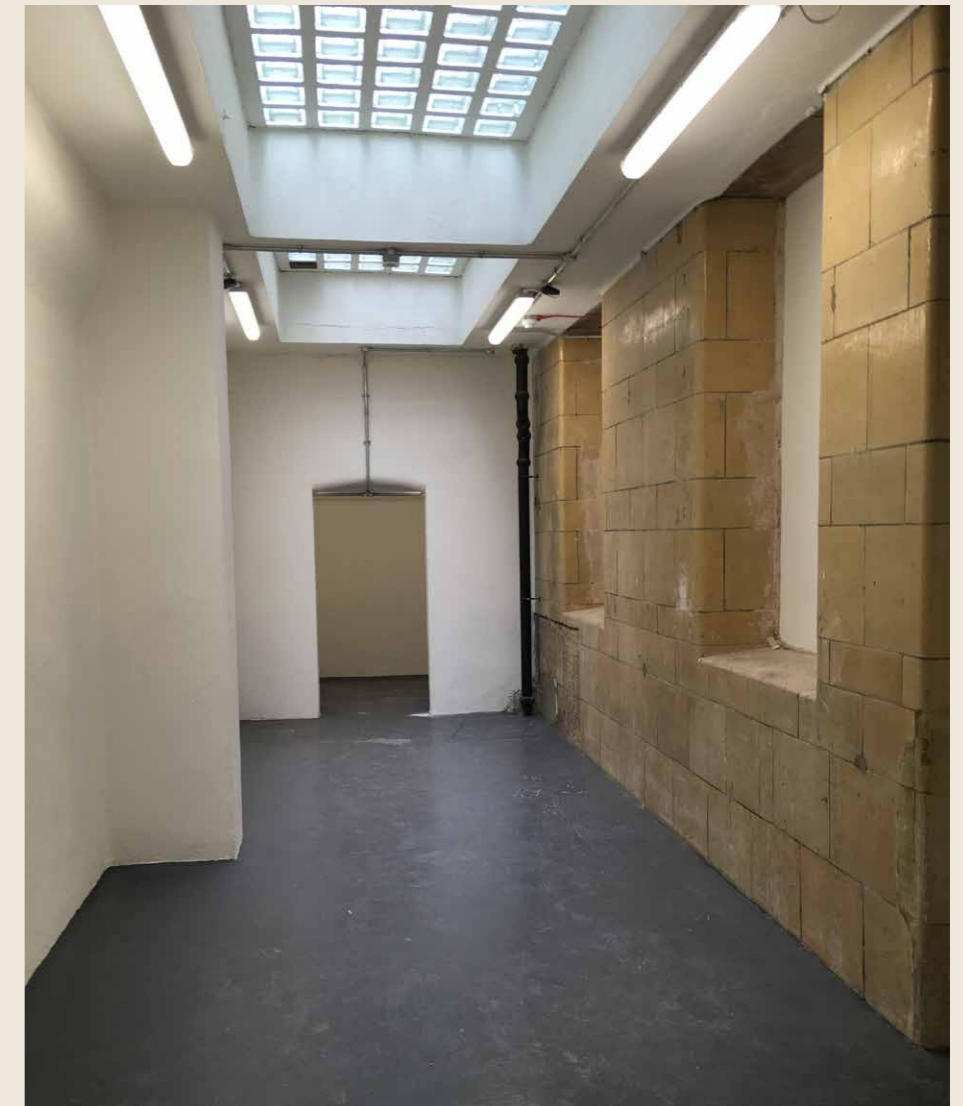
5.3.G Lower ground floor north east covered lightwell

The only legible element of the original building is the separate and now enclosed eastern light well area to this northern office. As figure 5.3.G illustrates the original external faience facade of the building above continues down at this level and there are two infilled window openings. This highlights that this area was once an open light well - it is believed that this was infilled with the current concrete and glass roof and associated structure in 1936. This internal storage area is currently accessed via a standard timber door. What once would have been a mirroring light well to the western side of the main entrance is now occupied by a sub-station, with no access.
