Highgate Newtown Community Centre and  
Fresh Youth Academy

# Preliminary Ecological Survey

Highgate  
Newtown  
Community  
Centre,  
25 Bertram  
Street,  
London,  
N19 5DQ

## Preliminary Ecological Appraisal Report

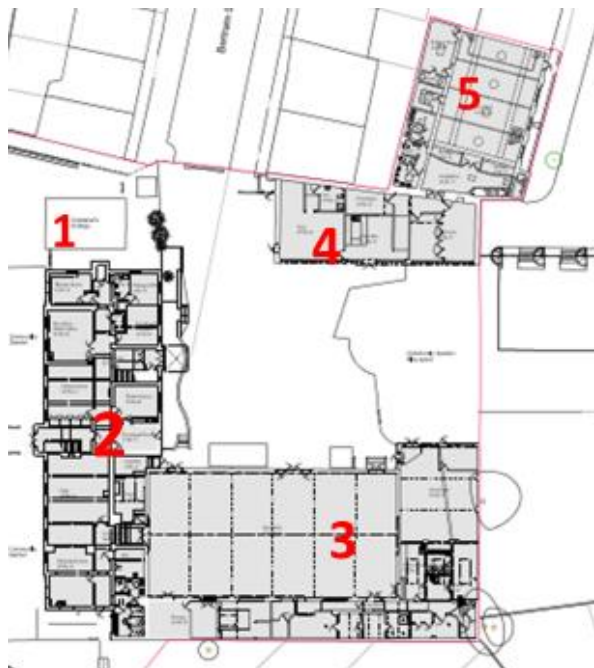
Figure 2: Layout of Buildings and Numbered for Ease of Reference in the Report

- 4.11 The daytime internal and external inspections consisted of five buildings set within hard standing. The exteriors of the buildings were inspected for access points, and evidence of bats and nesting birds. The internal inspection of the buildings examined features of interest, potential bat roost sites and bird nesting areas. For ease of reference in this report, the buildings have been numbered and can be seen overleaf in Figure 2.

- 4.12 In summary, building 1, is a detached derelict building. The building was surrounded by a locked gate and the surveyor had limited views of the building. Building 2, consists of a three-story bricked wall under a plain tiled gable roof. Building 3, is a semi-detached building comprising of a gymnasium and a workshop. The building has brick walls under a pitched felt roof and a flat felt roof. Building 4, has brick, stone and cement walls with a flat cement roof space. Building 5, has painted brick walls under a slate roof. The table below identifies confirmed and potential features along with the potential of the buildings. Under the section, Confirmed Evidence/Potential, green denotes limited to low potential for use by roosting bats and yellow denotes potential for use by roosting bats.

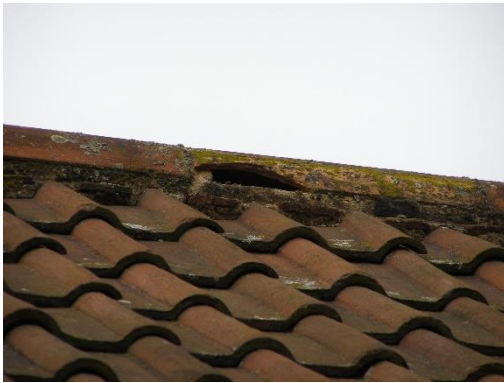
- 4.13 The internal inspection consisted of one loft space within building 2. The roof space had a ridge height of 2.2 metres. The roof space consisted of bitumen felt with timber battens and timber trusses. The roof space had two chimneys, one sitting central and one within the southern section of the loft. The floor space consisted of insulated floors cluttered with stored items. Potential access points were noted around the southern chimney with visible light noted. Crevice spaces were noted around the chimneys with gaps between the roof space and the breast and within the ridge space. No signs of bats in the form of droppings, marks, stains and or debris were noted during the inspection.

Hole and missing section of ridge tile in building 2

- Three of the buildings on site noted potential crevice roosting features, two of the three potential areas are recent compared to the previous 2016 inspection, records of crevice species bats are within 1km of the site, it is recommended that a detailed endoscope inspection is carried out on the three areas of noted potential, should signs of bats be found then further echolocation surveys will be required in the active survey season (May to August inclusive).

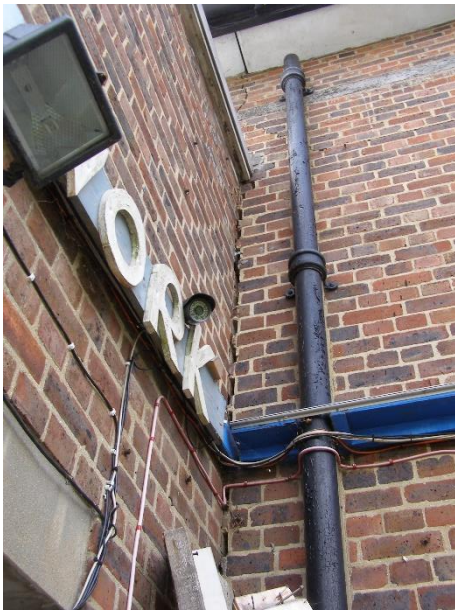
3	walls	brick	cracks noted between two semi-detached buildings, recessed and runs longer than a metre, spacing greater than 15mm and very little to no cobwebs present - potential for access and crevice opportunities for crevice roosting species
	roof	tar/felt	pitched roof in a good state of repair. Flat felt roof in a good state of repair - limited potential for access and crevice spaces
	soffits	wooden	boxed soffits, no gaps, weathered areas, cracks or missing areas - limited potential for access and crevice spaces
4	walls	brick, stone and cement	good state of repair, no holes, cracks, gaps or missing sections - limited potential for access and crevice spaces
	roof	flat lead and flat cement	good state of repair, no holes, lifts, or missing sections, limited potential for access and crevice spaces
5	walls	painted brick and adjoin to adjacent residential building with flashing	good state of repair, no holes, gaps, cracks or missing sections, adjoining flashing had no lifts, gaps or missing sections - limited potential for access and crevice spaces

Crack in brick wall building 3

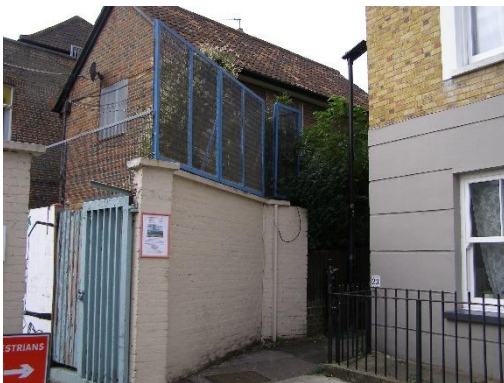
No access to building 1

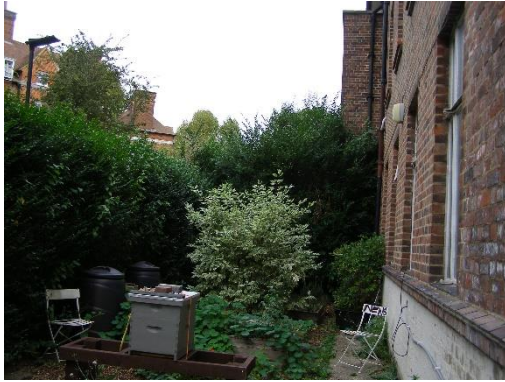
Garden typical areas to rea of building 2

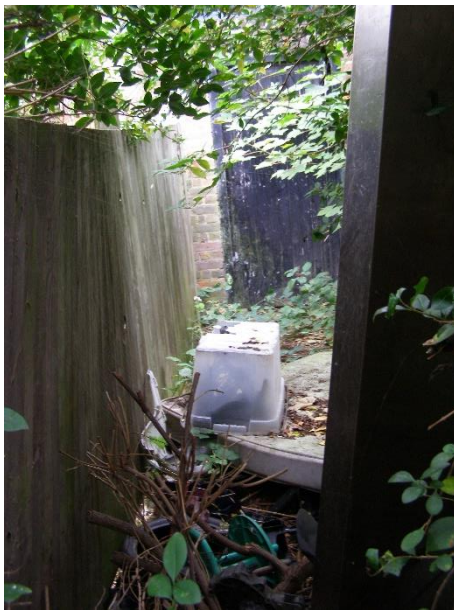
4.6 Areas of dense and scattered scrub are located within the north-western corner and north-eastern corner of the site. Within the grounds of the former cottage (referred to as building 1 in this report) had scattered fly tipping. No access was granted to the area around building 1, as a result the species composition was observed from gaps in the defunct hedgerow and it is likely that some species were missed and are not listed in this section. Occasional emergent scrub is located within the southern boundary of the site.

Fly tipping and scrub within gardens of building 1

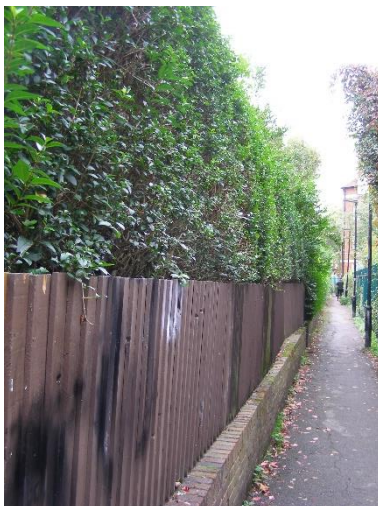
4.8 Within the western boundary and north-western corner of the site is a defunct hedgerow. The hedgerow shows signs of regular management with average heights of 2 metres and a width of 0.5 metres. The hedgerow consists of one species: privet (*Ligustrum sp.*) with occasional ivy.

Hedgerow within western boundary

- A lighting plan that is direct, low lux and low light spill to ensure future use as potential traversing grounds.
- Works to the boundary hedgerow should be carried outside of the nesting bird season to ensure minimal disturbance to potential nesting sites.

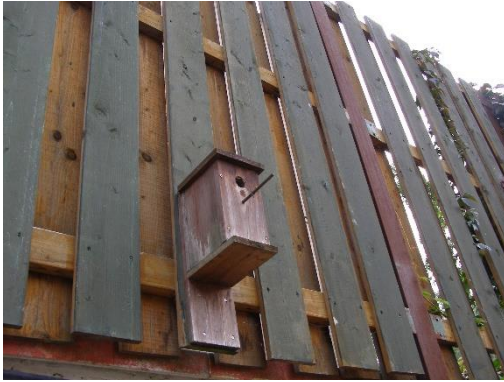
Bird boxes within eastern section of site

- Removal of the nesting boxes outside of the active nesting bird season (March to August inclusive), with compensation for the loss of these sites by incorporating nesting bricks/boxes into the design of one or more of the buildings on site.
