Appendix E Intrusive investigations

Job Ragged School

Project: 18 Vine Hill

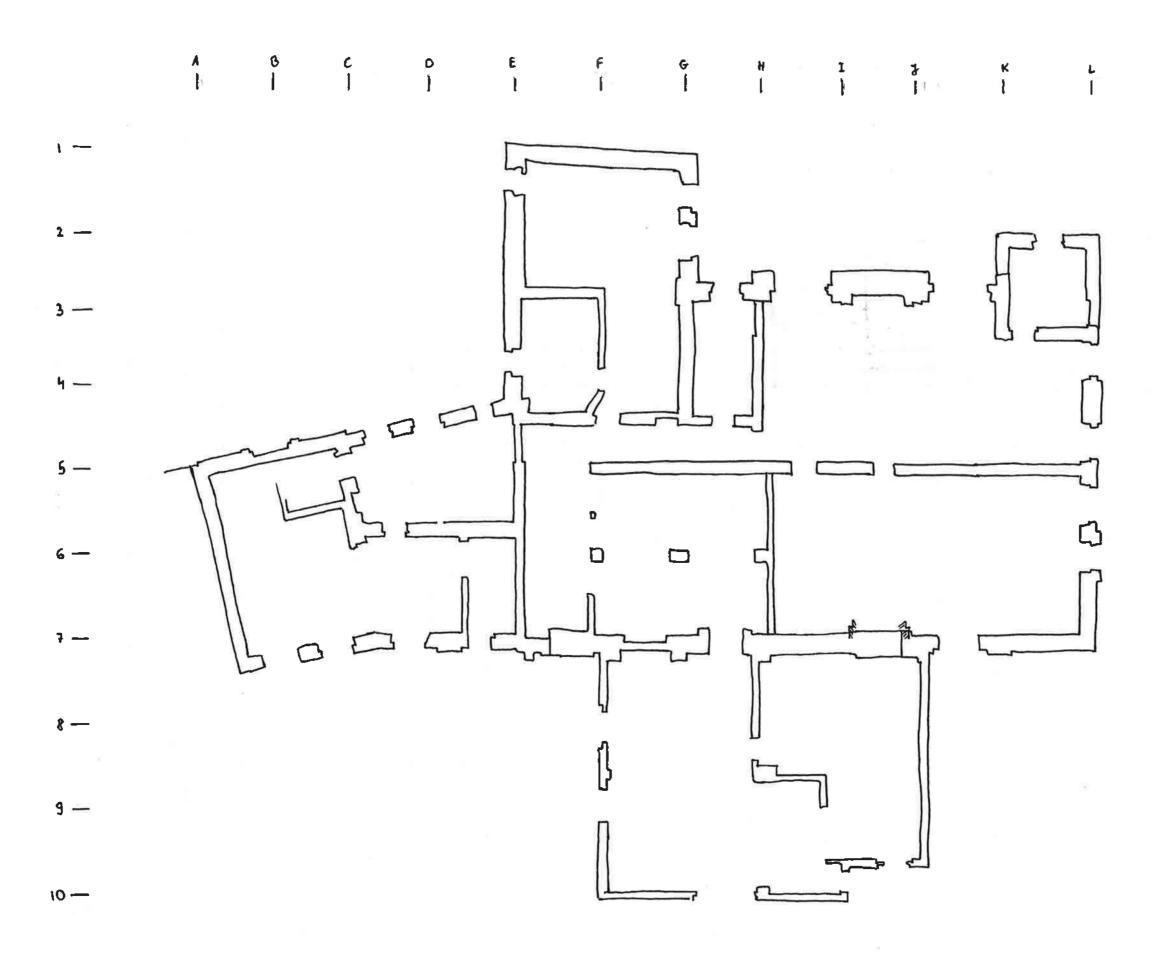
Title Lower Ground Floor

104.
-1	230×75 timber joists @ 400 c/c
-	140× 75 timber juists @ 400c/c
-3	? ×60 fieller joists @ ? c/c
	filler joists @ 600 c/c
-2	270×75 timber joists @ 500 c/c
B1	355 x 150 beam
12	1 - 150 x 60 timber joists @ 400 c/c
2	2 - 220 × 100 joists @ 2000 c/c
B2	205 × 205 beam (relatively recent)
4	? x? filler joists @? c/c
= 5	30 mm wide filler joists @ 600 c/c
6	275 x 75 timber joists @ 400 c/c
< 7	? × 60 fieler joists@? c/c
- 8	280 x 70 timber joists @ 350 c/c
-\frac{3}{4}	3 -> 130 x 60 timber joists @ 400 c/c
4	4 - 240 × 100 timber joists @ 2000 e/c
15 6	5 - 130 x 60 timber joists @ 400 c/c
-	6 - 220 × 100 timber @ 2000 c/c
83	140 x? beam (could be original section)
_ 9_	64 mm wide filler joists @ 600 c/c
-\frac{7}{7}8	7-0 140 x 60 timber joists @ 400 c/c
8	8- 260×85 timber joists @ 2000 c/c
B4	380 × 140 beau
B 5	355 × 140 beam
