**GROUND INVESTIGATION,  
BASEMENT IMPACT ASSESSMENT  
&  
GROUND MOVEMENT ASSESSMENT  
REPORT**

**138-140 HIGHGATE ROAD  
HIGHGATE  
LONDON  
NW5 1PB**

**Report Title:** Ground Investigation, Basement Impact Assessment Report & GMA for 138-140 Highgate Road, Highgate, London NW5 1PB

**Job No:** P1323J1303/SL

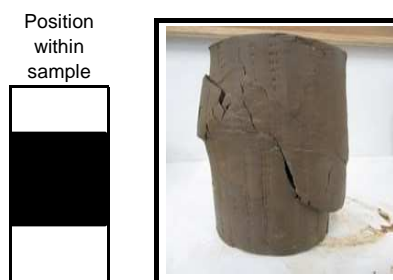
### Mohr Circles

Deviator stress corrected for area change and membrane effects. Mohr circles and their interpretation is not covered by BS1377. This is provided for information only.
