Grand Union House, Camden  
Existing vs Proposed 151118  
With Mango Consent

Grandunion House  
SUNLIGHT ANALYSIS

NOV 2018

## Appendix C – Window Maps

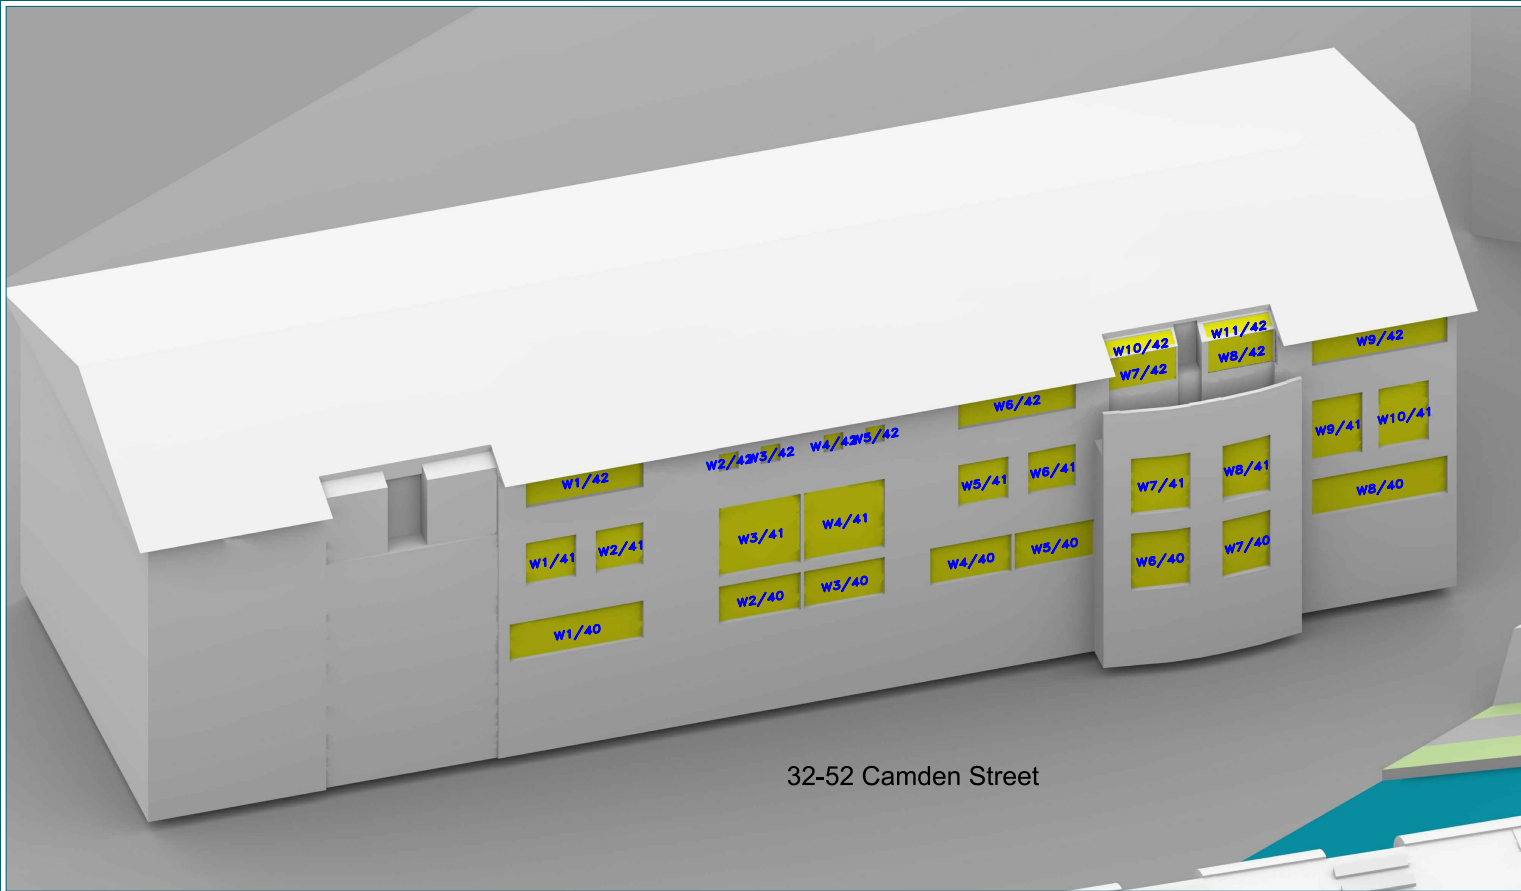
32-52 Camden Street

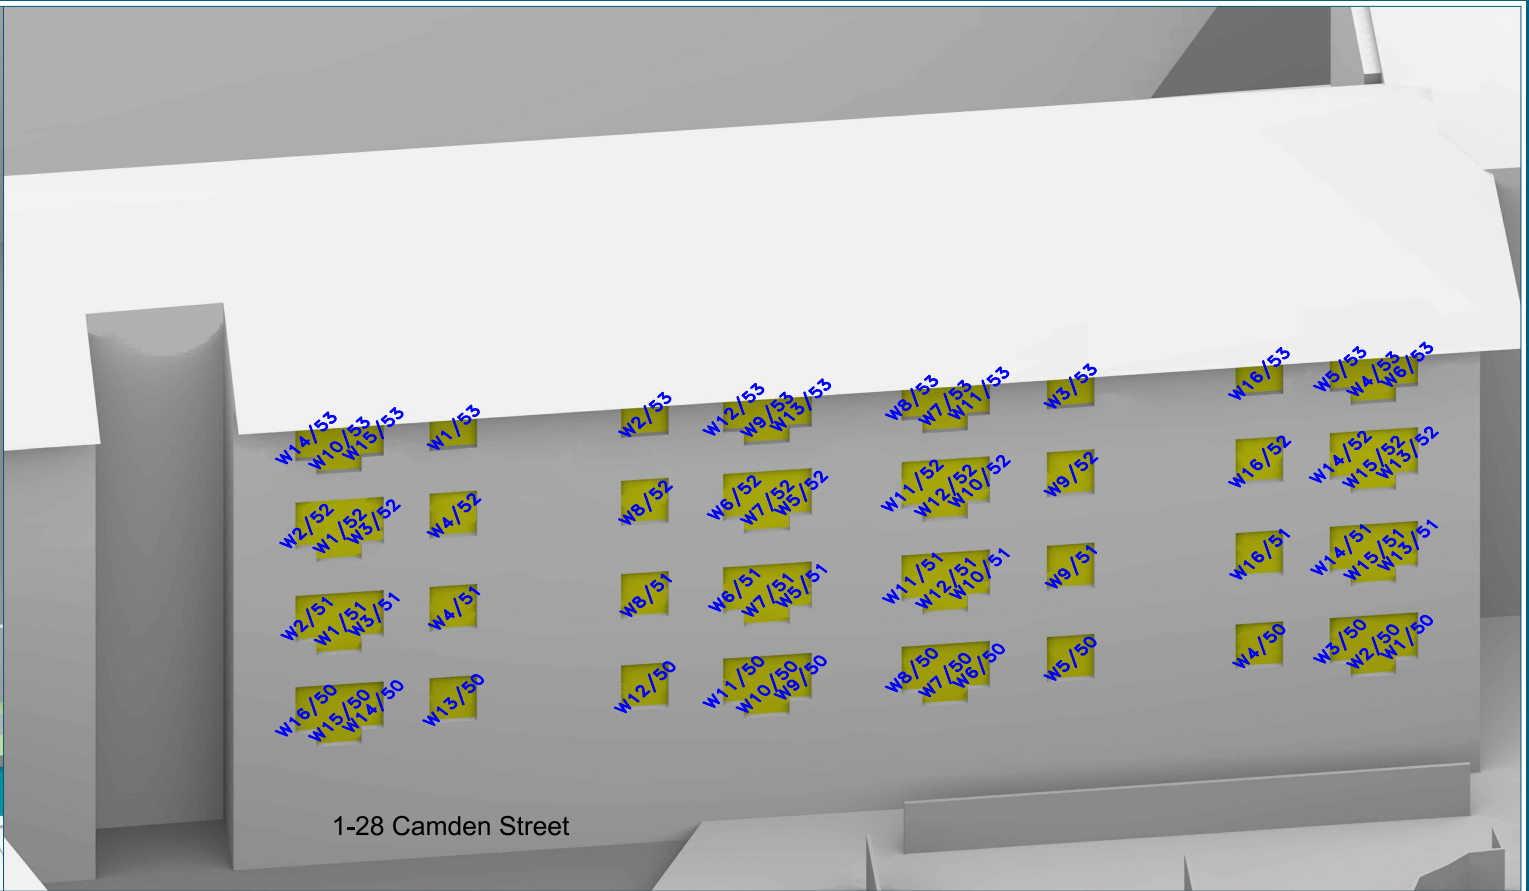
1-28 Camden Street

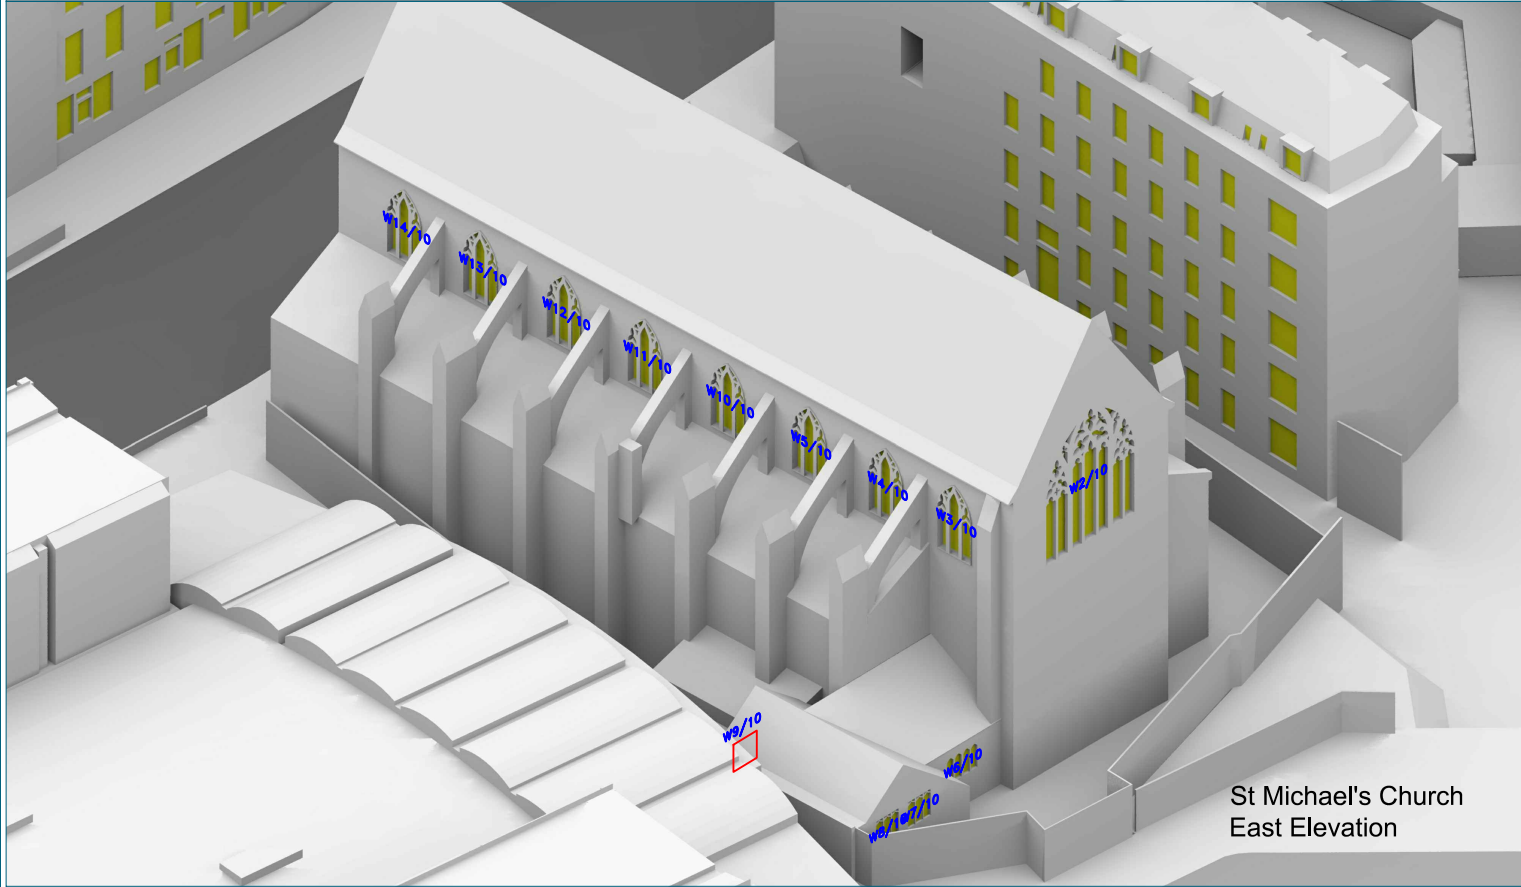
St Michael's Church  
East Elevation

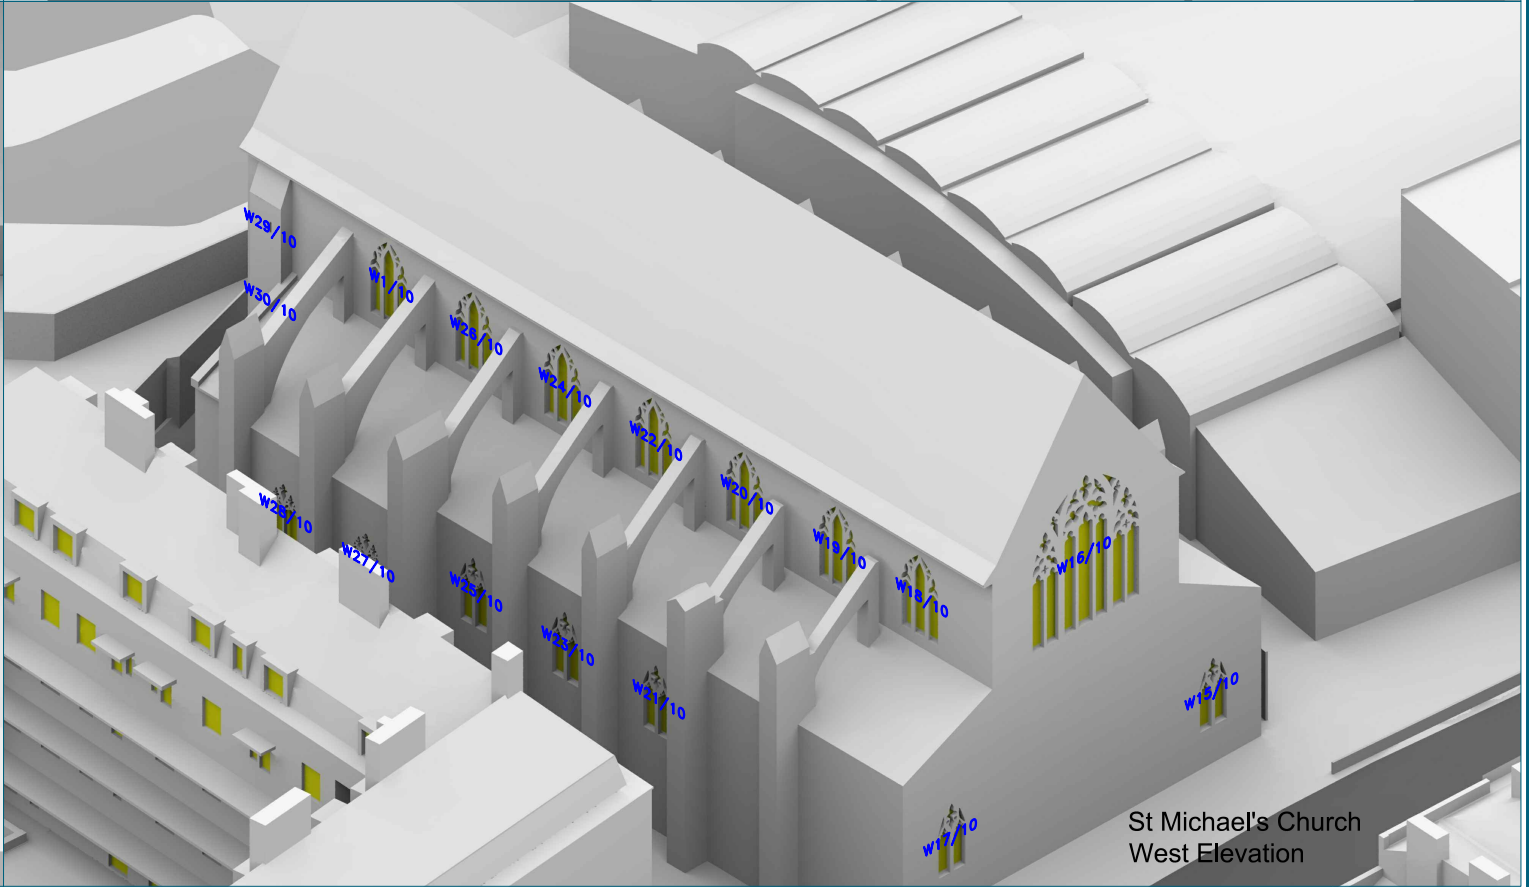
St Michael's Church  
West Elevation
