British Museum
 Perimeter Properties Refurbishment

P2007246

1-1A Montague Street
 Third Floor
 Reflected Ceiling Plan
 Planning and LBC Application

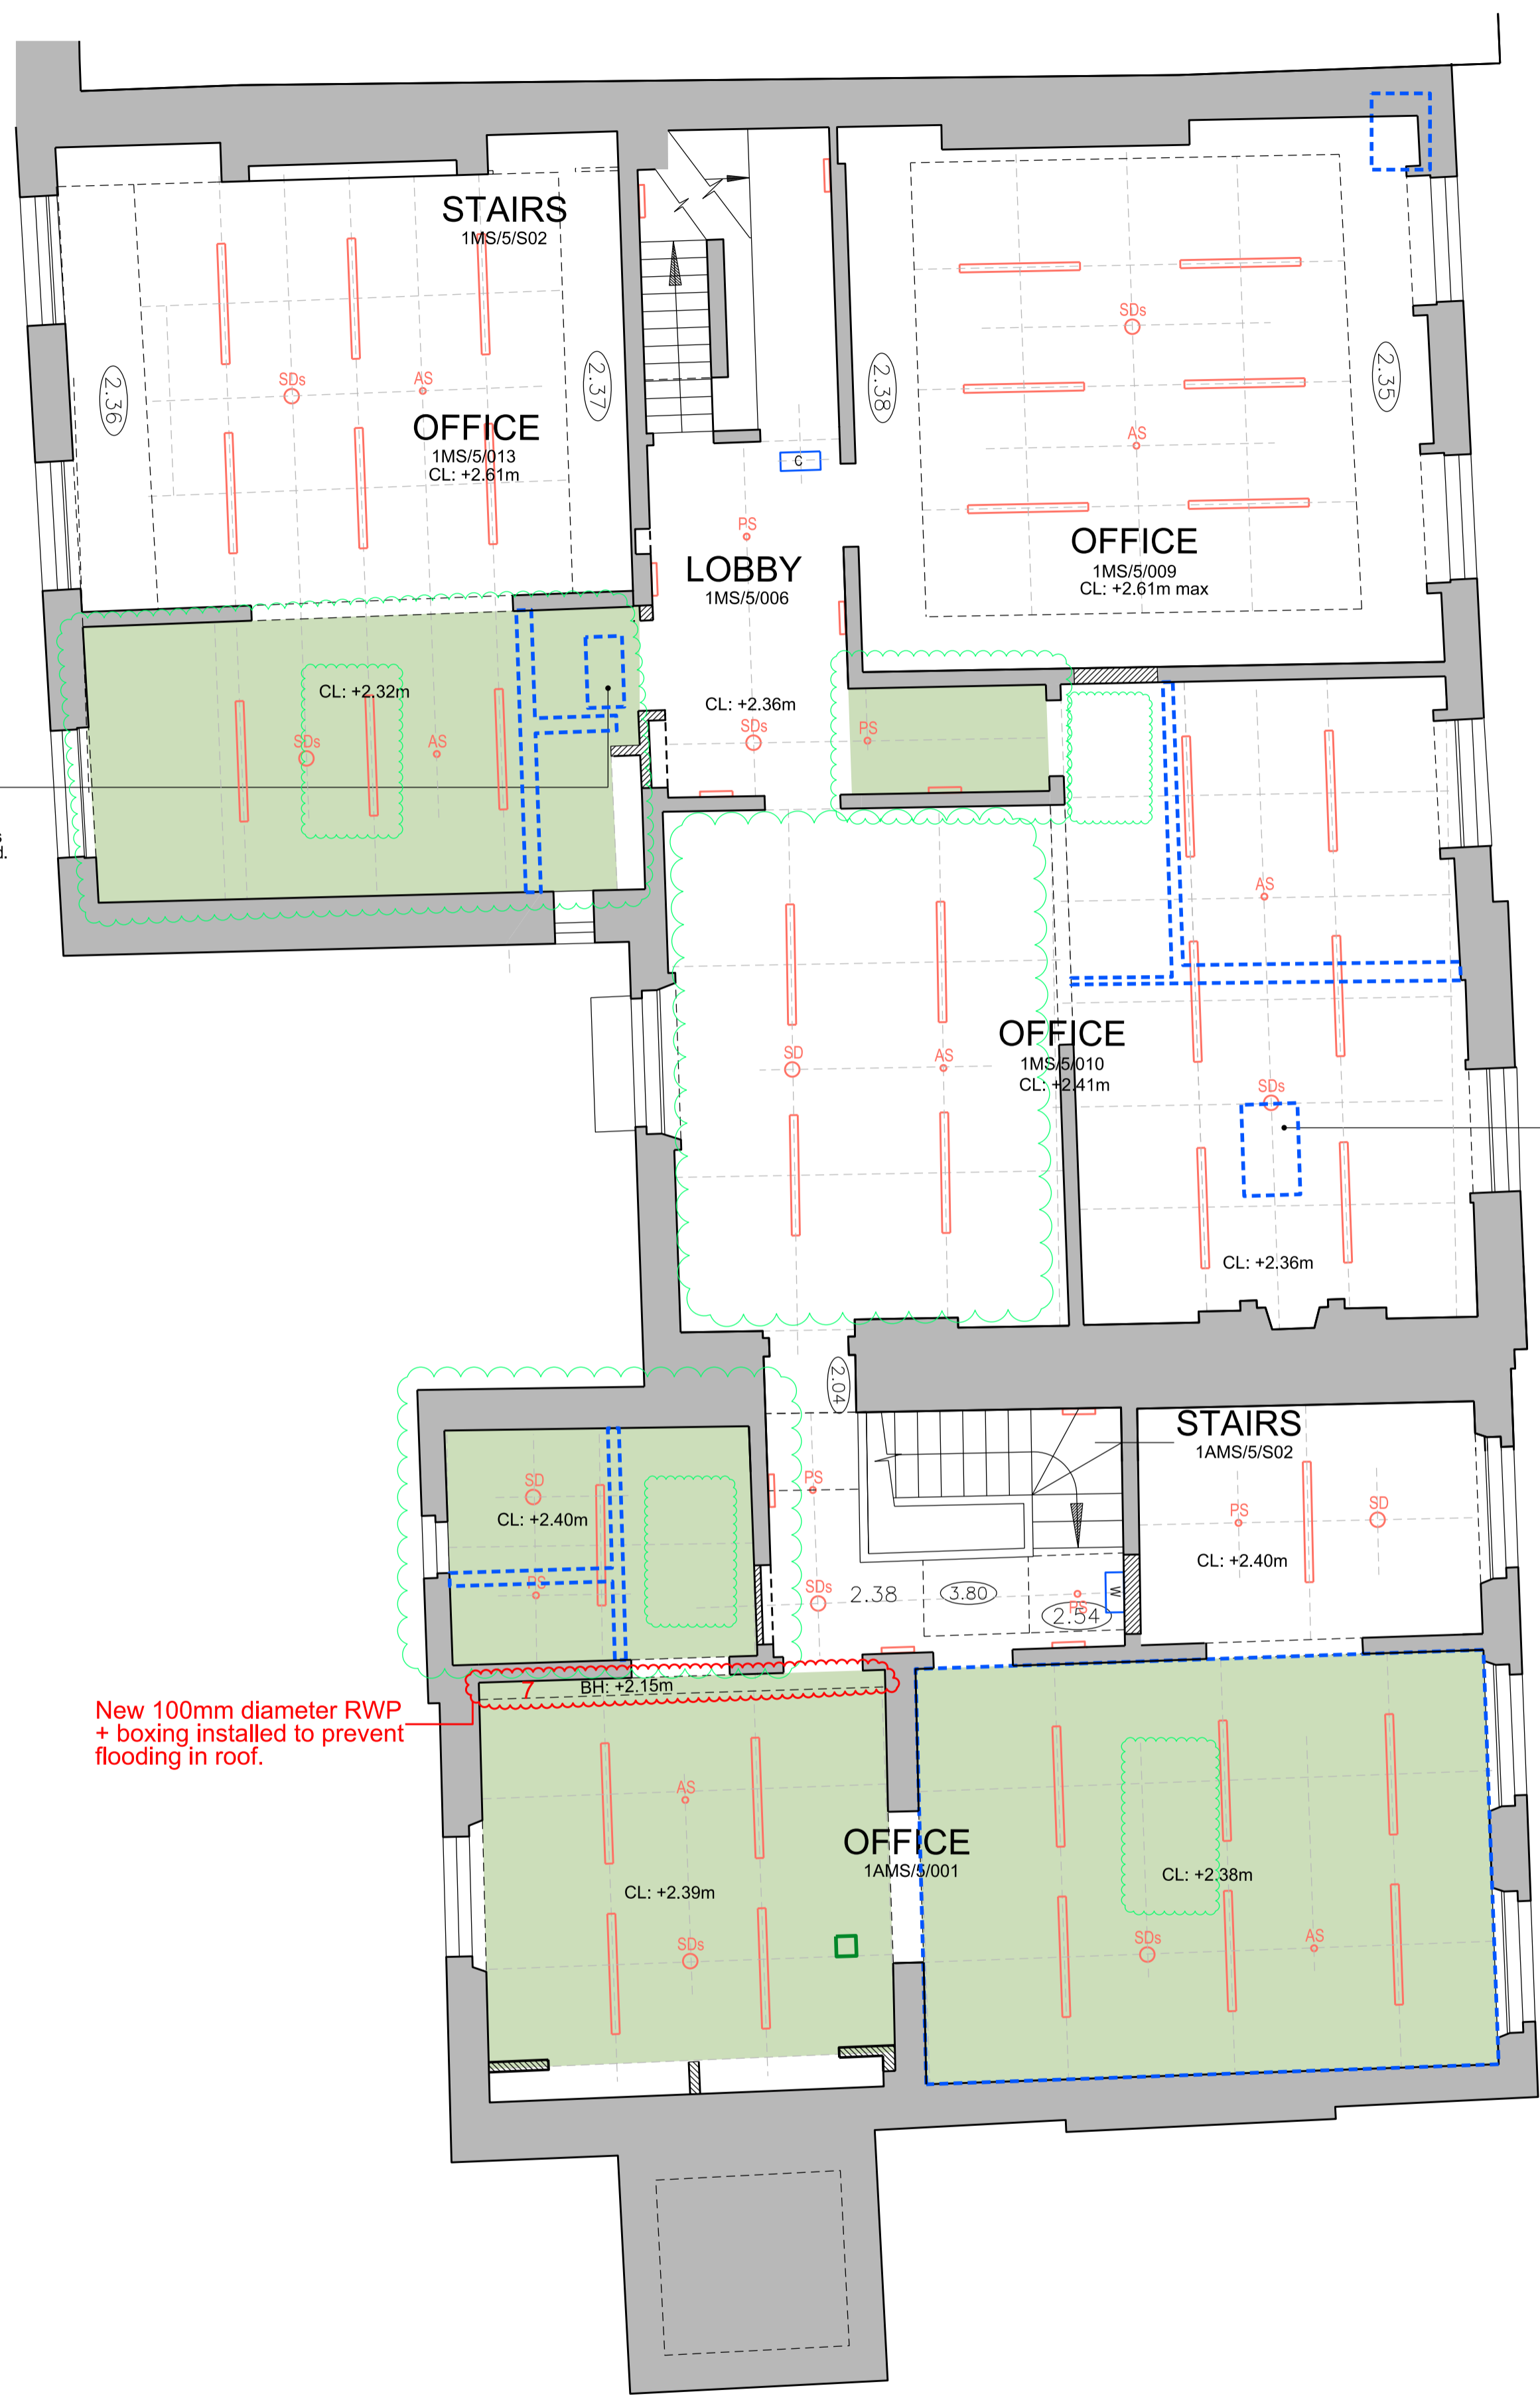
EXISTING CORNICE CAREFULLY REMOVED. SET ASIDE WITH CARE AND REINSTATED WHEN THE OVERBOARDING OF THE WALL IS COMPLETED.

Existing ceiling hatch to be enclosed. Timber surround, access door and reveal to be carefully removed. New timber ceiling joist elements to be fitted where previously removed to create access hatch. Remaining damaged ceiling to be repaired. New plasterboard to be installed and finished to match adjoining ceiling.

New 100mm diameter RWP + boxing installed to prevent flooding in roof.
