**William Ellis School, Highgate, London**

**Report on the Investigation of a  
Balcony Slab**

**Final Report - 4512**

**CLIENT:** London Borough of Camden

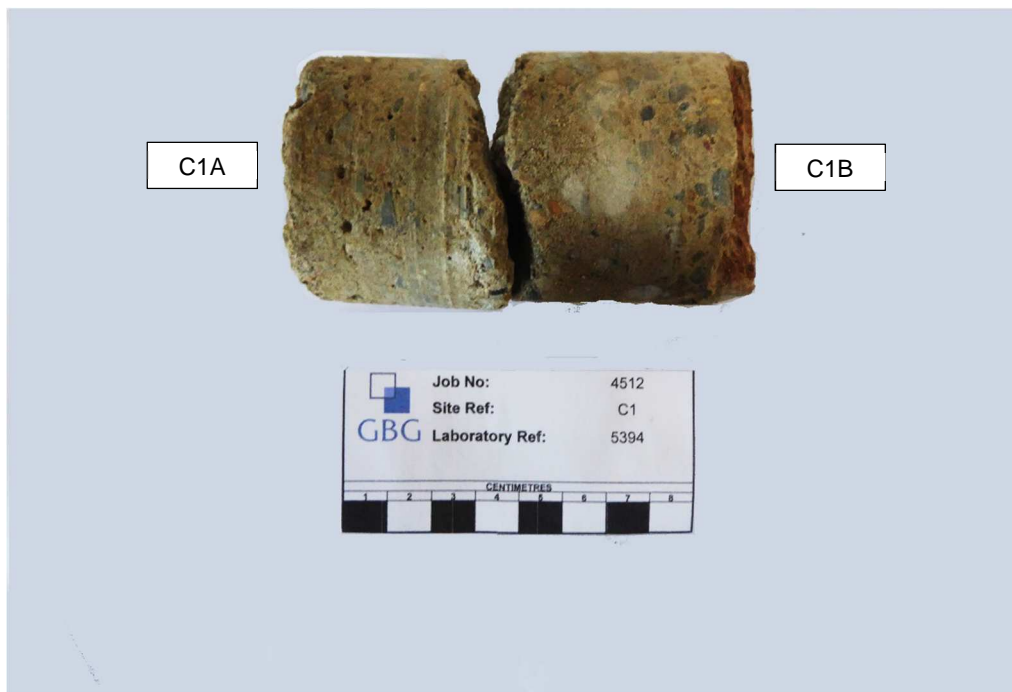
Upon extraction, the concrete core sample split into two, and each sub-sample was subsequently referenced as C1A (45mm in length) and C1B (60mm in length).

**Concrete Core Sample (C1) extracted from 1<sup>st</sup> Floor Deck.**

The concretes comprised of approximately 45-55% mixed-flint gravel as the coarse aggregate, which was sub-angular to sub-rounded and equant to elongate in shape. The coarse aggregate was generally well graded and evenly distributed, with a maximum nominal aggregate size of 10mm.

The cement pastes were generally sandy to light buff in colour and apparently of good quality and compaction, with excess voidage judged at 0.5%.

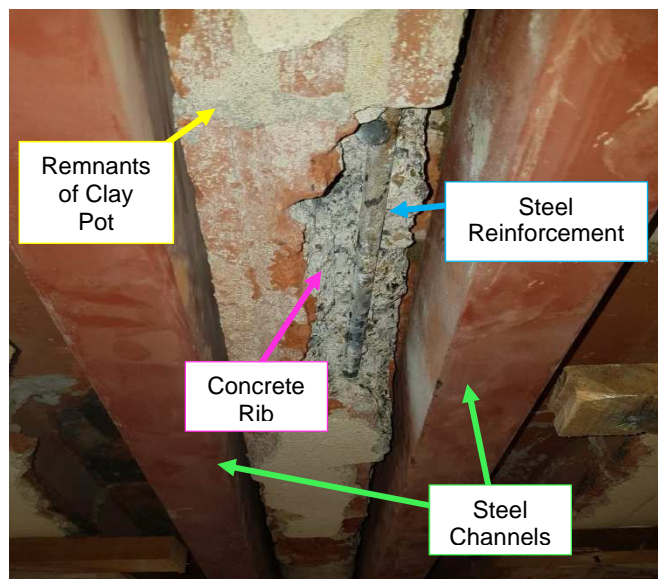
A localised breakout was carried out to the soffit of the specified rib in order to expose the steel reinforcement for sampling. The rib was found to contain 2No. 10mm diameter plain round bottom steel bars at mid-span. The concrete cover to the bars was 15mm. The rib width was measured to be approximately 90mm. Both bars were observed to be in visually good condition, displaying only light surface corrosion.

Breakout to the underside of the rib showing steel reinforcement bar sample (SS1) prior to extraction.

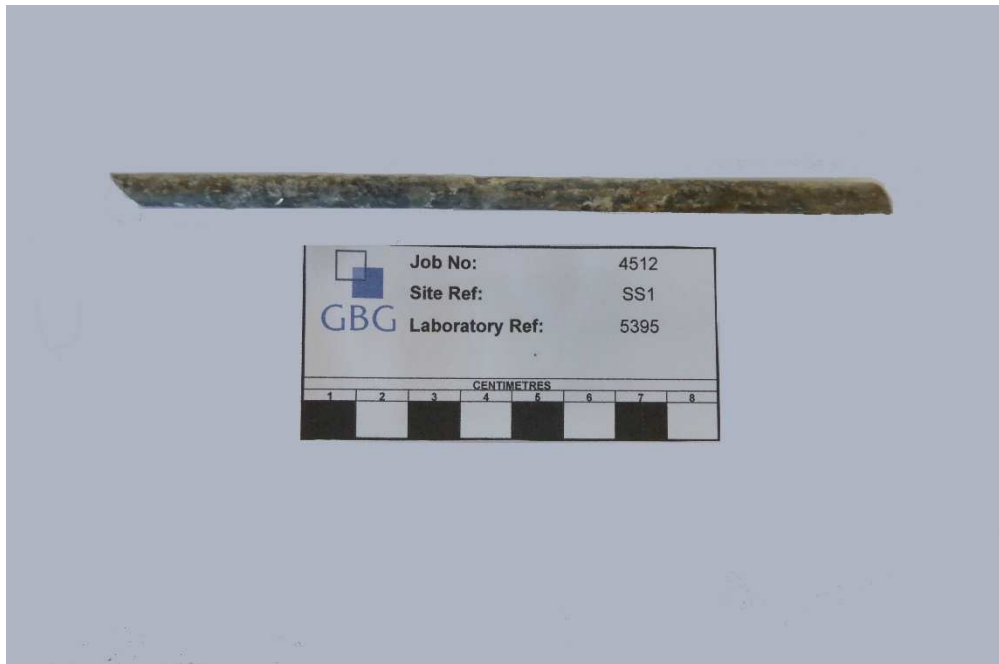
A single 10mm diameter plain round steel reinforcement bar sample (SS1) was extracted from the same reinforced concrete rib for laboratory testing to determine the yield stress and tensile strength of the steel.

**Steel Reinforcement Sample (SS1) after extraction**

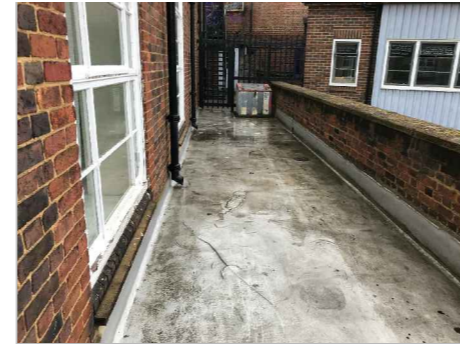
Pl1: 1ST FLOOR BALCONY DECK ABOVE STEEL/CORE LOCATION

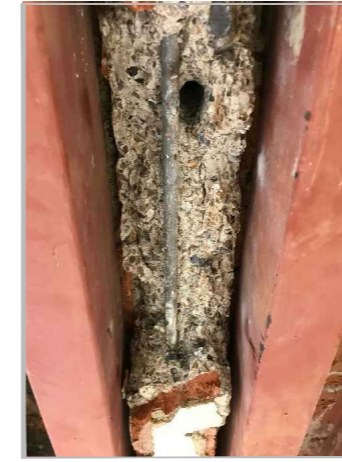
Pl2: STEEL SAMPLE LOCATION TO SOFFIT OF RIBS AFTER EXTRACTION

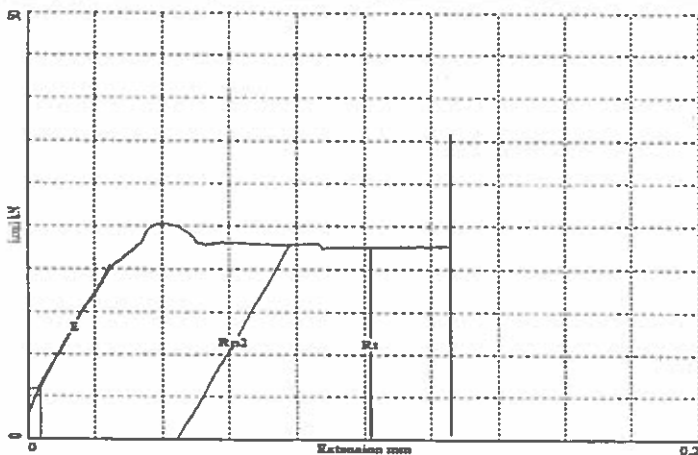
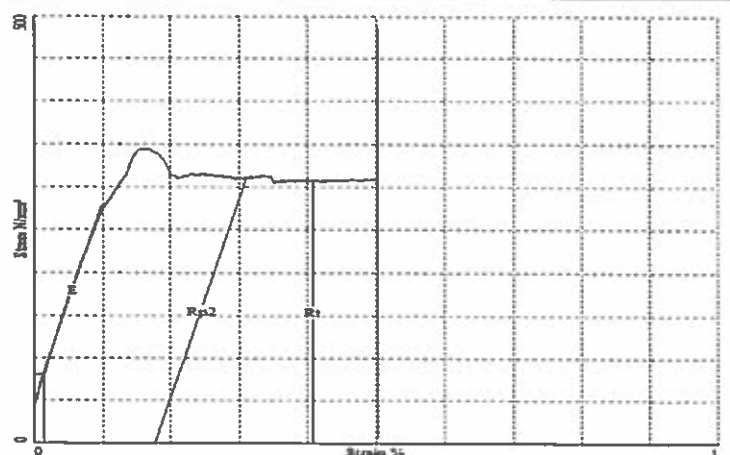
Cross-Sectional Area.....	73.49 mm <sup>2</sup>
Rebar Length.....	216.5 mm
Rebar Weight.....	124.9 g
Rebar Density.....	0.00785 kg/mm <sup>2</sup> /m
Rebar Mass/Length.....	0.5769 kg/m
Rebar % Deviation.....	-6.347
Specimen Geometry.....	Rebar
Specimen Gauge Length.....	50 mm
Parallel Length.....	100 mm
Extensometer Gauge Length.....	25 mm
Maximum Load.....	35.78 kN
Ultimate Tensile Strength.....	486.861 N/mm <sup>2</sup> (35.78 kN)
Fracture Strength.....	121.919 N/mm <sup>2</sup> (8.96 kN)
Young's Modulus.....	230.7 kN/mm <sup>2</sup>
Rt(0.43%).....	306.975 N/mm <sup>2</sup> (22.56 kN)
Rp2(0.2%).....	310.241 N/mm <sup>2</sup> (22.8 kN)

Reh.....	343.442 N/mm <sup>2</sup> (25.24 kN)
Rel.....	309.697 N/mm <sup>2</sup> (22.76 kN)
Temperature.....	Ambient
% Elongation.....	38.44
Load Device.....	Load1
Load Serial No.....	.
Extr Device.....	Extr1
Extr Serial No.....	607
