Lady Chapman Hall (1927)

Lord Cameron Hall (1935)

Rosalind Franklin Hall (1965)

3.2 Listed Buildings- within and outside the application site boundary

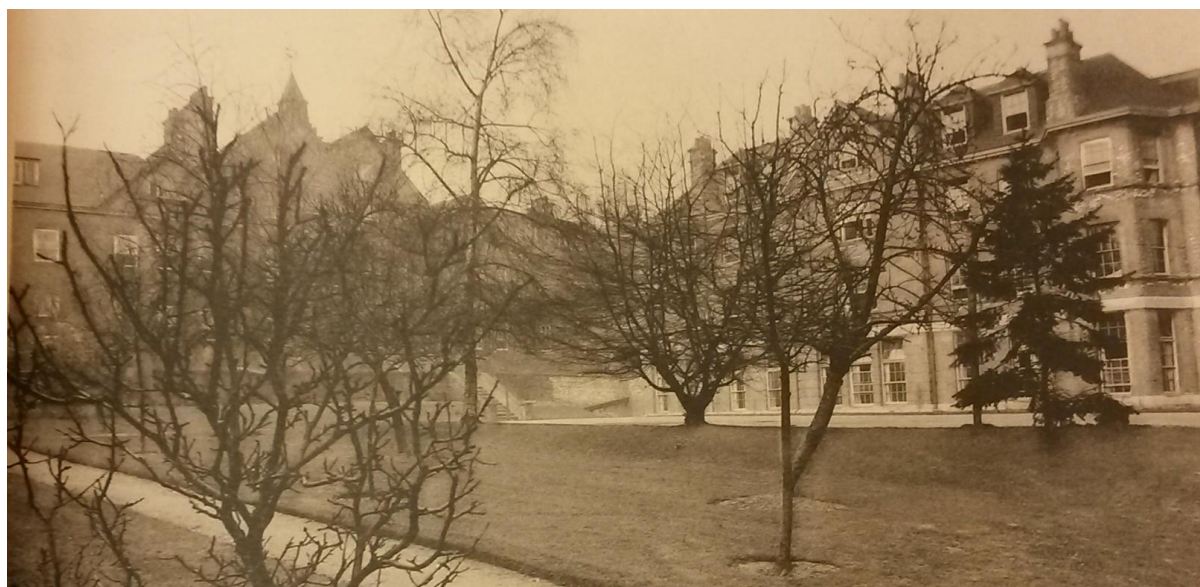
Figure 35 An image of the Maynard Wing and Lady Chapman Hall from the south looking northeast c.1929.

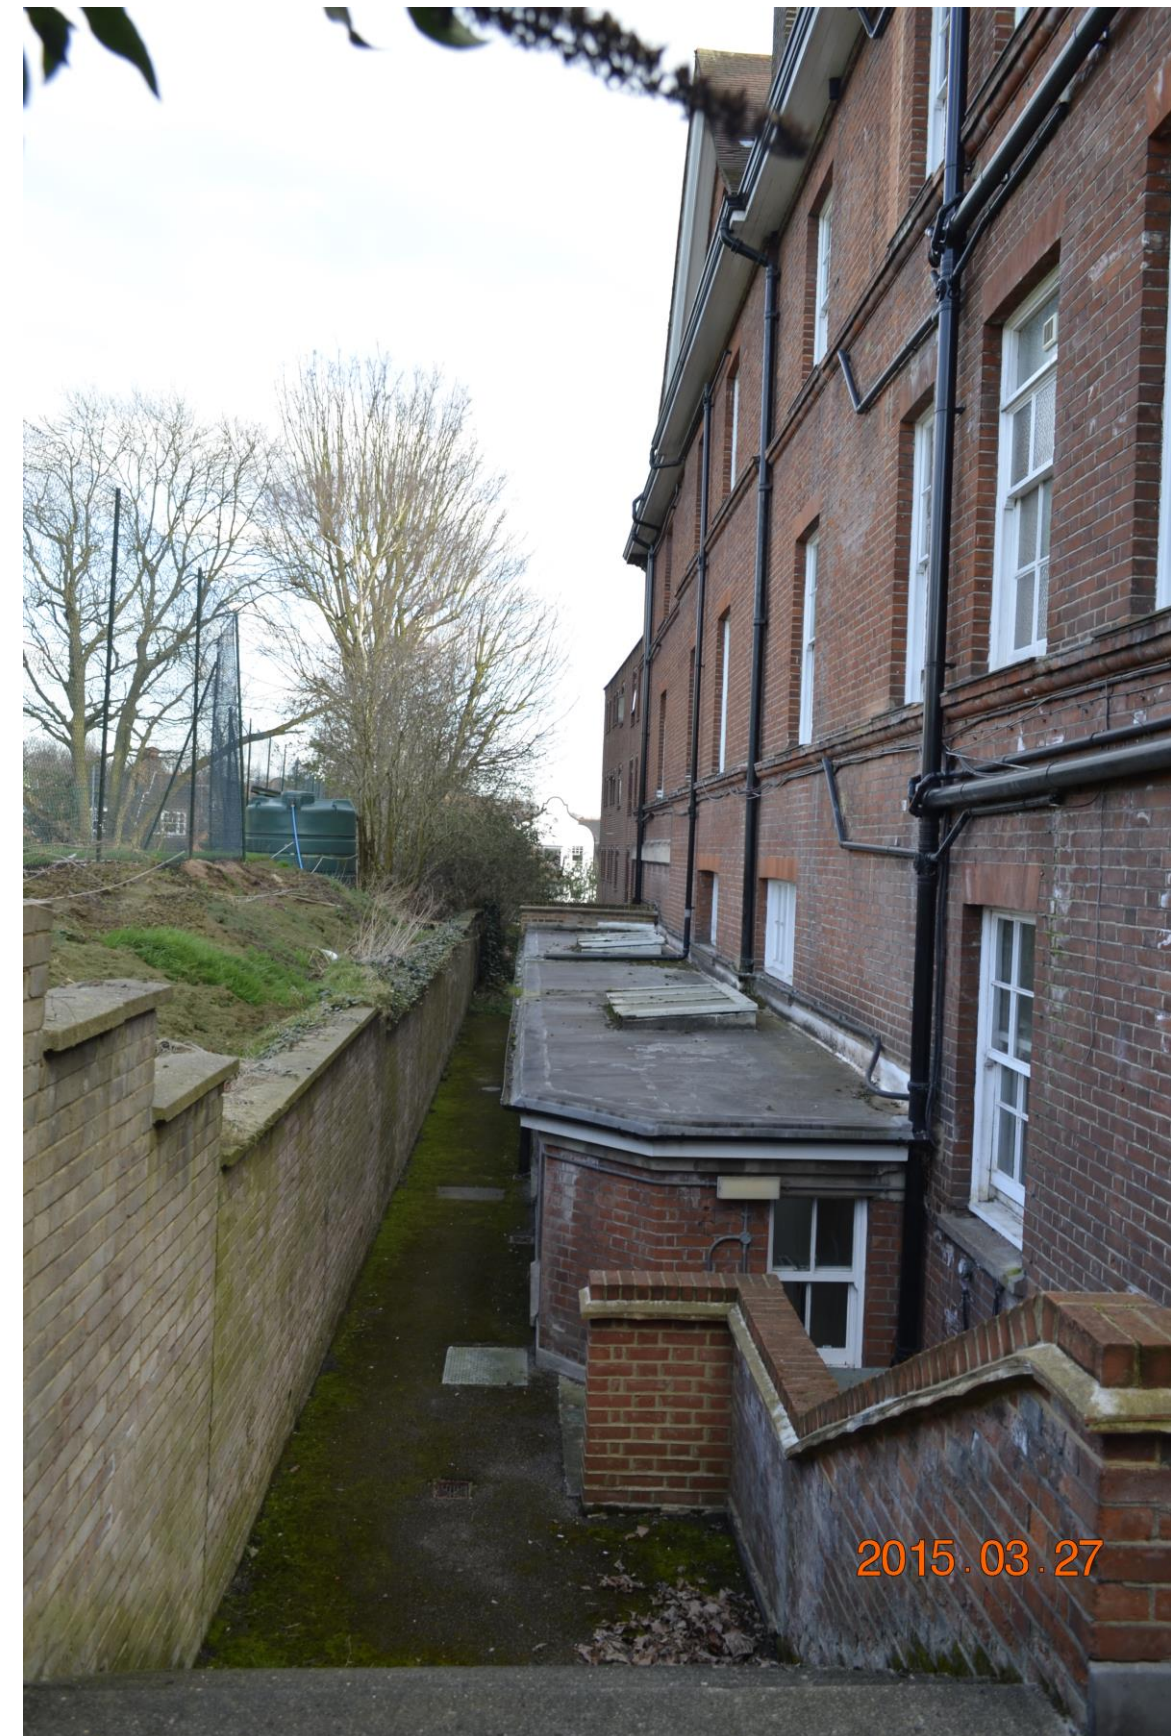
Figure 36 The boundary wall to the north of the site and the rear elevation of Lady Chapman Hall.

- 3.35 As one might expect of a building designed on a site edge boundary, the rear elevation of Lady Chapman Hall is less detailed and has been extended in a piecemeal fashion. Figure 36 shows the relationship of the rear wall with the brick boundary wall, and the single storey extension at the lower ground floor.

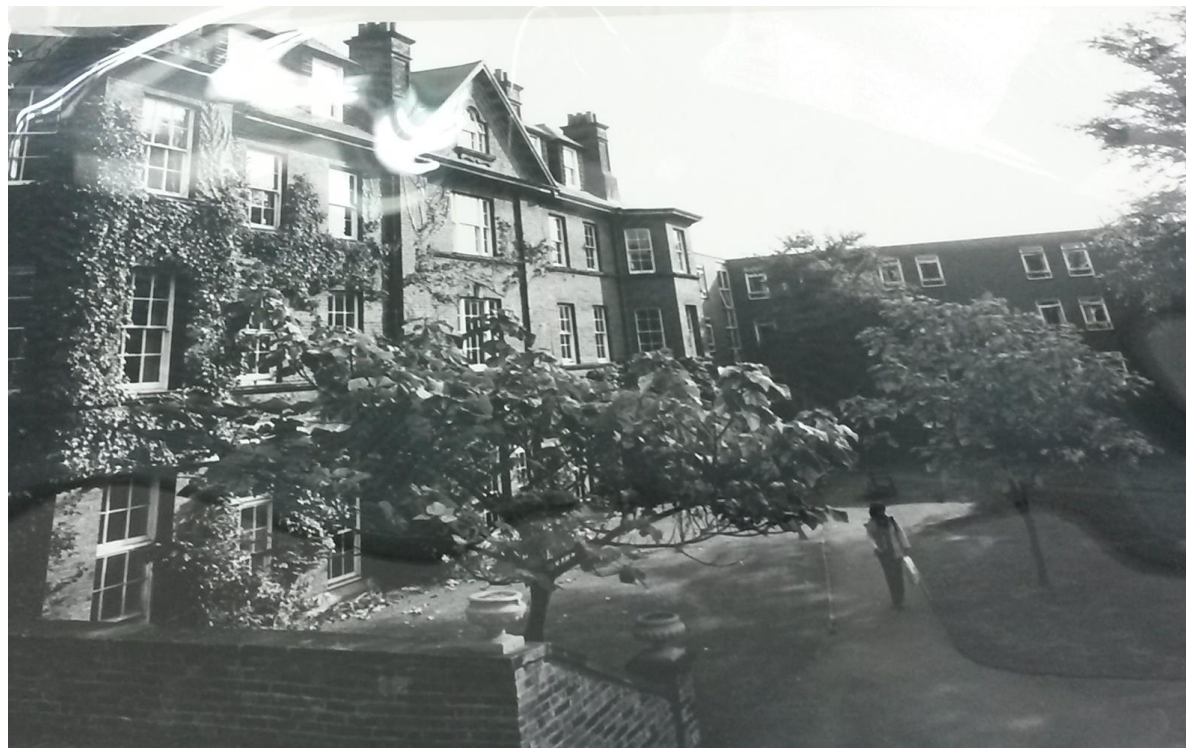
Figure 37 A photograph of Lady Chapman Hall and Rosalind Franklin as seen from the cobbled walkway fronting Maynard in 1962.

- 3.33 At three storeys in height above ground level with a storey in the attic and a lower ground floor, this building is greater in height and scale than the earlier Dudin Brown Hall. The principal elevation to the eastern courtyard is asymmetrical; the western flank of the building extends out to join with the Maynard Wing. So too does the eastern range adjoin Rosalind Franklin Hall.

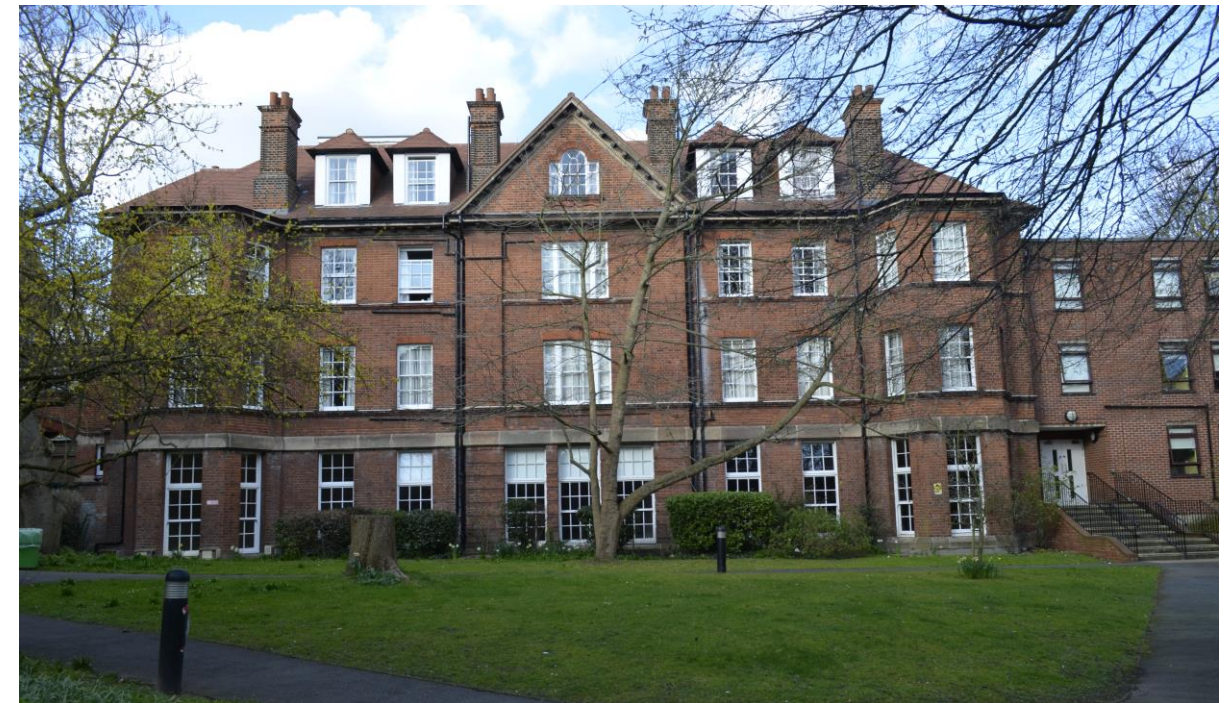
Figure 39. The principal elevation of Lady Chapman Hall as seen from within the eastern courtyard looking north. Rosalind Franklin Hall can be seen abutting the building to the right of this photograph.

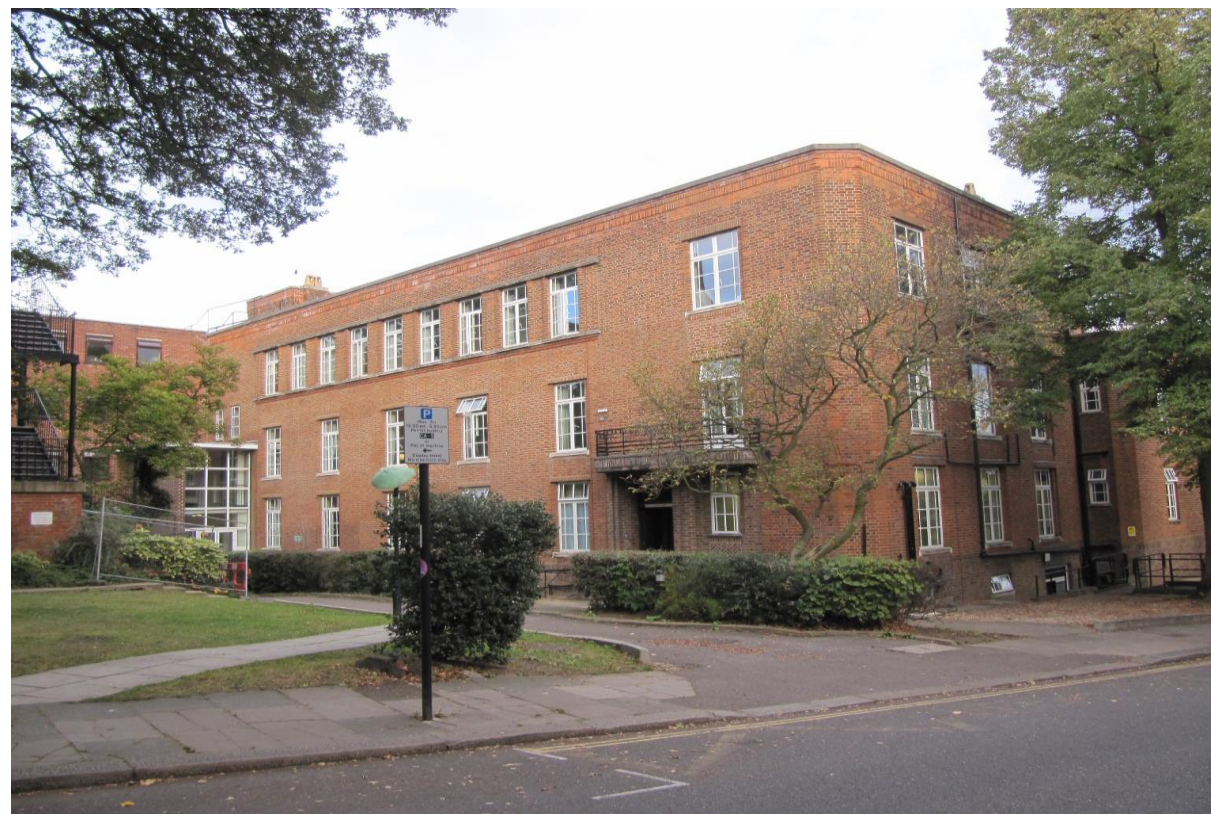
Figure 40 A photograph of the west and south elevations to Kidderpore Avenue

- 3.43 The south elevation of the building to Kidderpore Avenue is awkward and badly proportioned. The building was evidently not designed with an awareness of this view from the south. The form and fenestration of this two storey section disrupts the composition of the three storey main building when seen from Kidderpore Avenue.

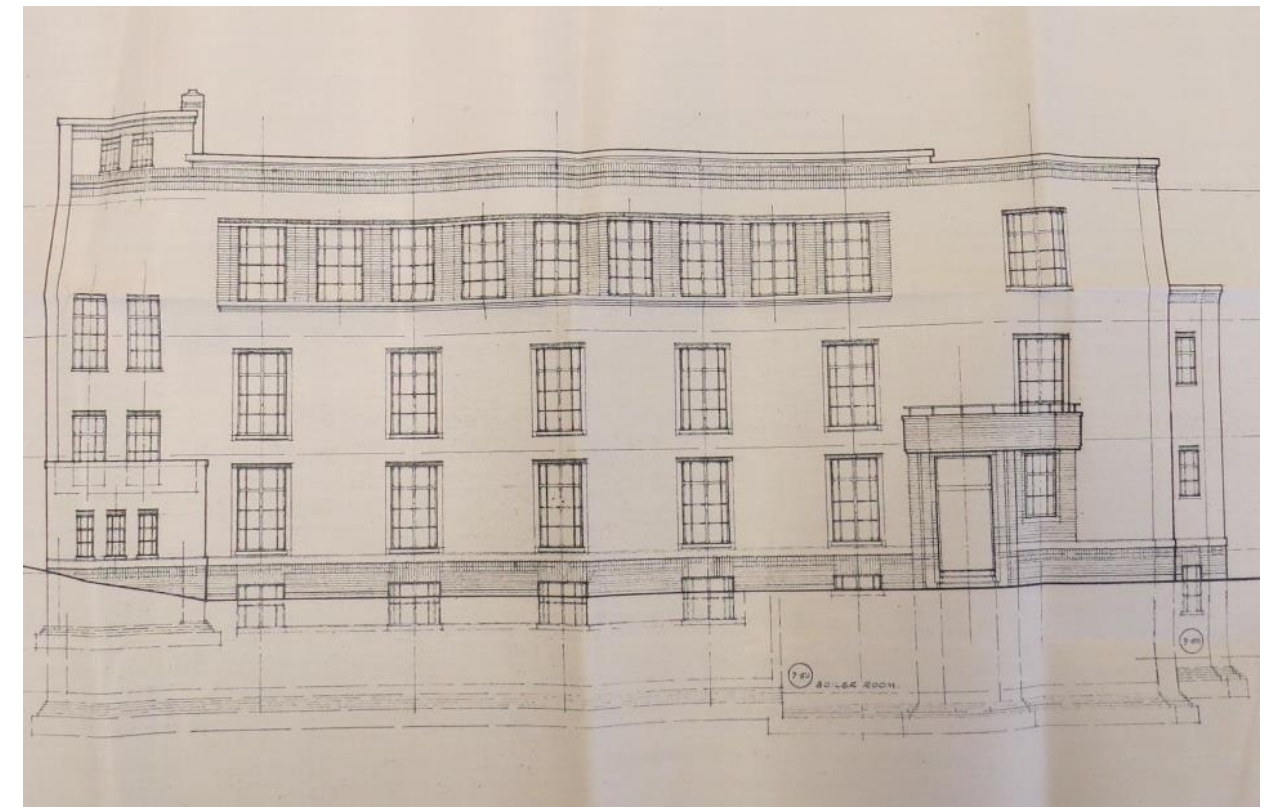
Figure 42 The west elevation produced for the new Lord Cameron Hall in 1934.

- 3.42 The west elevation encloses the space to the east of Dudin Brown Hall and is of simple design, with the only relieving features being the rectangular windows which are recessed and have brick soldier courses. These windows have been replaced by casement windows of recent date.

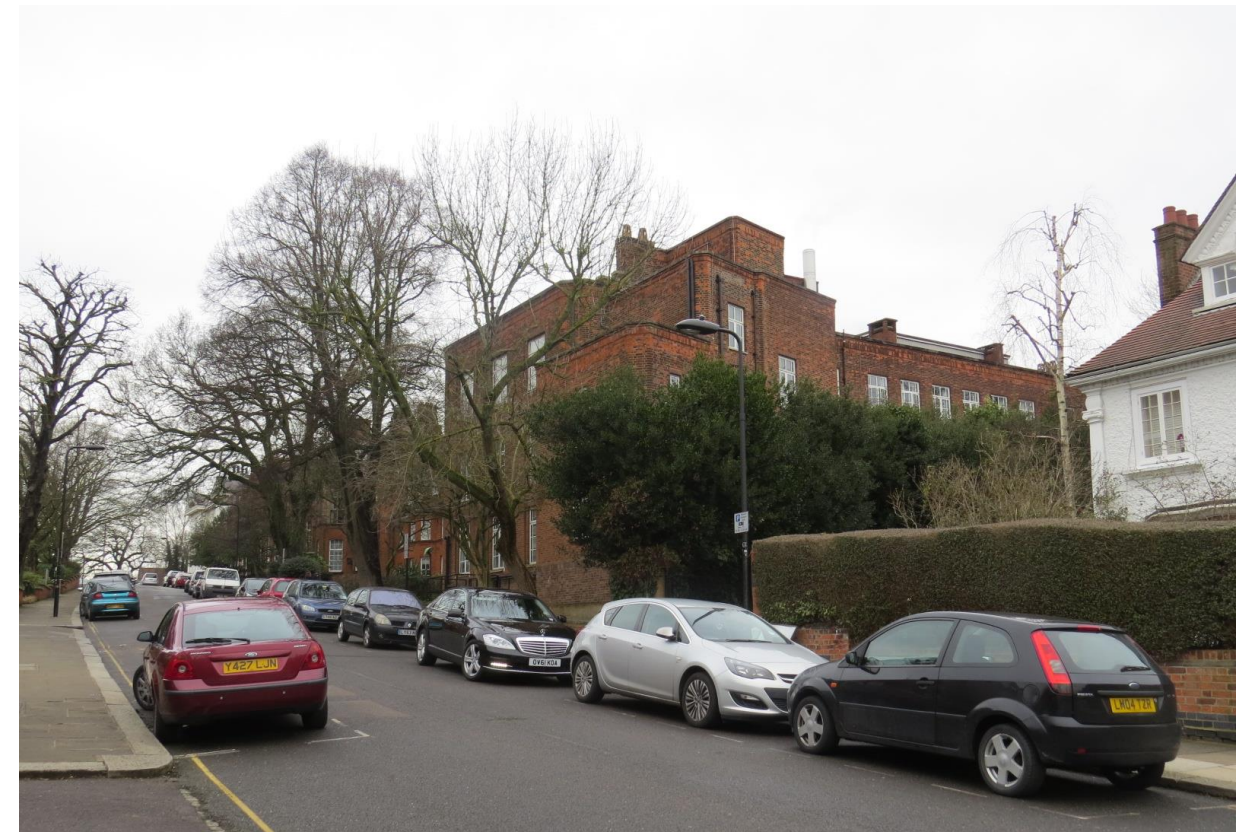
Figure 43 A photograph of Lord Cameron Hall as seen from the south of Kidderpore Avenue looking north.

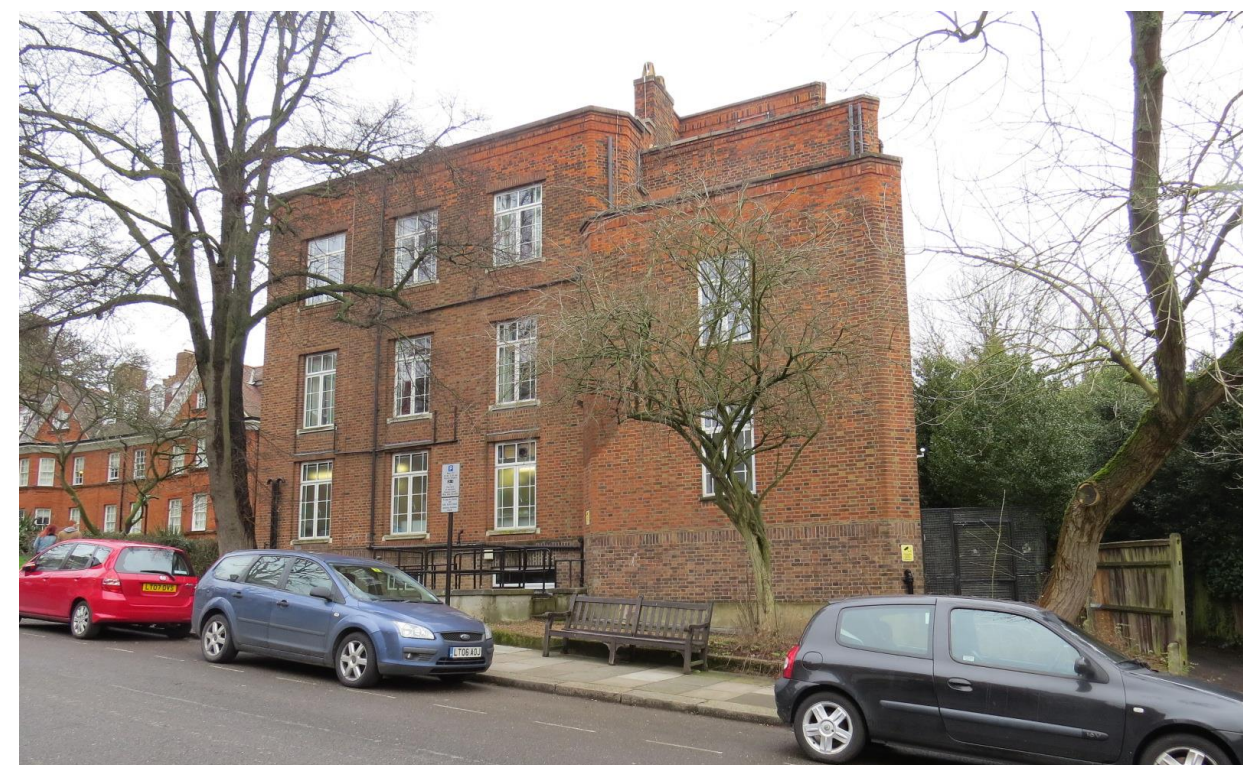
Figure 44 An image of Lord Cameron Hall looking into the site from a location almost opposite Lord Cameron Hall.

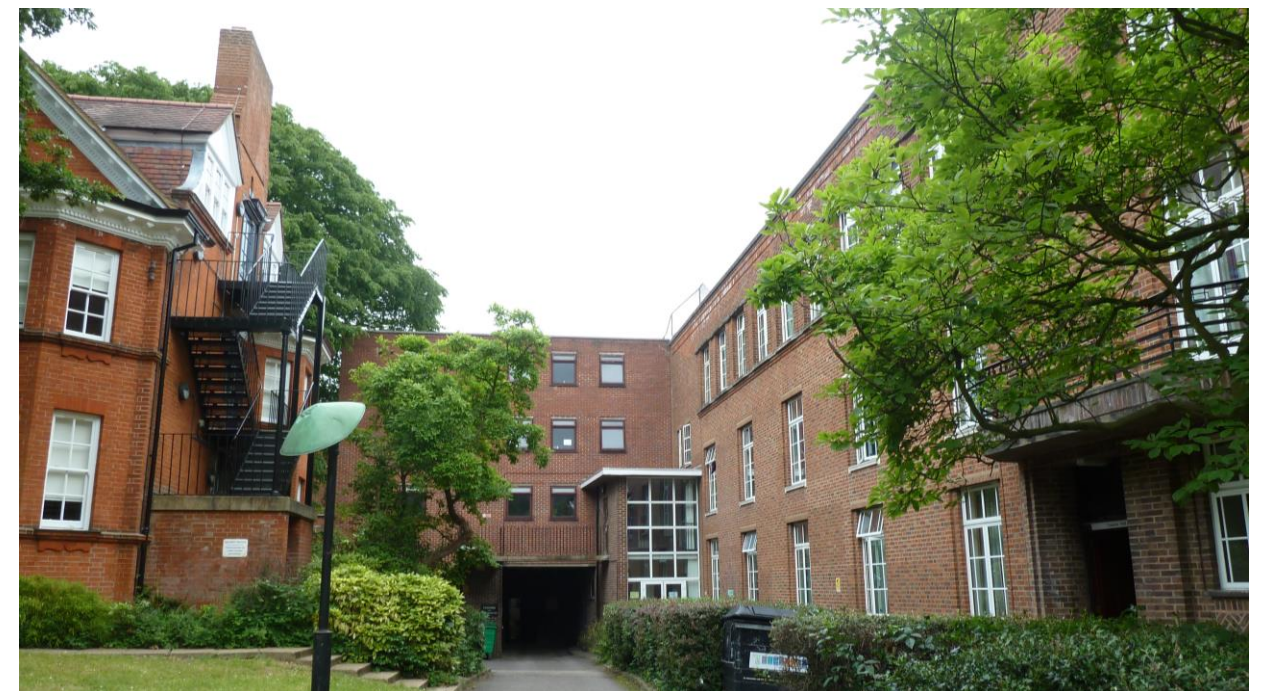
Figure 45 A view into the site from Kidderpore Avenue, showing the vehicular access into the basement parking level beneath Rosalind Franklin Hall.

- 3.52 The south elevation as seen from Kidderpore Avenue incorporates a vehicular access way. This is a dark and uninviting space which detracts from the composition of this elevation. The appearance of the west elevation in particular as seen from within the eastern quadrangle is repetitive and lacks variety in the fenestration pattern or style on any of the elevations.

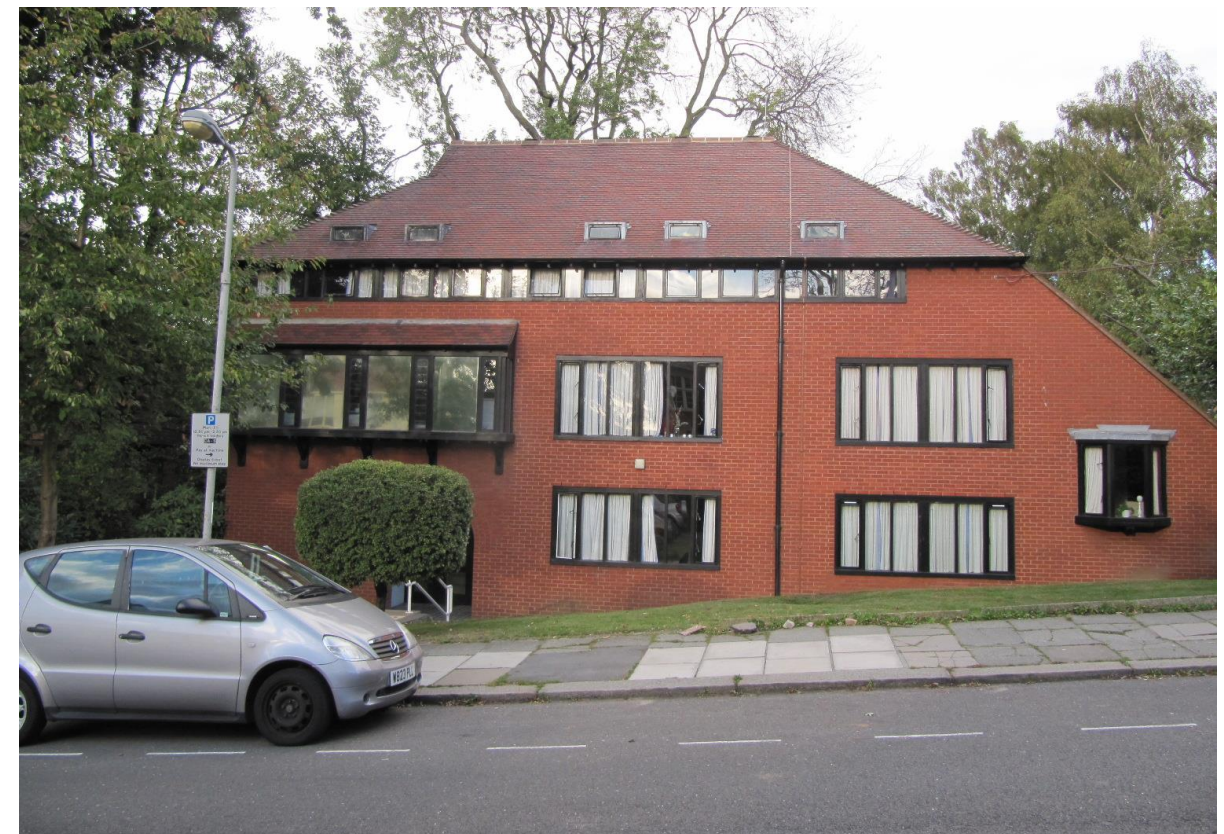
Figure 46 An image of Queen Mother's Hall as seen from Kidderpore Avenue, current date.

- 3.57 A comparison of this photograph and that of the existing appearance of the building, shown in Figure 46, make it clear that little has been done to the exterior of the building which has altered its appearance since 1982. The building was refurbished in 2010 for continued use as student accommodation.

- 3.59 The building itself is not of architectural quality or high quality materials. The photograph included at Figure 46 shows the principal elevation to Kidderpore Avenue. The detailed design of this building, in terms of the architectural style, fenestration detail and profile; the roof form, and refined materials, do not reflect those of the prevailing characteristics of the Conservation Area.

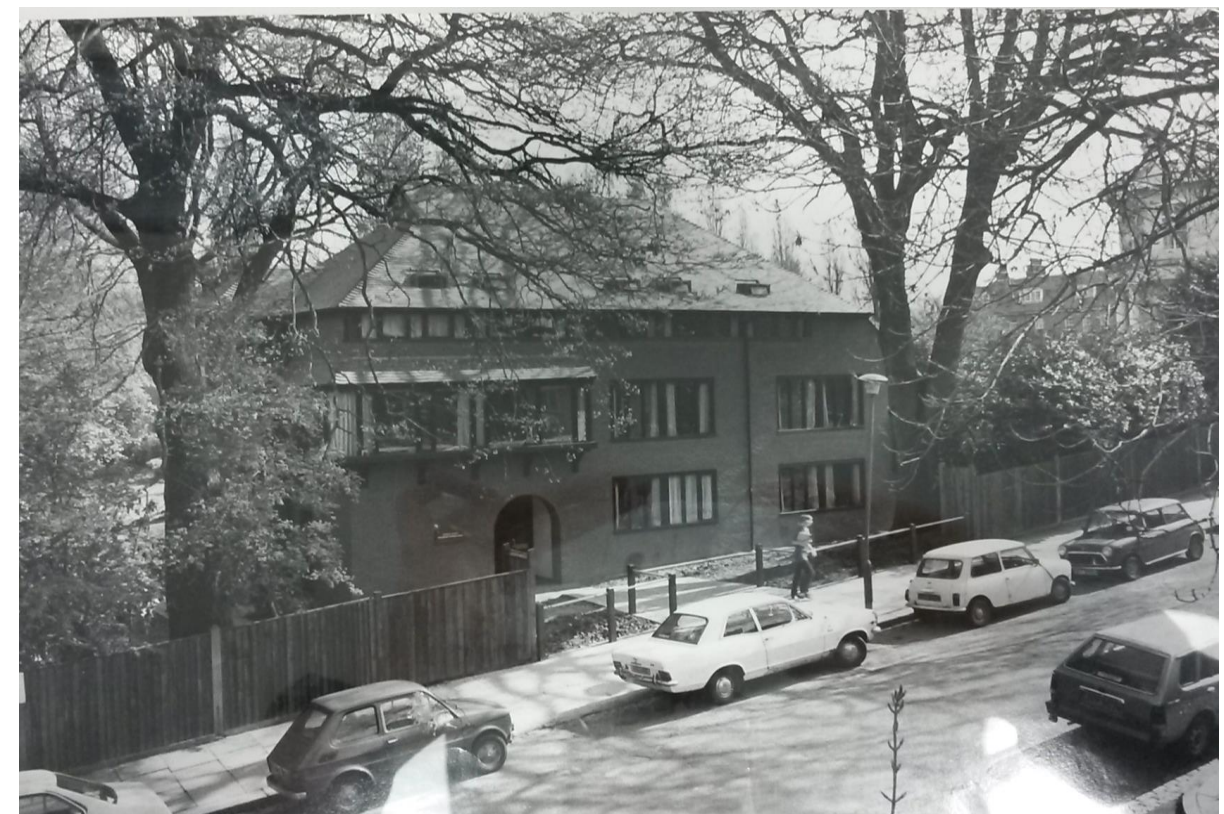
Figure 47 A photograph of Queen Mother's Hall as seen from Kidderpore Avenue in 1982.

- 3.56 Completed in 1982 to provide student residential accommodation, Queen Mother's Hall was built following a grant of planning permission in July 1981 for residential accommodation to comprise a building of twenty four single study bedrooms and a common room. A photograph of the newly completed Queen Mother's Hall can be seen in Figure 47.

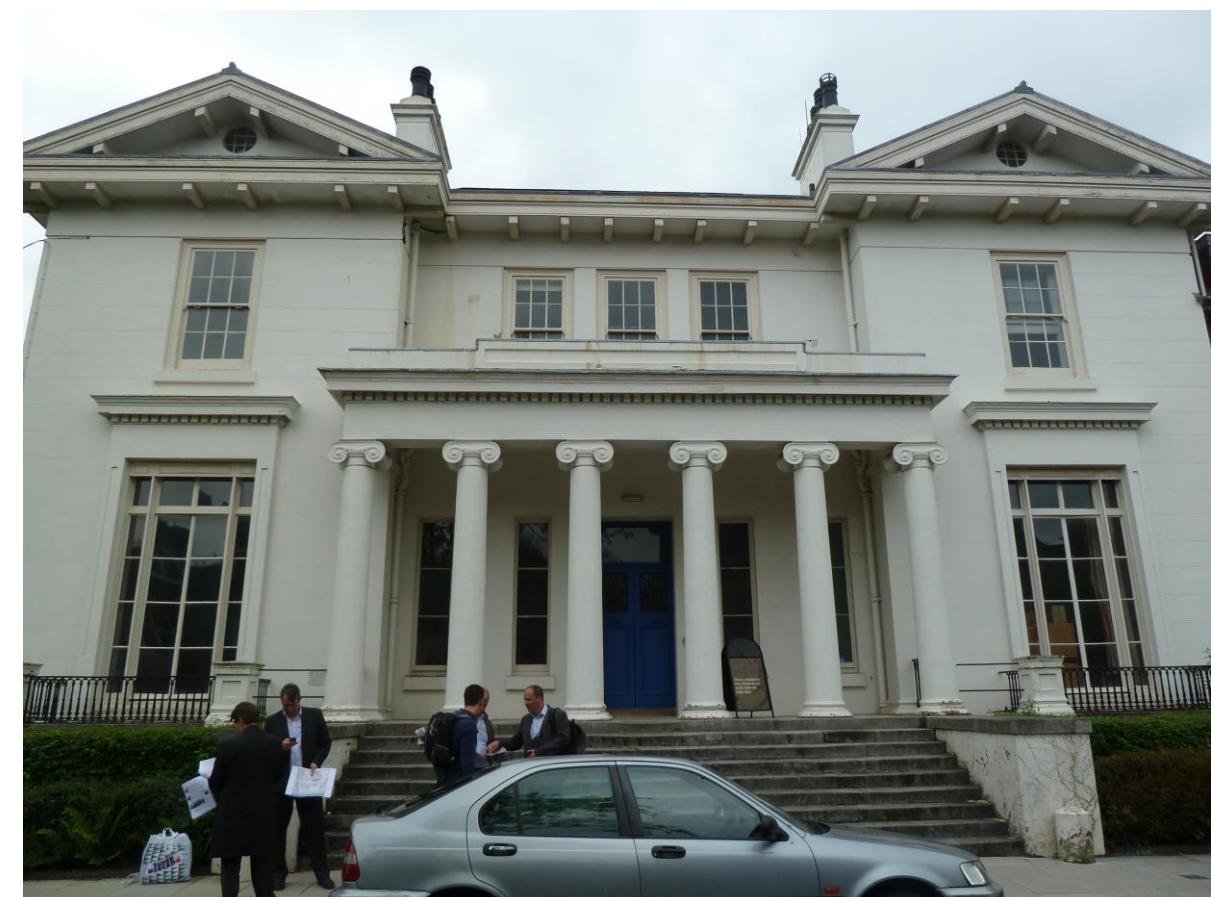
Figure 49 A photograph of the principal elevation of Kidderpore Hall.

- 3.74 The exterior of Kidderpore Hall is, in some areas, in need of significant repair and refurbishment. The windows have been replaced at different times and to different specifications which has reduced the architectural integrity of the appearance of the elevations. In many places the plaster render and stonework require repair, and the roof slates are damaged in places.

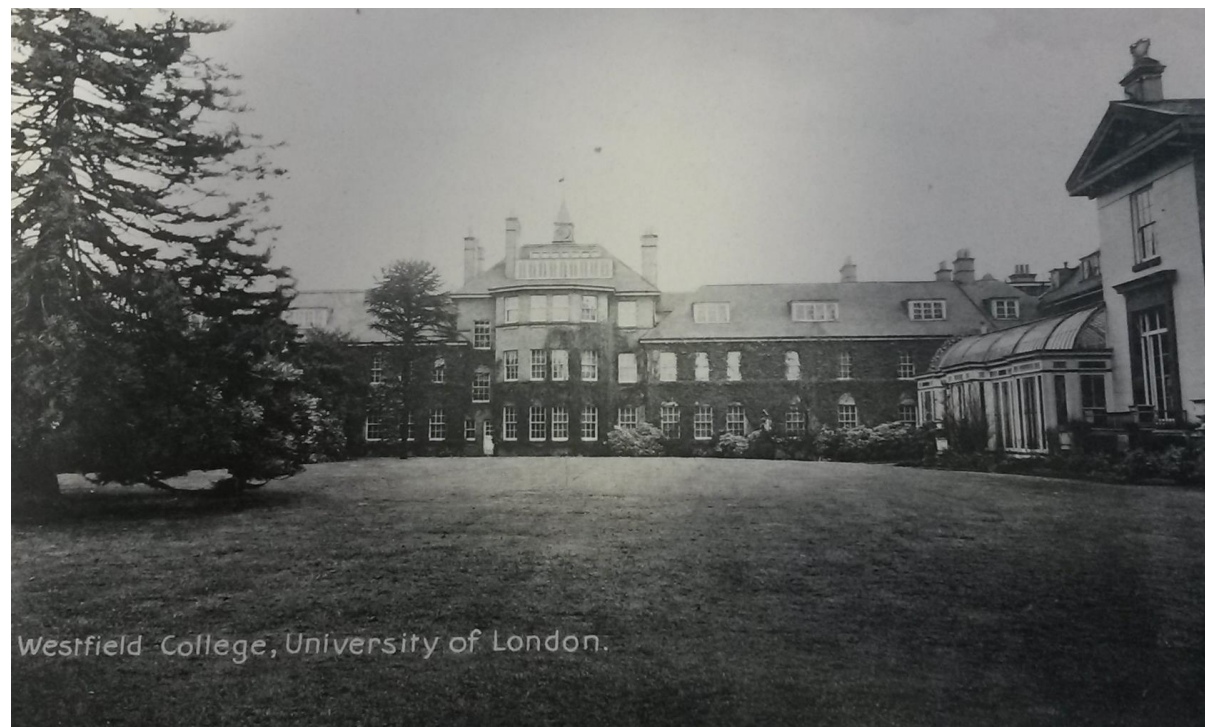
Figure 50 An image on a postcard c. 1905 of the lawn outside Kidderpore Hall prior to the demolition of the conservatory and its replacement with the 'Bay'.

- 3.68 A *'handsome conservatory'* is also noted within the sale particulars, and the photograph at Figure 50 provide evidence for this conservatory which previously existed connected to the southeast of the Hall and which was demolished at a point in the early twentieth century, this part of the site then being re-used for the 1921 extension known as 'Bay House.'

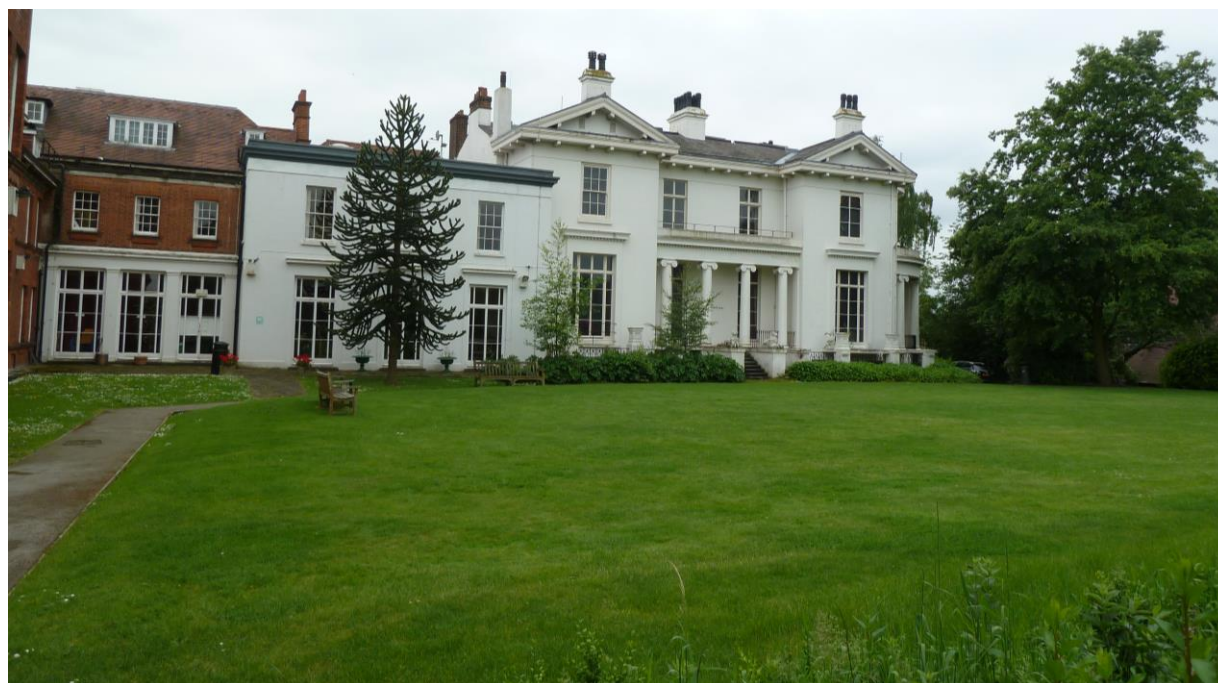
Figure 53. The rear elevation of Kidderpore Hall taken from a location near to the north boundary of the application site, with the Maynard Wing located to the left of this view. The 1921 Bay House extension which was built to replace the former conservatory can be seen to the left of Kidderpore Hall.

- 3.73 Now, the D shaped lawn is the only remaining part of the original pleasure garden laid out with the house in the 1840s, and the green bank to the west of Kidderpore Hall marks the original division between the pleasure garden and the wider grounds which have now been built upon. This green bank does not retain a meaningful relationship with the Hall or contribute to the significance of the listed building. The reservoir and the tennis courts continue to occupy parts of the original garden to Kidderpore Hall to the north. This greened bank can be seen in the photograph included at Figure 53.

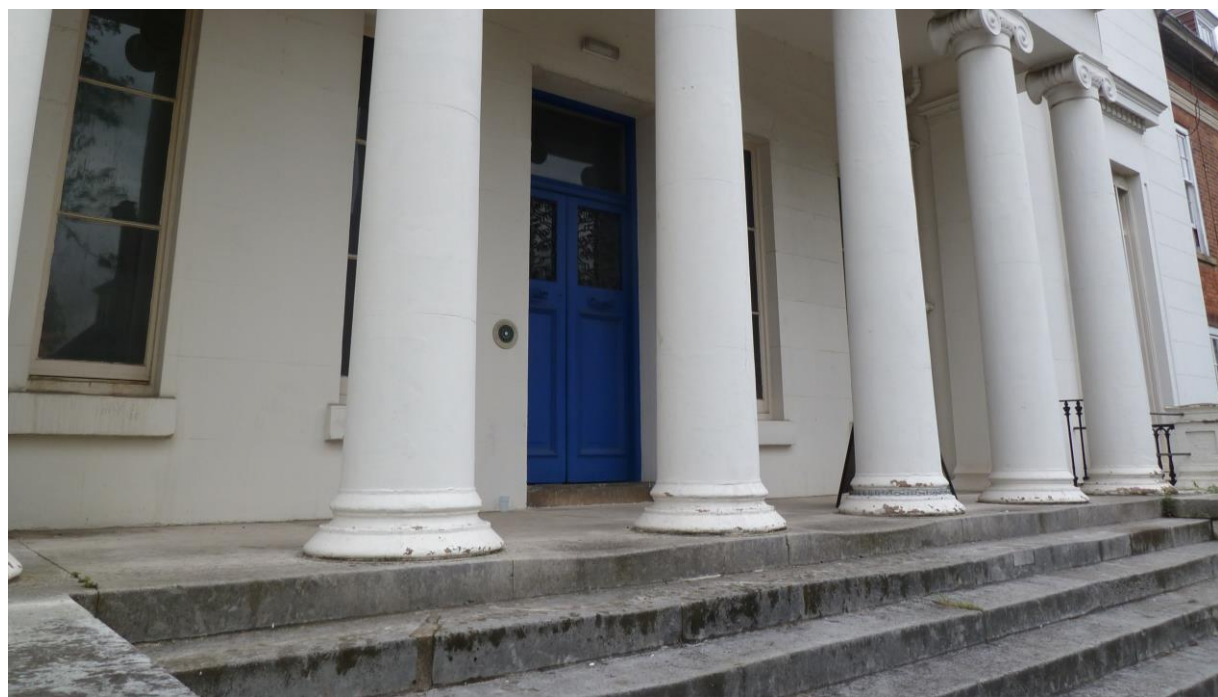
Figure 54 The entrance steps to Kidderpore Hall accessed from Kidderpore Avenue. The plaster render and the stonework of the steps are in need of refurbishment.

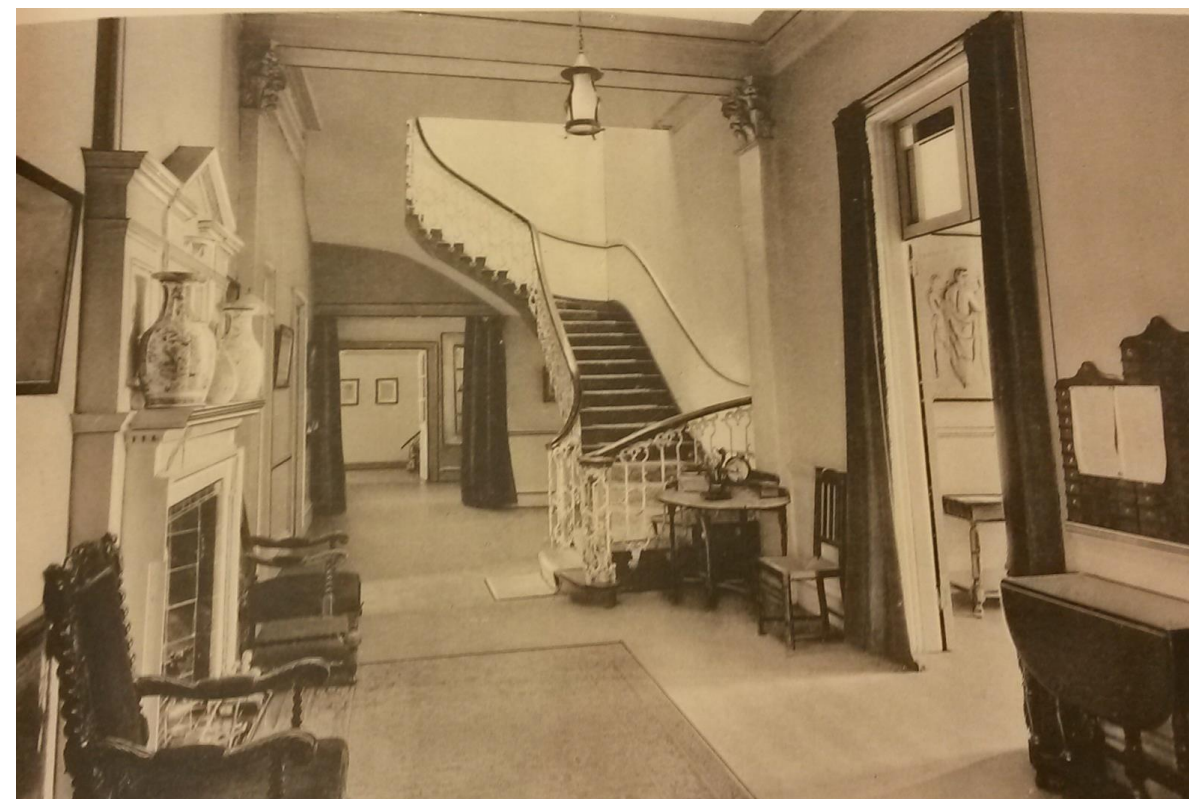
Figure 55 Entrance hallway to Kidderpore Hall c. 1905.

- 3.77 The photograph of the entrance hall taken c. 1905 included at Figure 55, shows the interior detail of the hallway. The original balustrades on the staircase remain, albeit in places these have been damaged or lost. The principal fireplace has been replaced.

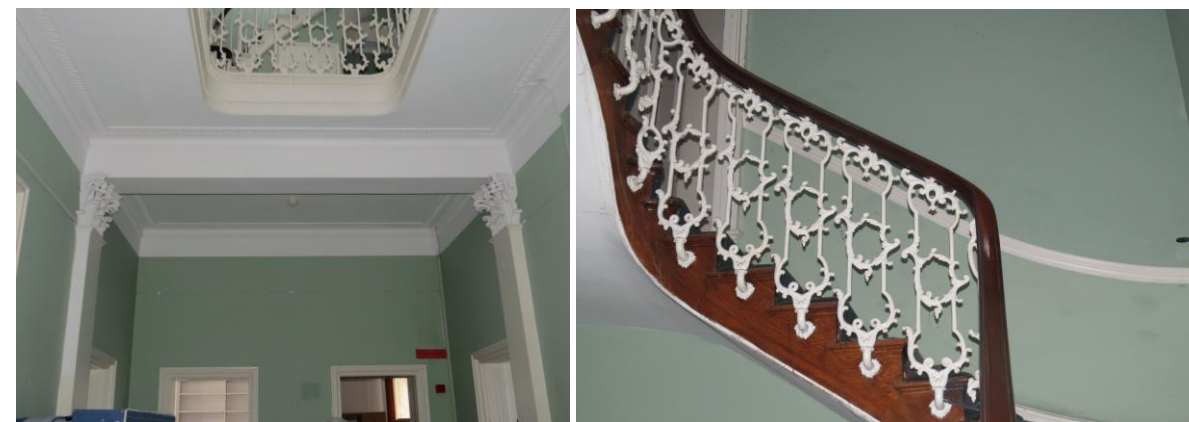
Figure 56 A photograph of the ceiling of the entrance hallway to Kidderpore Hall, and detail of the balustrade of the principal staircase, current date.

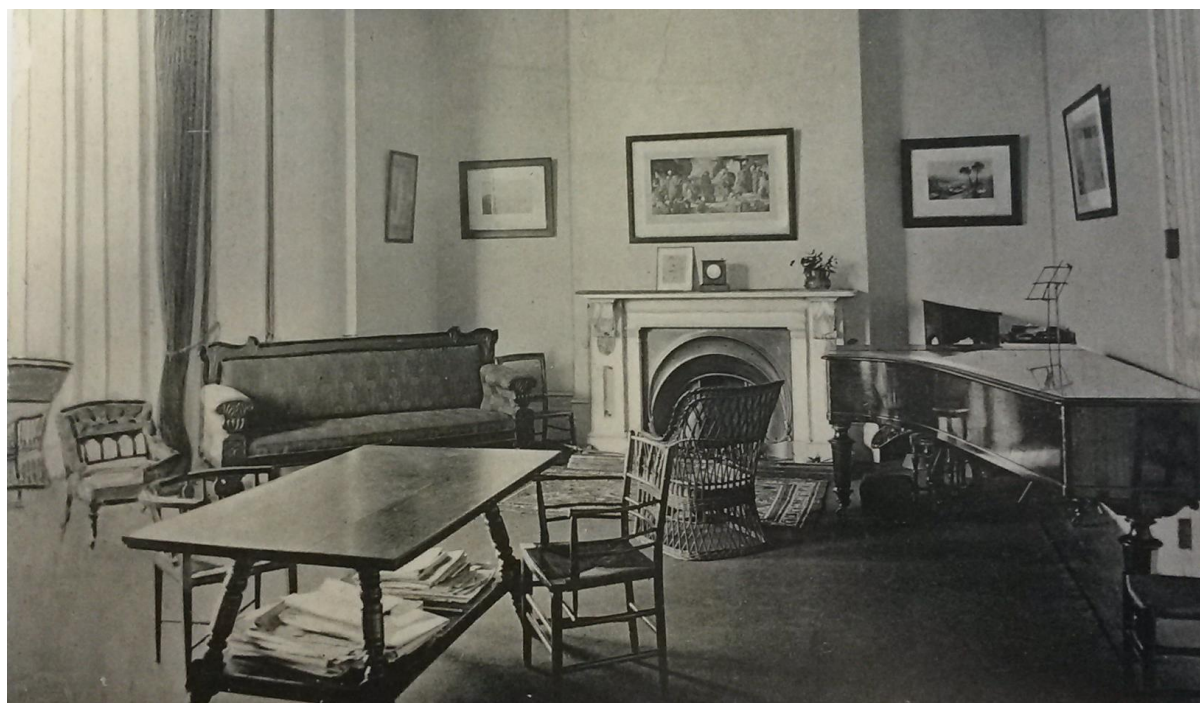
Figure 57. A photograph of the ground floor front bowed room in Kidderpore Hall which was used as a student's common room from 1905-1912.

- 3.78 Original plans for Kidderpore Hall have not been found. The earliest comprehensive general arrangement plans showing the layout of the property are provided in the set drawn up by Casson Condor Architects for the proposed refurbishment in 1966. The ground floor plan of the property is shown at Figure 58, which shows the layout of rooms at the ground floor level largely as they exist today. Six rooms lead off the entrance hallway, with the grandest reception room (Room 11) to the north west of the house, where the large bay window provides an aspect into the garden. It is known that this room was used as a student common room from the years 1905-12 when Westfield College occupied the site. A photograph of this room dating from c. 1905 is included at Figure 57, which shows the existing fireplace in situ.

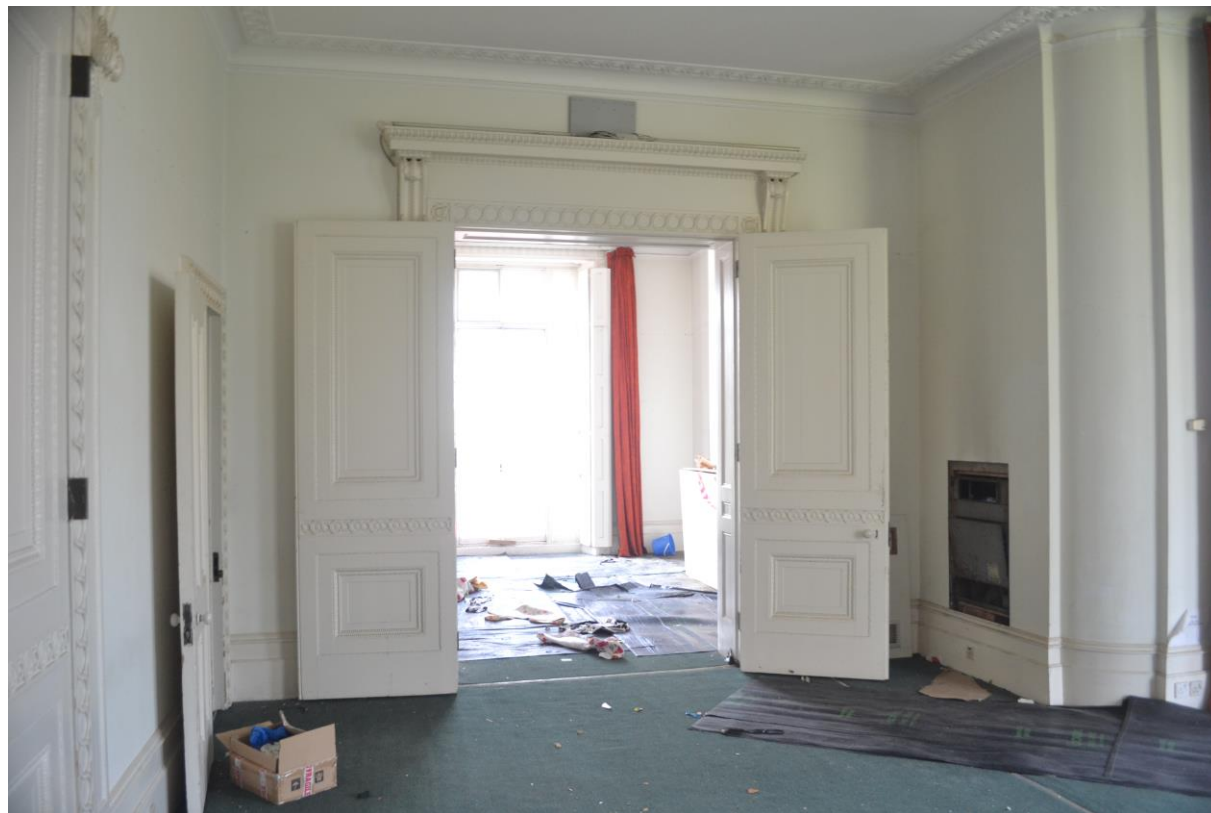
Figure 60. A photograph of the double door connection between the principal reception rooms at the ground floor level.

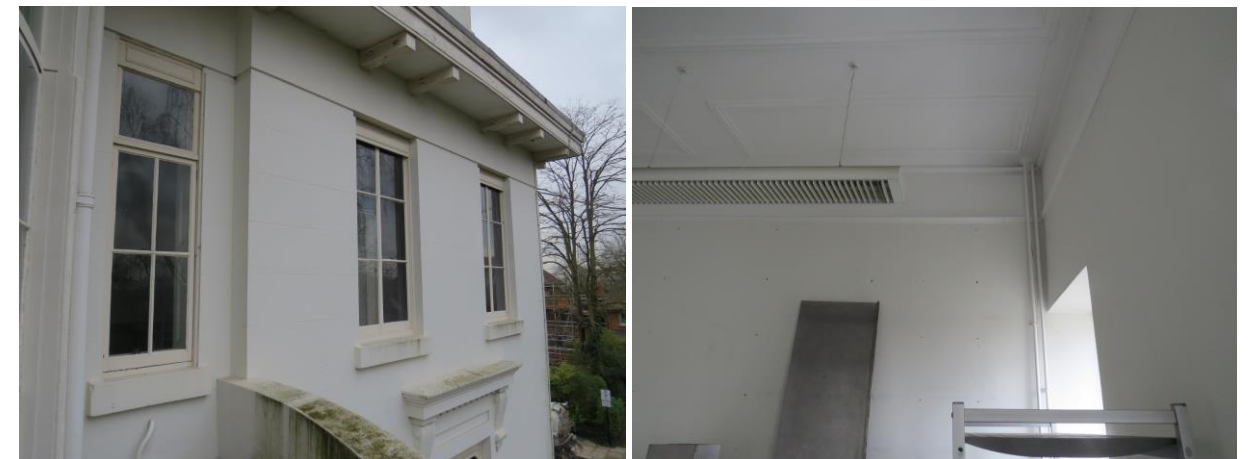
Figure 62. (Left) A photograph of the west elevation taken from a location on the balcony to the bay window. The central window is divided internally by the later partition. (Right) The internal partition which cuts the window internally.

- 3.82 Our investigation of the interiors at the property in conjunction with the exterior appearance of the west elevation has revealed that the partition at the first floor level which divides the two rooms must, in fact, be a later addition. This is owing to the position of the alignment of the window. This is discussed in more detail in the Kidderpore Hall Historic Building report prepared by Scott Brownrigg.

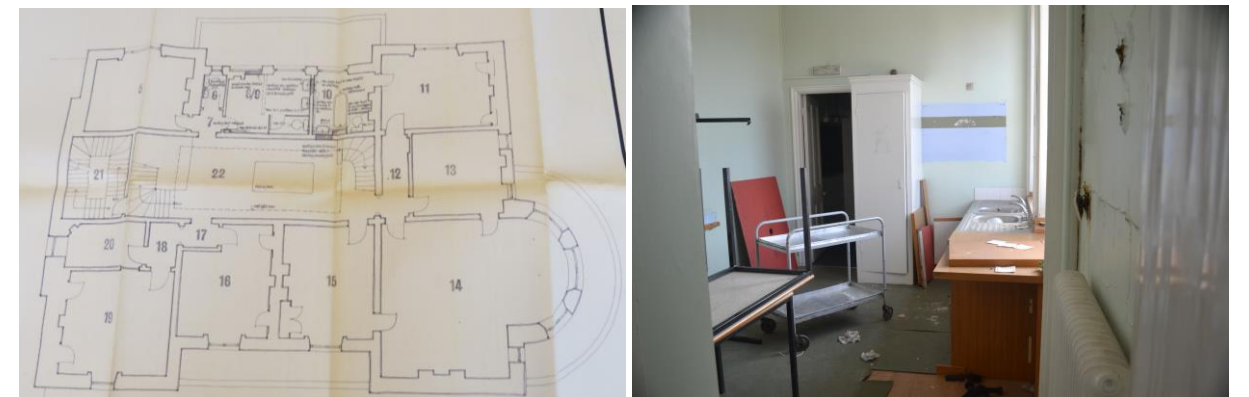
Figure 63. (left) The First Floor general arrangement plan produced in 1966 by Casson Condor for the refurbishment works undertaken in the late 1960s. (right) An image of the kitchenette in one of the former bedrooms at the first floor level.

- 3.80 The general layout of the planform at the first floor level largely reflects that of the ground floor. The central landing provides access to, what would once have been, bedroom accommodation for the family. One room at this floor level is now a converted kitchen.
