1EW02 Enabling Works – Area South

Heritage Agreement Method Statement

Recording and Dismantling Railings around Euston Square Gardens

Document no.: 1EW02-CSJ-HS-MST-S003-000492

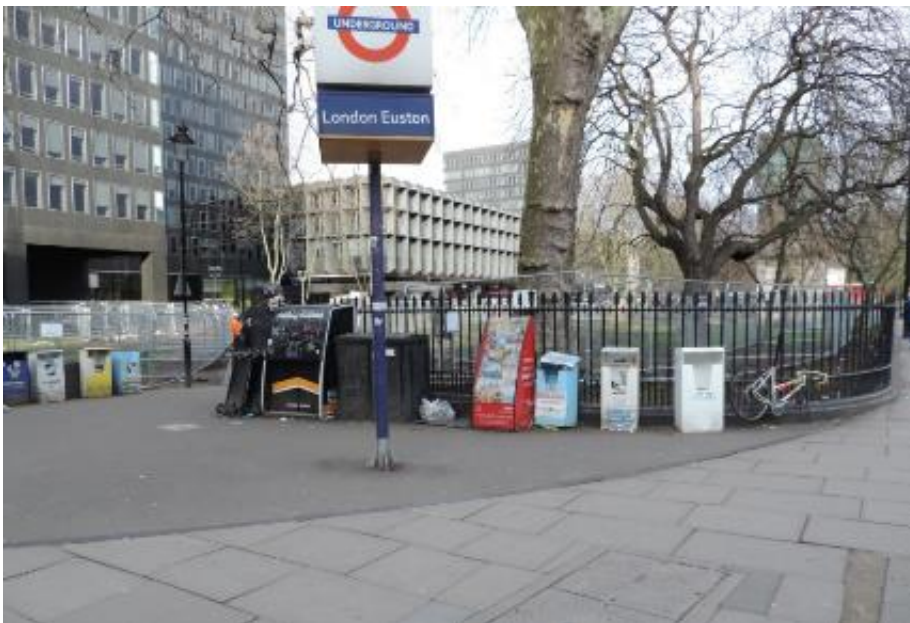
Figure 2 The south-west corner of Euston Square, showing railings partly obscured by newspaper stands and services

- 2.4.4 As illustrated in Figures 1 to 4 above, the railings feature prominently in views across Euston Square, especially from the south and east and in the vicinity of the lodges. The railings sit within the Bloomsbury Conservation Area (sub area 1) and Camden Council's 2011 review of this area Conservation Area Appraisal recognises the railings and surrounding views as significant. The influence of the classical style was significant in the Euston Station area and it was adopted by designers of later buildings fronting onto the square – notably the Royal College of General Practitioners (listed grade II*), the Wellcome Building (listed grade II, 1931-32) and Friends Meeting House (listed grade II, 1925-27). These buildings all contribute positively to the railings setting.

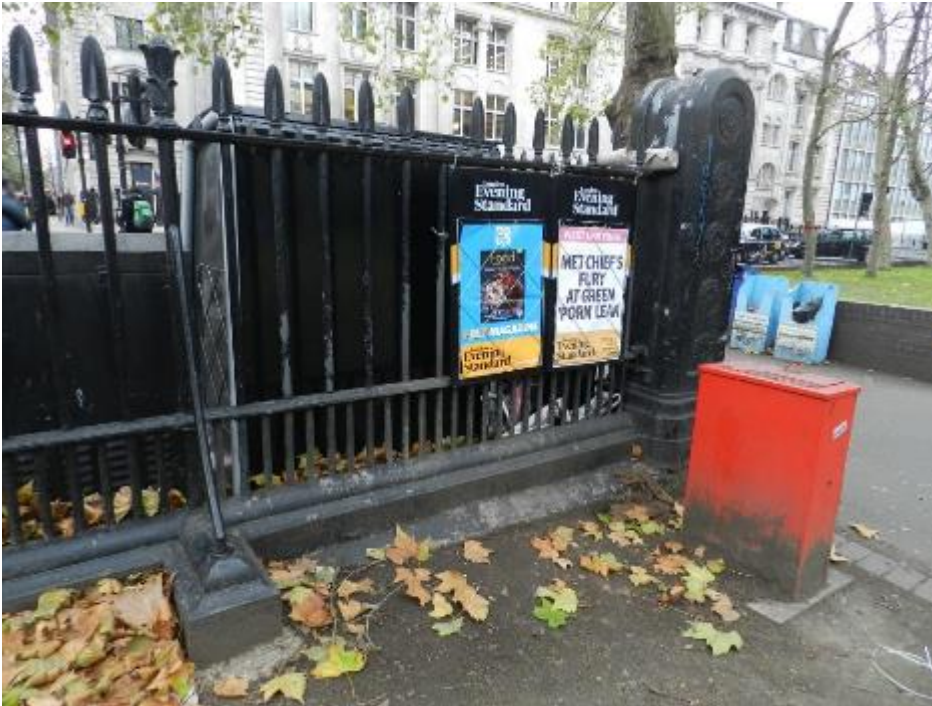
Figure 3 The pier in the south west corner of the western group, rear (gardens) elevation

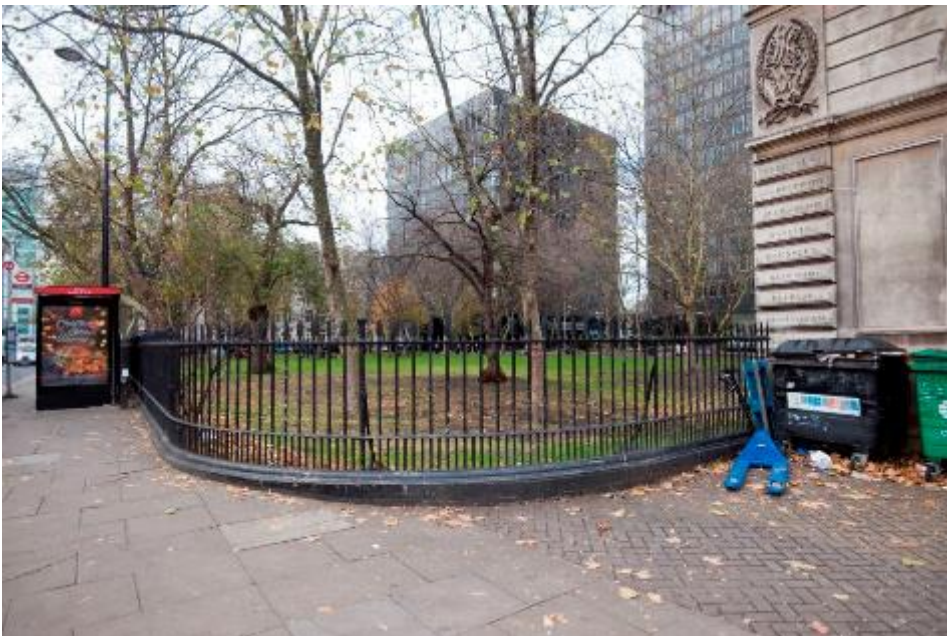
Figure 4 The western group of railings, abutting the south-western corner of the west lodge

- 2.2.10 There is a third variant type of panel, a curved section which occurs on the corners of the Square (SW and SW) and at the corners in front of the lodges. This is the longest section of the various panel types. It was formed with a single plinth section and 13 of the spear-headed palings. There is also a curved version of the T-shaped panel, again with 6 spear-headed palings. (See plan drawings in Appendix B and Figure 4)

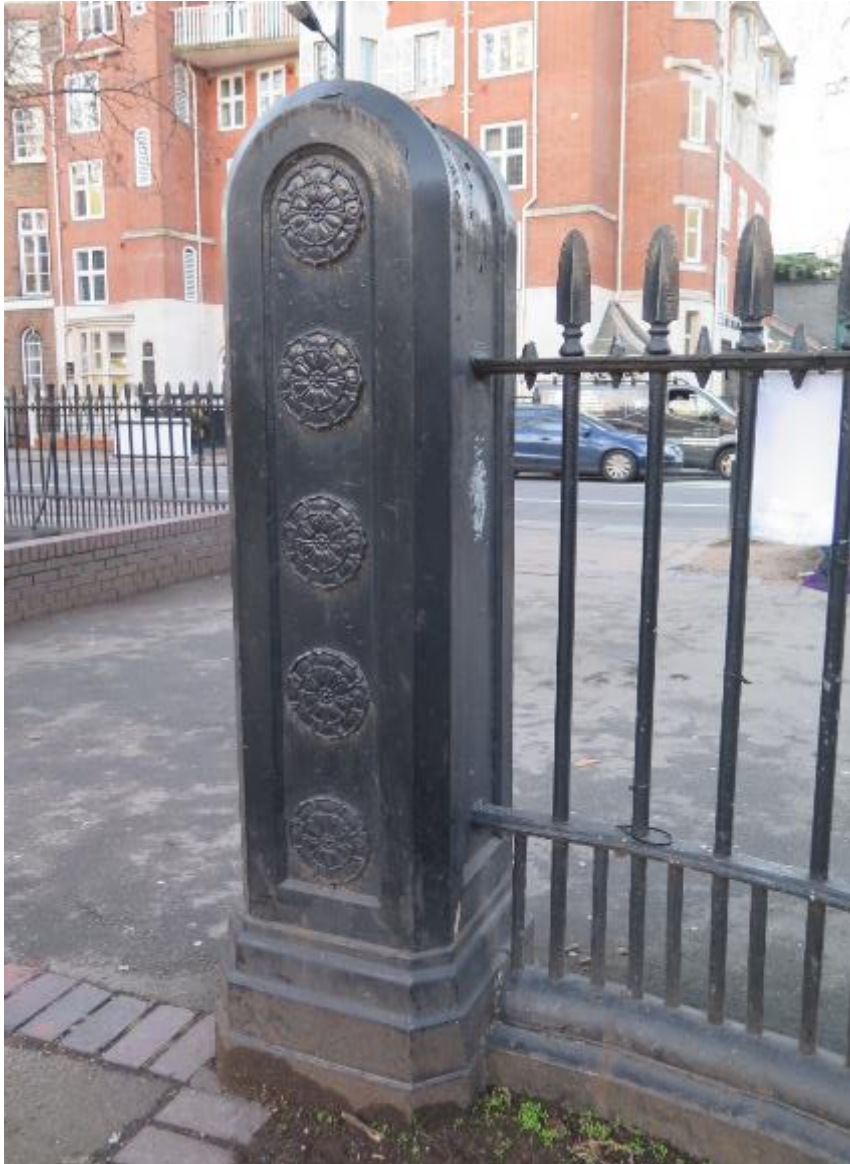
Figure 5 Detail of pier at the southeast corner of east gardens, looking east.

- 2.2.11 There are 6 piers in total and these have all been repositioned. The piers are square in plan and decorated with a row of 5 rosettes, set into recessed panels on their two principal faces and framed by a continuous perimeter moulding. (Figure 5) Similar rosettes can be seen on the door architraves of St Pancras New Church located to the southeast at the junction of Euston Road and Upper Woburn Place. In both these cases the rosettes are stylised, unlike the more naturalistic Tudor roses which also differ in having five inner and five outer petals, fewer than the classical rosettes. St Pancras Church was built c.1820 in a Greek neo-classical style, based on two ancient Athenian buildings – the Tower of Winds and the Erechtheion on the Acropolis. The railing finials feature classical motifs – spearheads, which were a common feature of military trophies, and acanthus leaves, in this instance in a stylised, simplified form. Matching finials are visible on the short section of historic railings located on the south side of Endsleigh Gardens, at the east end of this road opposite St Pancras Church.

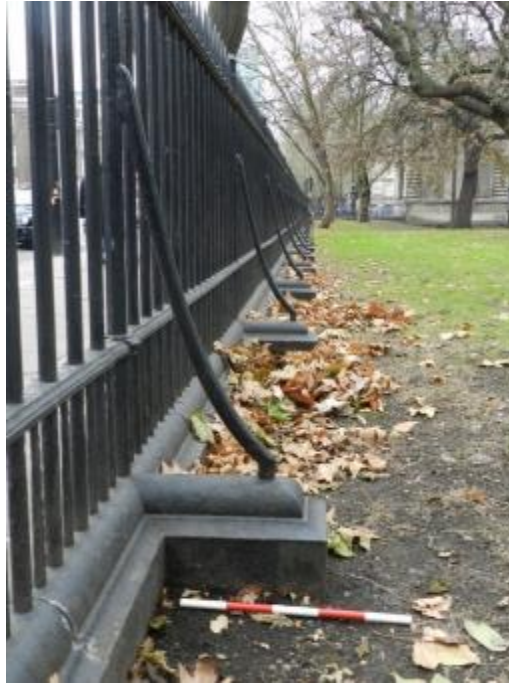
Figure 6 The rear elevation of the railings facing into Euston Square illustrating backstay supports

(As seen on the eastern group of railings looking west to the Euston Lodges)

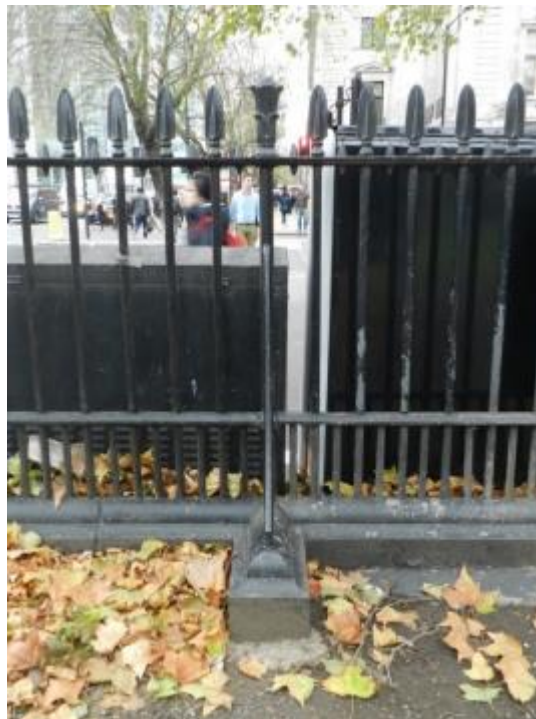
Figure 7 The rear of a backstay panel in the western group of railings, looking west

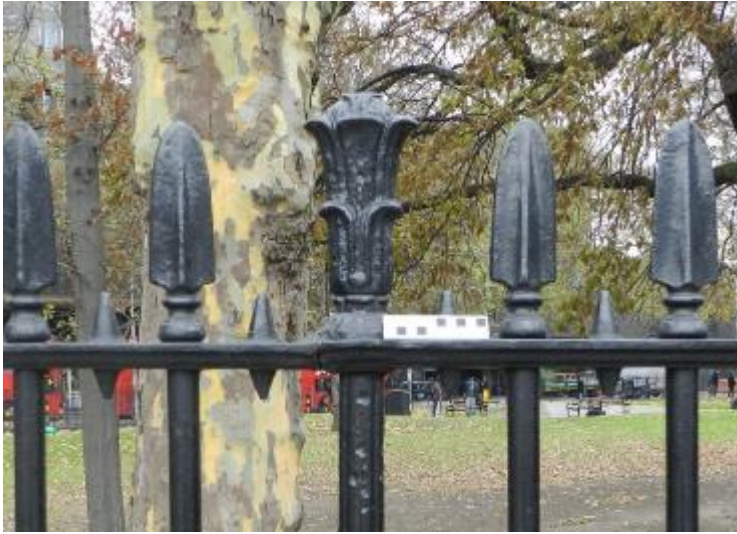
Figure 8 Foliate and spear head finials in the eastern group of railings looking north

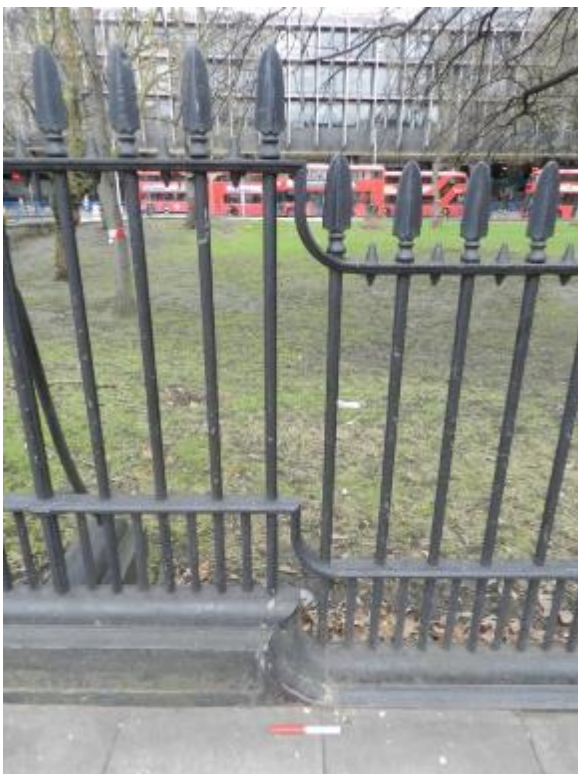
Figure 9 The step in the railings at the west end of the eastern group, looking north

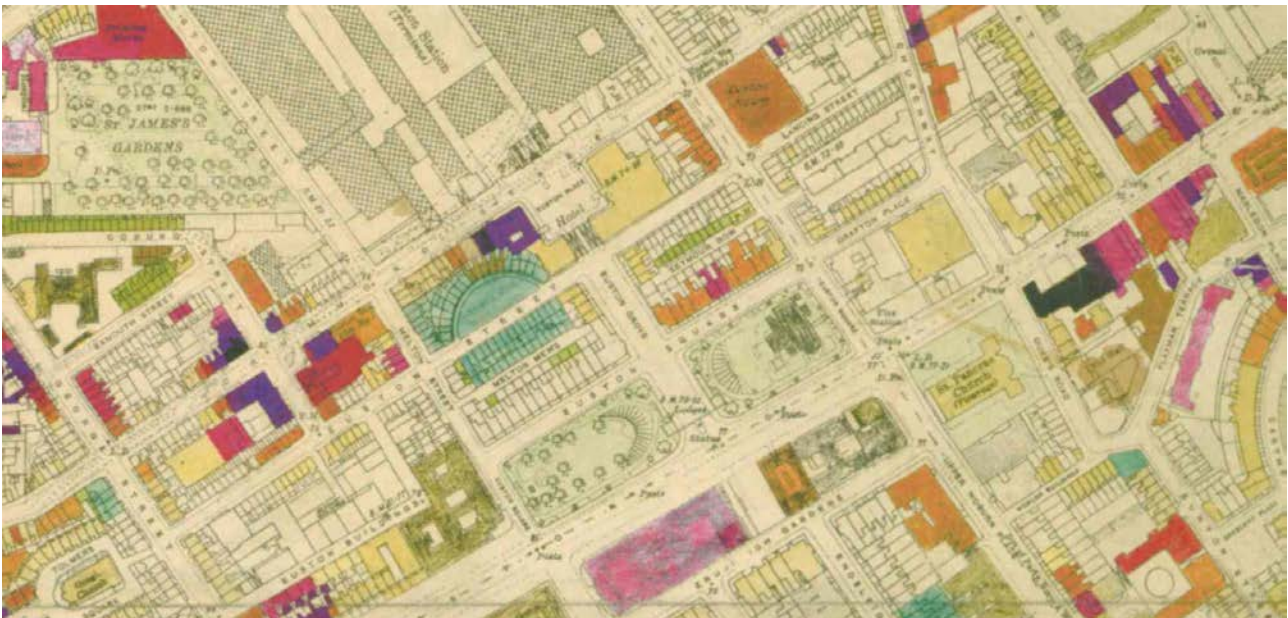
Figure 9 A scan of the Bomb Damage map of the area (London Topographical Society, 2005)

The bomb map shows the varying extent of World War II damage to structures around Euston Square Gardens. For example, purple colour indicates damage beyond repair whilst yellow signified blast damage. Euston was not severely affected in comparison to other areas of London.

- c. Some damage occurred to the area during the Blitz of World War II. As can be seen from the Bomb Damage Map (Figure 9 below), Euston was not severely damaged in comparison to other areas of London. However, the terraced houses to the north of the gardens were affected especially, to the northeast. Post war clearance of heavily

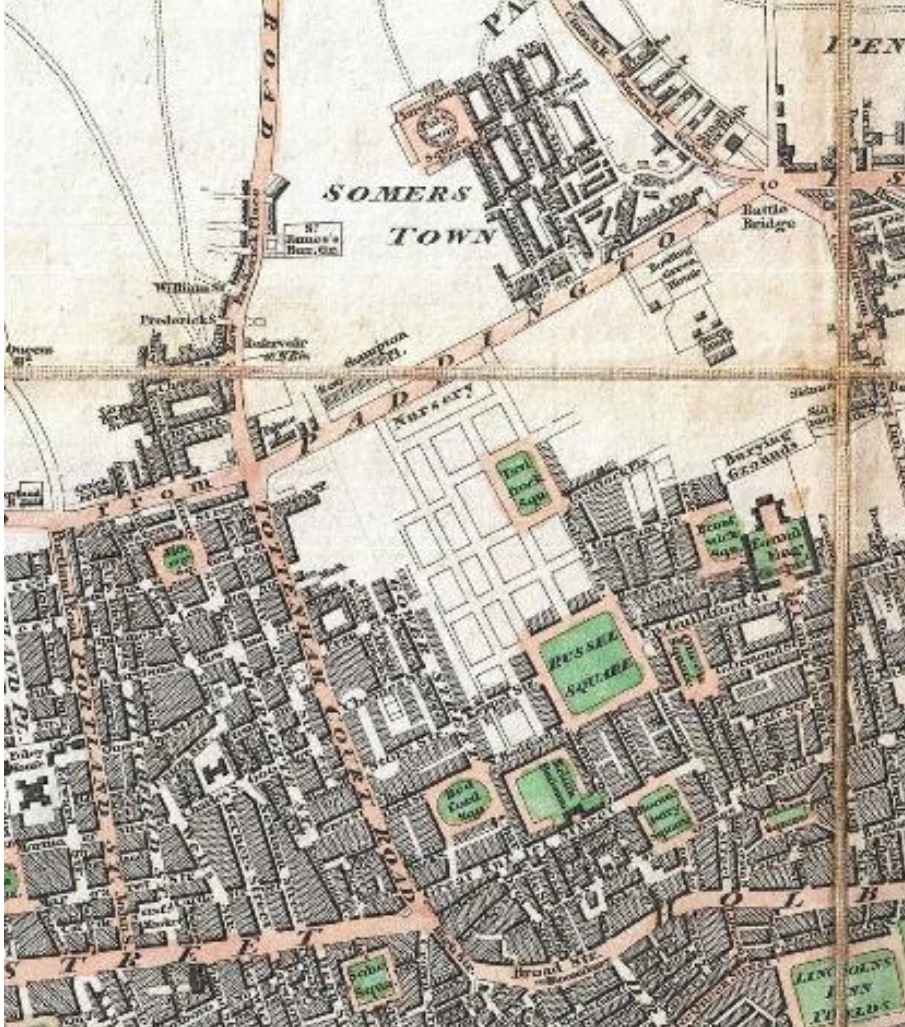
Figure 10 Detail of Edward Mogg's map of London c 1808 ⁵

- 2.3.1 The area around Euston remained undeveloped open land until the late 18th century. The land surrounding London had comprised estates, owned by the landed gentry who gradually sold off their property to speculative developers. A map created by Edward Mogg c. 1806 (Figure 10 below) shows the streets and blocks laid out to the north-west of Russell Square, but before the construction of buildings. The Euston Road was at this point known as “the New Road from Paddington to Islington”, with Somers Town to its north. (see Figure 10 below) An open area named as a nursery can be seen on the southern side of this thoroughfare and this corresponds to what would become Endsleigh Gardens. Opposite this area the space that would become Euston Square is open except for a row of buildings called Southampton Place.

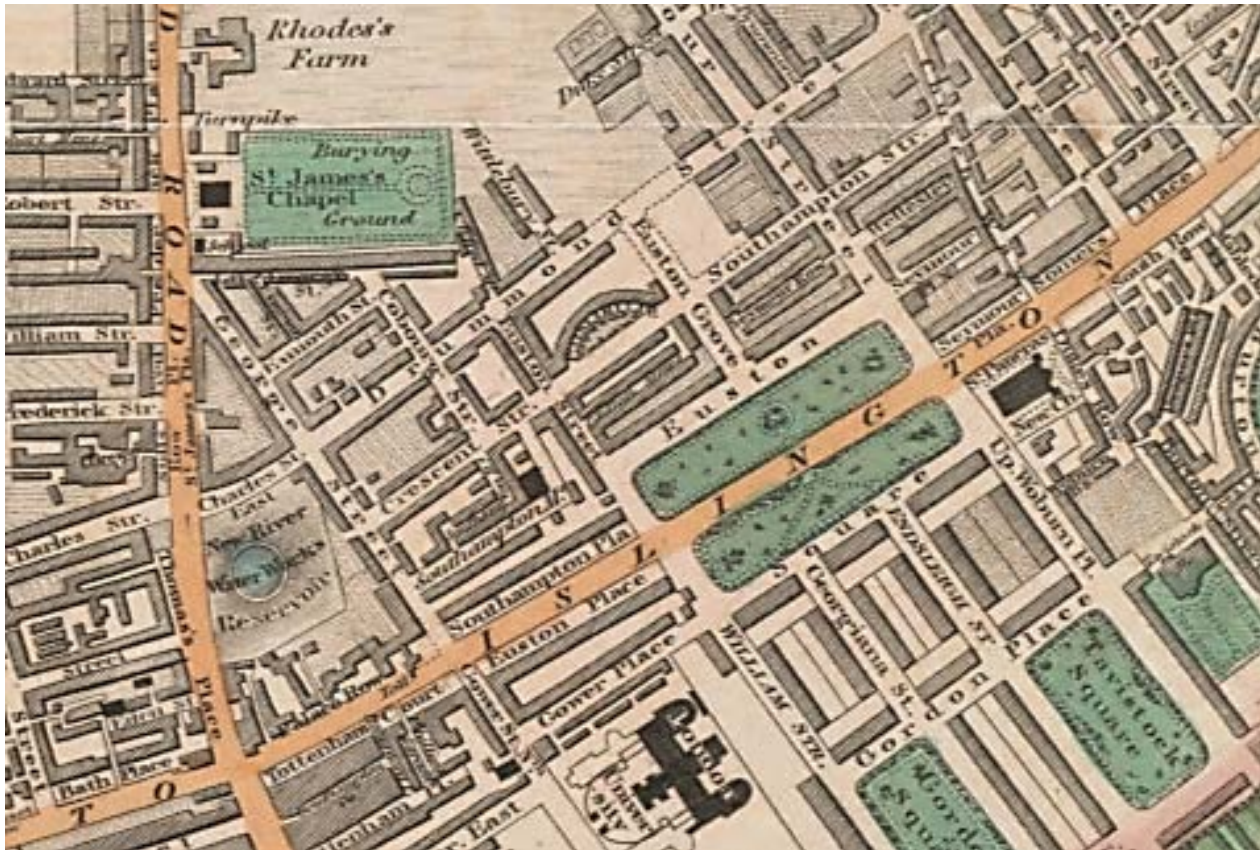
Figure 11 Detail of London Map by Neele and C and J Greenwood of 1830 ⁶

- 2.3.2 C&J Greenwood’s Map of London (1824-26) shows the former nursery amalgamated with land on the north side of the “New Road” (now Euston Road) to form Euston Square. (see Figure 11) Bisected by the “New Road”, Euston Square appears on the map in the same style as nearby Gordon and Tavistock Squares and as St James’s Chapel burial ground – in green with details suggesting plantings and a perimeter boundary, possibly railings. Although it seems probable that the square had railings at this stage, it is unknown if any of these were retained in subsequent redevelopment. Given the significant alterations made to the area in the following decades with the arrival of the railway, this seems unlikely. By this stage Euston Grove had been established north of Euston Square and would be extended south later to form the central approach road to Euston Station (currently the bus access road).

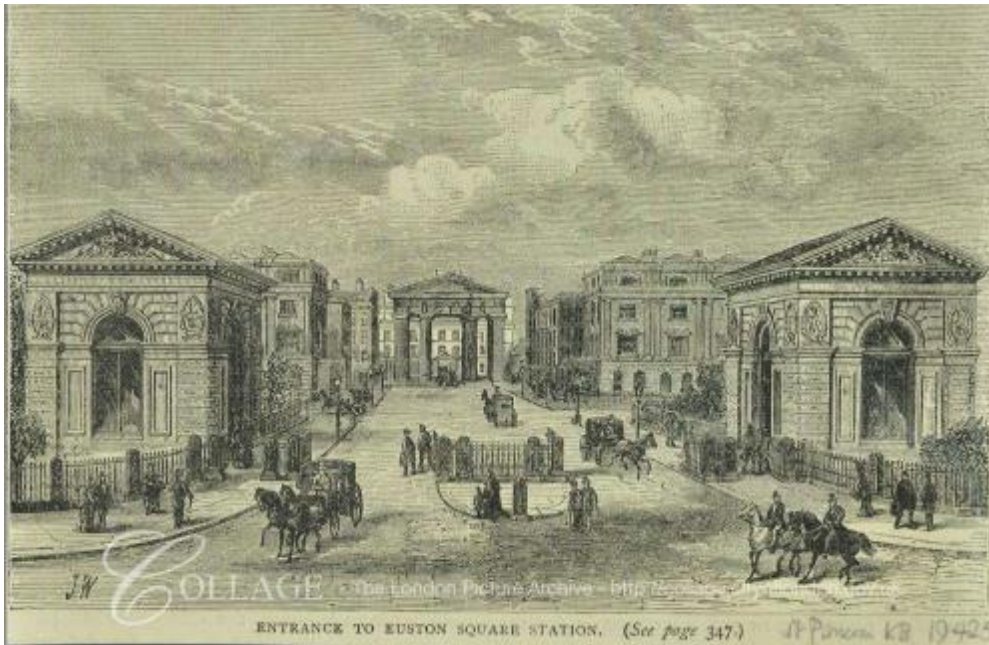
Figure 12 Wood engraving of Euston Square garden railings soon after installation (Copyright City of London Corporation)

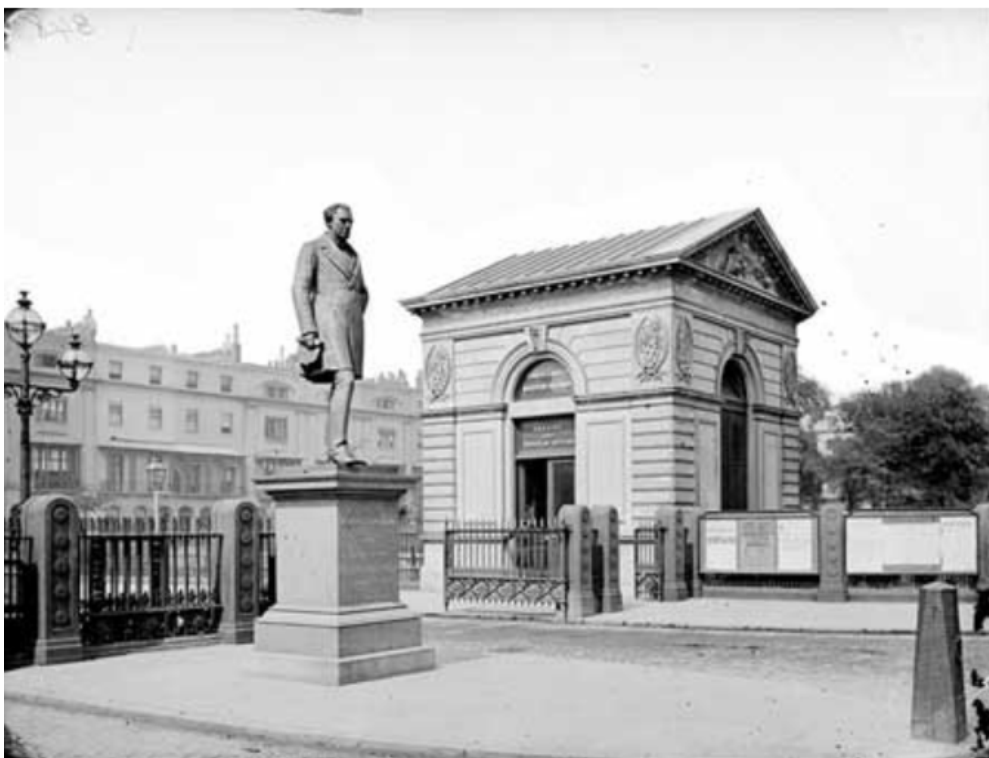
Figure 13 Photograph c.1870-1900 of railings and Robert Stephenson sculpture recently installed (reproduced by permission of Historic England Archive, image no.CC97/00265, General View of the Robert Stephenson Statue in Euston Square London)

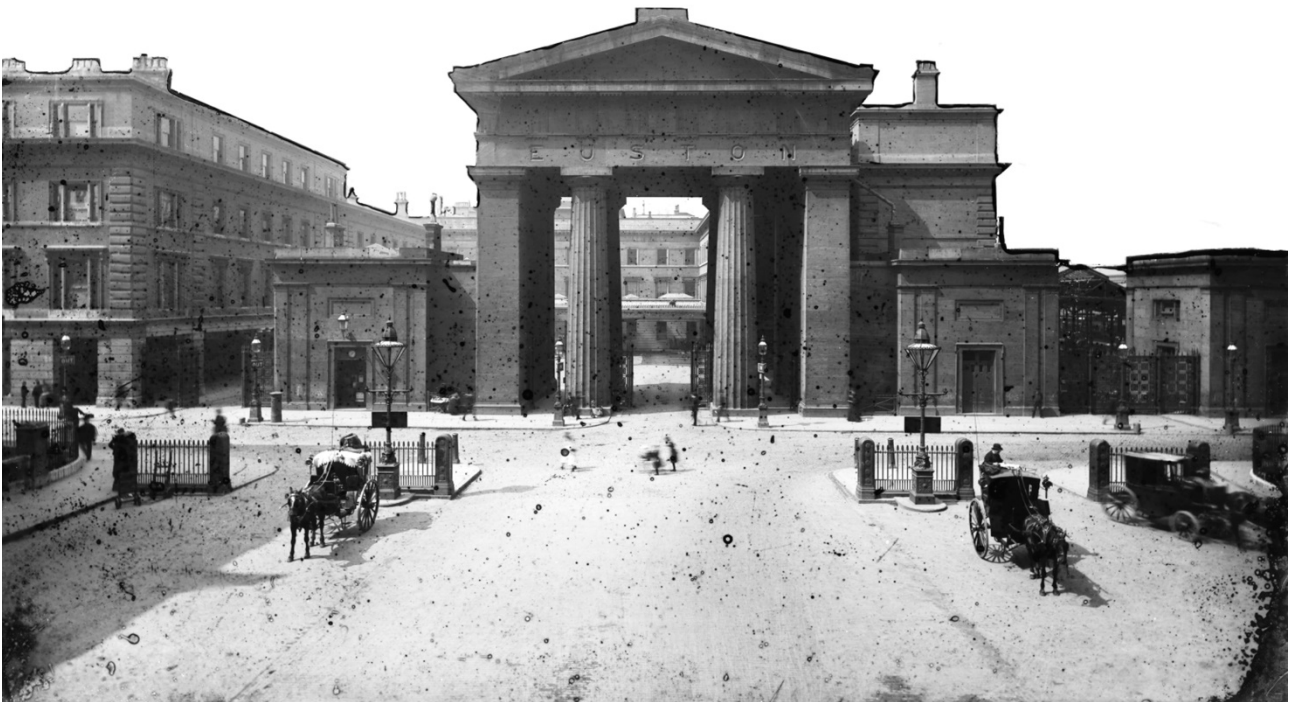
Figure 14 Photograph of Euston Arch in 1898 and railings in foreground of same form as Euston Square Garden railings (Copyright: Science and Society Picture Library, reproduced under licence. Photograph identification number 10666517)

Note gate piers and railings located in front of the arch, which framed the opening. The gate piers formed part of the monumental station approach illustrated in the previous figures and were a visual link between the lodges and the arch. The rosettes on the railing piers echo the rosettes of the decorative gates set within the arch opening.

- 2.3.5 The exact date of fabrication, original location and extent of the railings remain uncertain. They are of the same design and arrangement as the railings located immediately in front of the Euston Arch, as they appear in late 19th century photographs.² (See Figure 14 below) The distinctive stele-like gate piers in these photographs are unmistakably the same as those that survive in Euston Square Gardens. It is unknown if the existing railings incorporate any earlier elements from the 1830s station development, or if new sections were made to match the existing, possibly earlier ironwork, during the c.1870 remodelling of the square. Alternatively, the railings may belong entirely to the c.1870 scheme. It seems likely they were introduced at this stage as part of the monumental Euston Grove station approach.

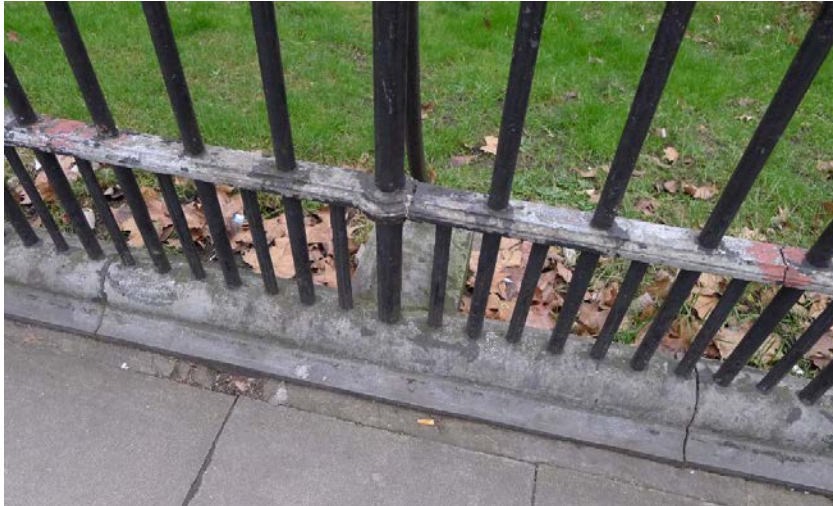
Figure 21 Lower section of railings with extensive loss of paint and open joints in moulded base, and cracks in lower rail

Note the open joints in moulded base and red areas on lower rail where past cuts were made, apparently to permit dismantling, and have been welded. The weld has failed in the red area on the right where cracking is visible.

(base) moulding and between the upper and lower rails where joints are often open or past repairs have failed. (See Figure 21)

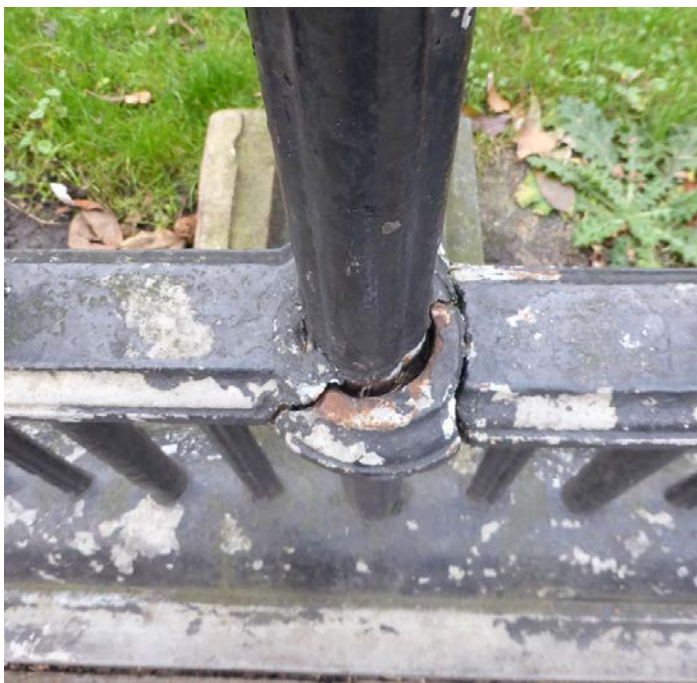
Figure 22 Fracture at the collar joint of the lower railing (around the principal, central paling).

This is a defect noted in various locations which may be due to several factors including minor movement and settlement, and possibly mis-handling during past relocation.

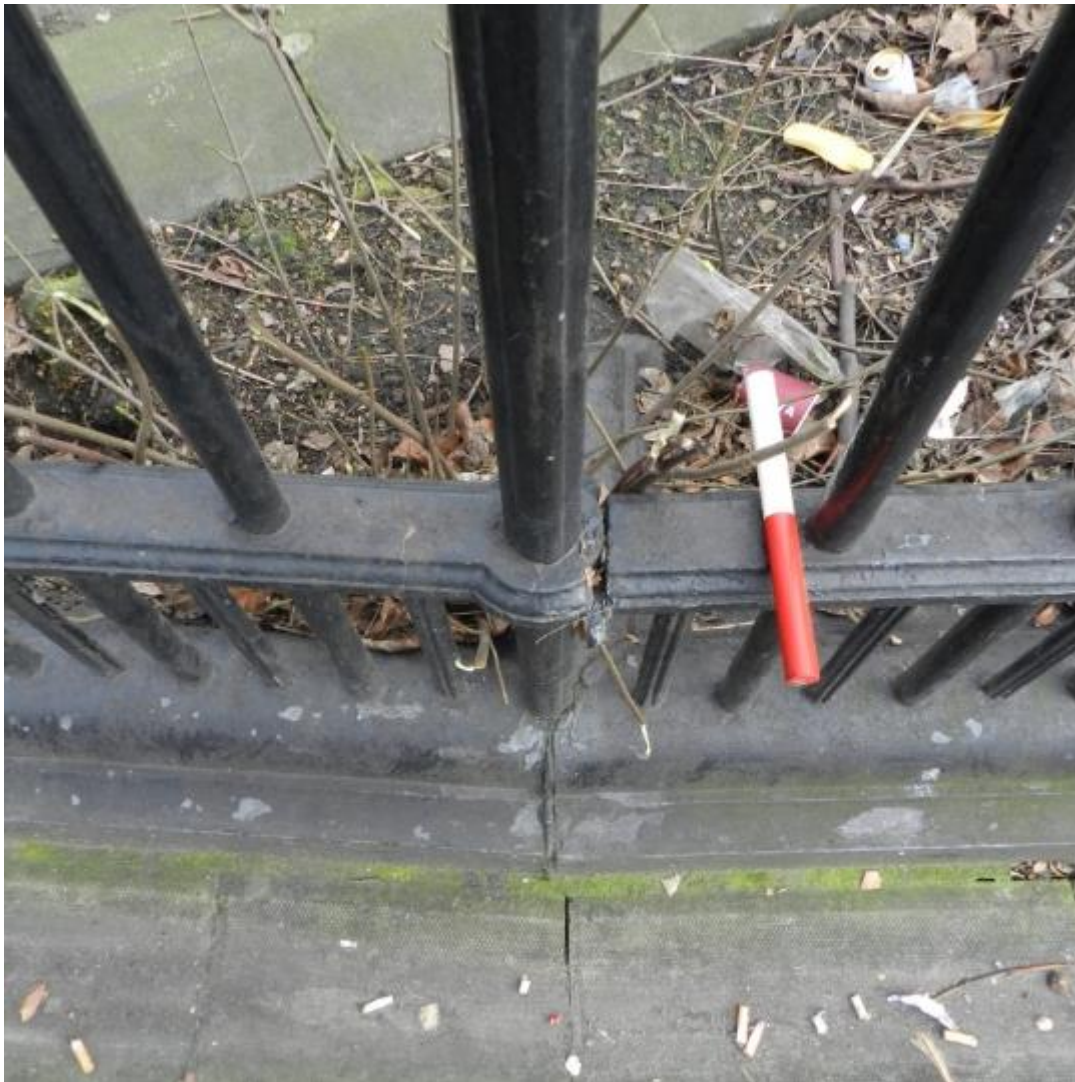
Figure 23 Detail of base to the north of the east lodge where base has been cut and realigned

Comparison with previous photograph shows that railings have been cut at base and lower rail, to form a slight angle, apparently to permit widening of the road. This photograph along with previous two illustrates the variable surface condition. There is extensive failure and loss of the protective paint coating in many areas, often down to the metal surface.
