CONTAMINATED LAND RISK ASSESSMENT

Phase 2 Environmental Site Investigation Report

18 Acton Street
London
WC1X 9ND

PH2-2018-001032

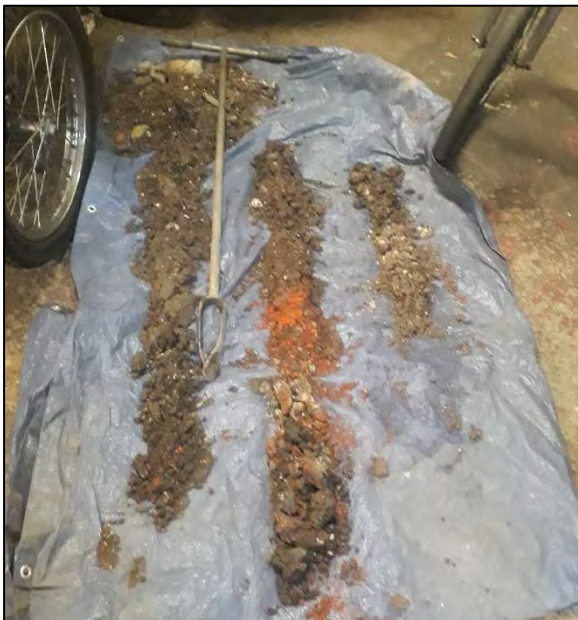
Image 2: Excavations at BH01.

Boreholes were advanced to a maximum depth of 2.2 mbgl. The strata encountered in each borehole consisted of a concrete hardstanding and made ground comprising of dark brown silty clay and fragments of debris (i.e., brick, chalk, concrete, glass and plastic).

Visual indications of contamination of the made ground to depths of 2.2 mbgl were observed (i.e. building rubble and brick) across the site. No significant odours or PID readings were recorded during the investigation.
