**FIREMEN'S COTTAGES
WEST END LANE FIRE STATION
327B WEST END LANE
WEST HAMPSTEAD
LONDON**

Historic Building Assessment

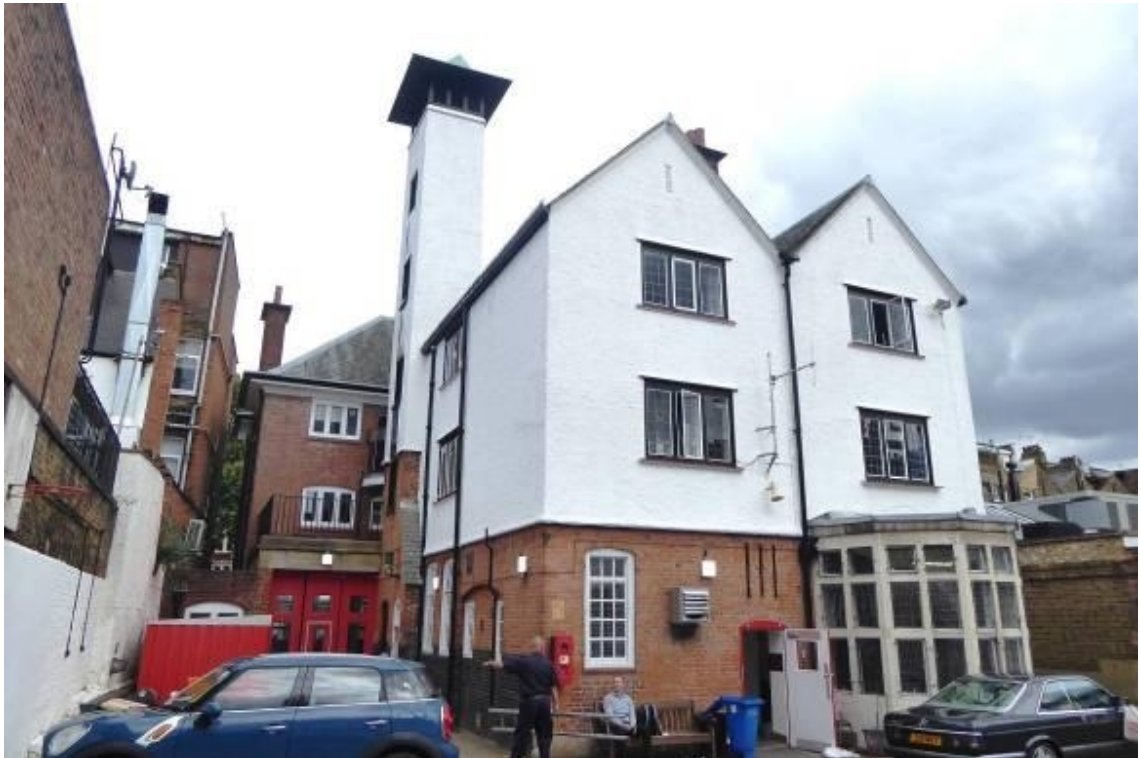
Fig 2.1.2: West End Lane Fire Station rear

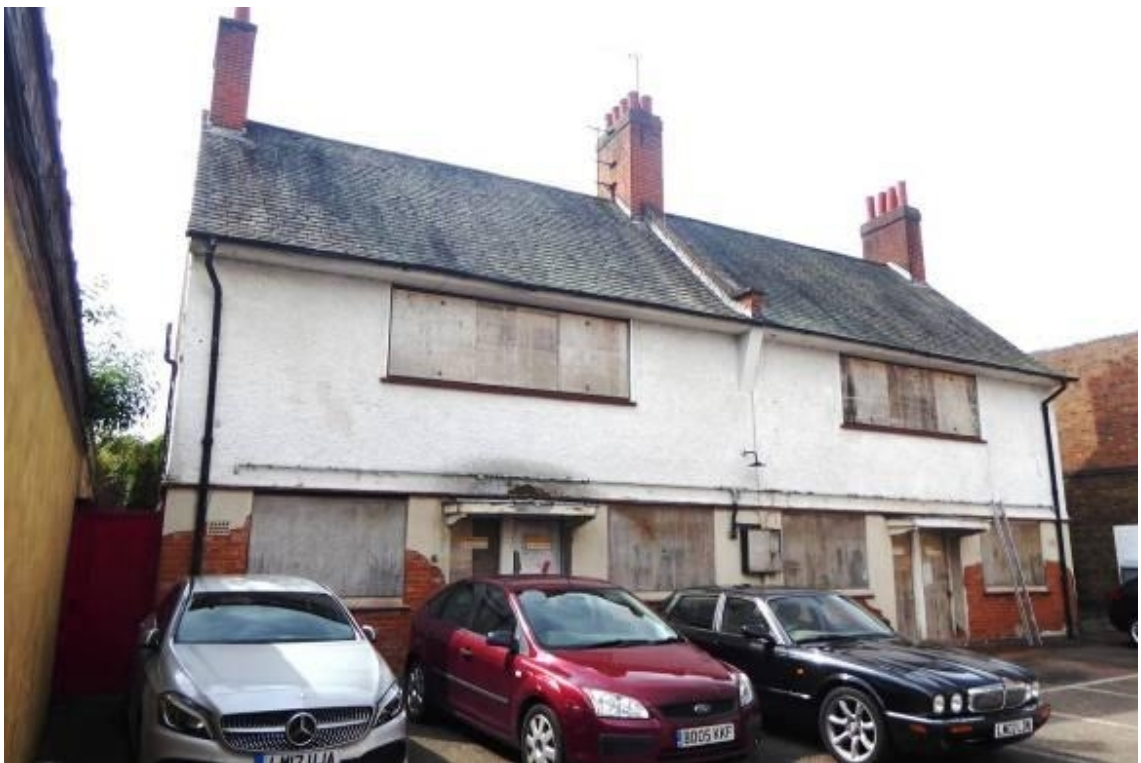
- 2.2.1 This is a two storey terrace of four cottages that from a general architectural consideration of the front (east) of the building they appear to have been designed to give the impression of being just a pair of cottages with an upstanding parapet dividing wall projecting through the roof. They have been altered with blocks of added bathrooms on the rear as a form of late 20th century modernisation.

Fig 2.2.2: Front elevation of cottages
