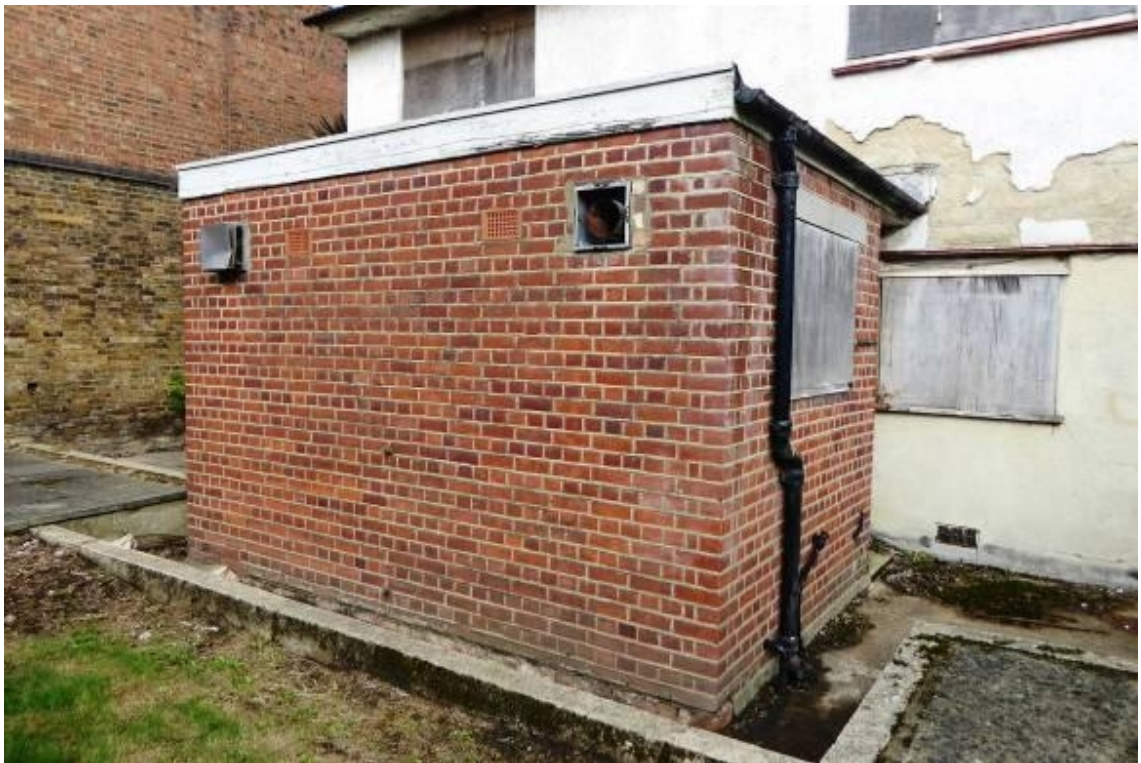
Fig 3.5.12: Rear extension walls

- 3.5.11 There was no obvious indication in the base of the external walls where these could be seen externally to suggest that a damp proof course (DPC) having been installed when the structure was built.
- 3.5.12 The single storey extensions to the rear of the building have walls where the external face is laid in English bond using red/brown brickwork that is pointed with a hard cement type mortar. From the apparent thickness of the wall seen through openings this could suggest a cavity construction with the outer face being employing snapped headers.

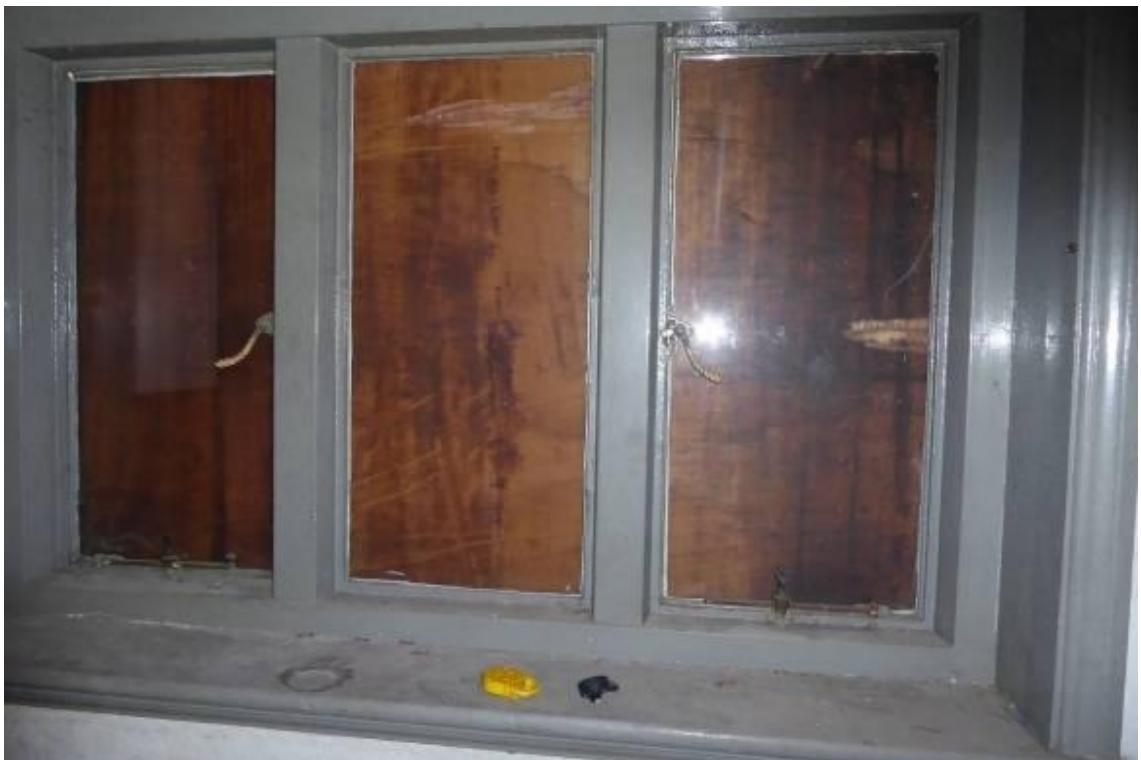
Fig 3.6.2: Internal view of sitting room window

- 3.6.1 All the windows around the building were boarded up so no external inspection of these was possible.
- 3.6.2 Internal inspections reveal that these were all single glazed with sheet glass. The original window openings all have timber linings to the reveals with a splayed architrave to the perimeter and were fitted with a window board, but the bathroom windows were just had plastered reveals and window board.

- 3.6.3 In general terms the ground floor sitting room windows are a heavy timber framed three light unit with metal opening lights on either side and a fixed light in the centre. In the kitchen there is a similar framed two light with one side being an opening timber casement.
- 3.6.4 At first floor level the front bedroom window is a three light casement with a heavy timber surround that is positioned against the dividing wall to the adjacent cottage with a front link or cover panel joining to the next frame to give the visual

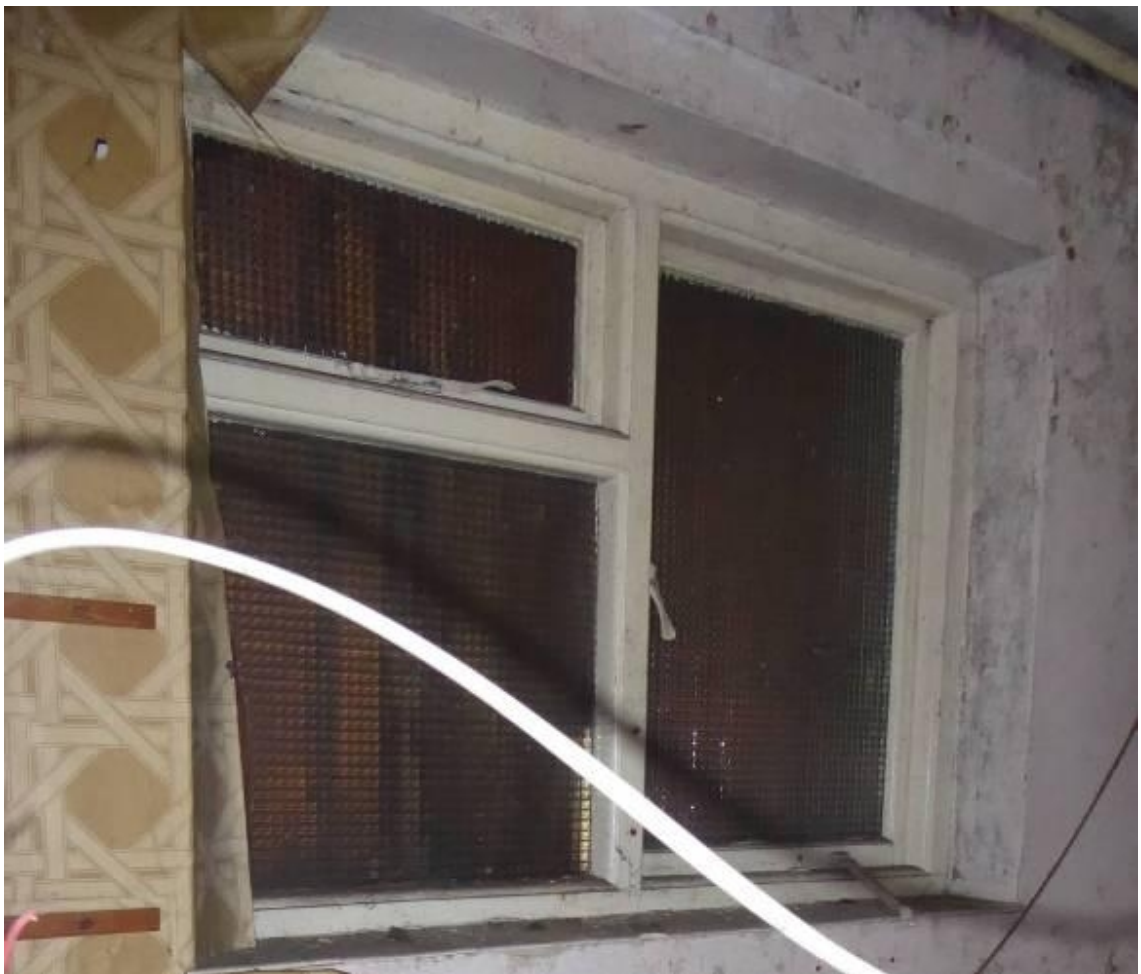
Fig 3.6.6: Typical bathroom window

- 3.6.5 In the rear bedrooms the windows are similar to those on the front, but are situated centrally in the wall of the room. The opening central casement is timber framed.
- 3.6.6 The bathroom windows are a single glazed standard joinery item of 1960 – 70s style with an opening casement on one side of a central mullion with a top opening casement over a fixed light on the other. The ironmongery is all of that period.

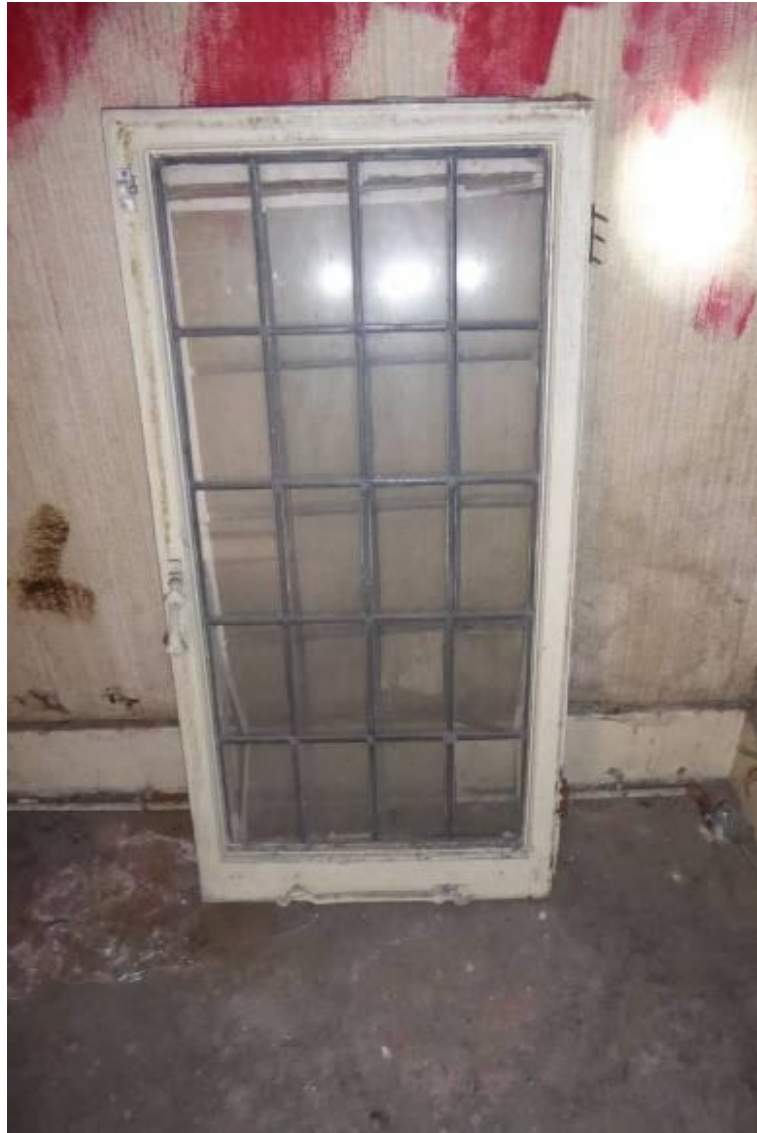
Fig 3.6.7.2: Possibly original casements

- 3.6.7.2 Second from north cottage sitting room - the right hand side casement has more original style latch handle that is different from the right hand latch. Propped up in the sitting room at the time of the inspection were a pair of
