4 INTERIOR - NORTH SIDE COTTAGE

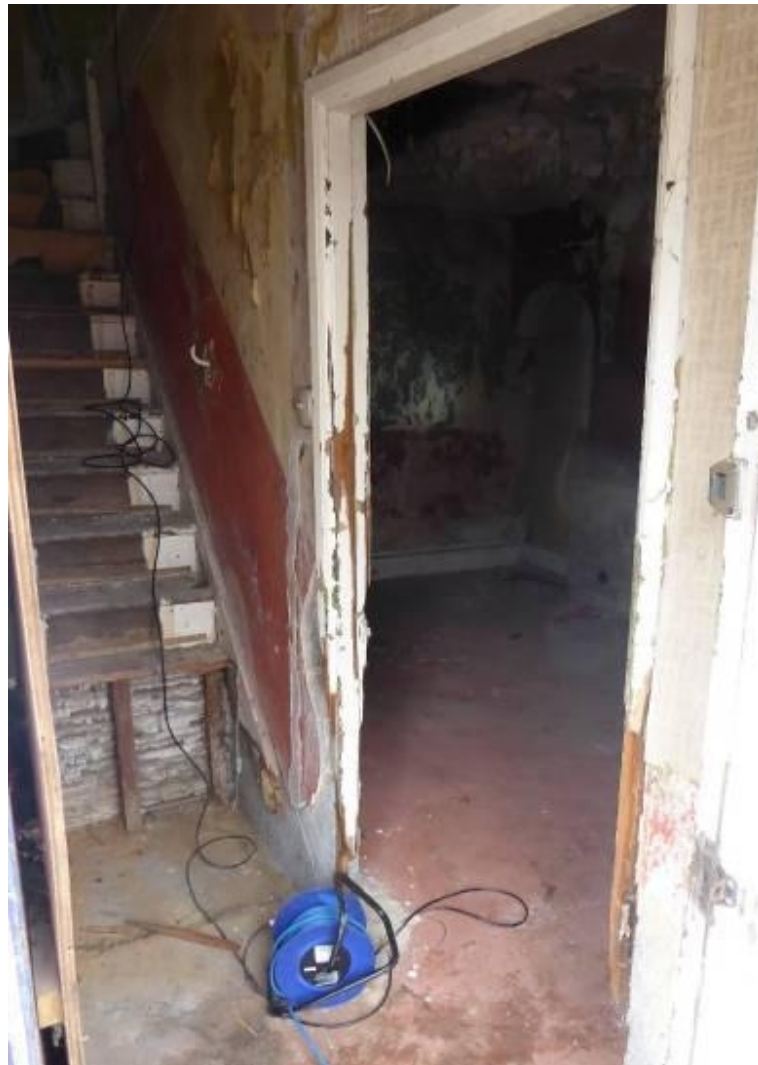
Fig 4.1: Entrance Lobby

- 4.1.1 This has a floor of concrete with granolithic type top.
- 4.1.2 The walls are all of solid construction where the internal face of the external wall is painted plaster on brickwork. The internal walls are of cast in situ concrete that has used timber boarding as formwork and this included the stairs as indicated by casting marks.
- 4.1.3 There was no indication of this having had a door at the bottom of the stairs.
- 4.1.4 The lining to the door to the sitting room is painted softwood, 10 mm stops and a simple ovolo architrave on both sides. The door was missing and was originally mounted on a pair of 75 mm steel butts.
- 4.1.5 The ceiling over this area is a lath and plaster type that has been decorated.

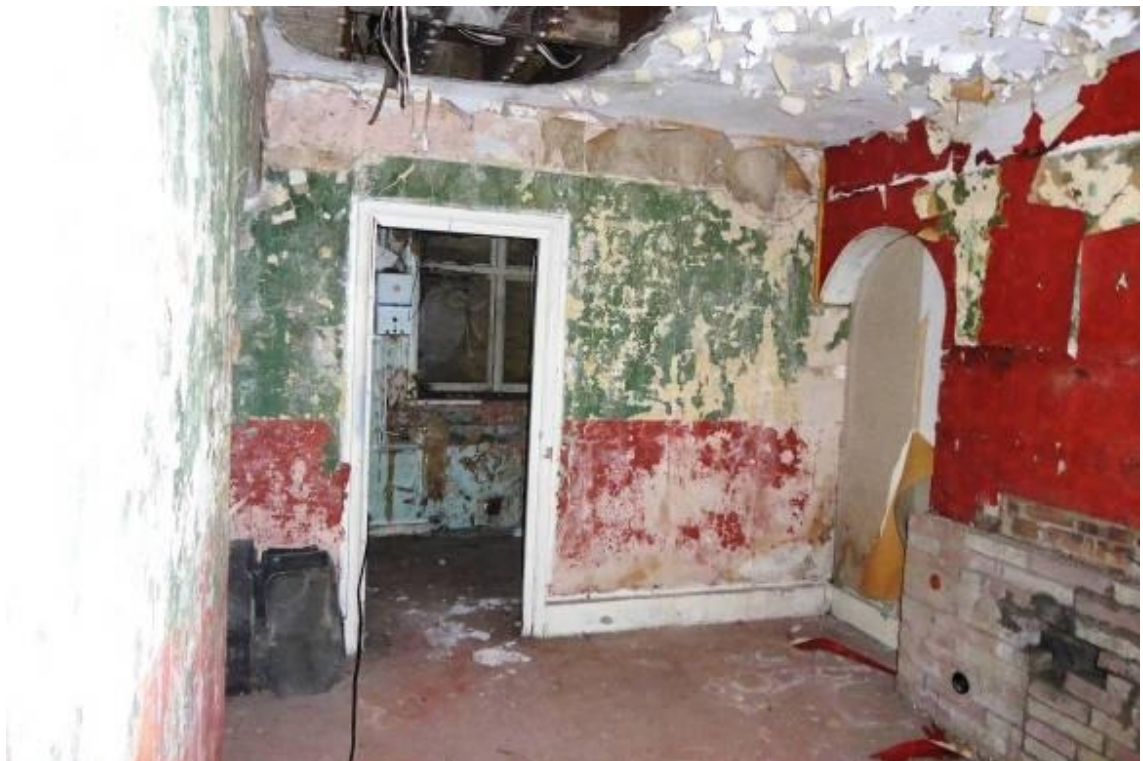
Fig 4.2: Sitting room

- 4.2.1 The floor is a solid concrete structure with a plain screeded surface and not a granolithic finish as the lobby.

- 4.2.2 The walls are generally as that described within the entrance lobby being of brickwork to the exterior and cast in-situ concrete for the internal structures. These have all been finished with what appears to be a two coat lime plaster and then painted.

- 4.2.3 The skirting boards to the base are simple painted timber board with a slight rounded top edge.
- 4.2.4 A picture rail was originally fixed around the head of the wall approximately 30 mm down from the ceiling, but this appears to have been removed some time ago with only a shadow line in the decorations remaining.

- 4.2.5 Where modern decorations, such as wall paper, have been removed it was possible to see the original colour scheme to the walls. At first this had been a uniform cream colour and then red paint applied over it to a height of approximately 1.2 m above floor level all the way around, this being just above internal windowsill level. At a later date all of this was over painted with a dark / leaf green paint.

- 4.2.6 Running down the north wall there is a chimneybreast that has a fire opening in the bottom that has been blocked up. Across the base of the chimneybreast is a decorative late 20th century style of fire surround that possibly had the flue for a solid fuel combustion or gas stove passing through it into the chimney above. To the front is a hearth covered with glazed ceramic tiles approximately 75 mm square of a pinkish buff colour that is flush with the main floor.

- 4.2.7 The modern fire surround it built in multicoloured concrete bricks. Just above the top of this modern facing it is possible to see where earlier fire opening has been blocked up using a London Brick Company (LBC) Fletton type bricks laid in cement mortar. It is still possible to see part of the original fire back bricks behind the later closing to the side.

- 4.2.8 At high level to the left hand side of the chimneybreast there is an arch in the head of the wall that extends sideways to the wall to the kitchen. This would suggest that this may have been where a flue from the kitchen at the rear spanned across to this chimney.

- 4.2.9 The ceiling in its present form has the remains of polystyrene ceiling tiles applied over lining paper on top of plasterboard that has been fixed to the underside of the first floor joists. Along the abutting wall to the staircase (south) there is the remains of the lathing of the original ceiling and there is staining to the exposed floor joists to show where this form of ceiling was originally over the whole room.
