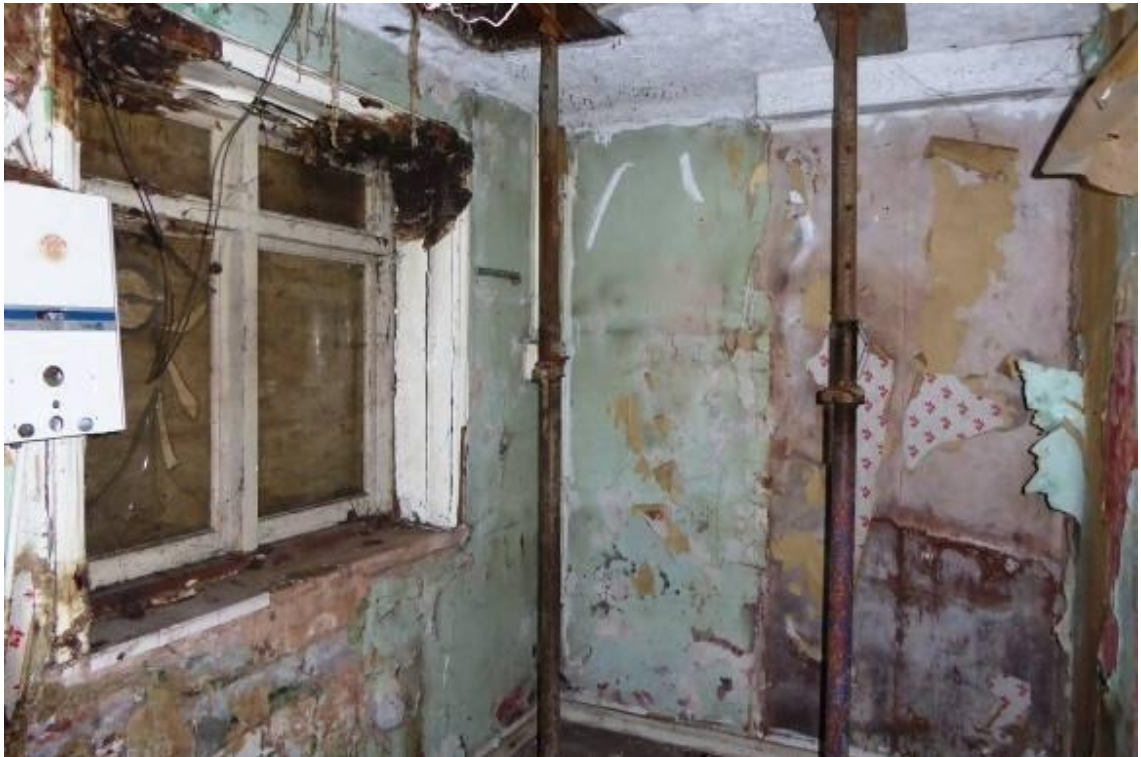
Fig 4.3: Kitchen

- 4.3.1 The floor is of solid construction with a hardened smooth granolithic type surface over which has been covered with what appears to be vinyl asbestos tiles that from their overall size and type would suggest a date to the 1960, these being approximately 225 mm square.

- 4.3.2 The walls are generally as that described for the plaster and paint finish that were originally decorated with a dark red or maroon colour to a height of approximately 1.5 m high and above that with cream colour. Over the top of that there is a considerable build-up of fairly modern plastic or polymer based paints and been subsequently with wall papers.

- 4.3.3 It is possible to see ghost lines within the decorations on the surface of the south wall where a wall has been removed. Generally on this wall the decoration pattern would suggest that that was applied at a more recent dating.

- 4.3.4 On the north wall, it is possible to see where a chimneybreast has been cut off and plastered over with modern pink gypsum plaster. At ceiling level there is a form of boxed trunking or similar.

- 4.3.5 Around the base the walls, where it survives, is modern standard joinery splayed and rounded timber skirting board that has been painted.

- 4.3.6 The ceiling, where it survives, is of lath and plaster and onto which a stippled finish of an Artex type has been applied over the top of lining paper.

- 4.3.7 In the wall below the original window board to the rear window has been lost and shows the remainder of glazed ceramic tiles on a rendered bed. Below the cill it is possible to see where waste pipes and similar from the kitchen sink were located.

- 4.3.8 A modern small gas fired instantaneous hot water heater was mounted on the wall to the left hand side of the window. Over the rear door head is what appears to be a cast in situ concrete lintel using breeze or clinker as an aggregate.

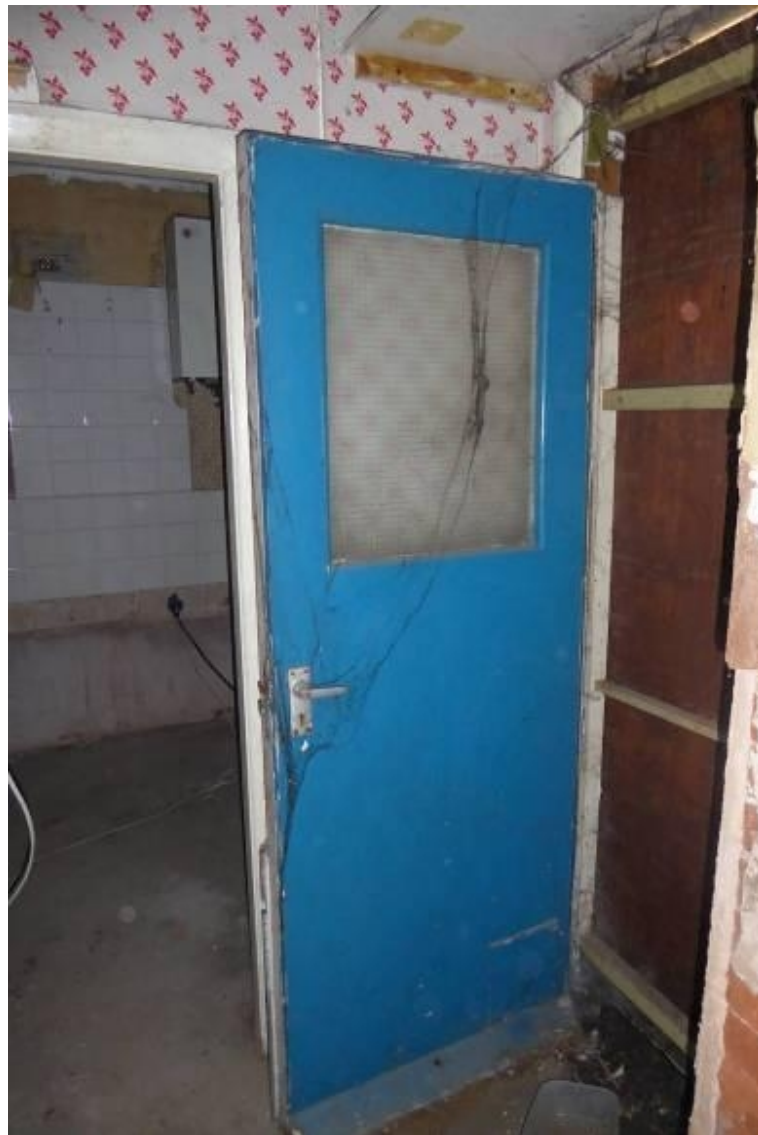
Fig 4.4: Bathroom / rear entrance lobby with external door

- 4.4.1 The floor is of solid construction with a screed type finish with no applied covering.
- 4.4.2 The walls are of solid construction with a painted plaster finish and standard joinery profile skirting boards to the base.

- 4.4.3 The external door is a standard joinery door with a Georgian wired glass panel in the top and a standard joinery weather bar at the base. It is fitted with an aluminium lever lock set of a late 20<sup>th</sup> century pattern.
- 4.4.4 The door to the bathroom is a standard joinery 35 mm thick hardboard flush door that is fitted with an aluminium lever lock set.
- 4.4.5 The ceiling is of plasterboard.
