Arboricultural Advice for Tree Protection		Prepared by:	Hal Appleyard Dip. Arb(RFS), F. Arbor.A MICFor, RC Arbor A
Project:	1-2 Eton Villas, London NW3	Produced for:	AS Studio Ltd
Date: 18th January 2019	Ref: ha/an1/etonvillas/2019		
Planning Ref:

1.0 Introduction and Scope

2.0 The Tree and Proposal

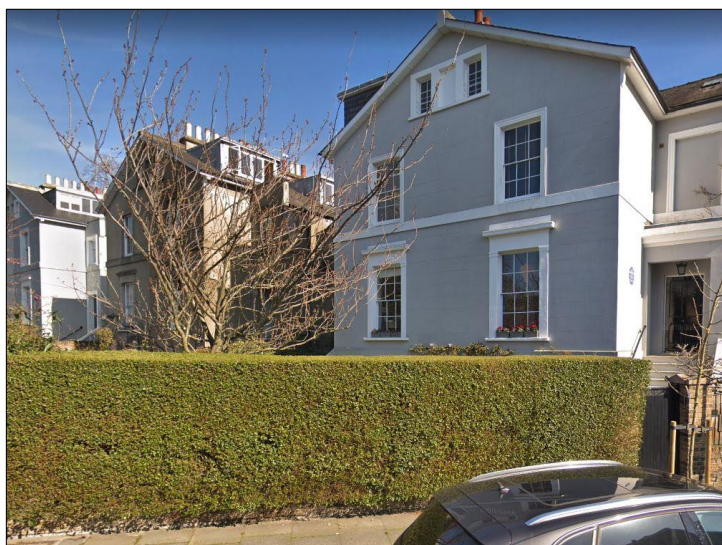
Fig. 1. Cherry tree in question T1 to the front of 1-2 Eton Villas

Image taken from Google Maps

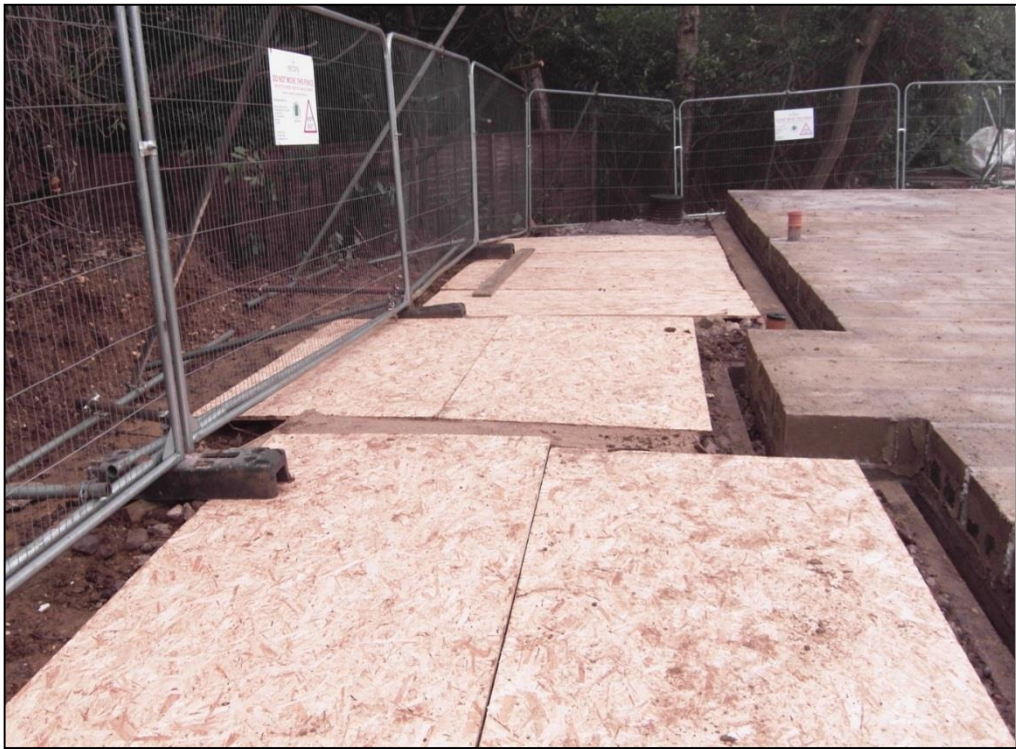
Fig. 1 Ground protection – hoarding over sharp sand and wood chip

Installing heavy-duty OSB boarding over a depth (min. 50mm) of sharp sand and/or wood chip between the tree protection fencing and the foundation line of new development is effective in protecting roots, which grow in the soil beyond the position of the fencing.

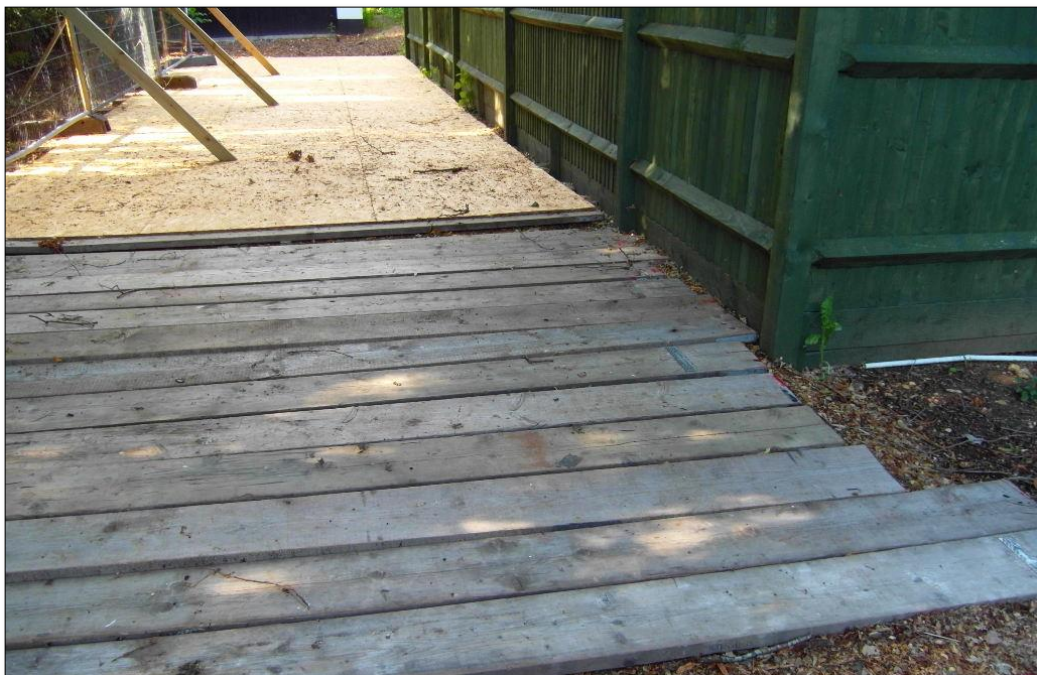
Fig.2 Side-butting scaffold boards and covered and fixed with 20mm OSB boarding

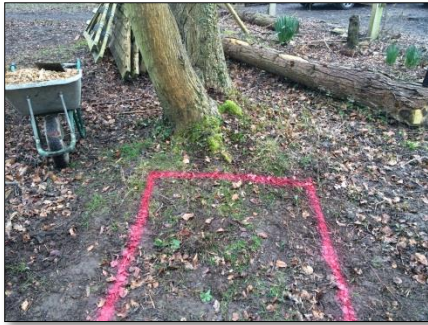
Mark out area to be excavated by manually and set ground protection at the side of the excavation area

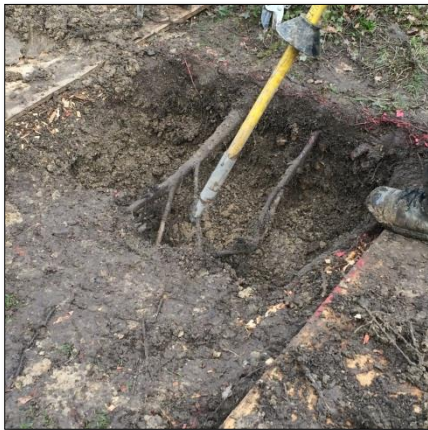
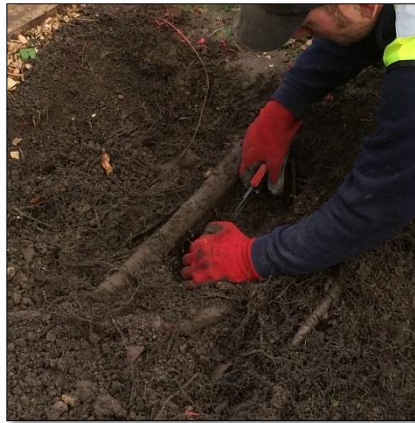
Expose the roots manually and with compressed air as necessary

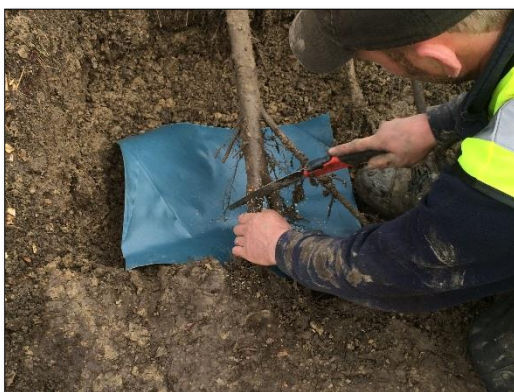
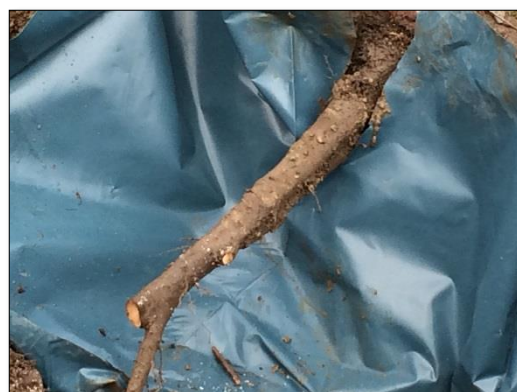
Undertake root pruning (<25mmØ) using sharp pruning tools, avoiding tears or splits and making the pruning cut as small as possible. Roots in excess of 25mmØ may be pruned following arboricultural advice. Line the exposed soil with an impervious liner before protecting any retained roots.

- vi) Unless after professional assessment permits pruning, retention of roots 50mm Ø or more will be by the use of void-formers (see **Appendix 4**).
- vii) Roots <25mm Ø will be pruned using sharp pruning tools ensuring that no splits or tears occur and that the pruning wound is made as small as possible. Roots will be pruned back to a side shoot where possible or to a suitable position.

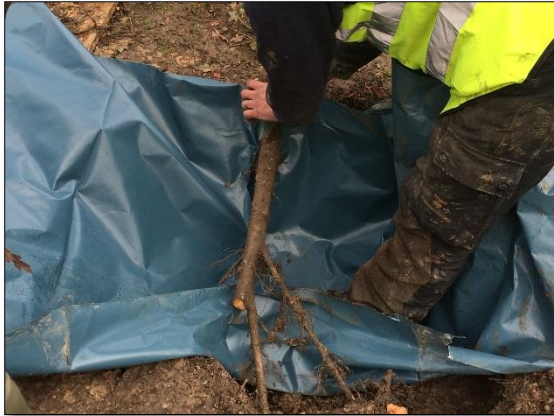
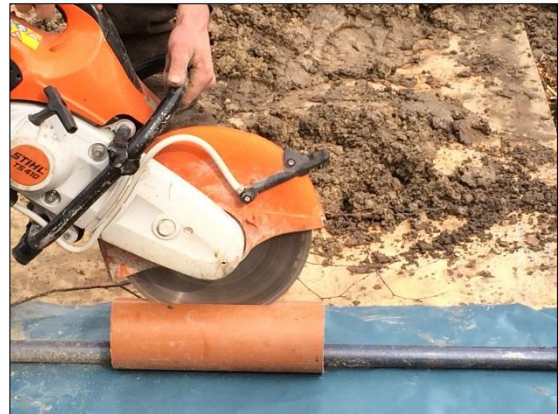
Identify the roots for retention and prepare a void-former (root protection 'sleeve').

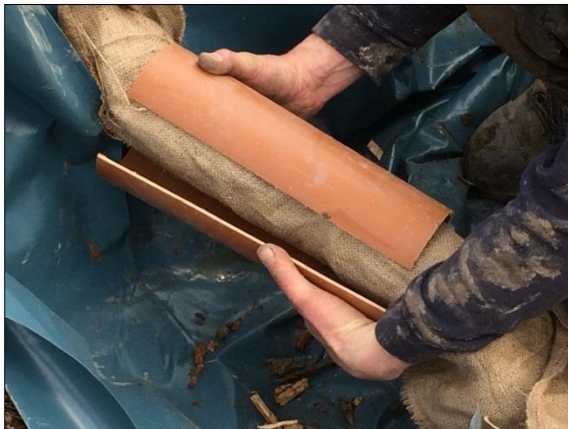
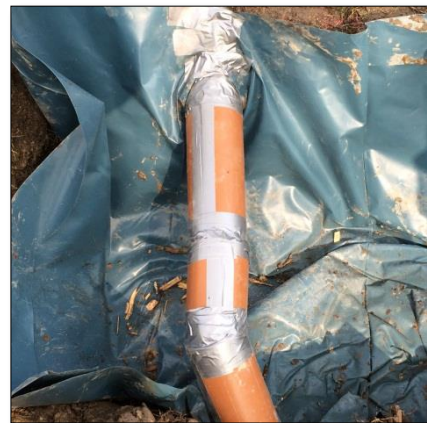
Wrap the identified roots in hessian before fitting the void-former and sealing with duct tape or similar.

- iv) Identify roots to be retained by brushing and cleaning
- v) Unless after professional assessment permits pruning, roots in excess of 25mm Ø are to be retained in-situ by manually clearing around (with compressed air for example), wrapping with non-woven geotextile (e.g. Terram), covering with a void former e.g. split, rigid polythene piping.

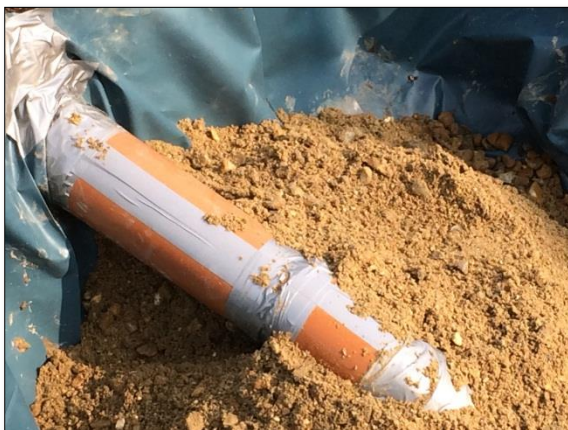
Back-fill the construction area (e.g. footing or base slab) following root protection.
