project
4 Bloomsbury Place
London, WC1A 2QA
client
The Bedford Estates

drawing title
Existing Stair 4 - 2F to 3F
drawing no.
257.04-530

Proposed Stair 4 - 2F to 3F

Proposed Stair 4 - Section
A

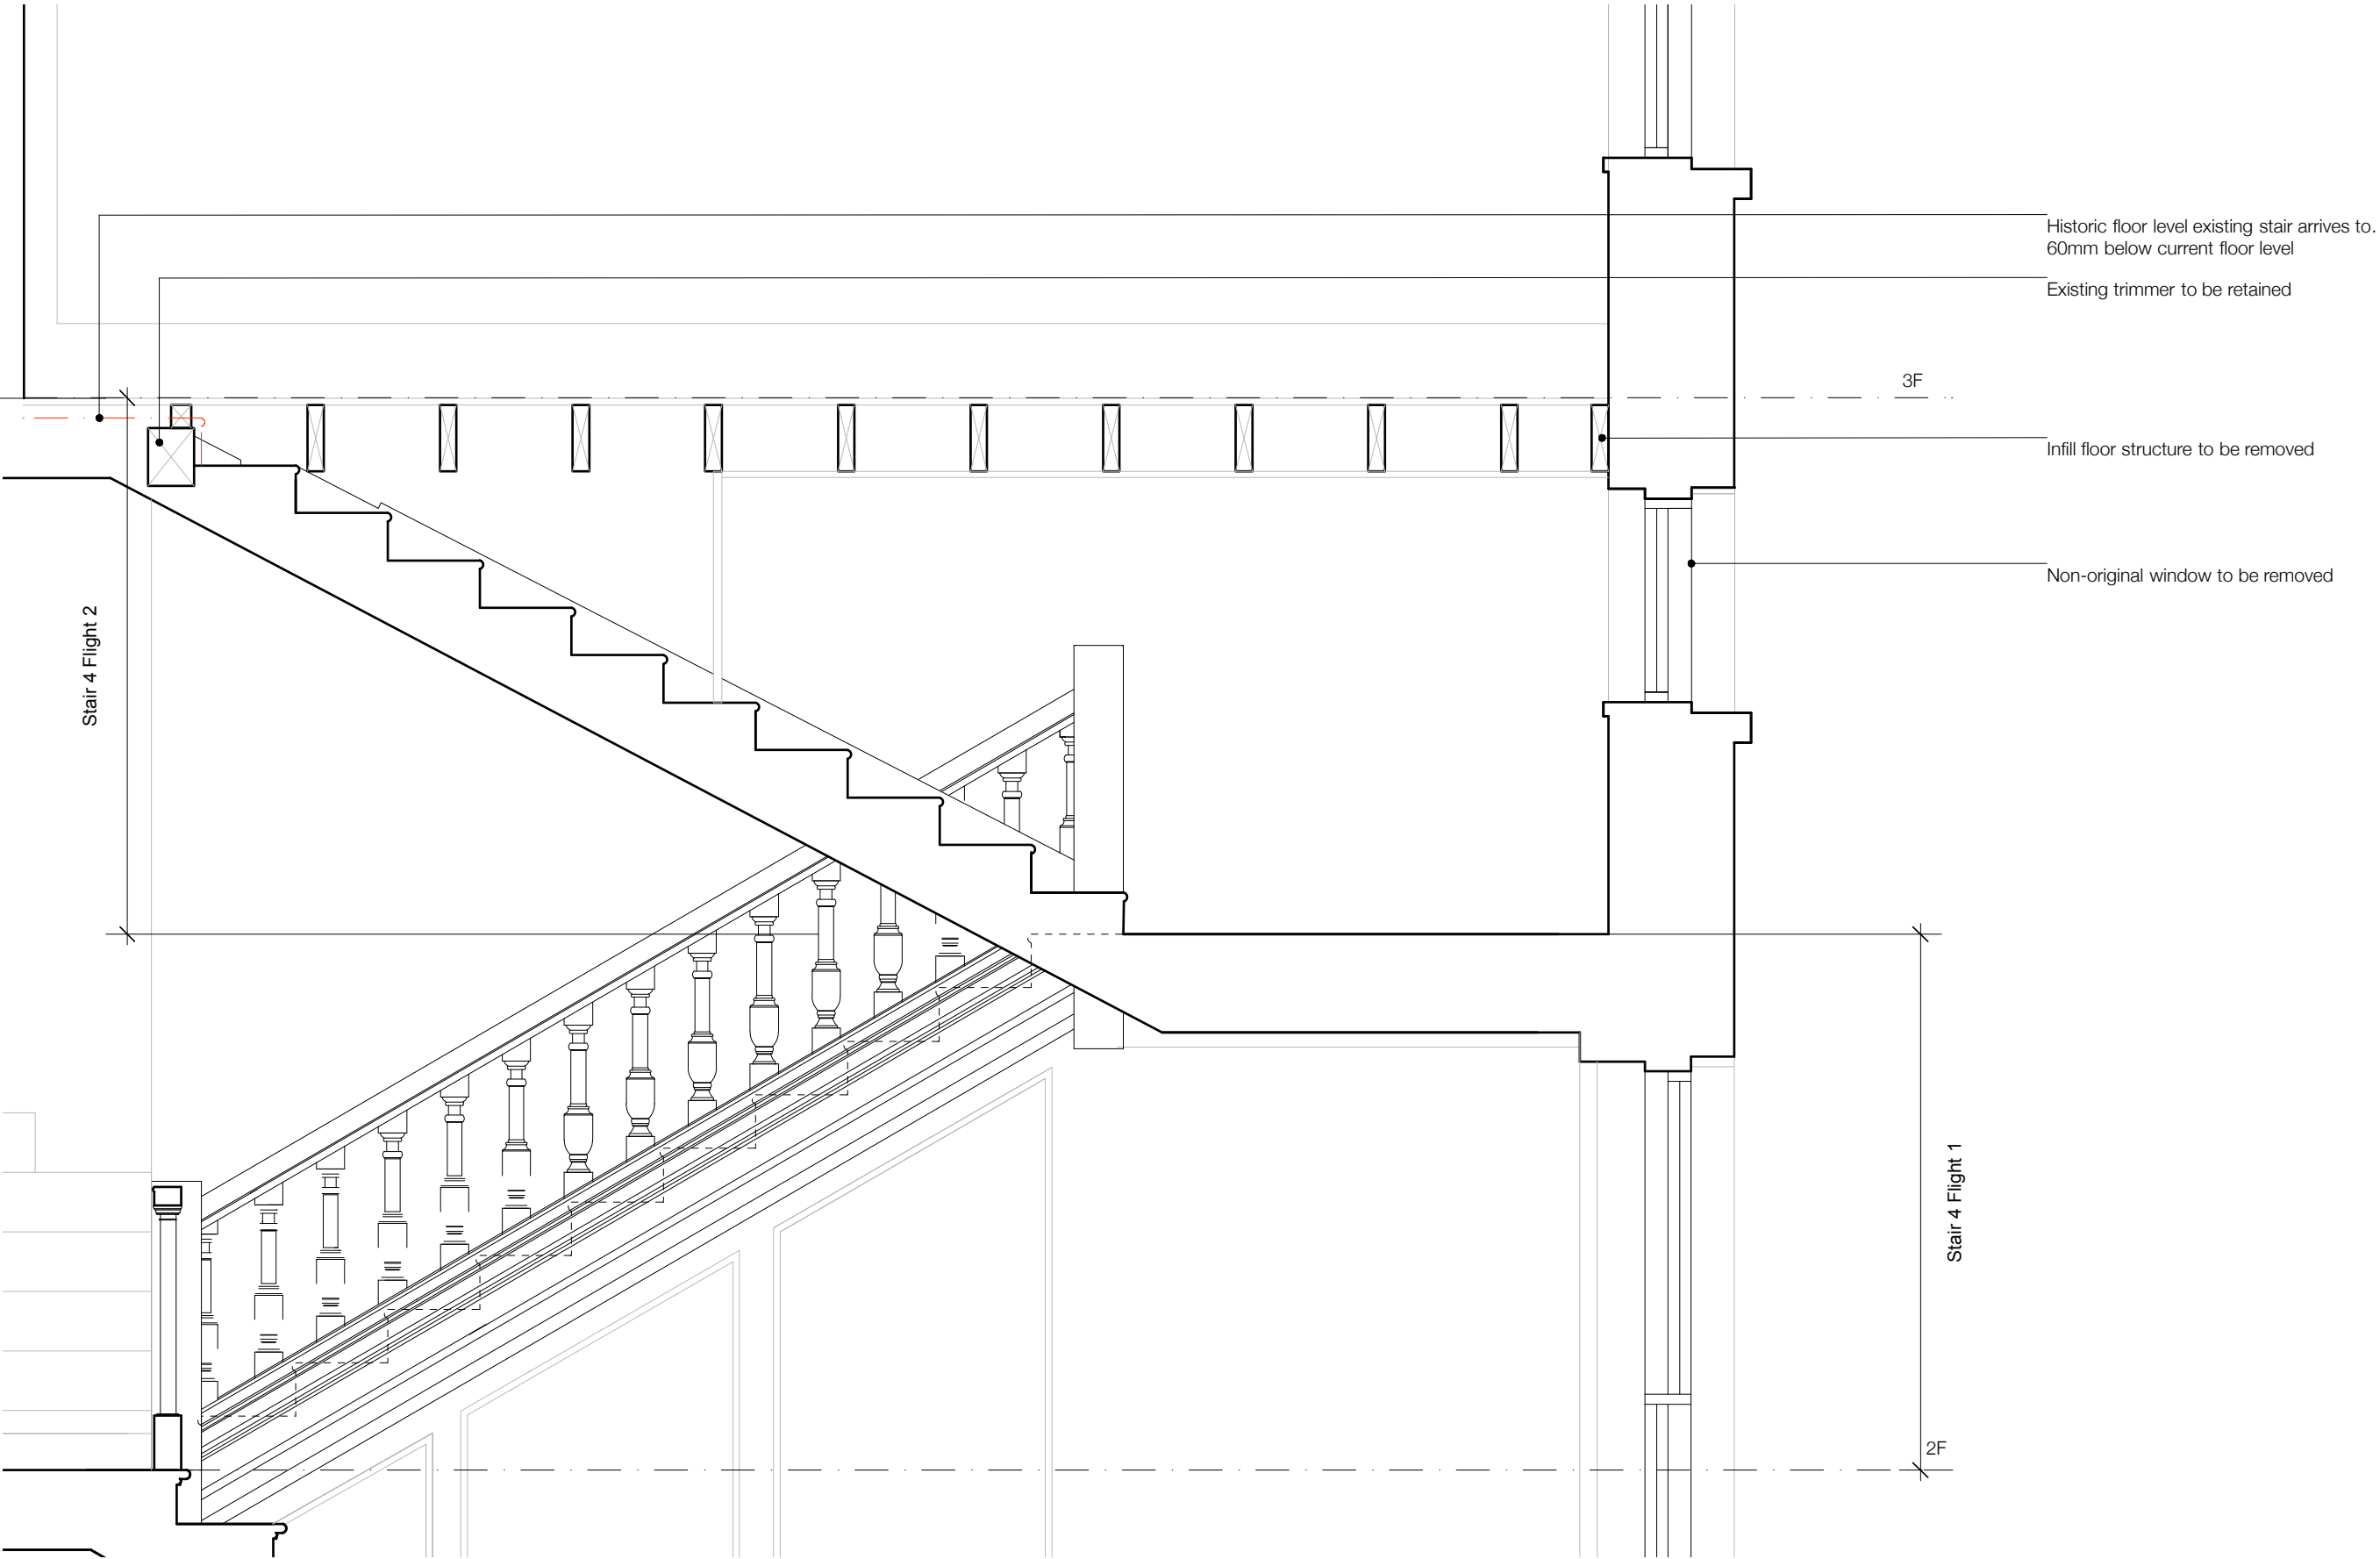
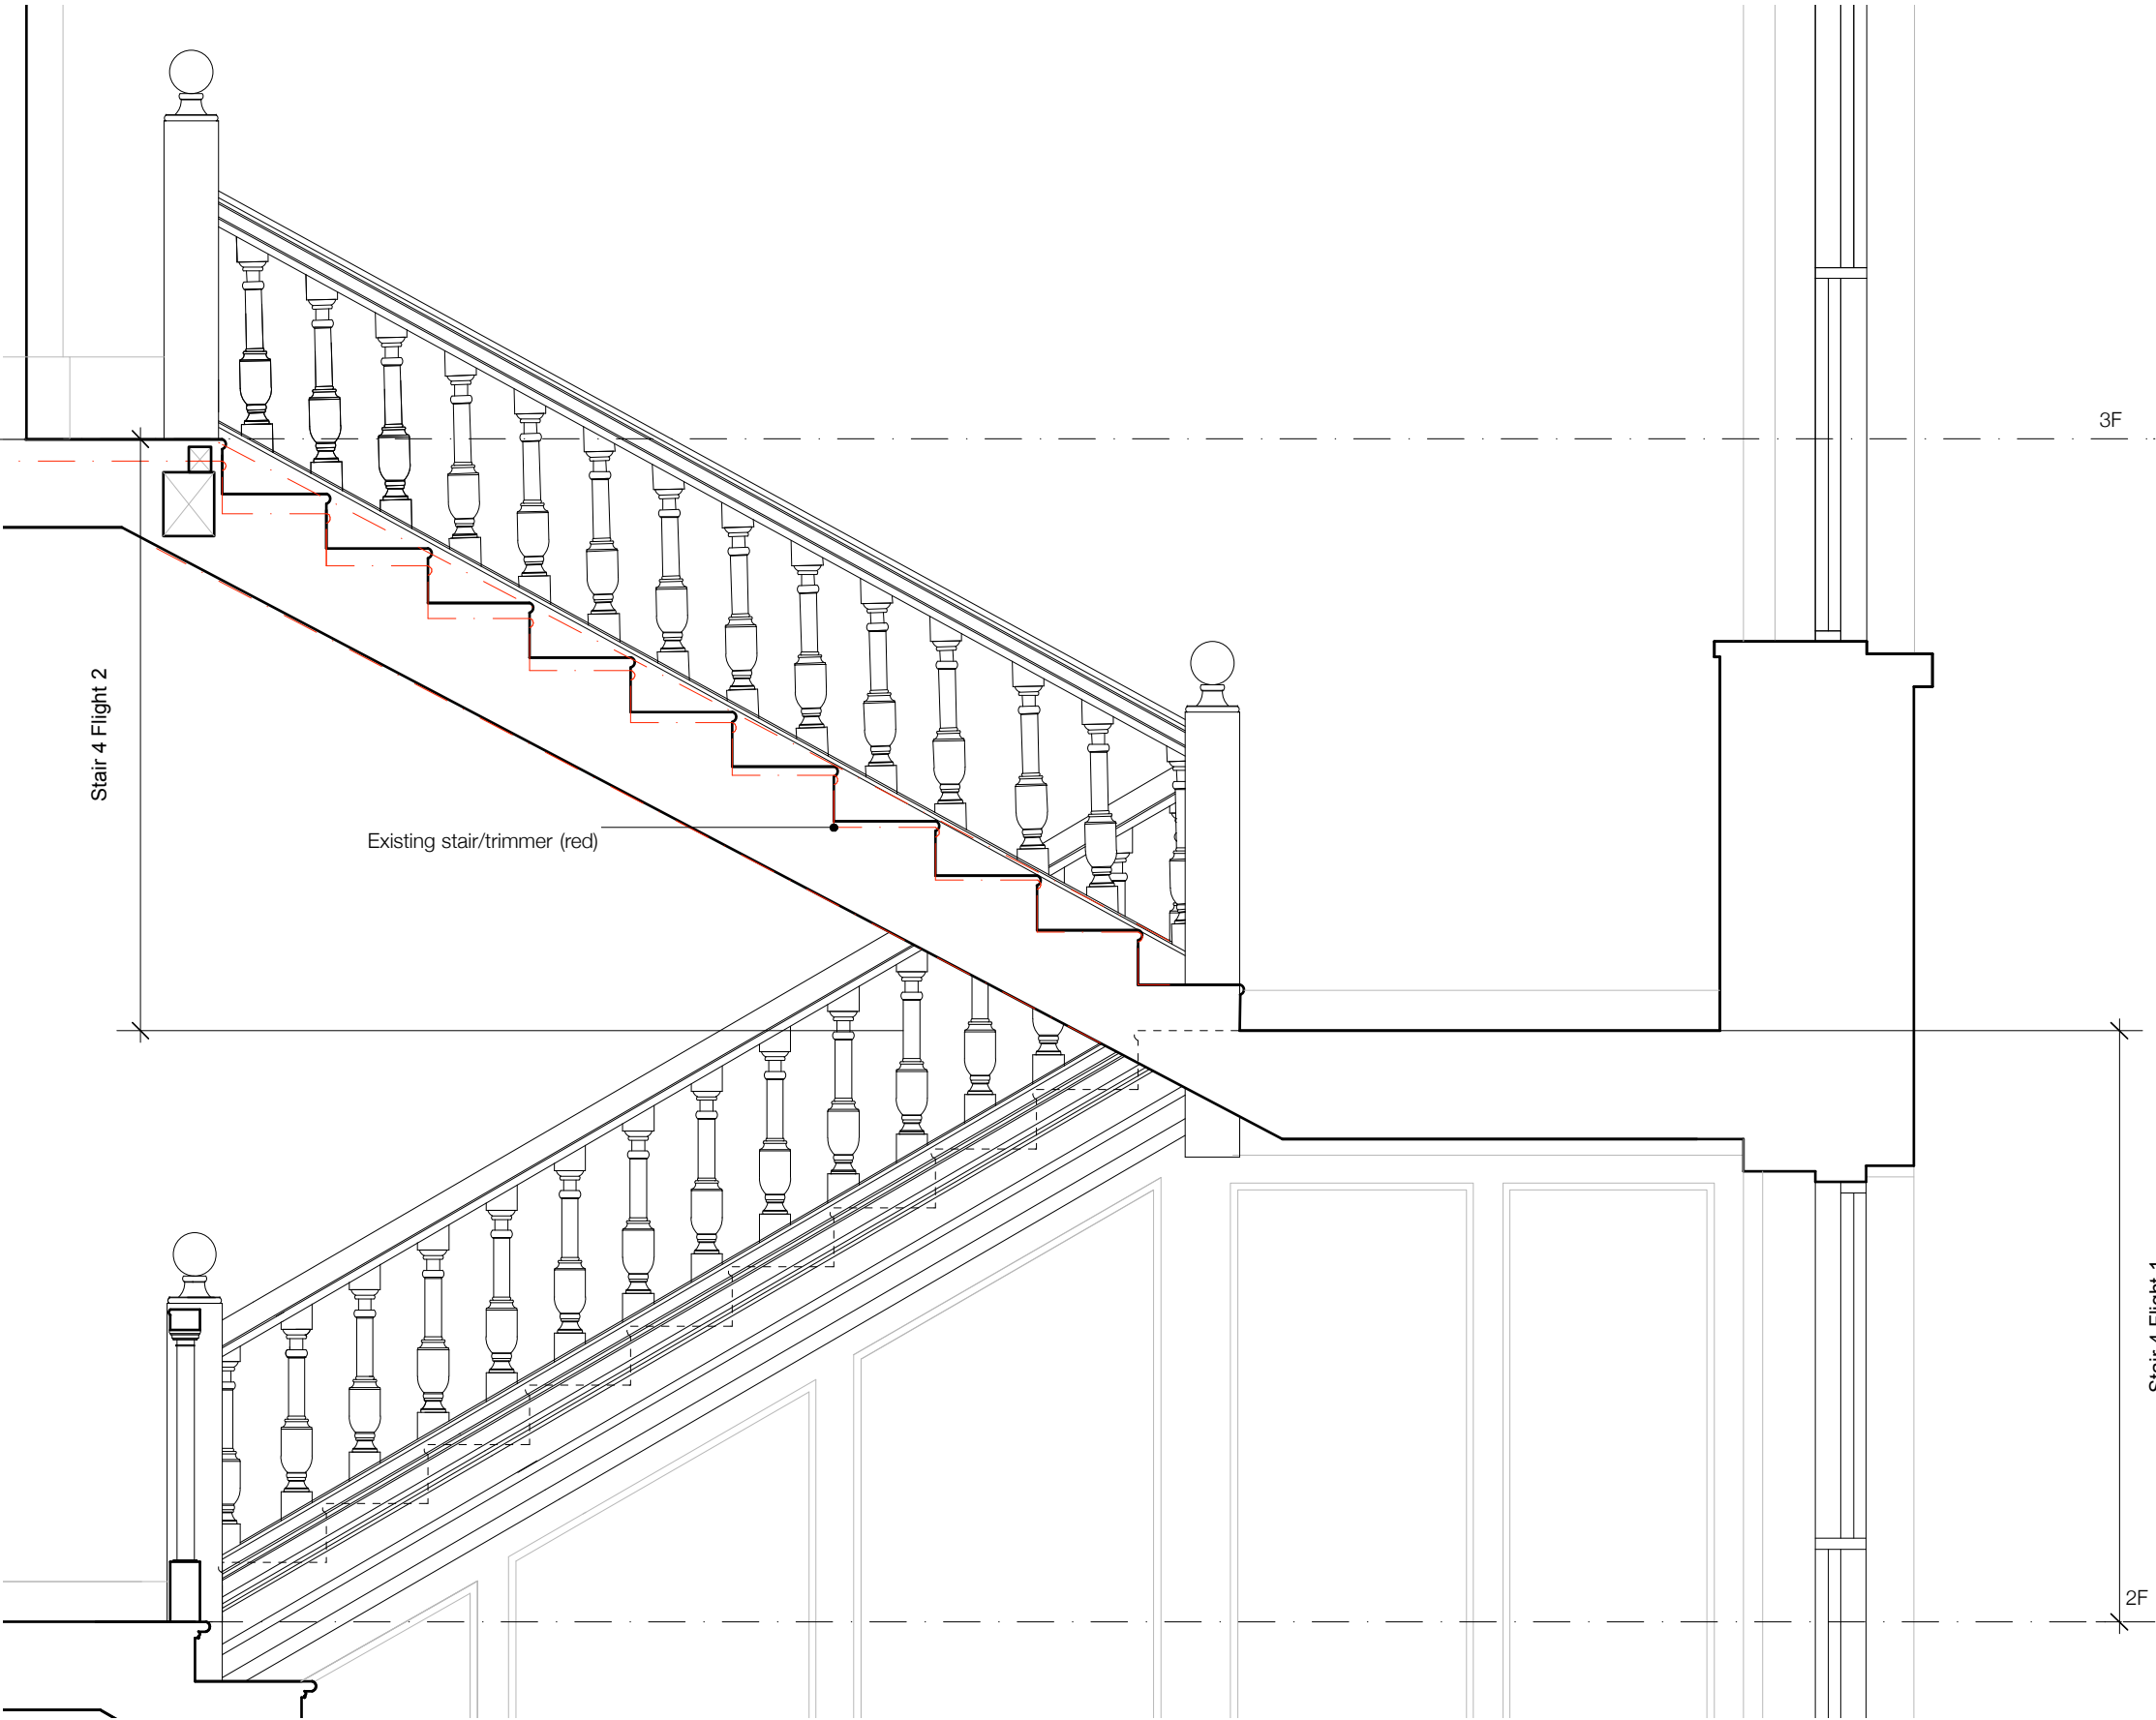
Due to the 3rd floor having been raised 60mm since this stair was in use, the stair does not arrive to the landing and will need adapting. Existing stringers/treads shown in red). Currently there are no newel posts, balusters or handrail to flight 2

- install new stringers/risers to match those to flight 1
- reinstall original treads allowing for replacing any significantly decaying/damaged/missing timber
- fill any minor surface damage
- prime any bare wood as required to receive
- black painted satin finish (Class 0)
- sisal stair runner

- Allow for replacing missing/redundant timber posts, balusters and stringers to flight 2 with those matching materia, profile and finish of flight 1
- Allow for new timber baluster/post return to 3rd floor landing
- fill any minor surface damage to existing
- prime any bare wood as required to receive
- white painted satin finish (Class 0).

- Allow for new handrail to match handrail of flight 1
- black painted gloss finish (Class 0).

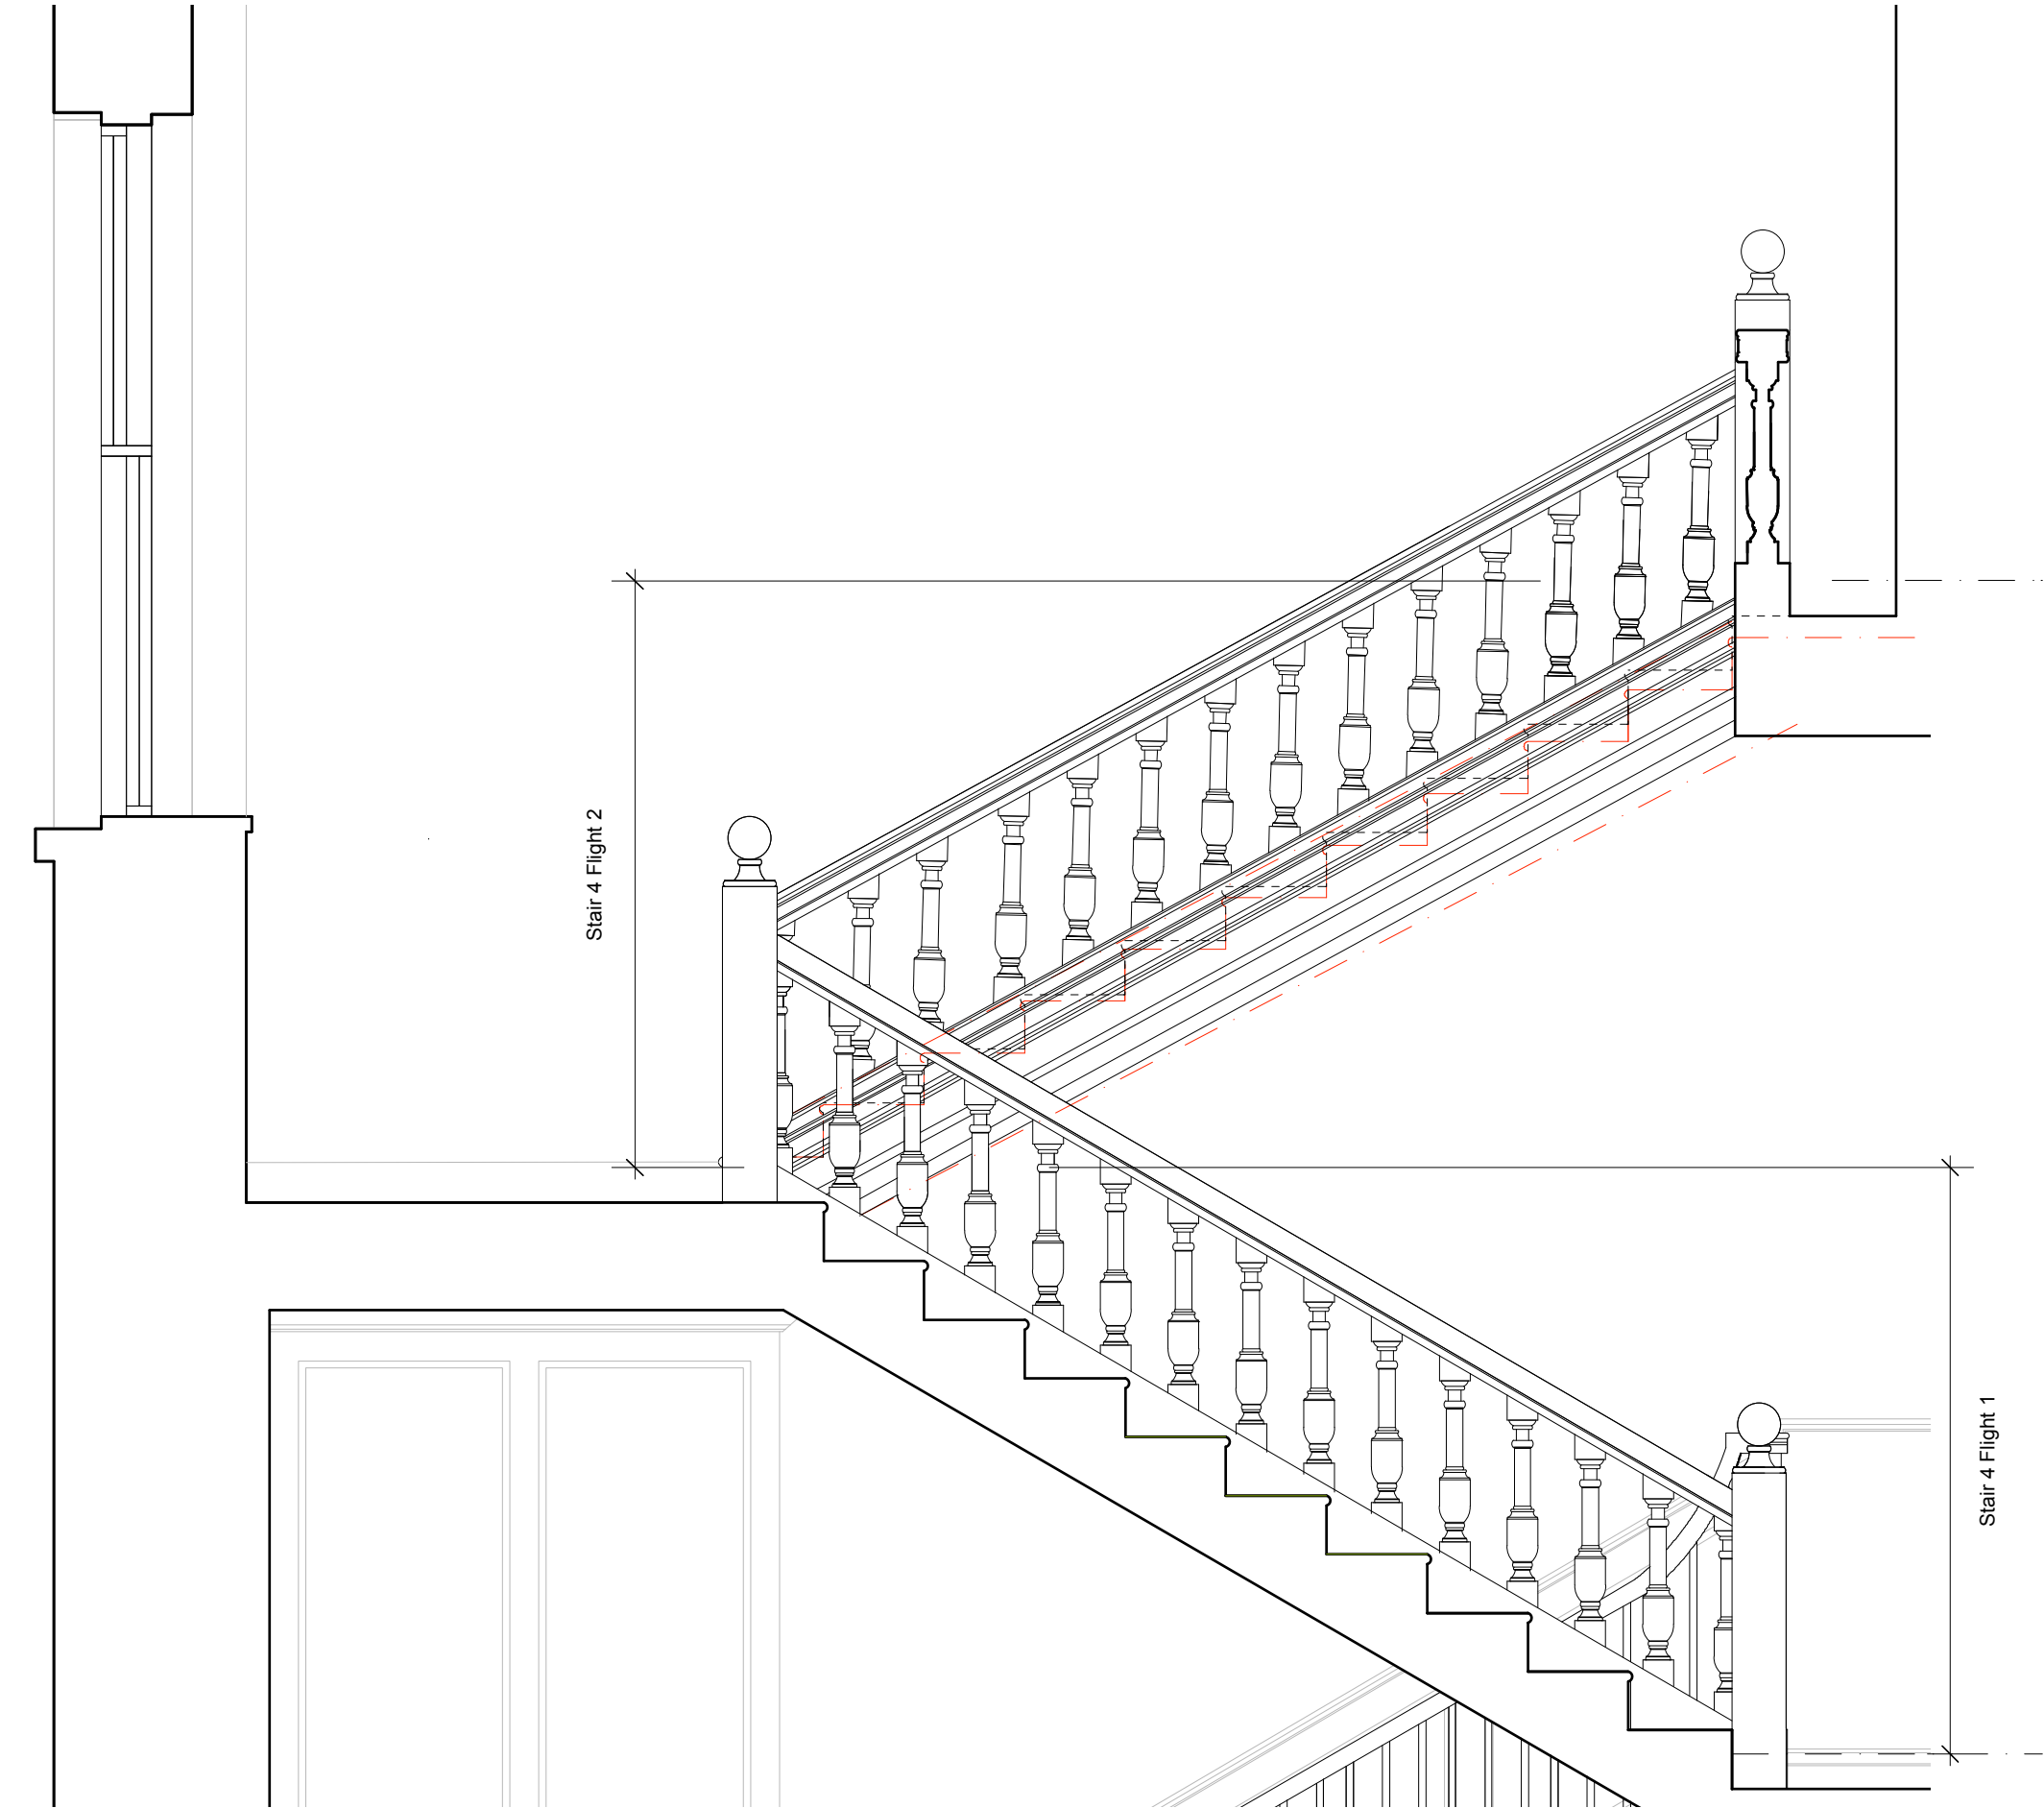
Proposed Stair 4 - Section
B

Due to the 3rd floor having been raised 60mm since this stair was in use, the stair does not arrive to the landing and will need adapting. Existing stringers/treads shown in red). Currently there are no newel posts, balusters or handrail to flight 2

- install new stringers/risers to match those to flight 1
- reinstall original treads allowing for replacing any significantly decaying/damaged/missing timber
- fill any minor surface damage
- prime any bare wood as required to receive
- black painted satin finish (Class 0)
- sisal stair runner

- Allow for replacing missing/redundant timber posts, balusters and stringers to flight 2 with those matching materia, profile and finish of flight 1
- Allow for new timber baluster/post return to 3rd floor landing
- fill any minor surface damage to existing
- prime any bare wood as required to receive
- white painted satin finish (Class 0).

- Allow for new handrail to match handrail of flight 1
- black painted gloss finish (Class 0).

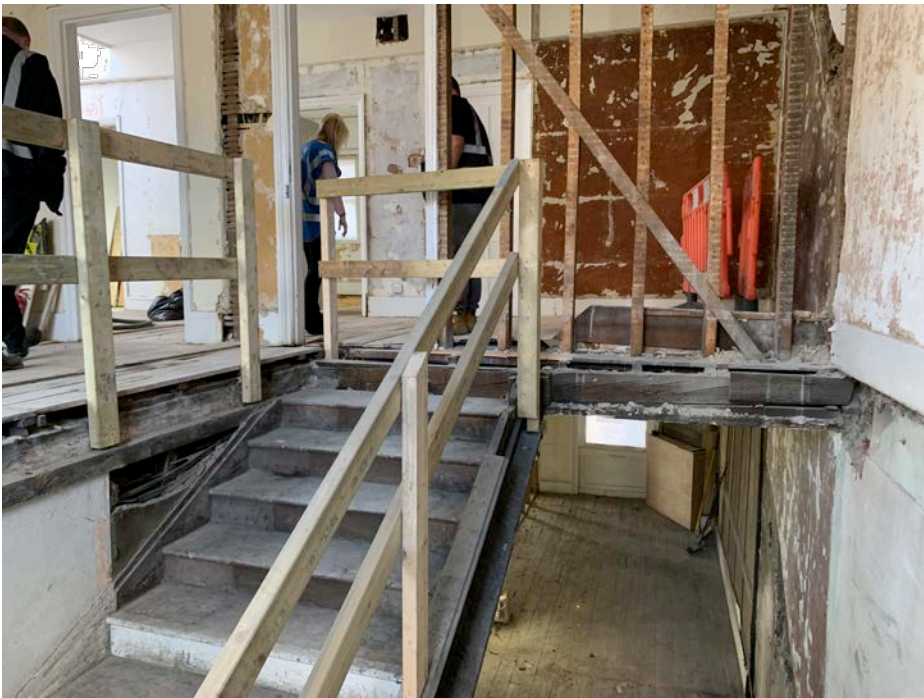
Arrival point of flight 2 to third floor landing showing original trimming beams at head of stair

We have inspected the timber trimming as shown in the below photos to the third floor stair case. This has been exposed following the removal of the more recent timber joist infill panel. The timber trimmers appear to be the original trimmers for the original stair case which has now been revealed. They appear to be sound and are not damaged. We are not increasing the loading to the floor or stair case. These are therefore suitable to leave in place to trim the stair void.

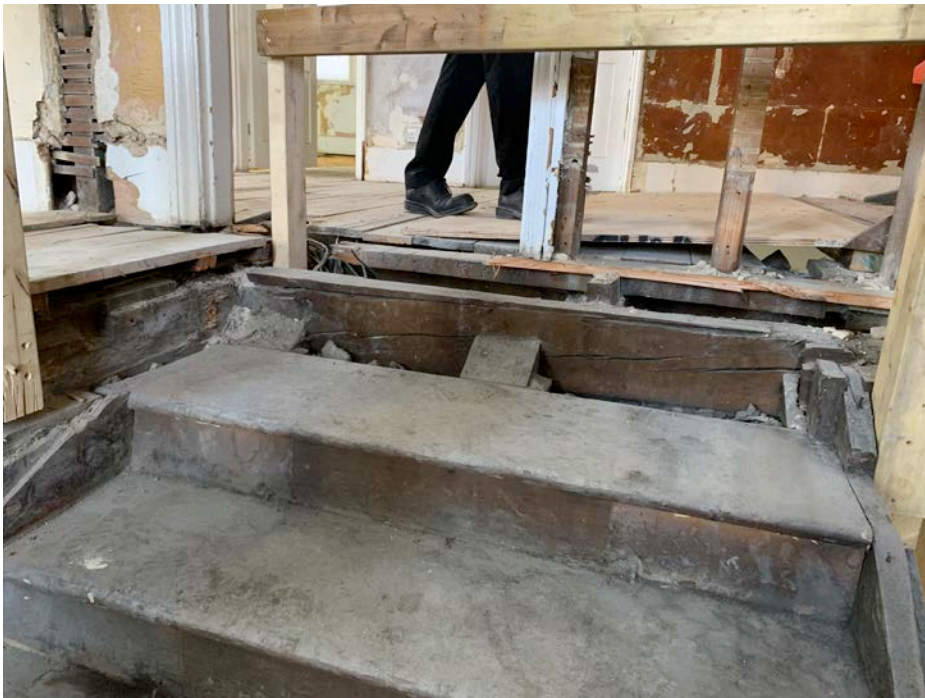
Detail showing raised landing floor is higher than arrival point of flight 2

Due to the 3rd floor having been raised 60mm since this stair was in use, the stair does not arrive to the landing and will need adapting. Existing stringers/treads shown in red). Currently there are no newel posts, balusters or handrail to flight 2

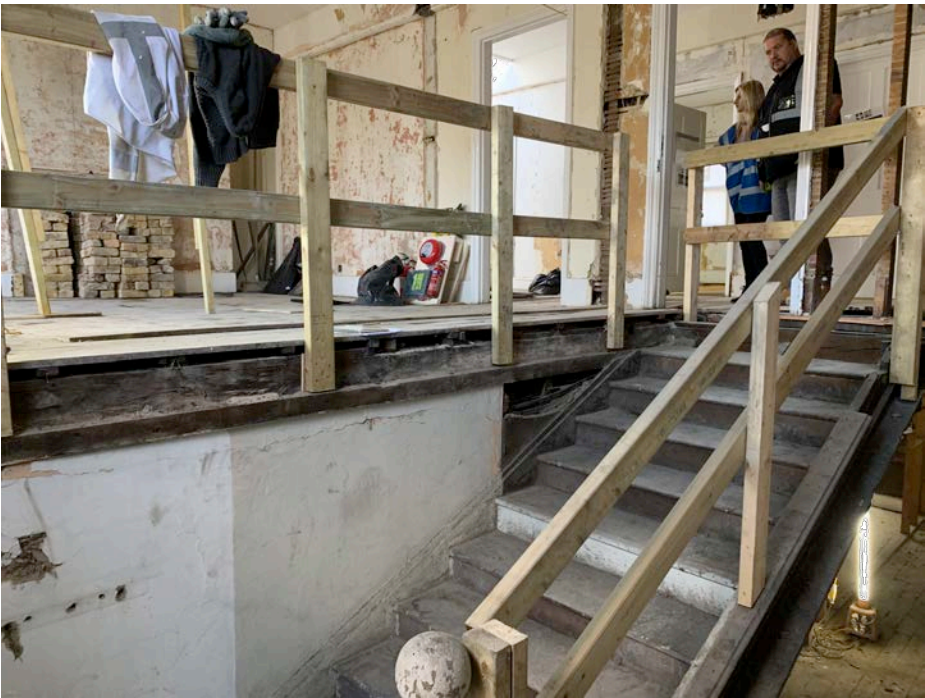
Original lateral floorplate trimmer to be retained. Wall to be repaired

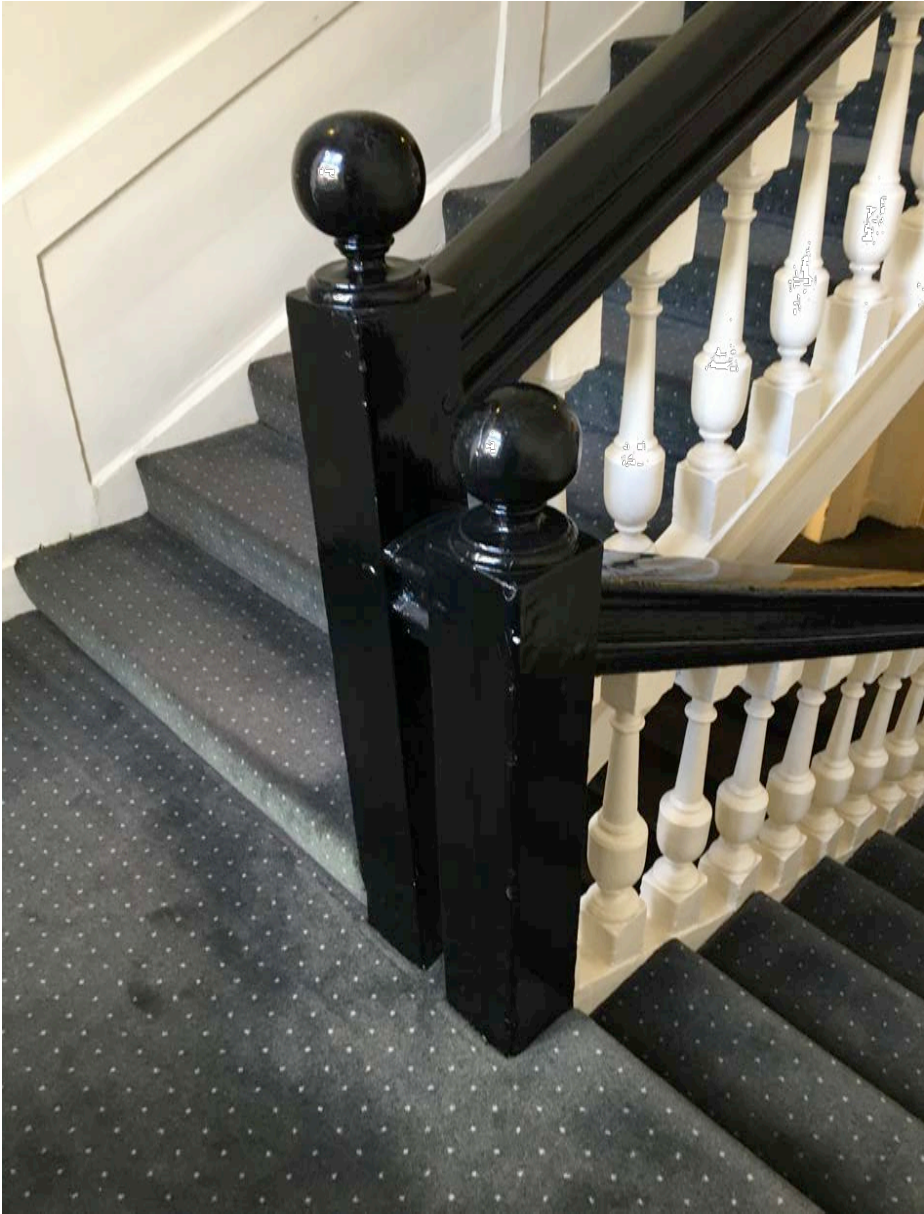
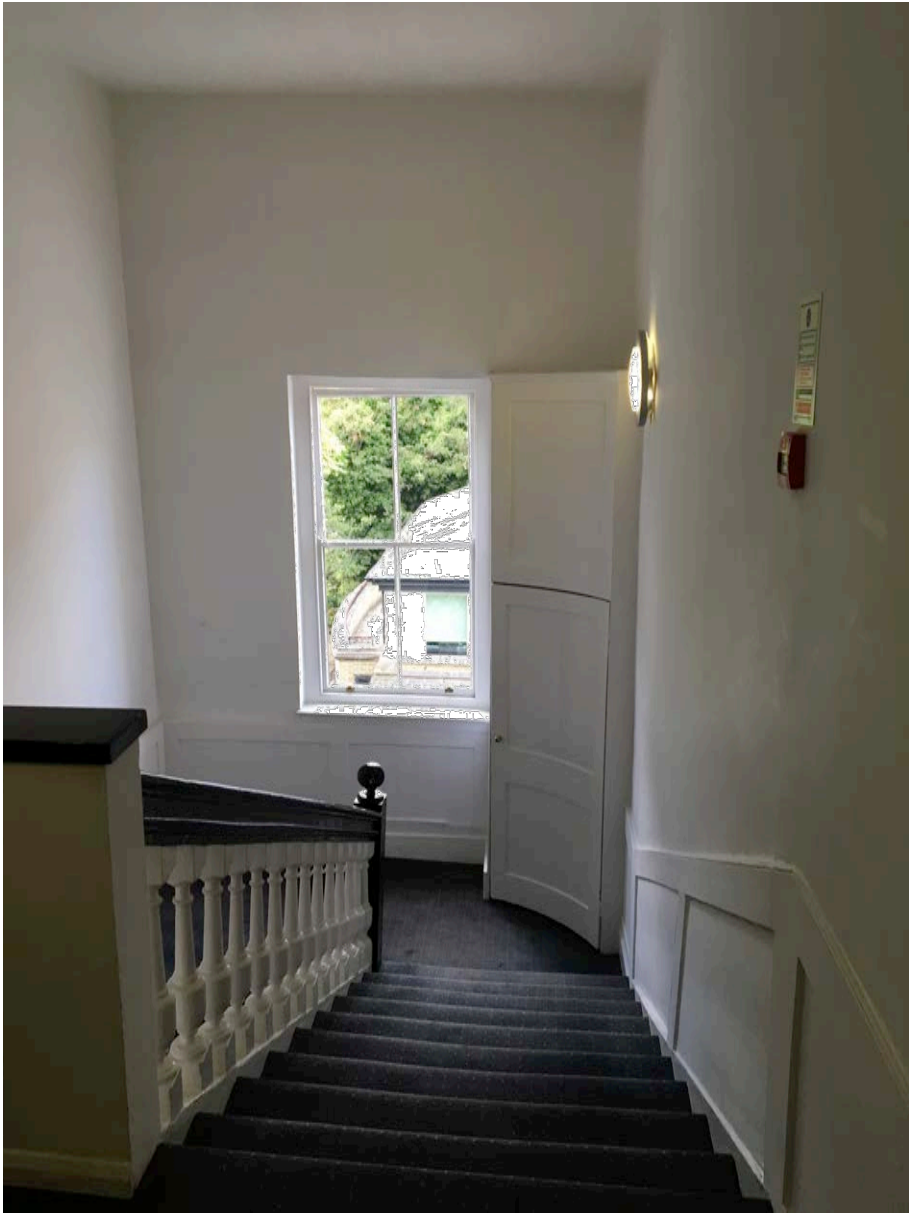
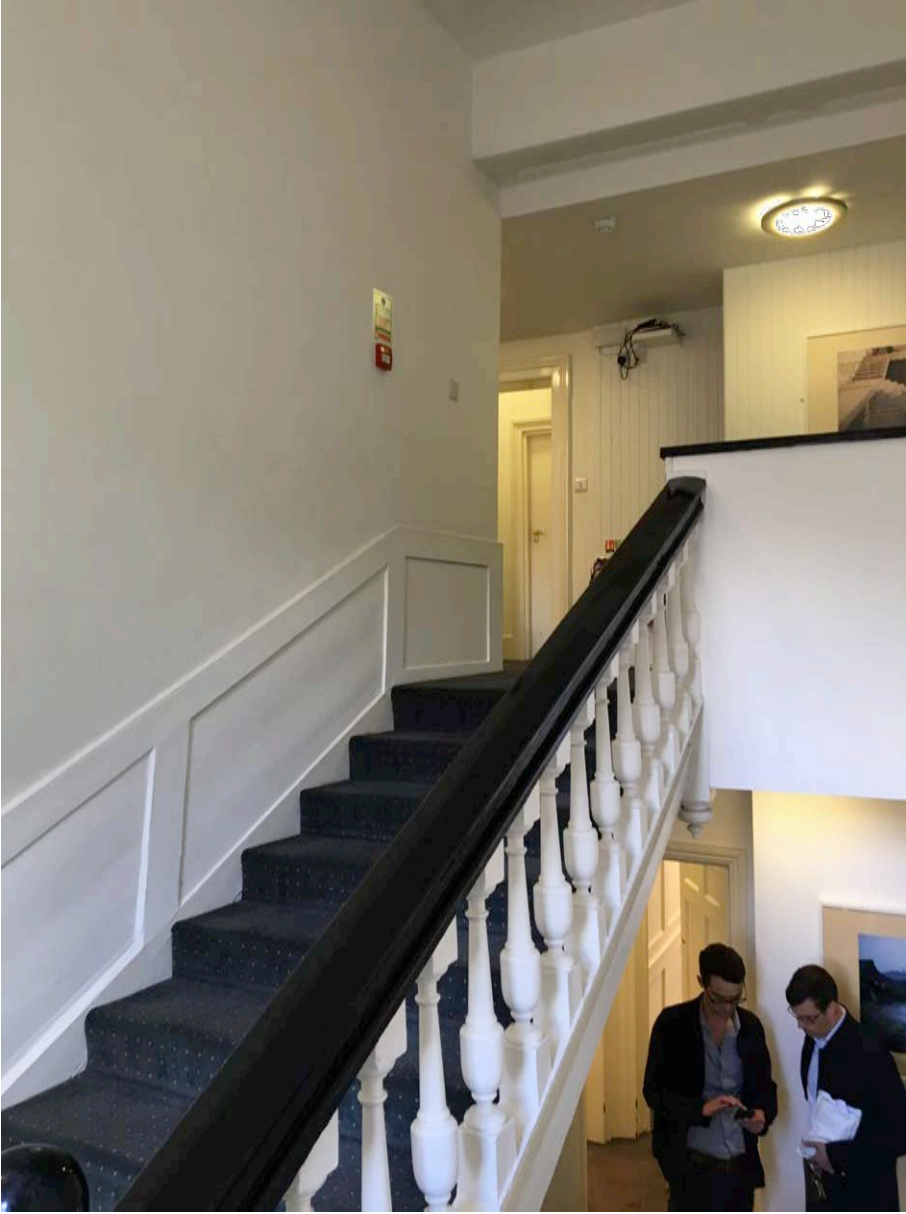
Note: 3 Bloomsbury Place original staircase. Reinstating balustrate at 4 Bloomsbury Place to match photos above.
