TRENDSIDE GEOTECHNICAL TESTING

PHASE 1 LAND QUALITY ASSESSMENT REPORT

8A BELMONT STREET,
CAMDEN,
NW1 8HH

NOVEMBER 2018

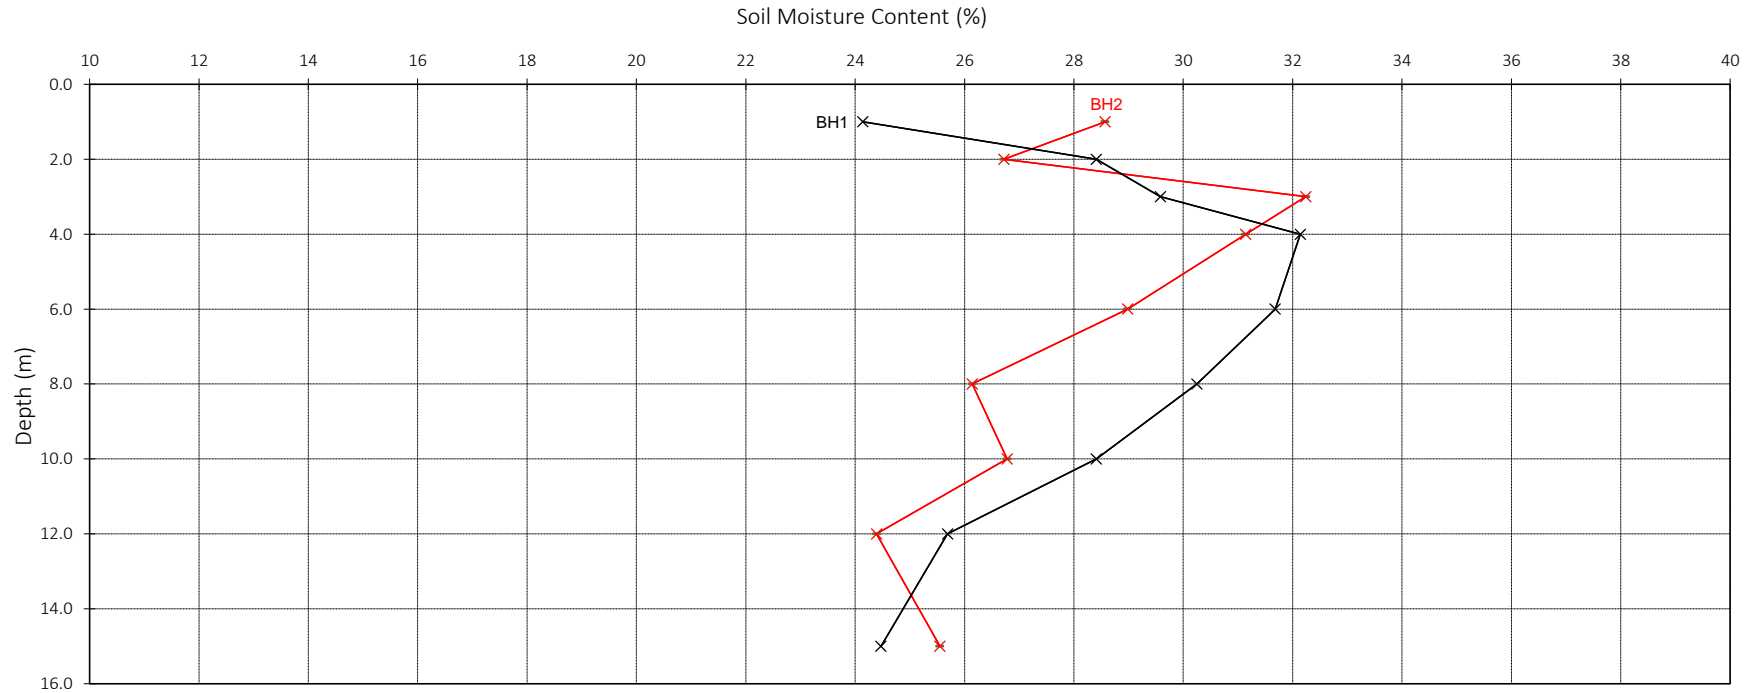
Moisture Content Profile

1. If the Soil Fraction > 0.425mm exceeds 5% the Equivalent Moisture Content of the remainder (calculated in accordance with BS 1377: Part 2 : 1990, cl.3.2.4 note 1) is also plotted and the alternative profile additionally shown as an appropriately coloured broken line.
2. If plotted, 0.4 LL and PL+2 (after Driscoll, 1983) should only be applied to London Clay (and similarly over consolidated clays) at shallow depths.
