ARBORICULTURAL IMPACT ASSESSMENT REPORT FOR:

1 Steele's Studio
Haverstock Hill
London
NW3 4RN

Ref: JGA/1STS/AIA/01b

Date: 19th October 2018

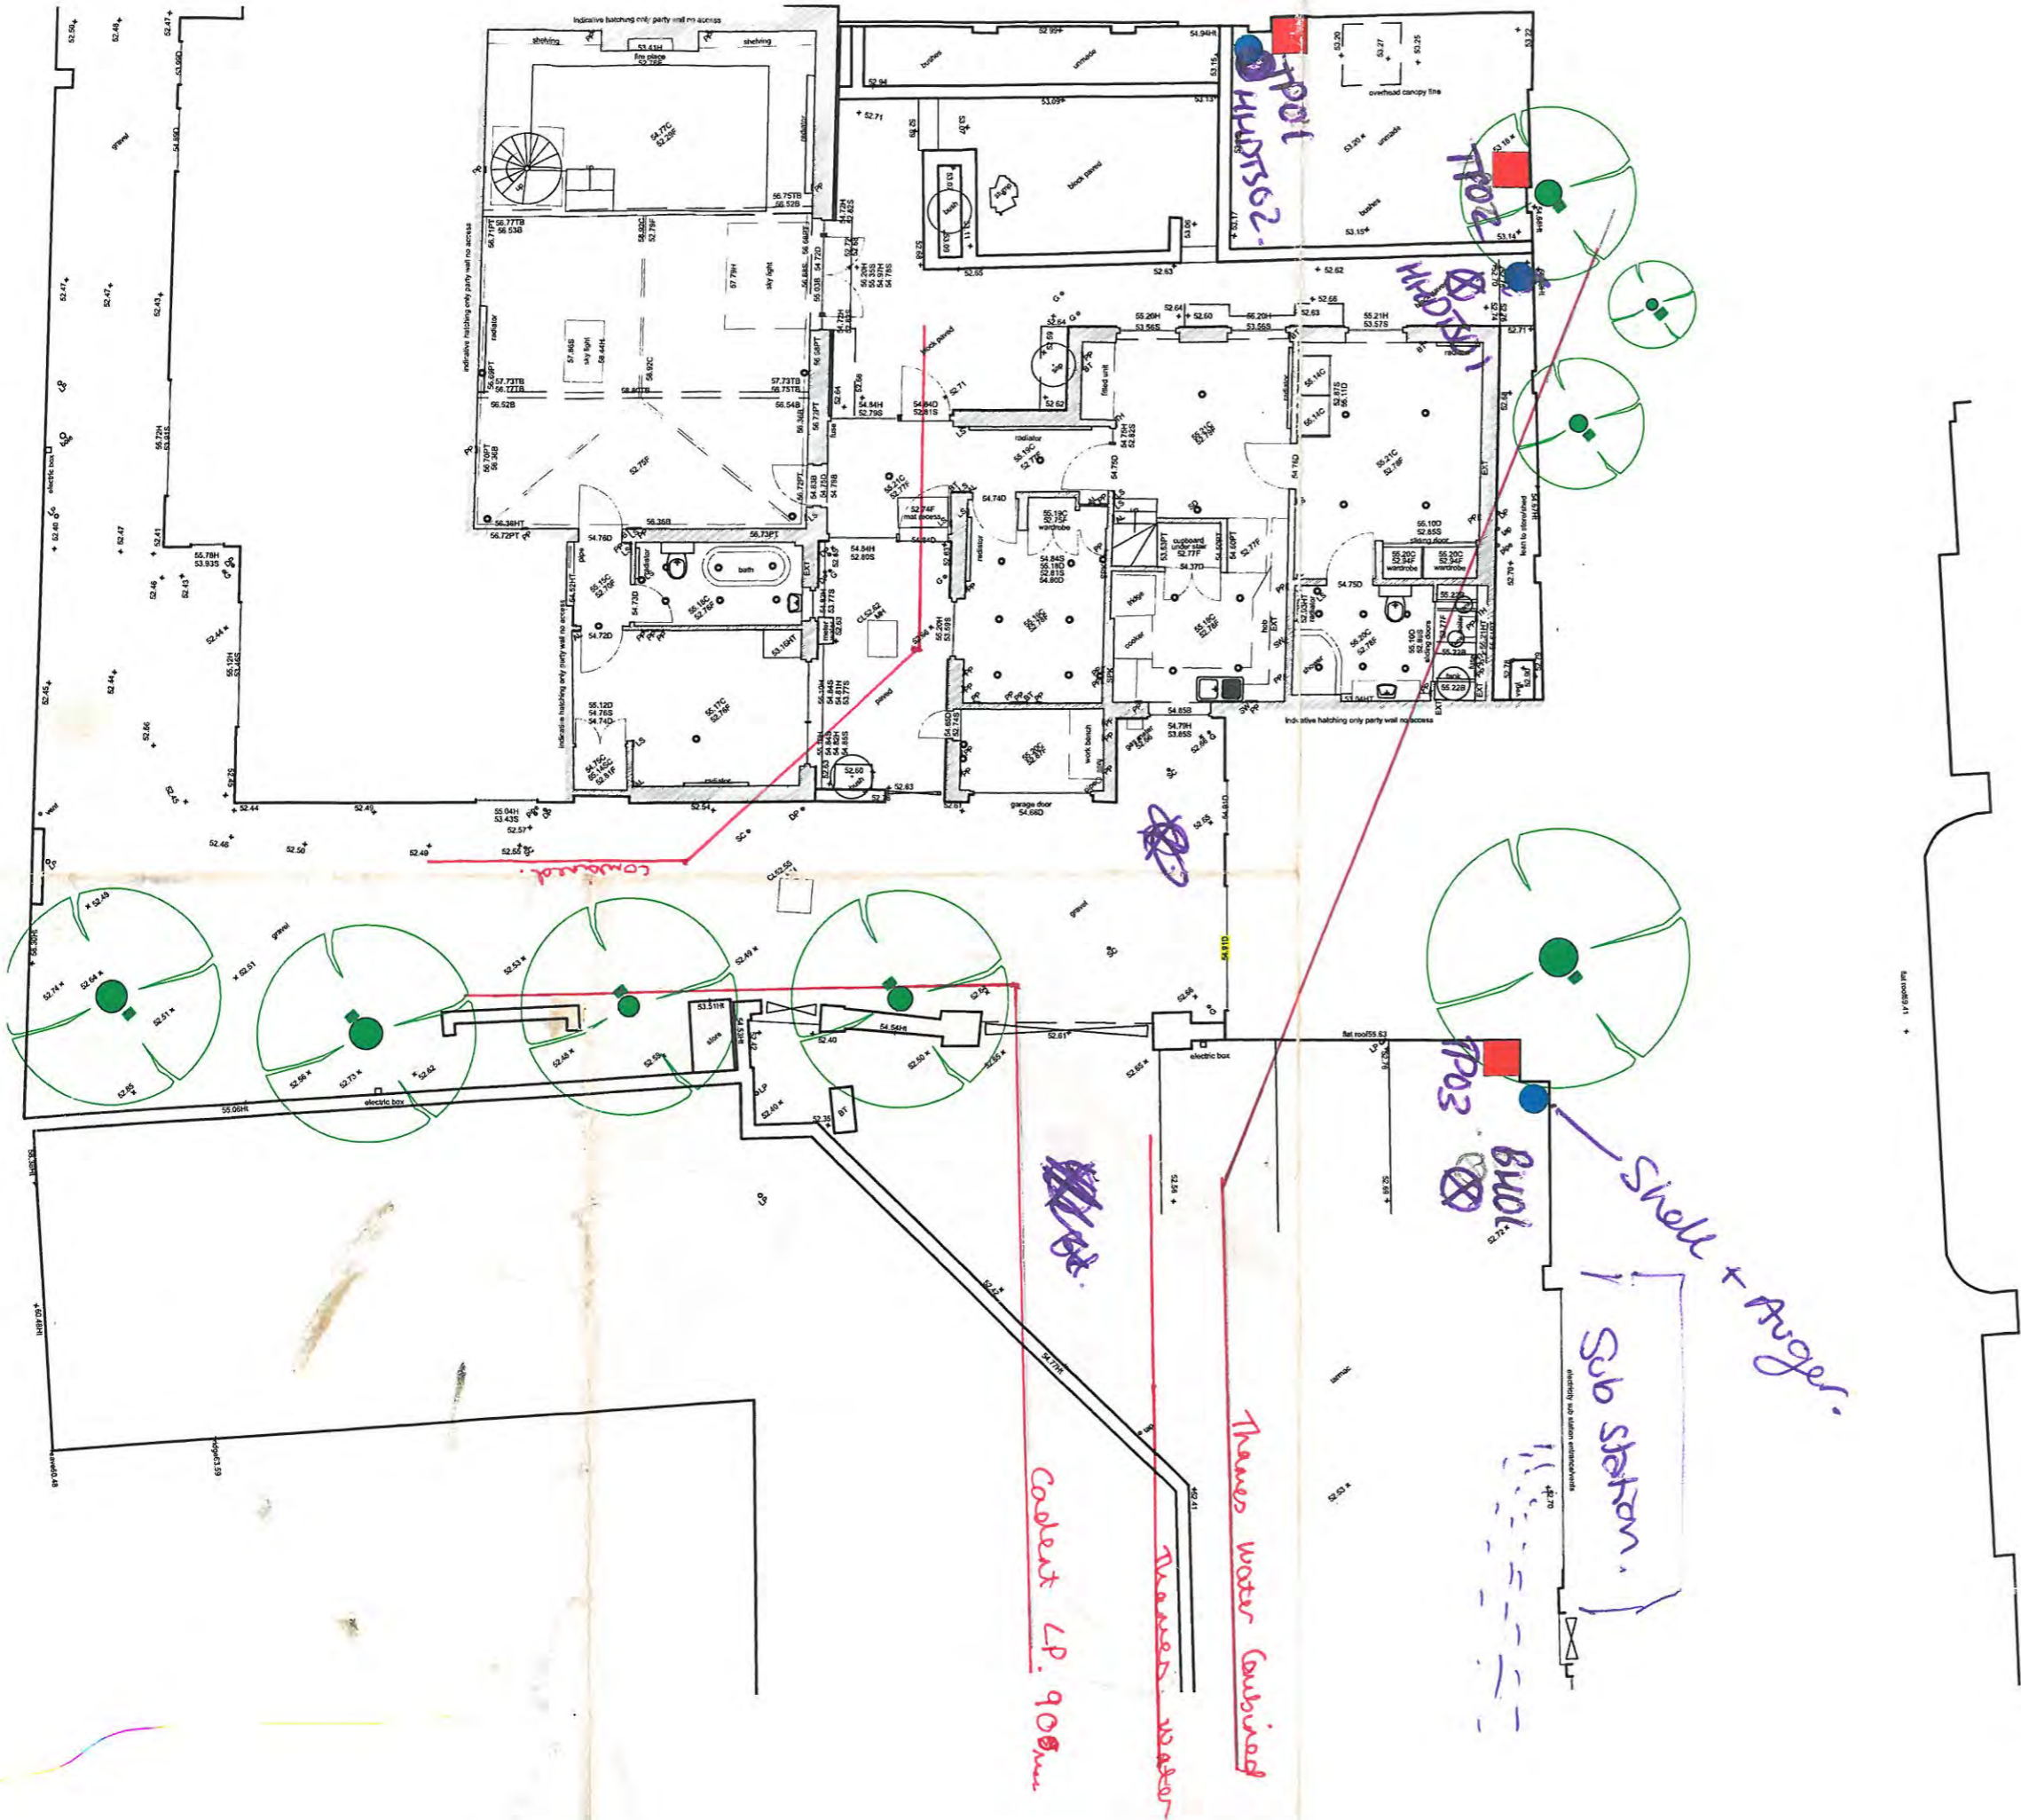
Location reference
TP01
Location plan on drawing number
02
Appendix
D

A. Firm dark brown slightly gravelly silty sandy CLAY with frequent rootlets and roots up to 20mm in diameter. Gravel consists of flint, quartz and brick. (MADE GROUND)

Title
Trial pit record
Date of works
26/01/2018
Scale
1:20 at A3
