# **6 Albert Terrace Mews, Primrose Hill, Camden, NW1 7ST**

**Geotechnical Site Assessment**

**29841-R01 (02)**

**DECEMBER 2018**

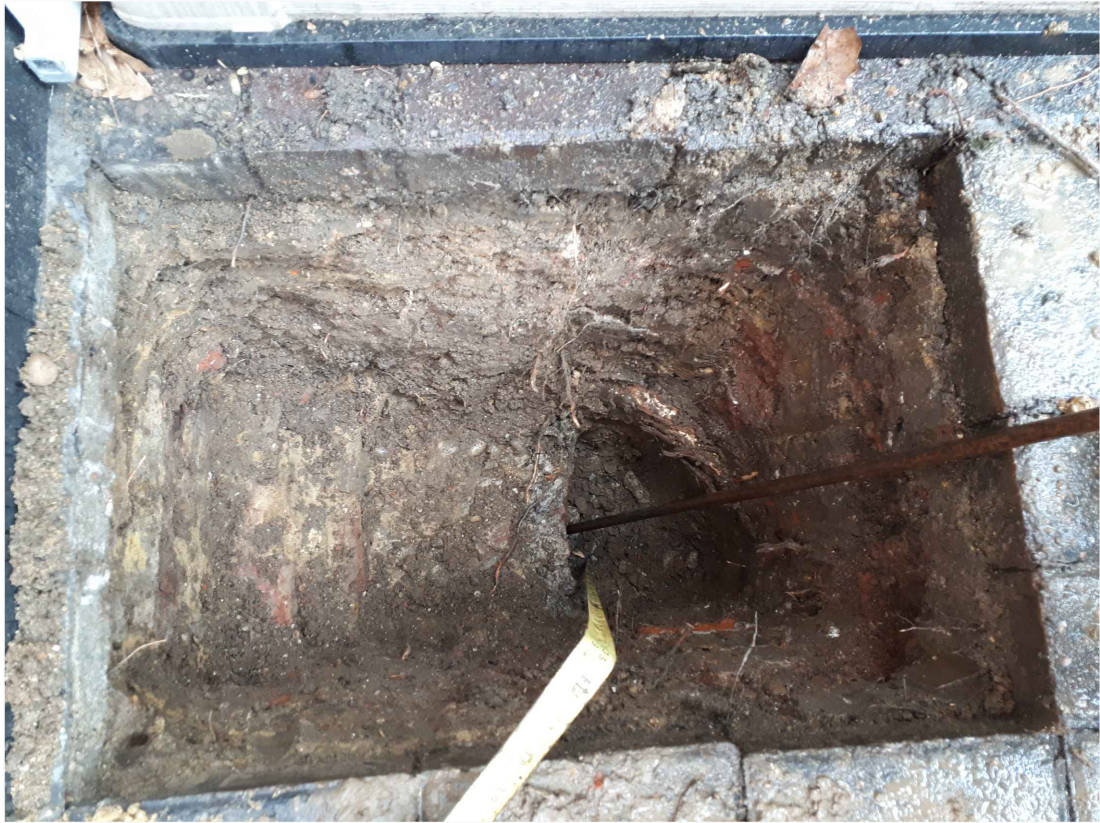
Plan view:  
(1:10)

Section A-A':  
(1:10)

The foundations exposed in TP2A located on the northern wall of the property consisted of two brick corbels extending 0.14m from the wall. The corbels sat on a concrete screed that extended 0.40m from the wall. Breaking out confirmed that this concrete was a thin screed over brick footing, which extended to a total depth of 0.85mbgl.
