27-29 Whitfield Street

Project Brief

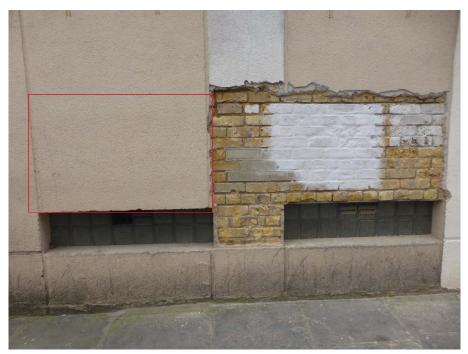
Plate 1: Area highlighted for trial on corner of Colville Place

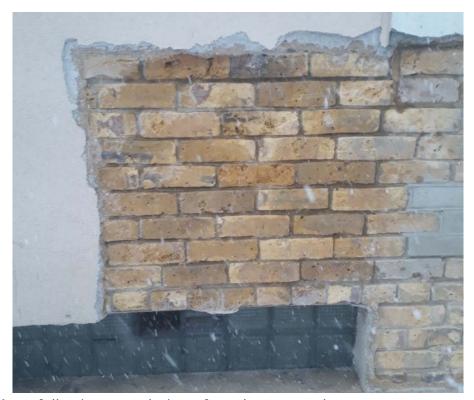
Plate 2: Area following completion of render removal

The render currently applied over the brick substrate at Whitfield Street is very hard, much harder than the substrate. In places it has now delaminated away from the brick behind and sounds hollow when struck. Elsewhere, it is steadfast. The areas that have delaminated pose a possible health and safety risk and so either removal or some form of repair is a necessity. Removal was initially considered by hand, but the render is simply too hard to break with hammer and chisel. A small 110V percussive hammer tool was therefore used with a wide chisel to try and get underneath the render and separate the 2 materials. On the whole, the render looks to separate away from the brick substrate causing minimal damage to the brick beneath, but this is not a precise science and therefore cannot be predicted. Where removed cleanly, the bricks are found to be in generally in good condition with little need for repair.

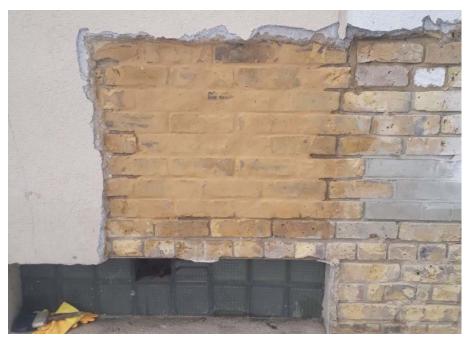
Plate 3: Area following repair and repointing

Pointing is cut back to receive new mortar, typically 20mm in depth or approximately twice the depth of the joint width.

Repairs and repointing works were completed to areas of exposed brickwork in an approximate blend of 1:2:9 (lime:cement:sand). This is a 'soft' cementicious repair mix that will both bond to the existing (we are applying a 'like for like' repair ethos), but still be sacrificial in nature, being as it is weaker than the original cementicious mortars used.

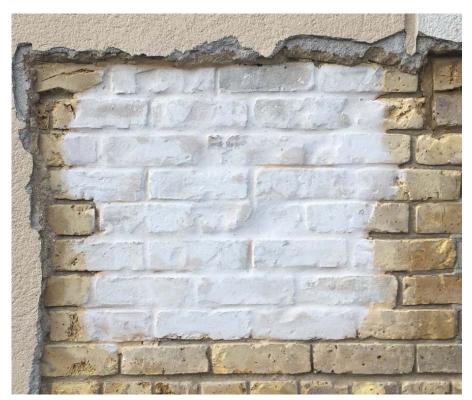
Plate 5: Overview of brickwork following repair and 1 tinted coat of Keim Restauro

Further to the brick repairs described above, we applied a two coat system of Keim Restauro Lasur. The first, an application of Fixative without any pigment added and then the second mixed with a pigmented solution at approximately 3:1. Keim Restauro Lasur is a Sol silicate based mineral paint system for use on stone, brick and rendered surfaces. It provides a natural styled colour wash or semi-transparent finish – allowing the substrate beneath to retain much of its aesthetic finish. As a paint, it forms a chemical crystalline bond with the substrate and offers both a water repellent finish but also vapour permeability.

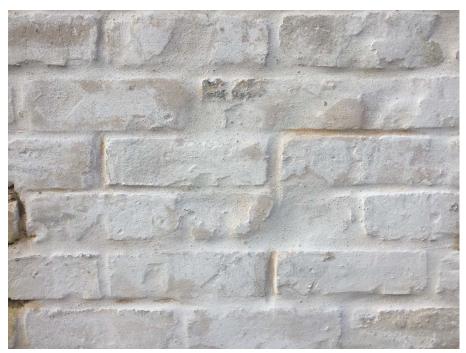
Plate 6: Detail of brickwork following repair and 1 tinted coat of Keim Restauro

In our view, the treatment proposed is a suitable approach to altering the brickwork finish and offers a tidy, low maintenance solution. Keim suggest it can be cleaned with low pressure washing, but that should be all that is required.
