**PHASE 1 ENVIRONMENTAL REPORT**  
**of a site at**  
**1 Belmont Street, London NW1 8HJ**  
**for**  
**RISNER DESIGN**

**Project No 1557**  
**Report ref: 1557-P1E-1**  
**Issued: 05 March 2019**  
**Revision:**

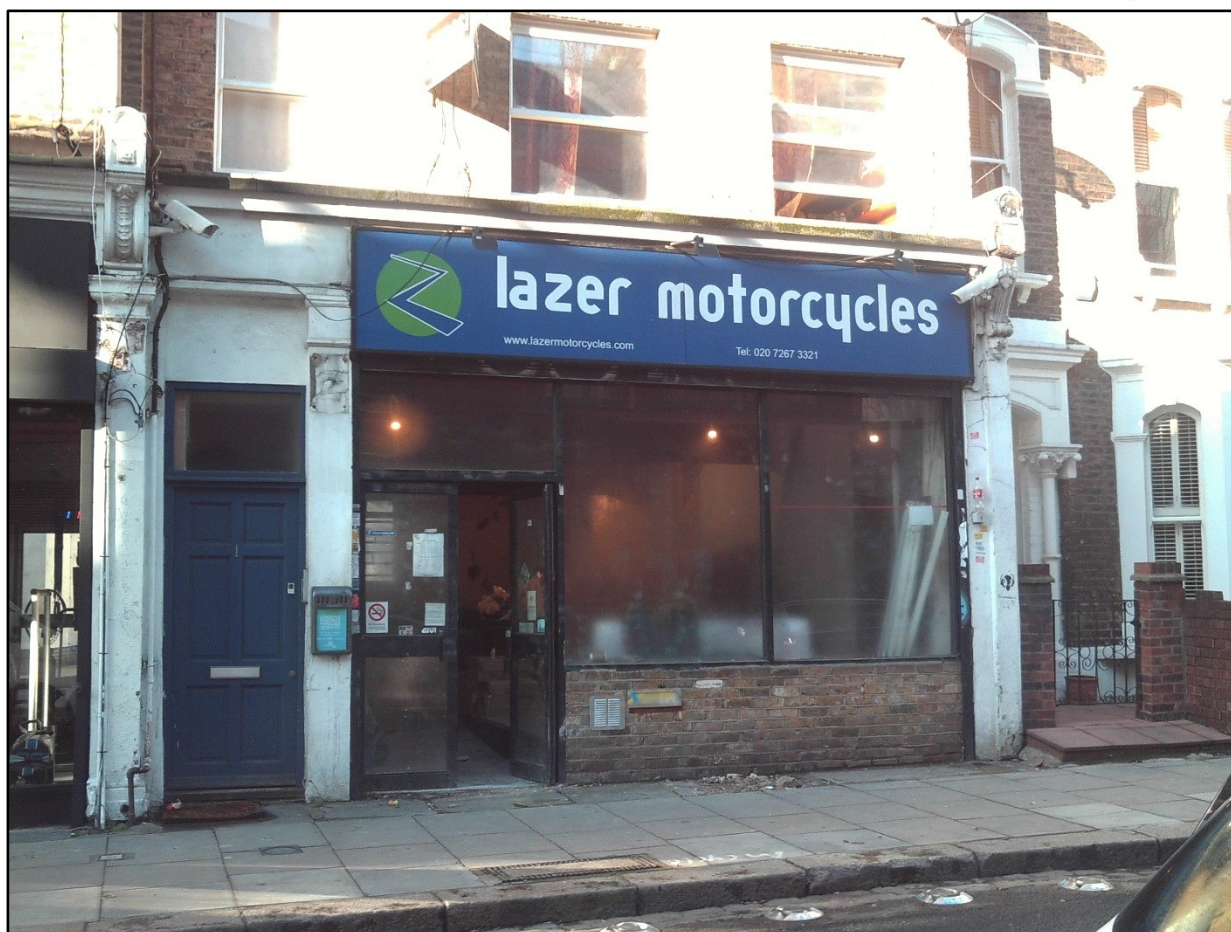
**Photograph 1: View of the site from Belmont Street**

The site was formerly occupied by a motorbike repair shop on the ground and basement floors and currently is vacant. There are no soft landscaped areas on the site. The building is constructed of brickwork under a flat roof. Access to the site is gained from Belmont Street, via a pedestrian entrance.

There is an odour of hydrocarbons on site, some spill of lubricants on the ground floor and some oil staining on the basement's wall.

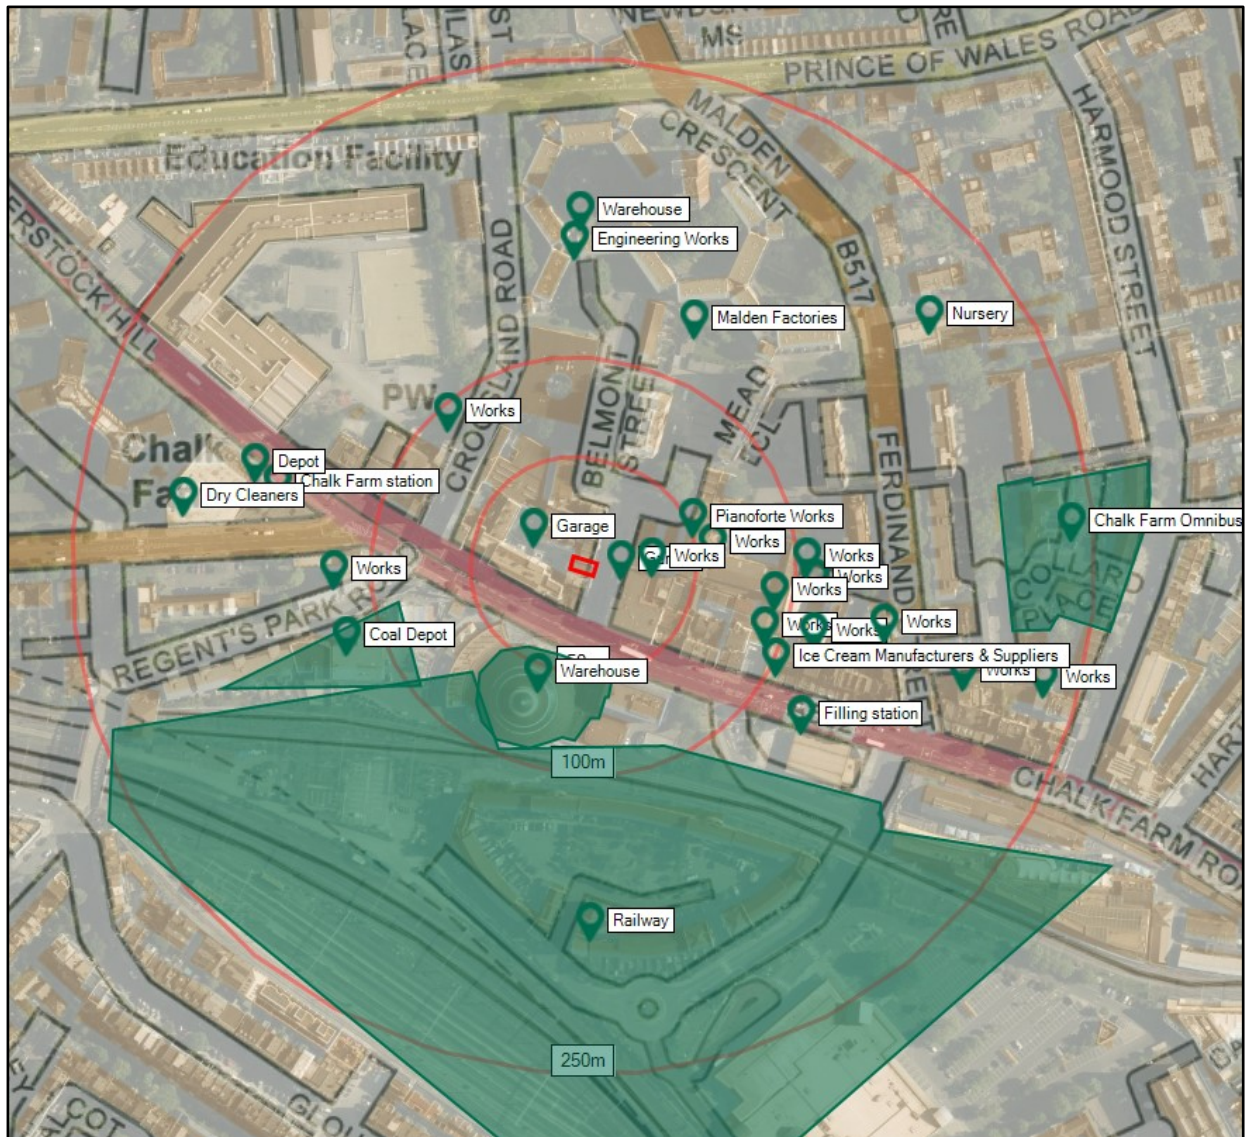
Figure 2: Potential sources of contamination within 250m of the site

Potentially contaminating commercial activities have been identified in the vicinity. The general topography falls to the south-east. This is assumed to be the general direction of the hydraulic gradient, therefore sources to the north-west and within the near vicinity are considered to have the most potential to impact the site. These include Garage, Works, Dry Cleaners and Depot.

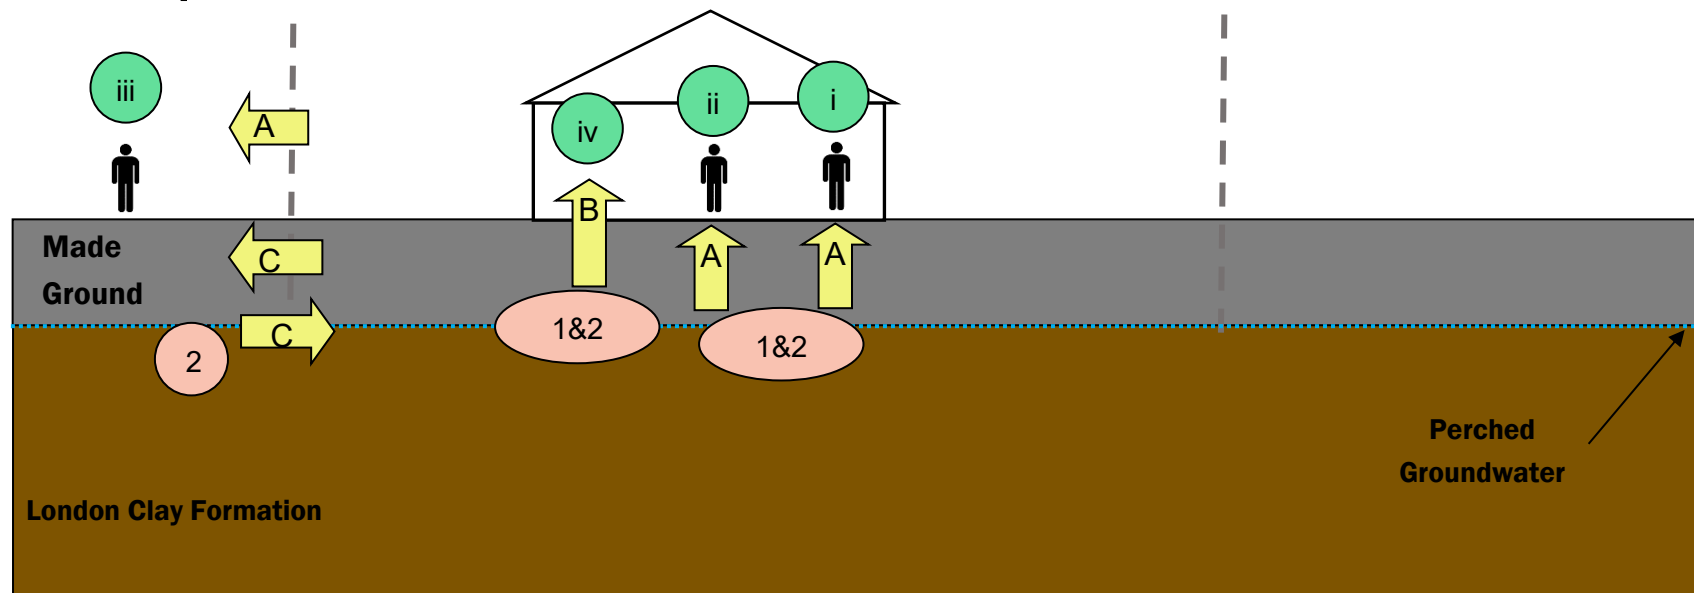
### Schematic Conceptual Model

Sources	Pathways	Receptors
<p>1 Made Ground (On Site)</p> <p>2 Commercial activity (Off Site)</p>	<p><b>A</b> → Inhalation, ingestion, dermal contact, vapours</p> <p><b>B</b> → Direct contact of soil with building materials</p> <p><b>C</b> → Migration via perched groundwater</p>	<p><b>i</b> Site Users</p> <p><b>ii</b> Ground Workers</p> <p><b>iii</b> Neighbours</p> <p><b>iv</b> Proposed Building</p>

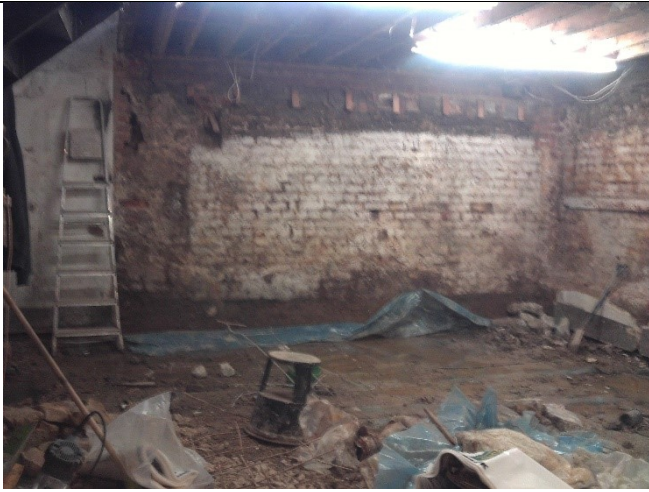
The basement consists of a wooden ceiling, brick walls, toilet and a sink. The basement slab has been removed and there is soil and the old damp proof membrane which is torn. The soil is wet and there are pockets groundwater flooding.

View east of basement

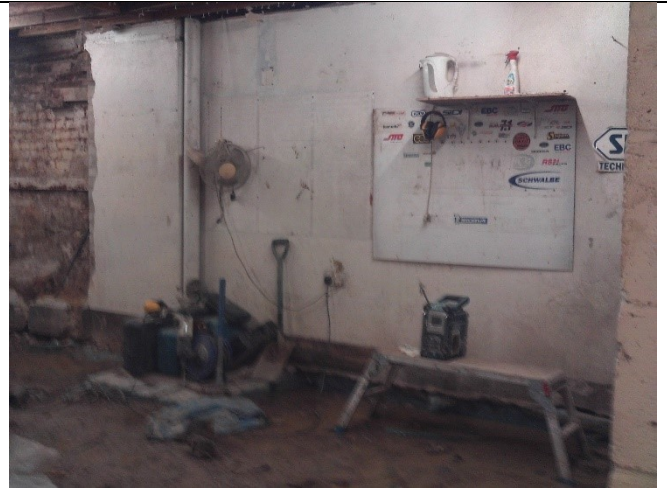
View north of basement

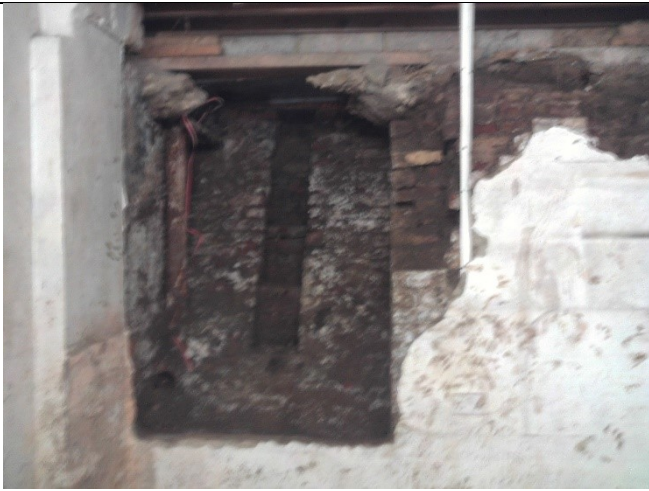
View north-east of basement

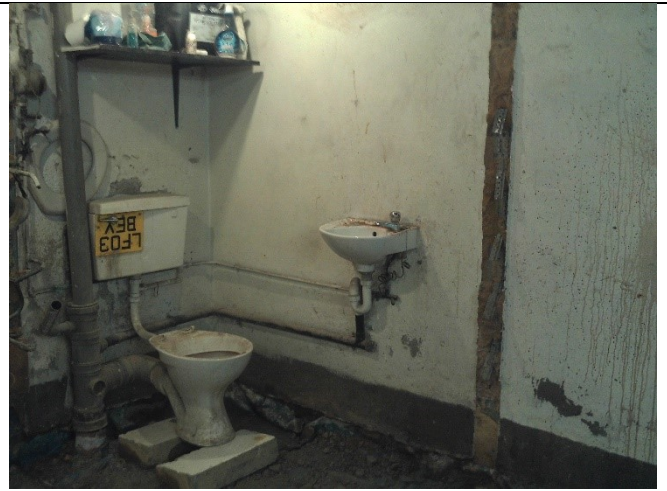
View south-east of basement

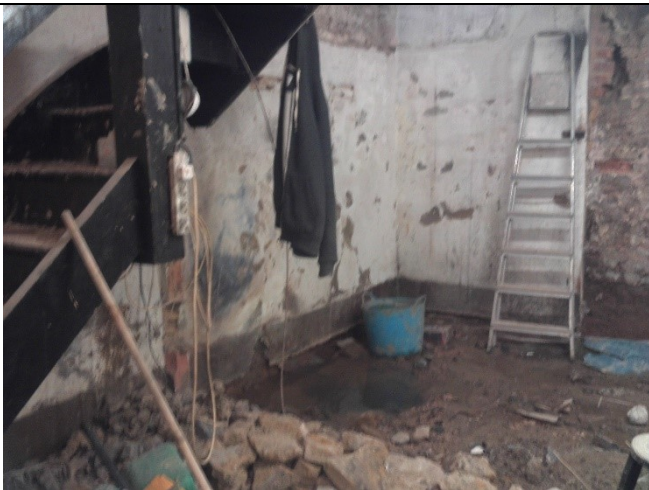
View south of basement

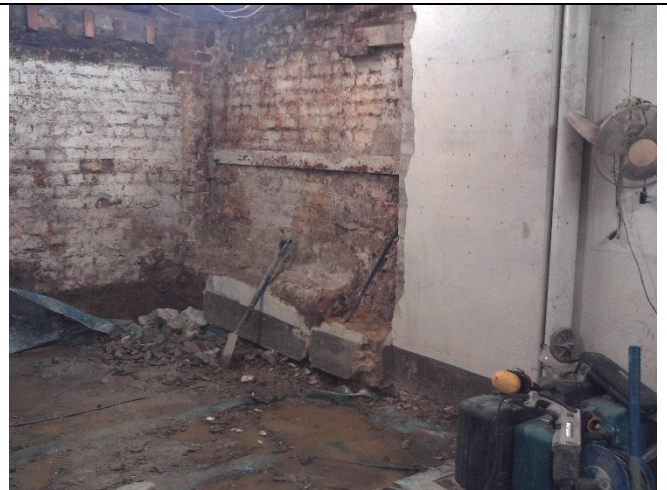
View north-west corner of basement
