**KEAT'S HOUSE**

**HAMPSTEAD, LONDON**

**ARCHAEOLOGICAL EVALUATION**

**FEBRUARY 2001**

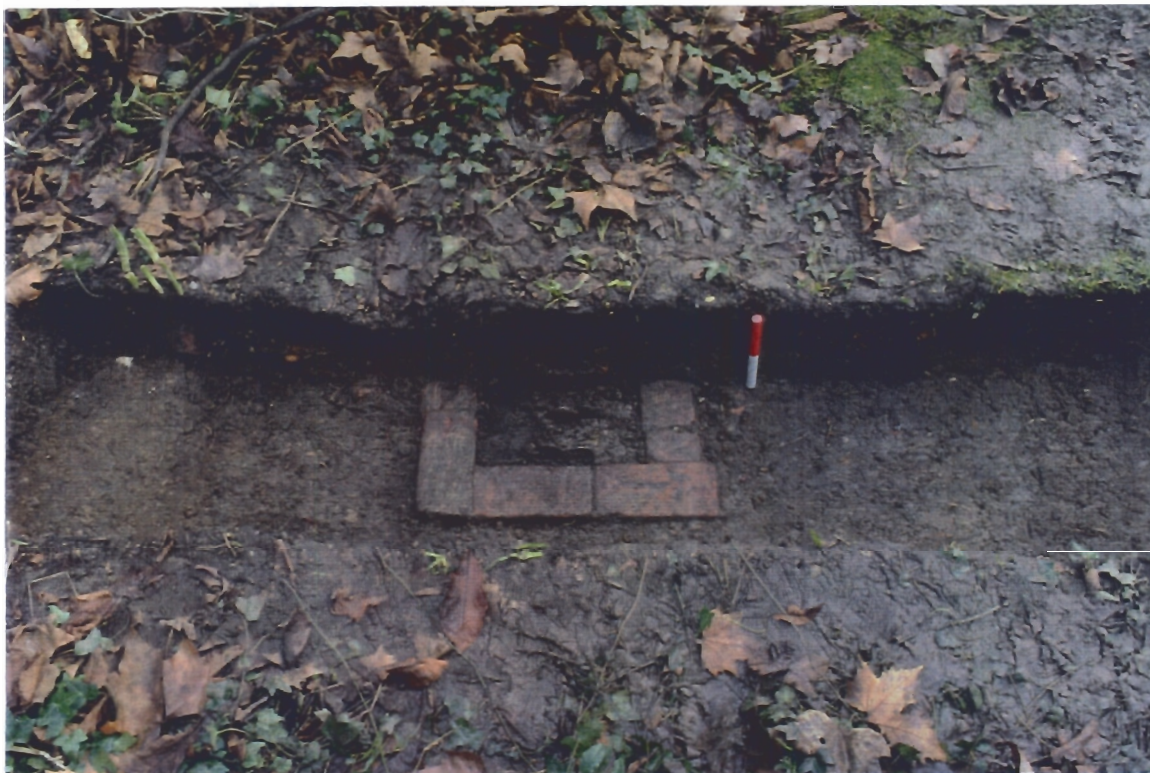
Fig. 8 Trench 3 showing the drain prior to full excavation . Looking to the south

Although the drain or soak away was of a similar construction to the drain recorded in trench 2 the slate detail was unique to trench 3. It is possible that the upright slates acted as a trap for debris, which would have otherwise blocked the outflow.

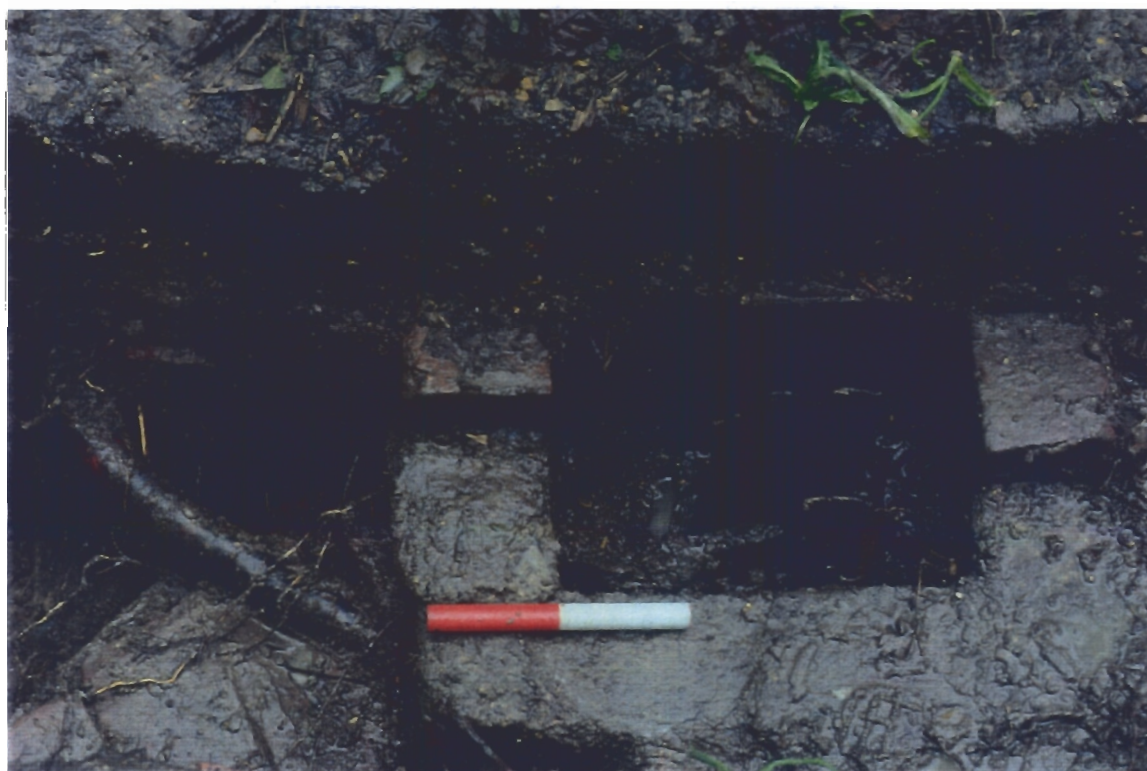
Fig. 9 Trench 3. The drain partially excavated showing slate detail. Looking to the south

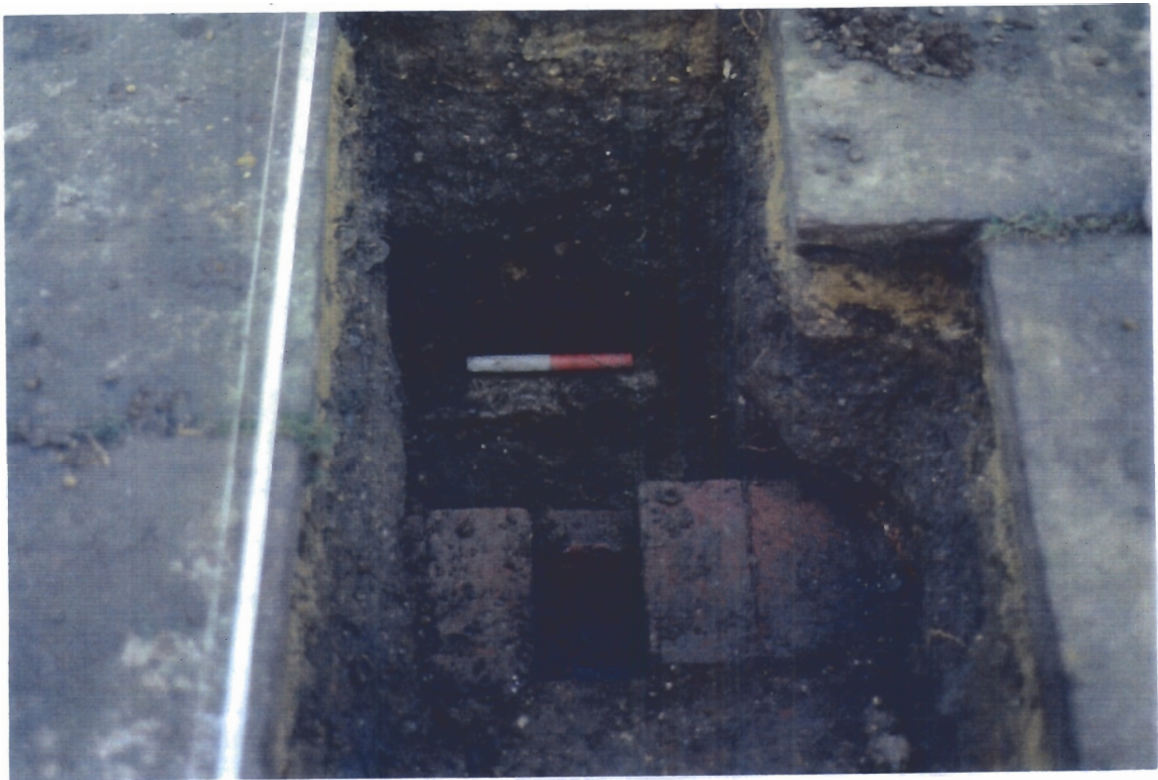
Fig.17 Trench 8, brick drain. Looking to then west.

A small earthenware land drain, running east/west within the buried soil [53] was recorded c0.15m below ground level towards the northern end of the trench. A brick drainage channel [54] was recorded at c0.4m below ground level near the centre of the trench. The channel, similar to that recorded in trench 3, ran east/west across the trench and appears to have been laid on the underlying natural clay before being buried by [51].

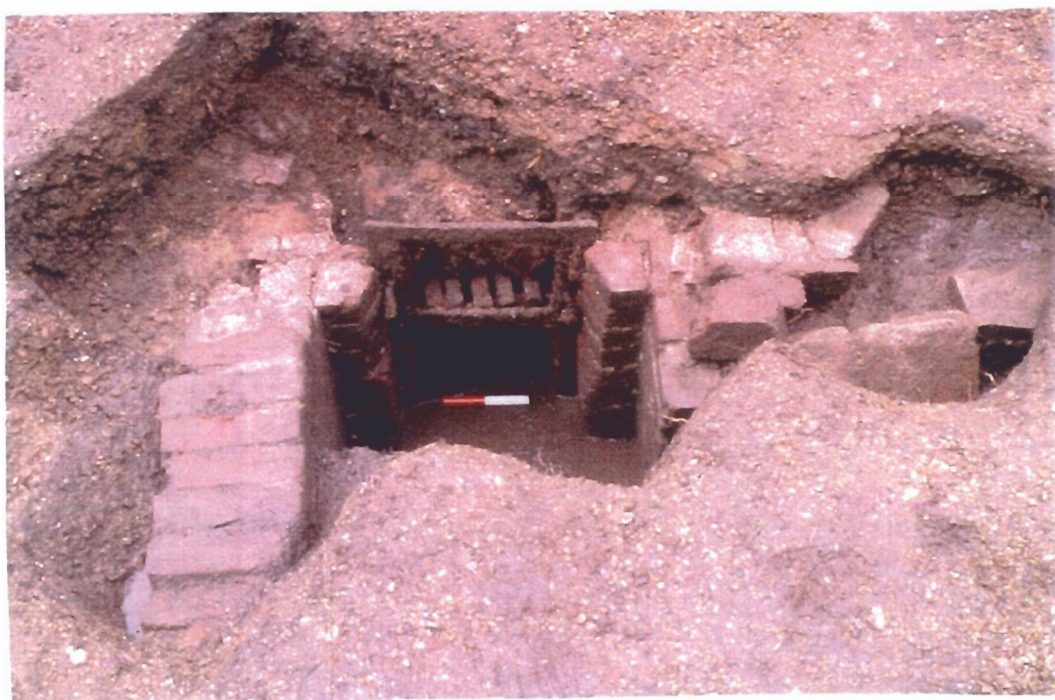
Fig18 Trench 10 showing detail of the fireplace. Looking to the north.

Rather than recording the corner foundations of the demolished conservatory the excavation appeared to have exposed the stock hole for a small stove which had been made in the south-east corner. A c9" wall (c22ms), [67], ran for an indeterminate length to the south-west of the firebox, and possibly supported steps leading down from ground level. The iron lintel [64] provided support for brickwork above the firebox. Fragmentary evidence for the foundations of the conservatory were recorded; the southern wall to the west of [67], and the eastern wall to the north of [66].

Evaluation of the remains of the conservatory exposed the external stock hole for the heating system and fragmentary evidence for foundation walls indicating that although the earlier conservatory had been demolished the foundation probably survived under debris from the demolished structure.
